Inspection Photos

API# 071-06436

Operator: Timber Creek

Inspection Number: 680102775

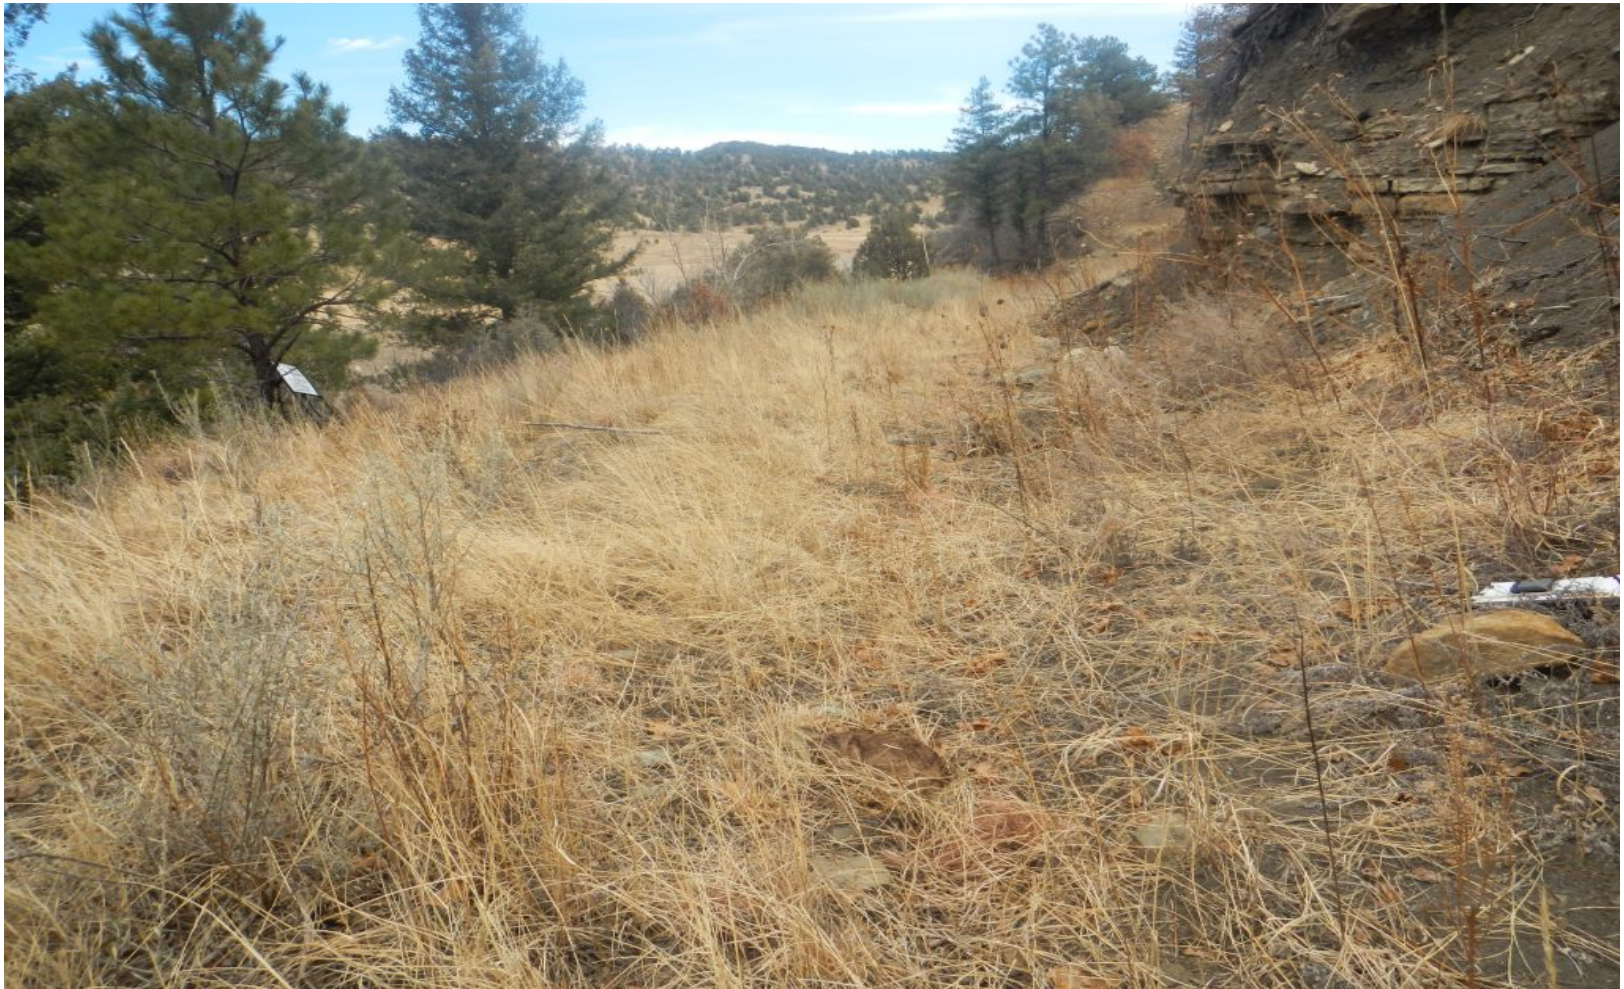
Photo#1:
Overview of Location to Northeast.

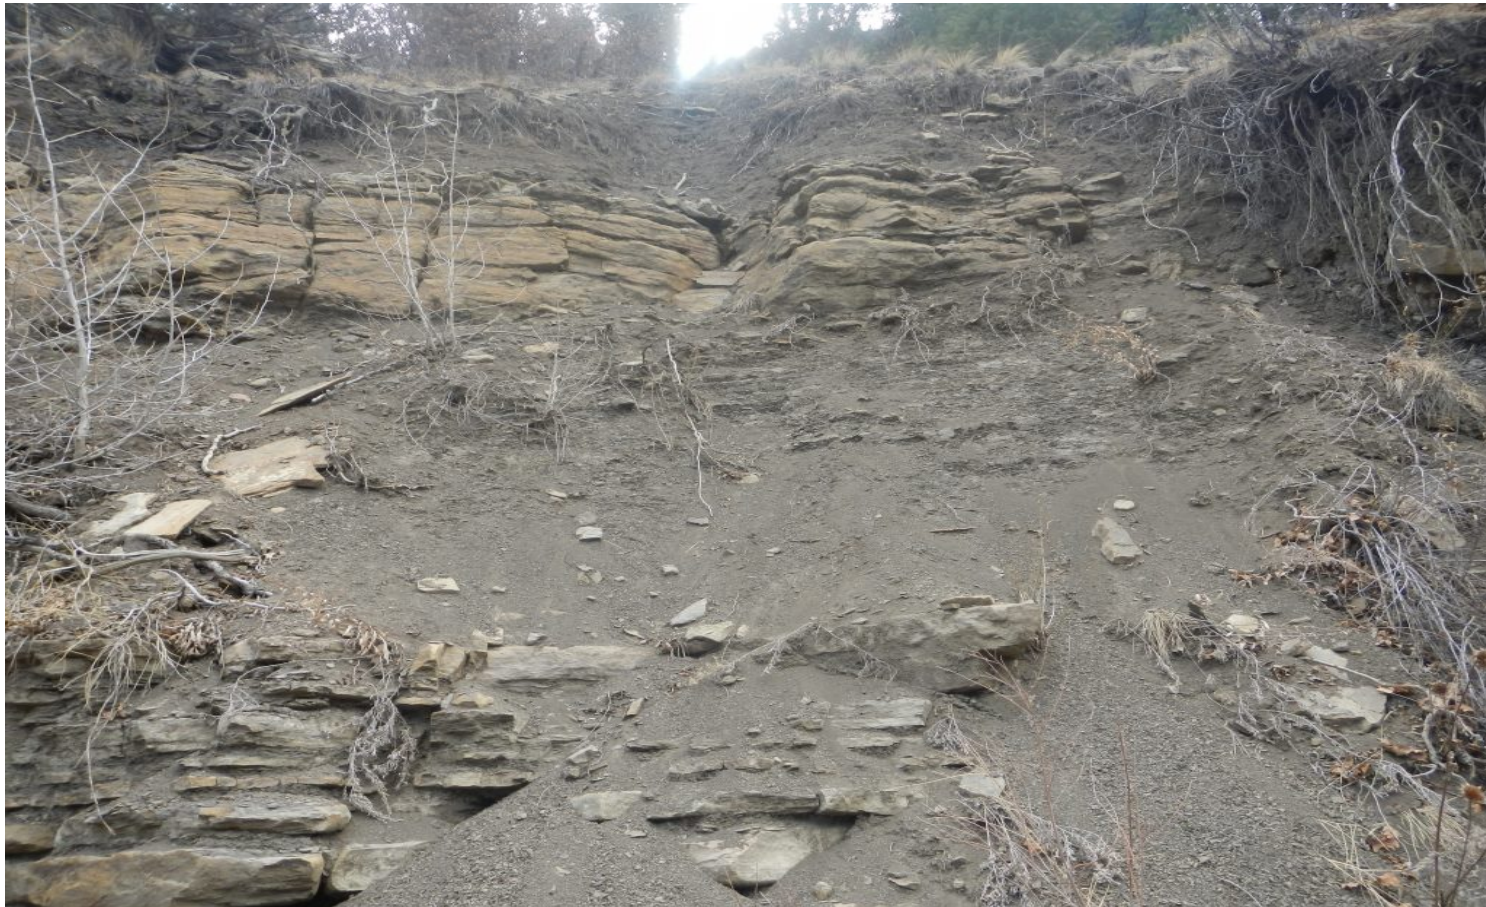
Photo#2:
Unstable conditions of East Cut Bank of Access Rd.

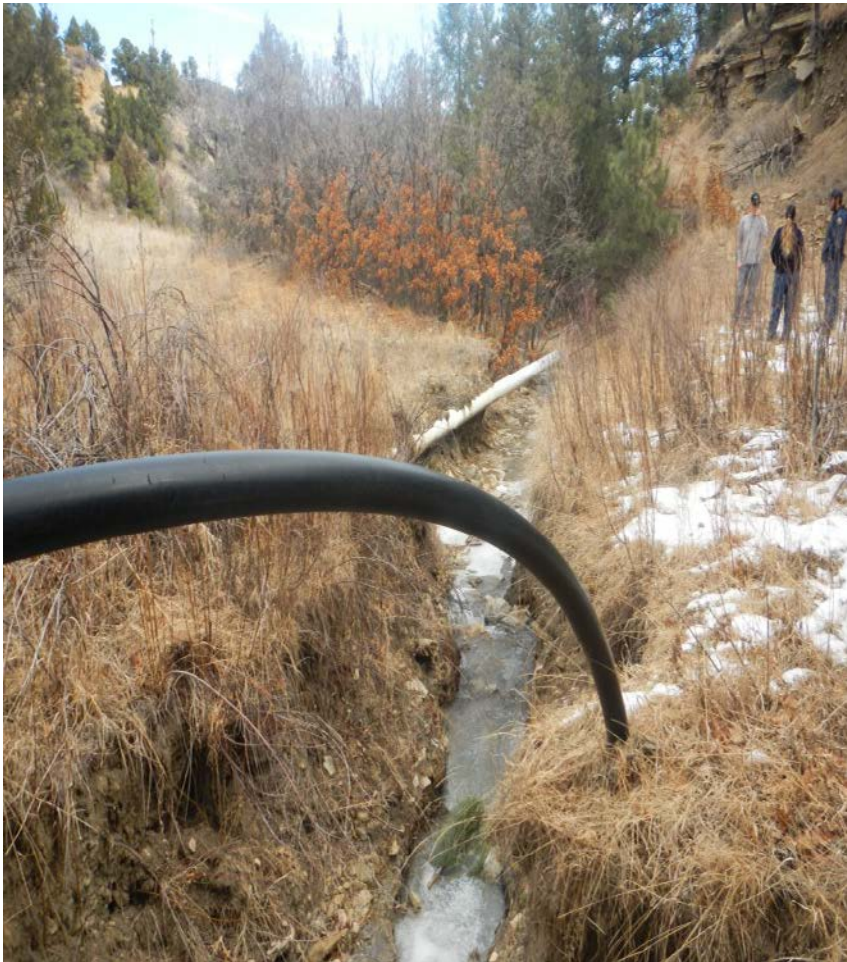
Photo#3:
Plastic & Metal Piping, risers & valves remain
in creek bottom Southwest of Well.

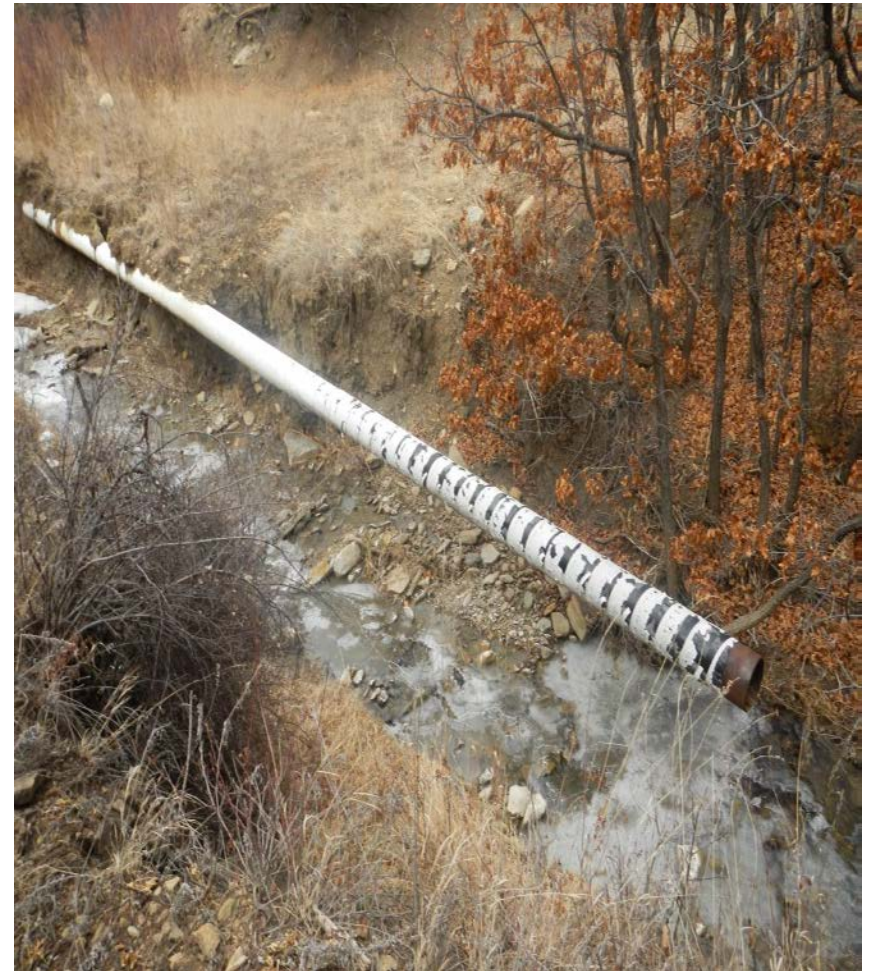
Photo#4:
Refer to Photo#3 description.

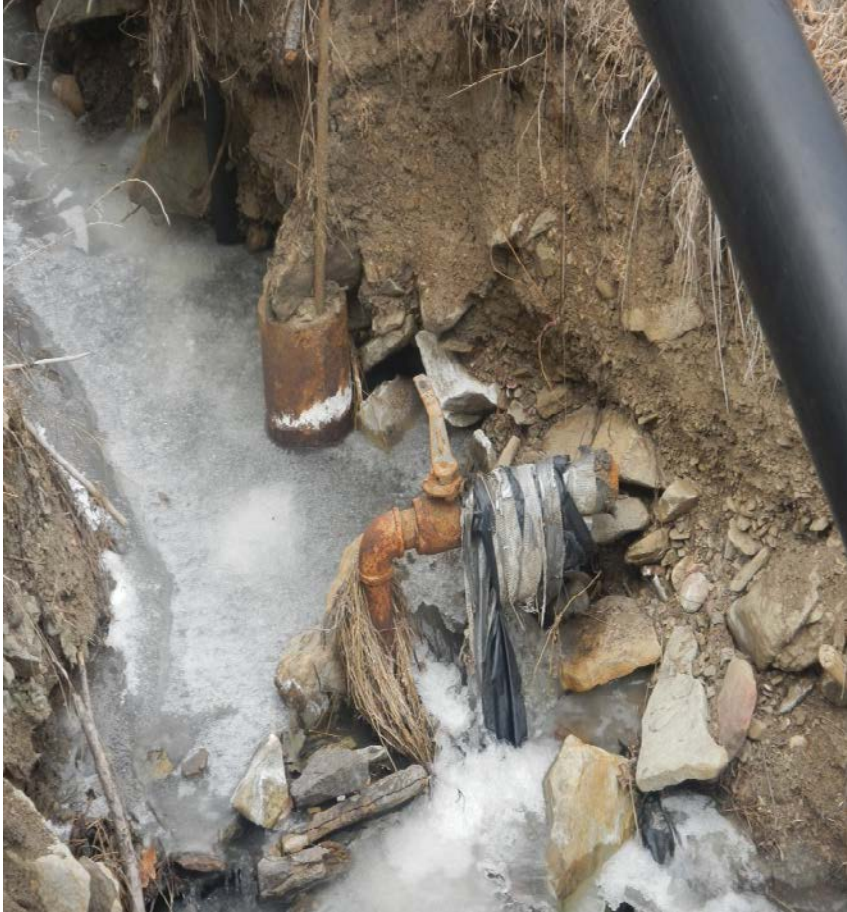
Photo#5:
Plastic & Metal Piping, risers & valves remain
in creek bottom Southwest of Well.

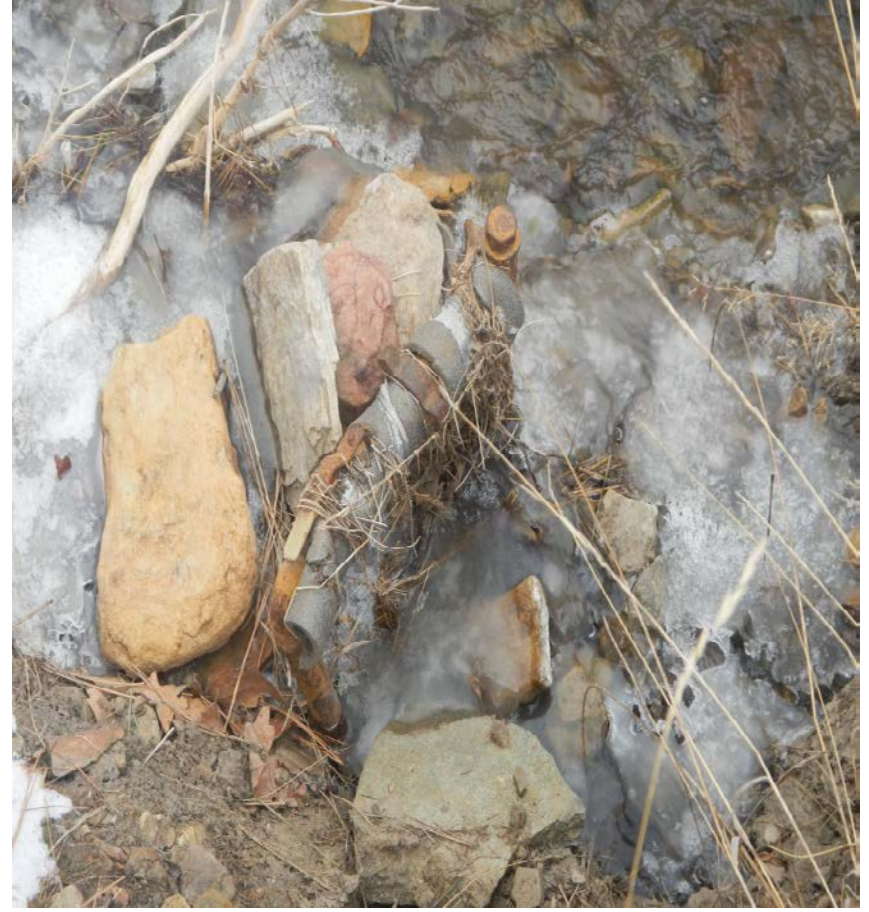
Photo#6:
Refer to Photo#5 description.

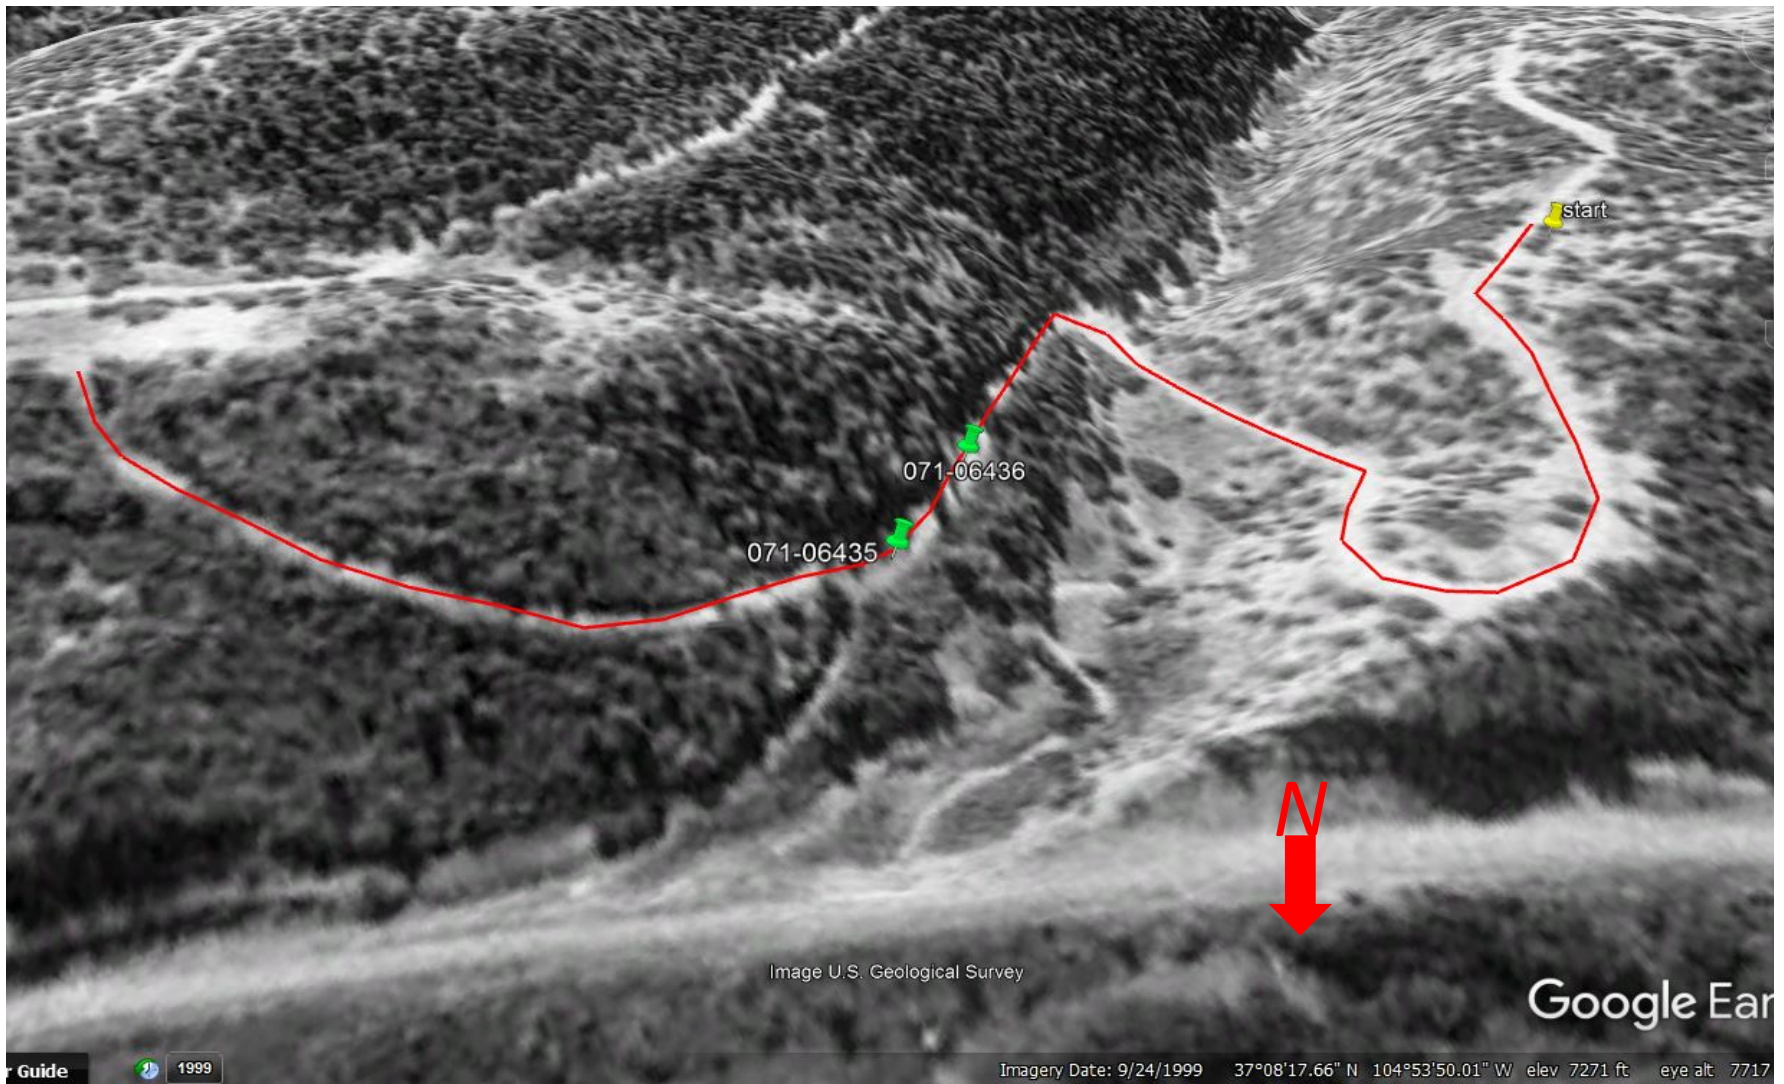
Photo#7:

1999 Path of Access Rd; view From North to South for better visibility.

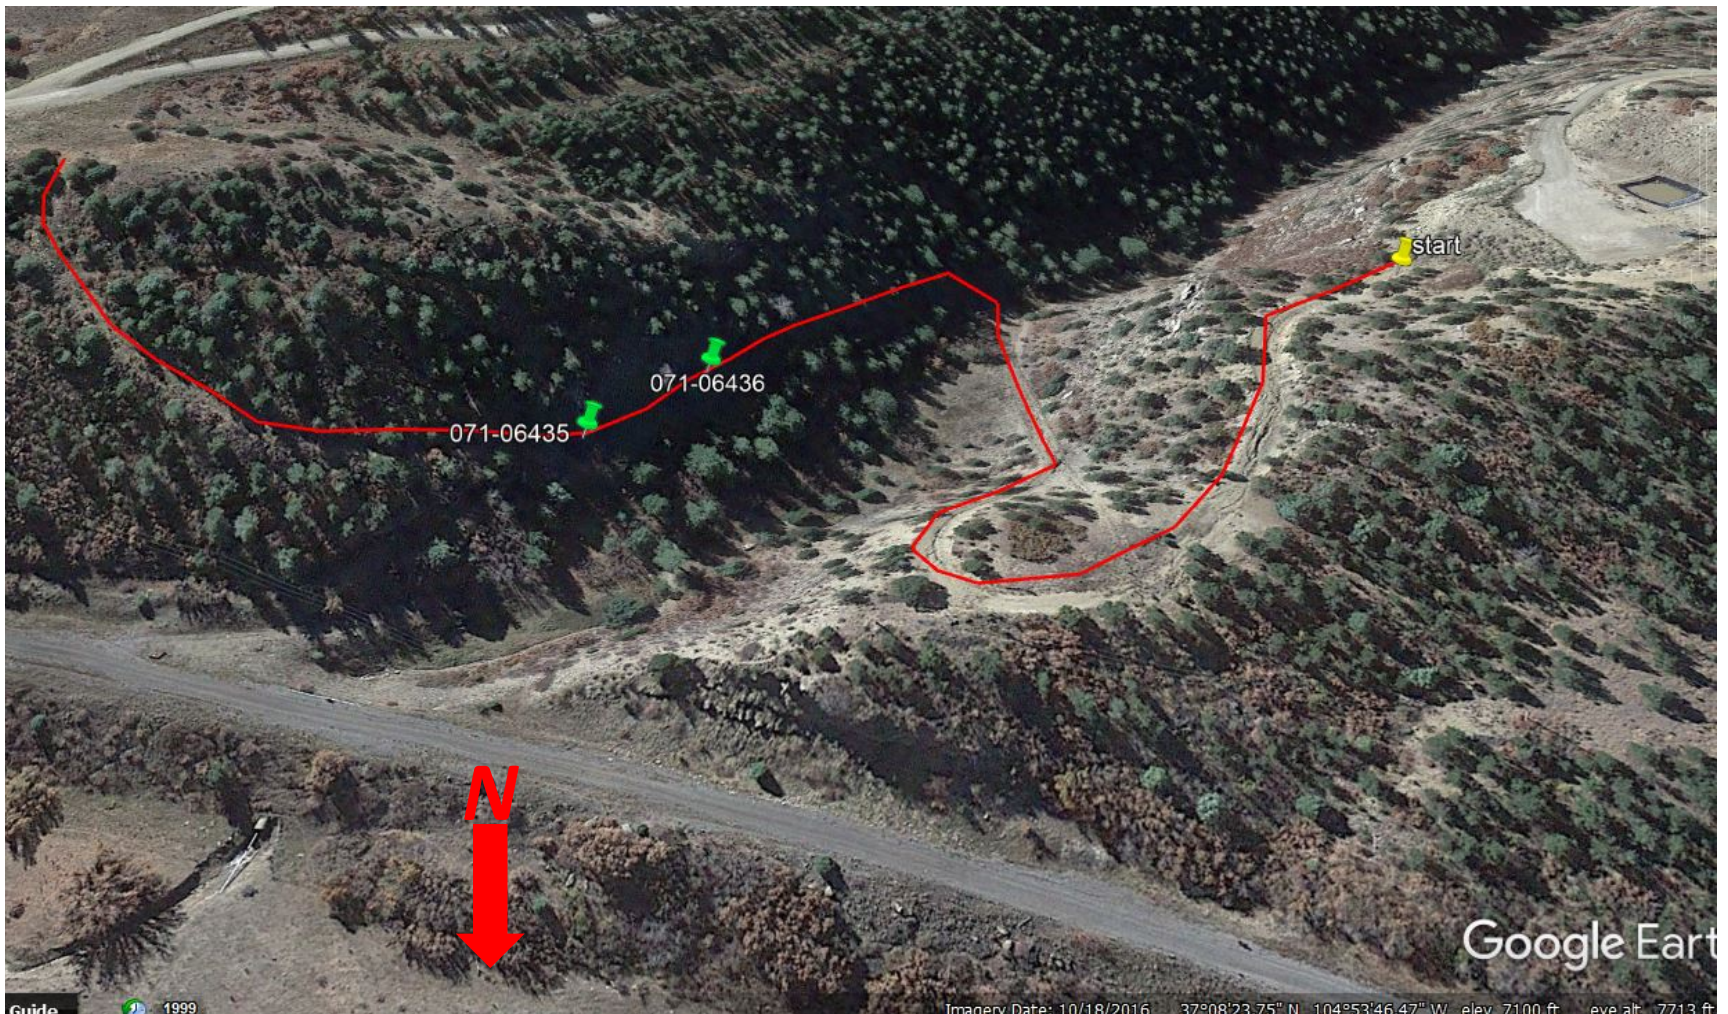
Photo#8:

2016 Path of Access Rd; view From North to South for better visibility. Location was built at Start pin since 1999 Aerial, shortening Access Rd to be reclaimed.
