# Inspection Photos

API: 05-067-08146

Operator: SG INTERESTS I LTD

Inspection Date: 3/7/2018

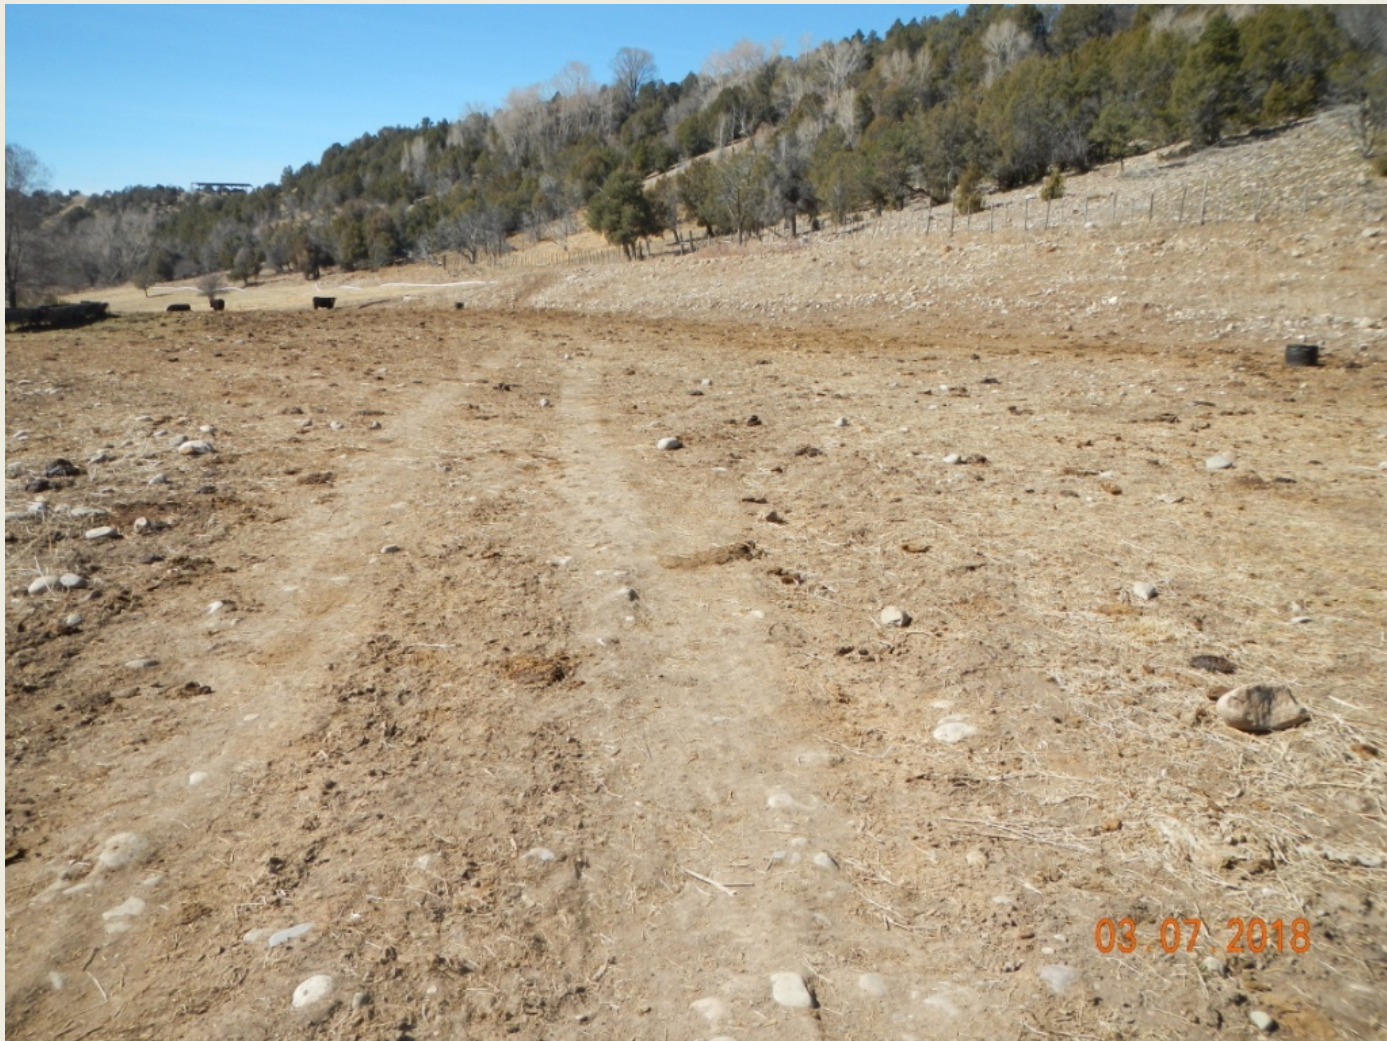
**Photo 1. View of the project area from the northeastern corner facing center. Well pad is constructed and not reclaimed. Cut-slopes are evident.**

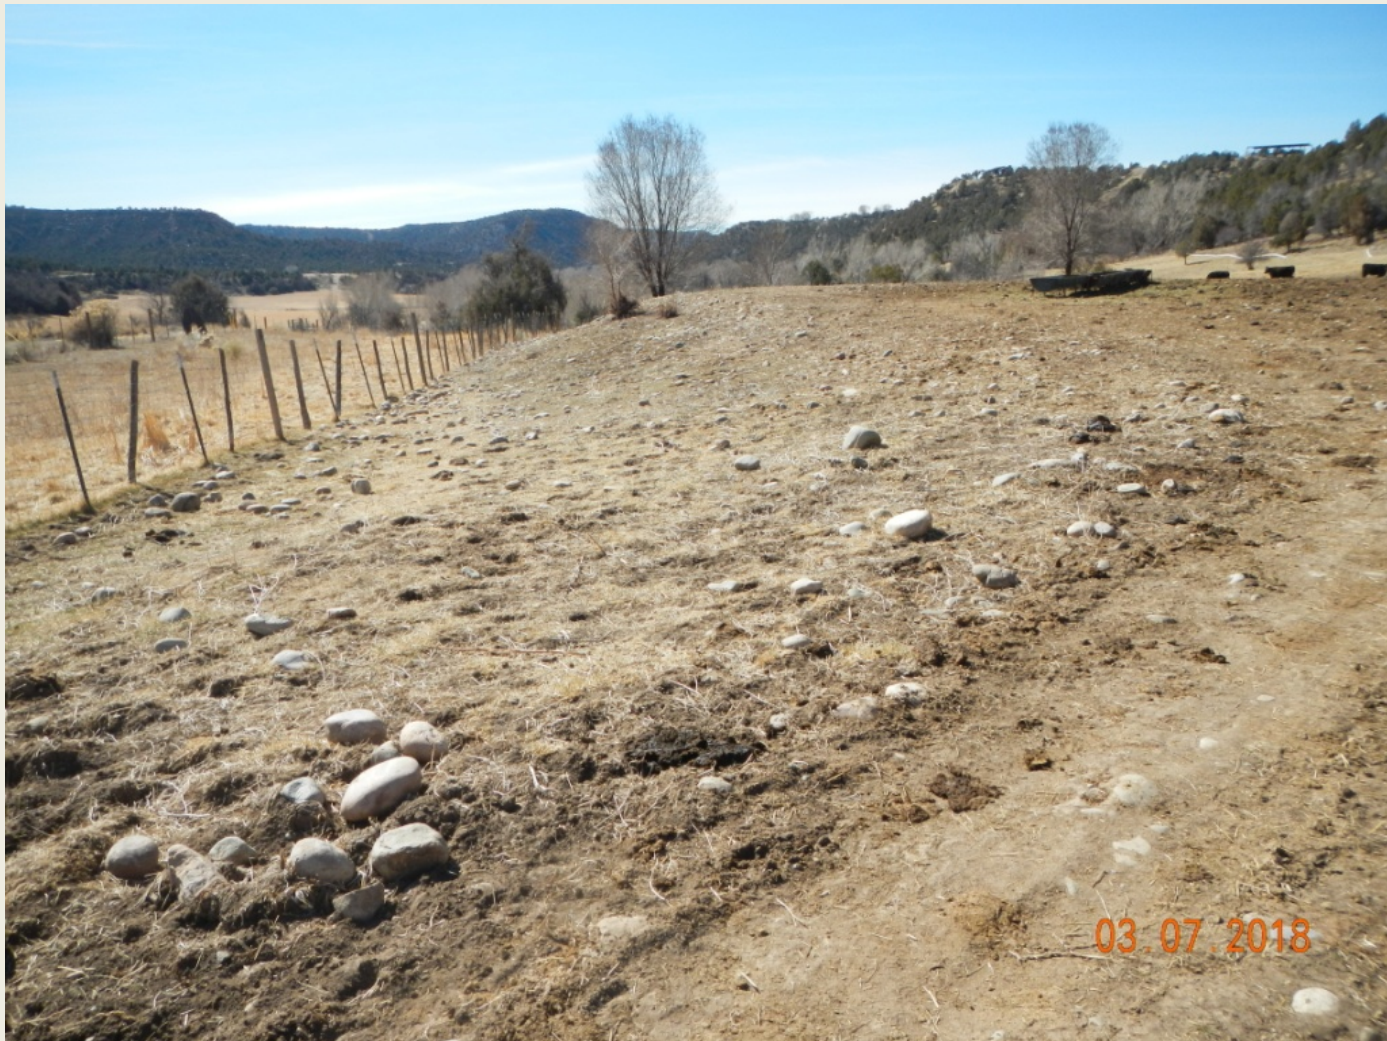
**Photo 2. View of the eastern portion of the well pad from the northeastern corner facing southward. Well pad fill-slopes are evident.**

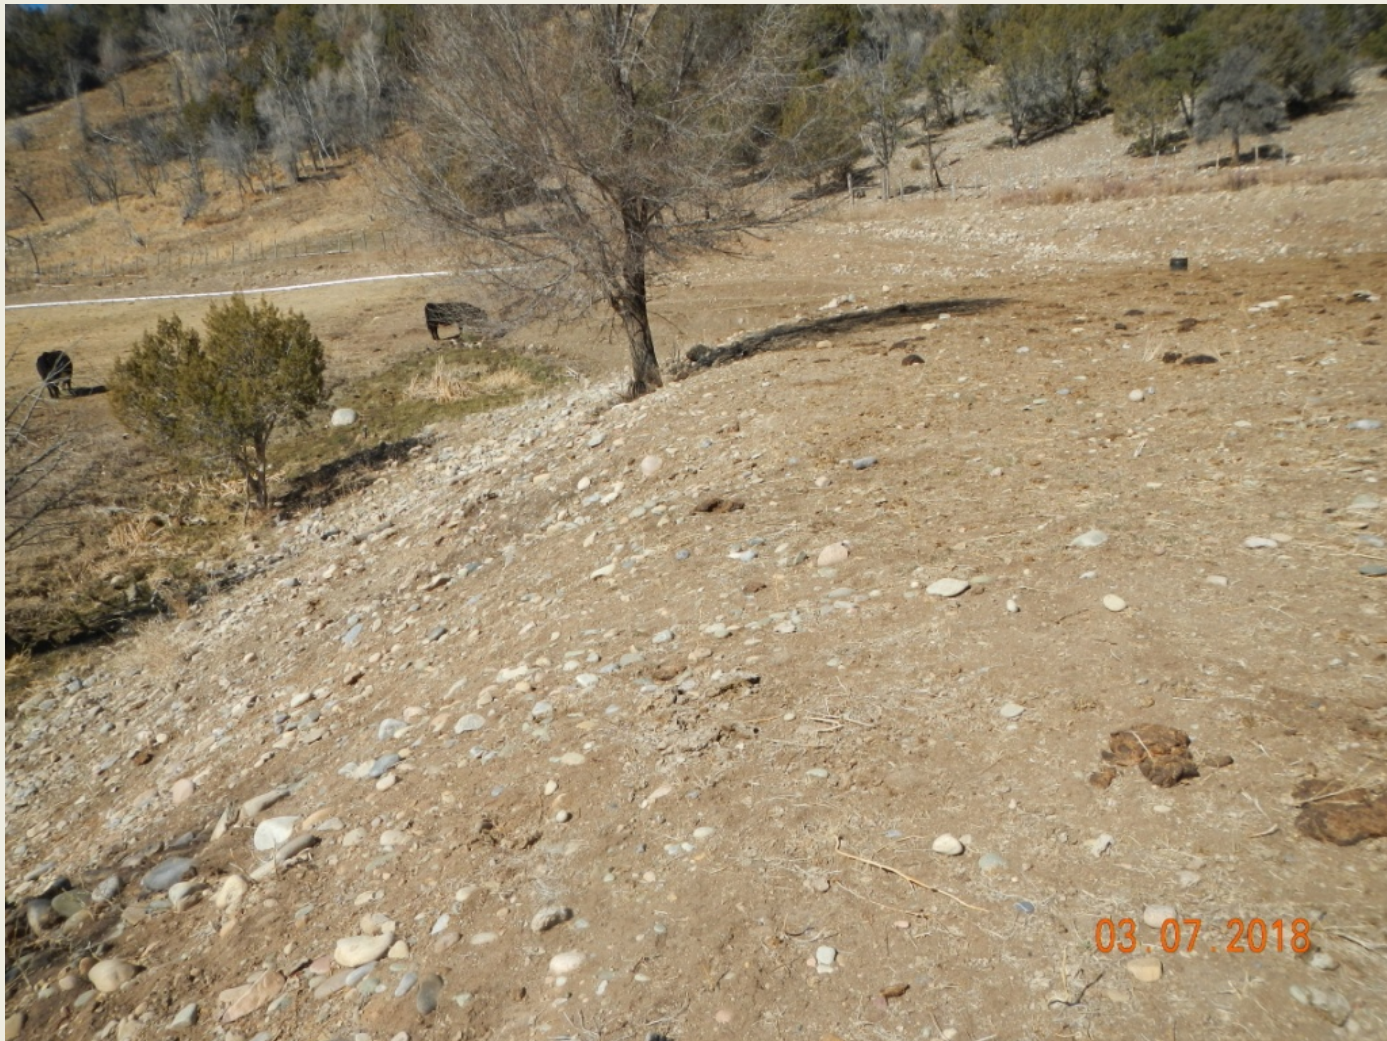
**Photo 3. View of the southern portion of the project area from the southeastern corner facing westward. Soils are rocky with little vegetation. Fill is elevated from adjacent contour by approximately 10 to 12 feet.**

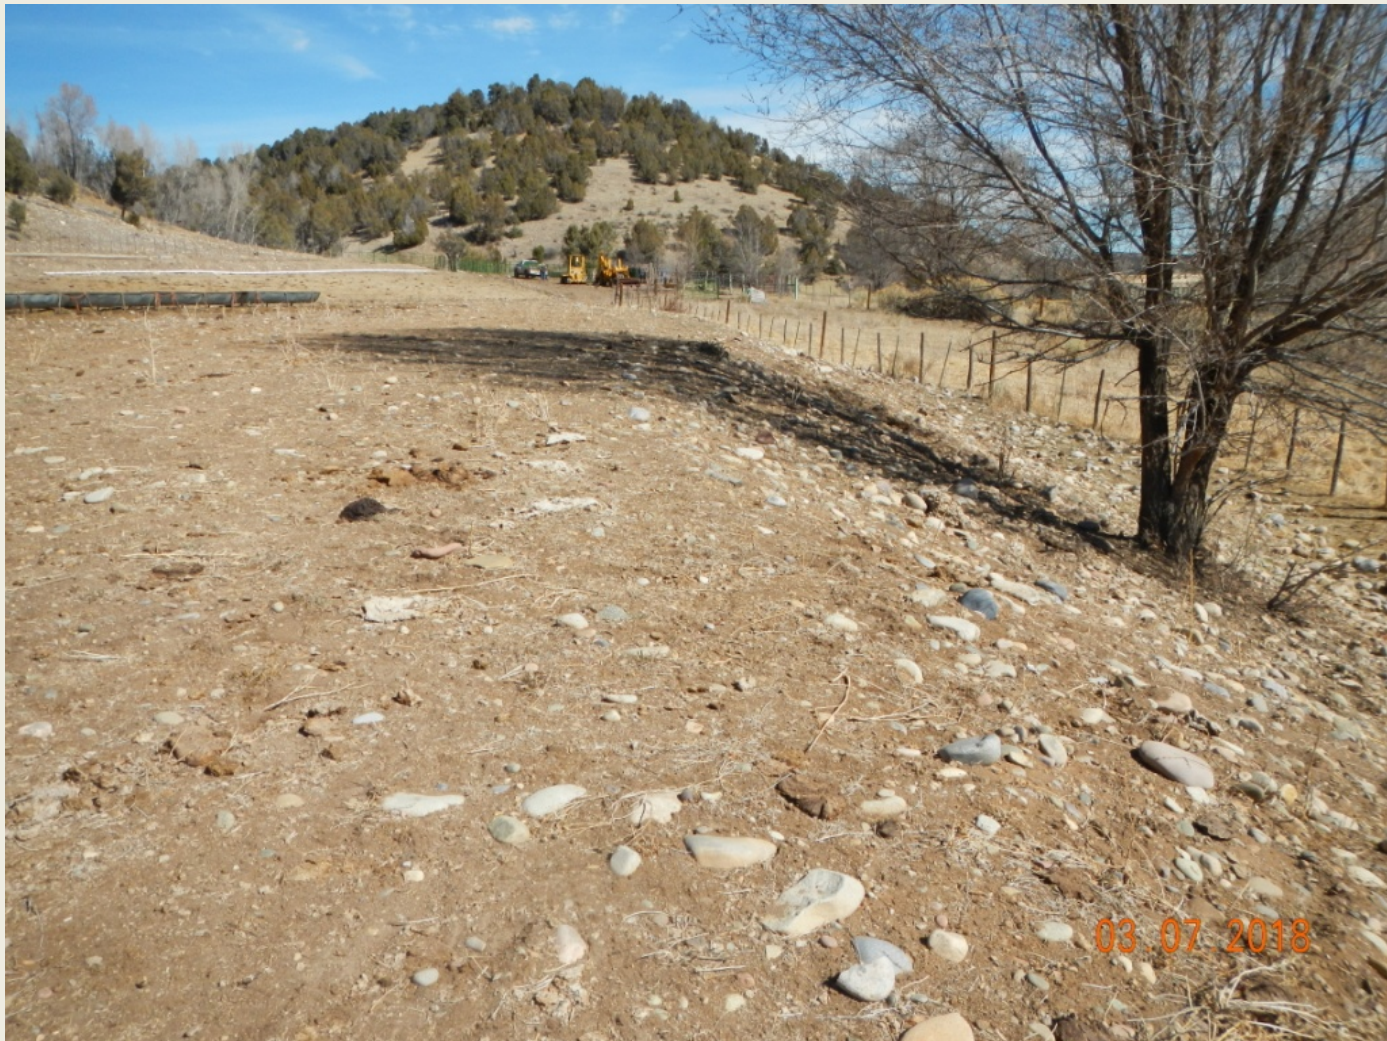
**Photo 4. View of the eastern portion of the project area from the southeastern edge facing northward.**

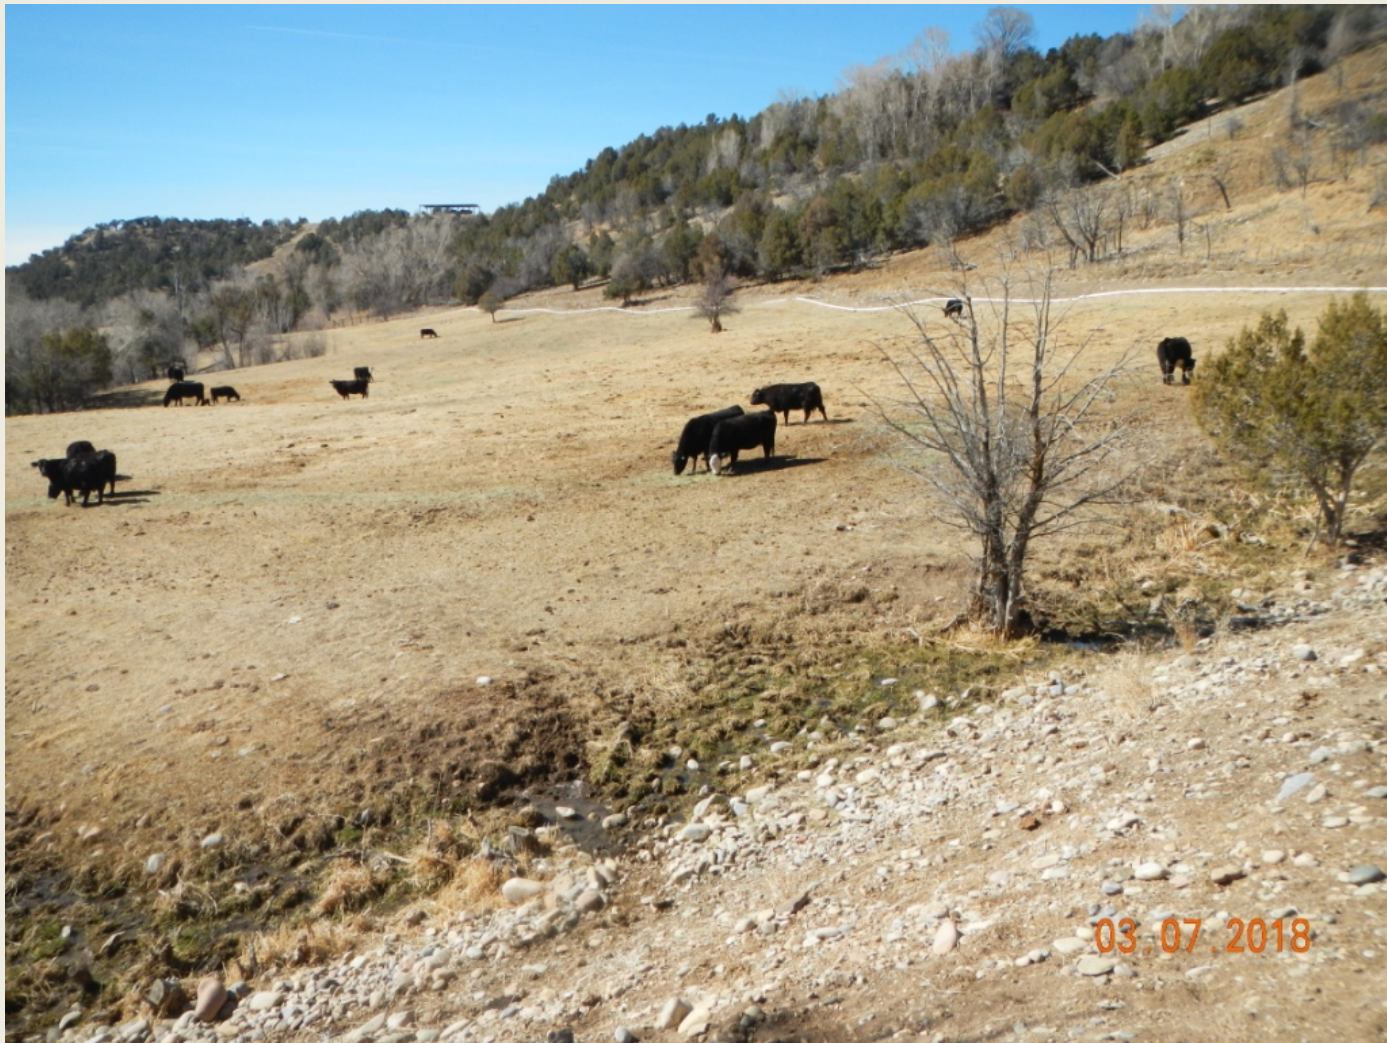
**Photo 5. View of reference area south of the well pad.**
