Inspection Photos
Location Name: Dowler #1A
API: 05-067-06406

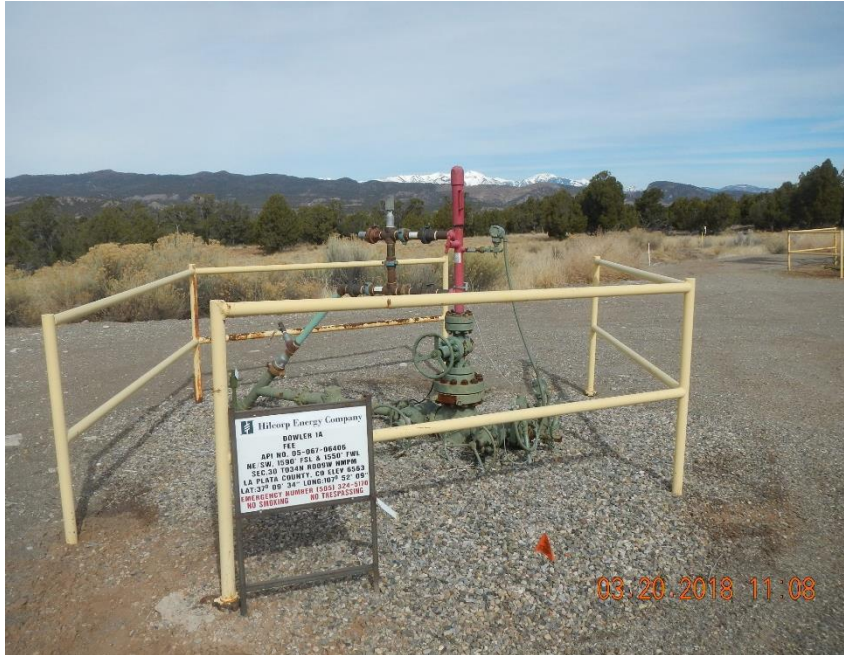
Dowler #1A well head.

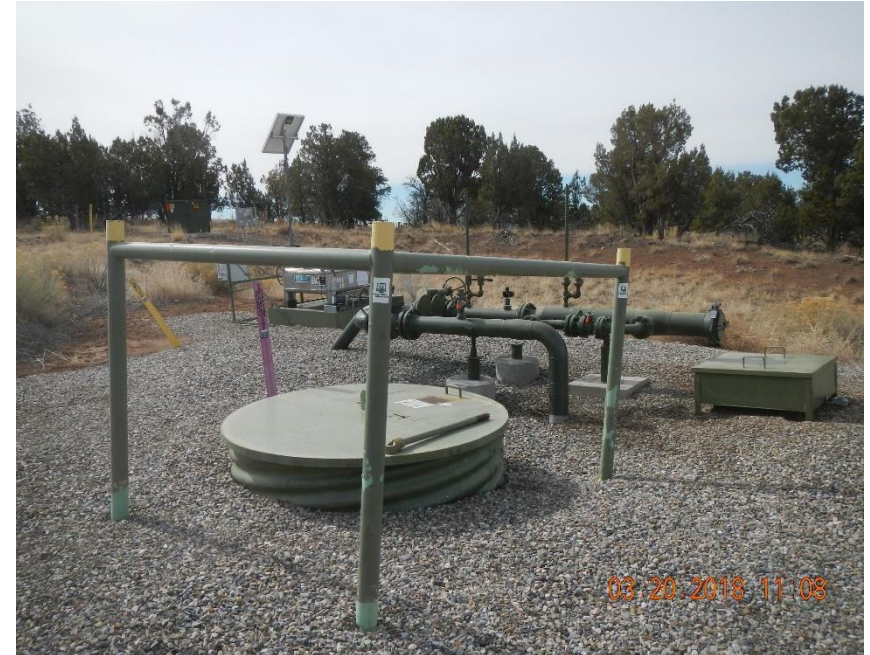
Below grade valve access and pig launcher.

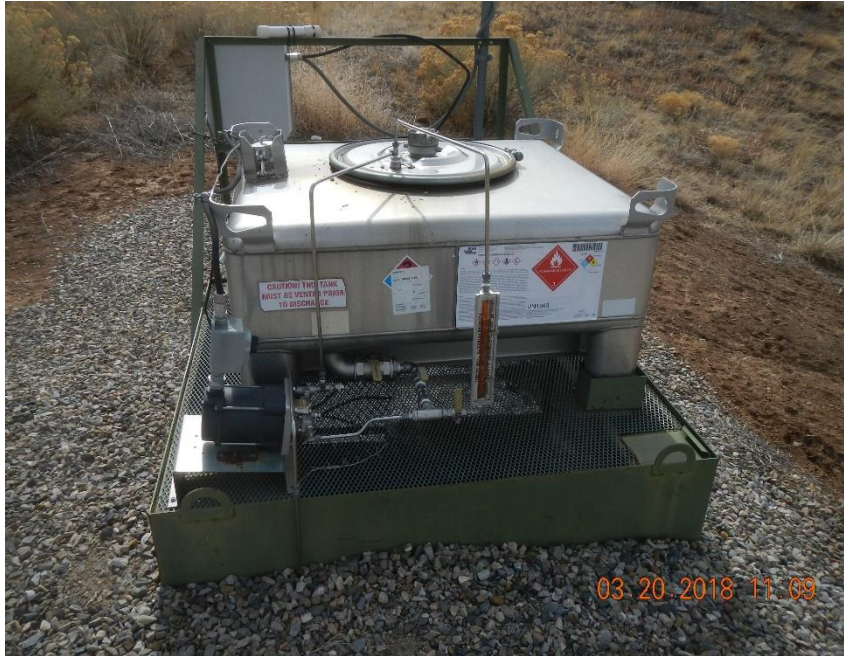
Chemical injection system on secondary containment.

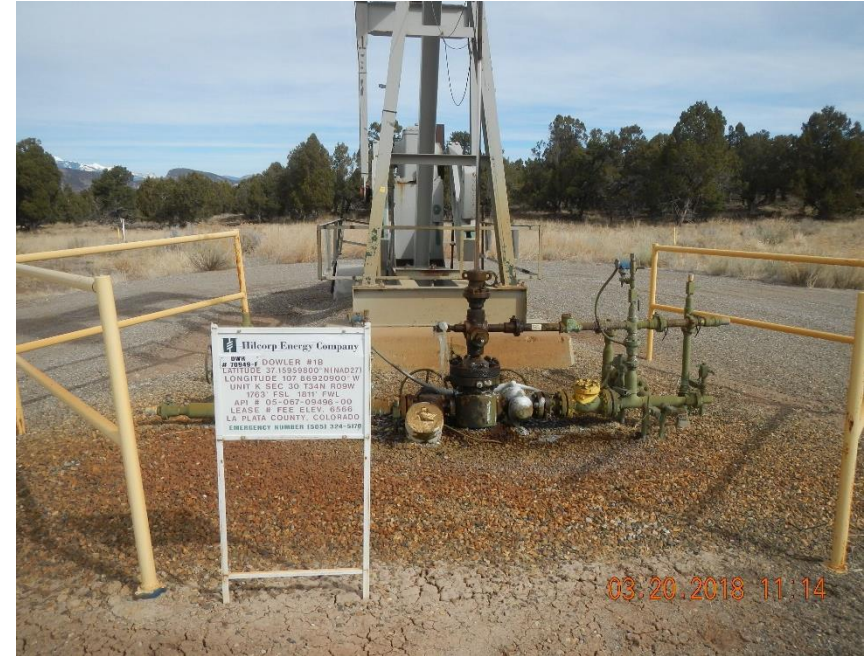
Dowler #1B well head.

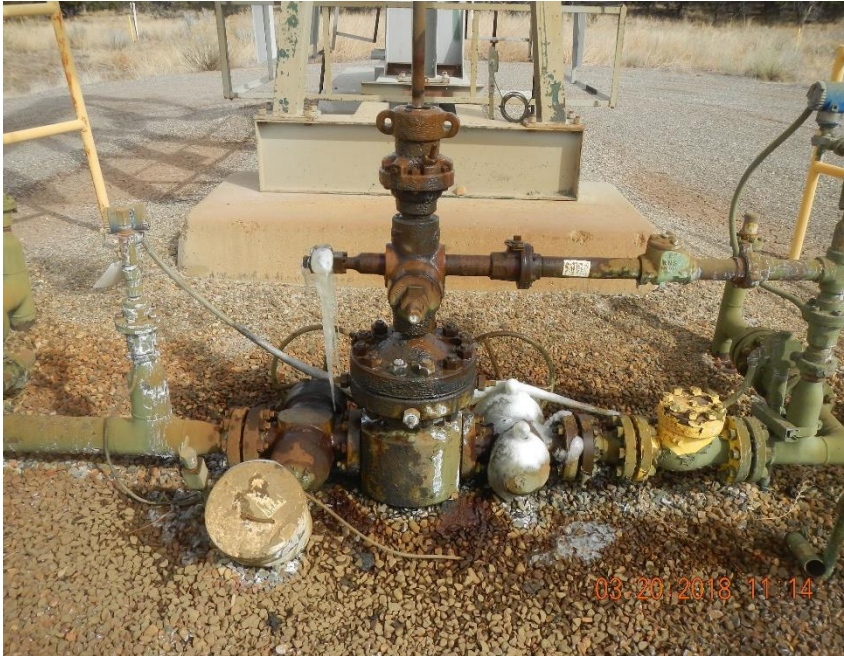
**Well head packing was leaking during this field inspection.
Ice had formed on well head and production piping.**

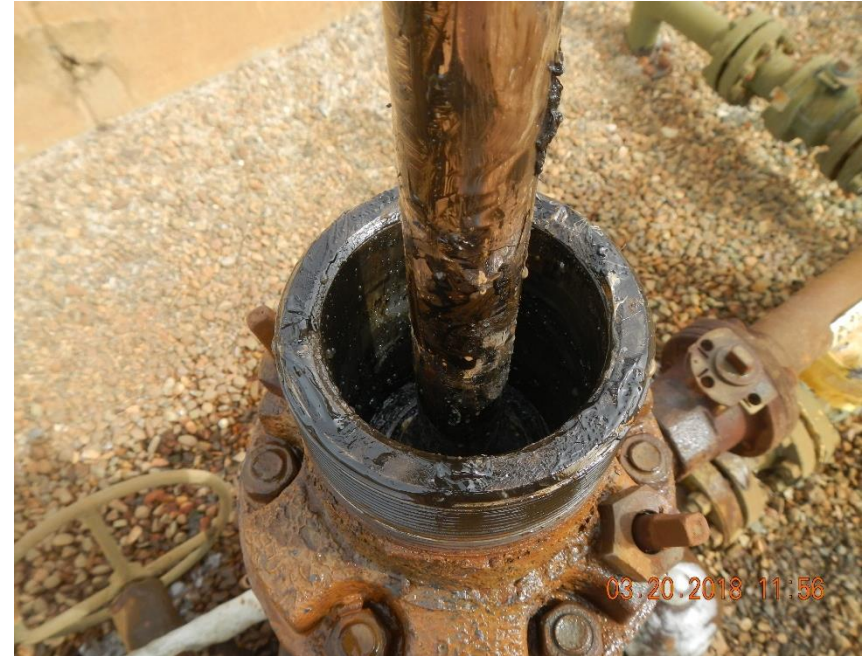
Worn out packing rings were allowing gas and fluids to escape.
