Inspection Photos
Location Name: DF Ranch #17-34
Location ID: 302912

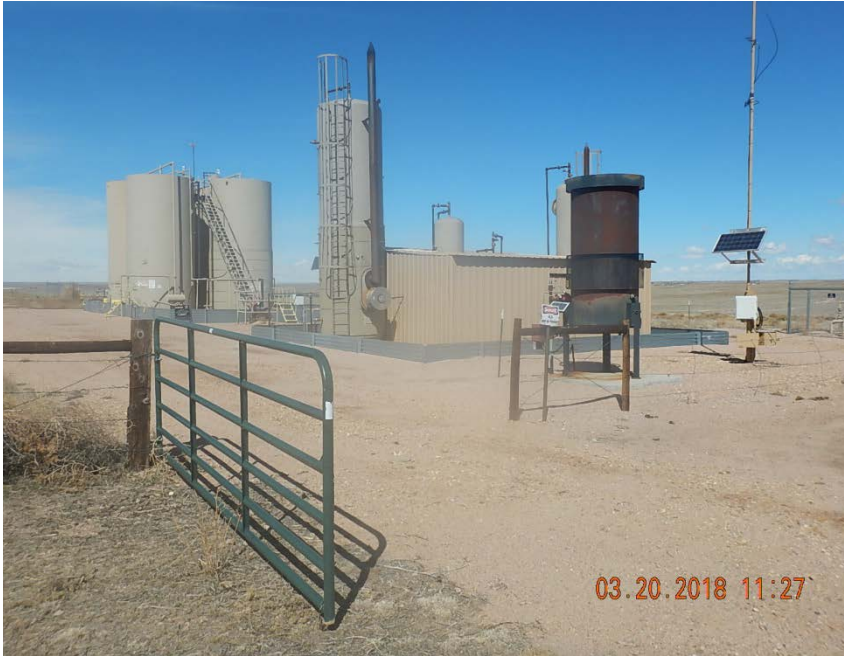
Photo 1: Location, looking NW

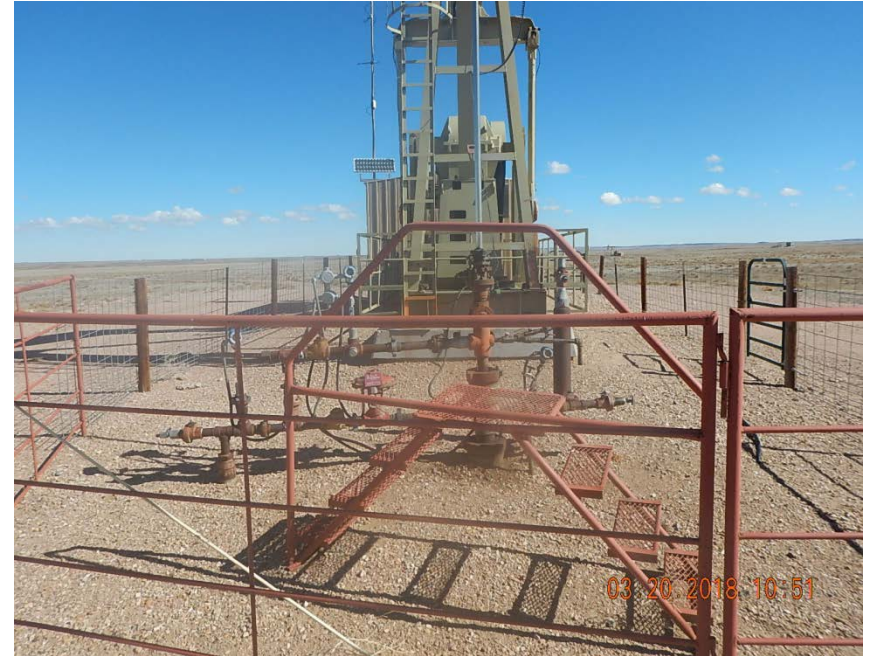
Photo 2: Wellhead, looking N

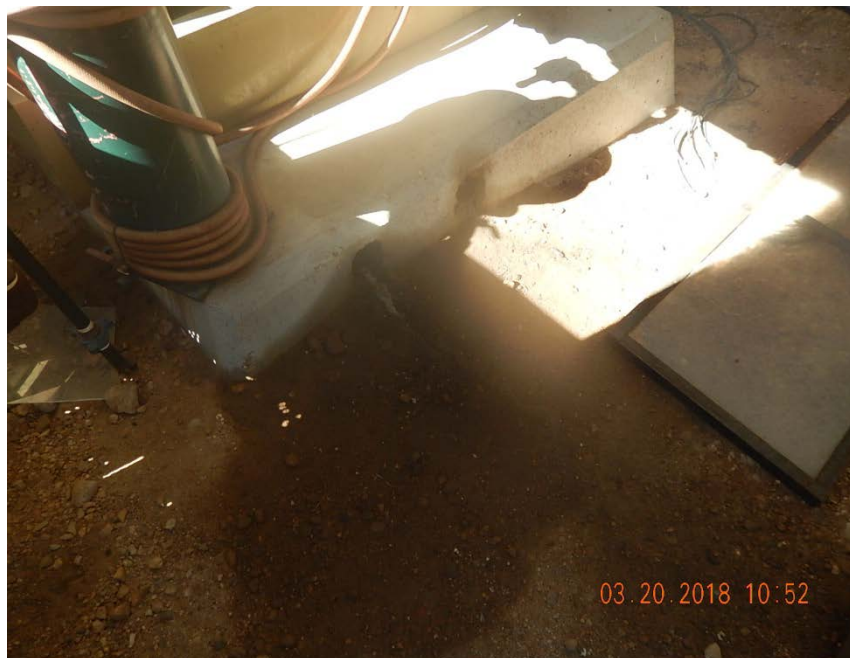
Photo 3: Stained soil, residue at engine

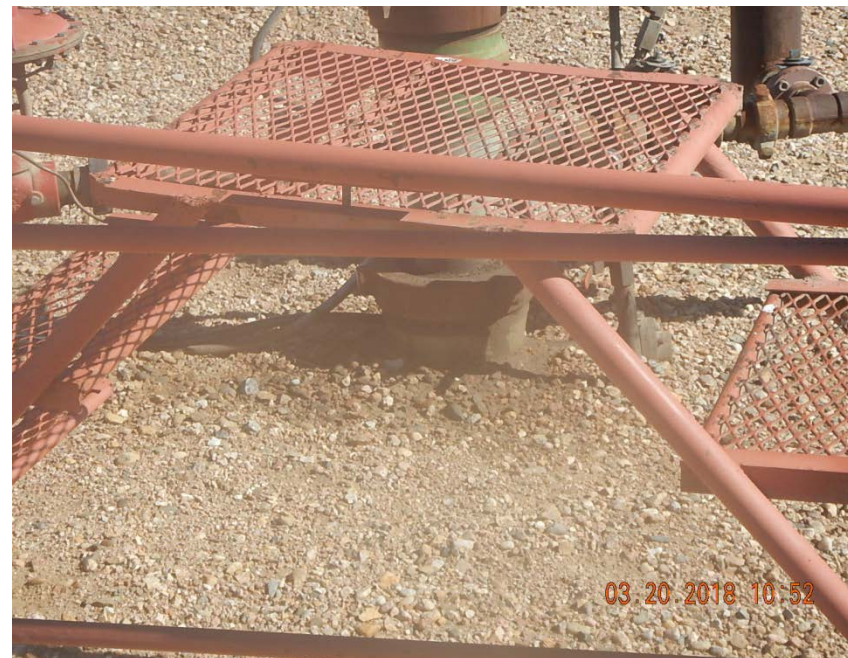
Photo 4: Stained soil at wellhead

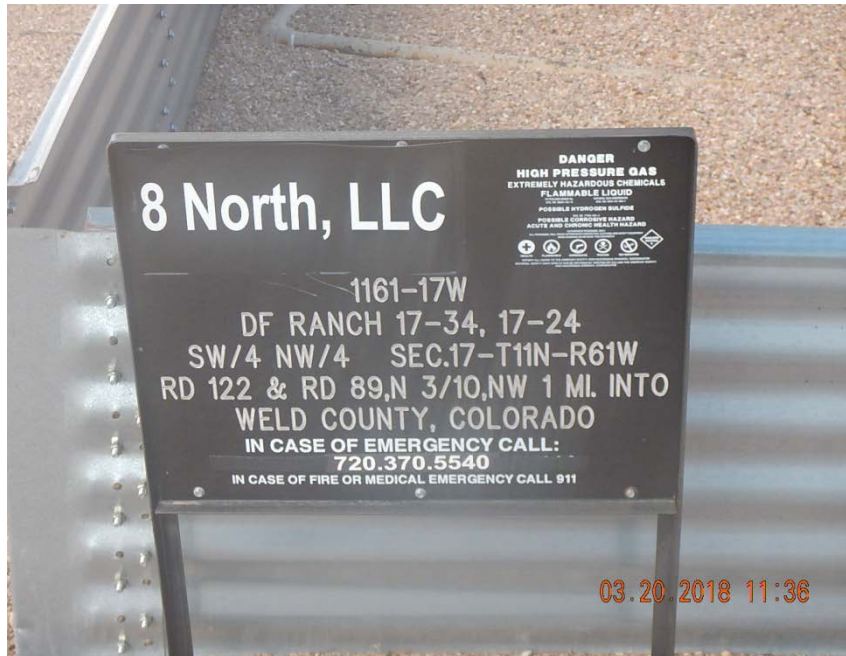
Photo 5: Battery sign is inaccurate
