Inspection Photos
Location Name: Gallegos PC GJ #13-99HZ
Location ID: 417344

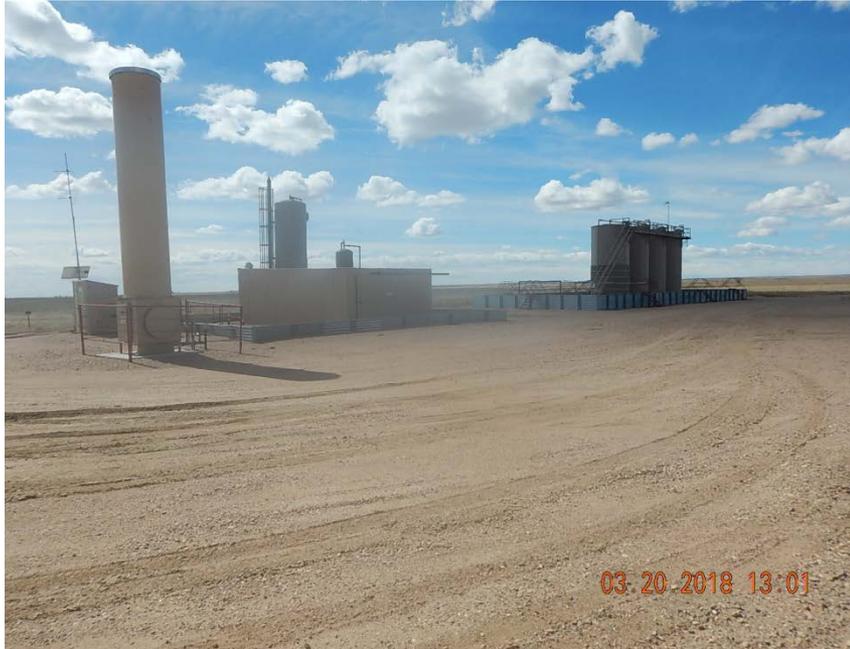
Photo 1: Location, looking SW

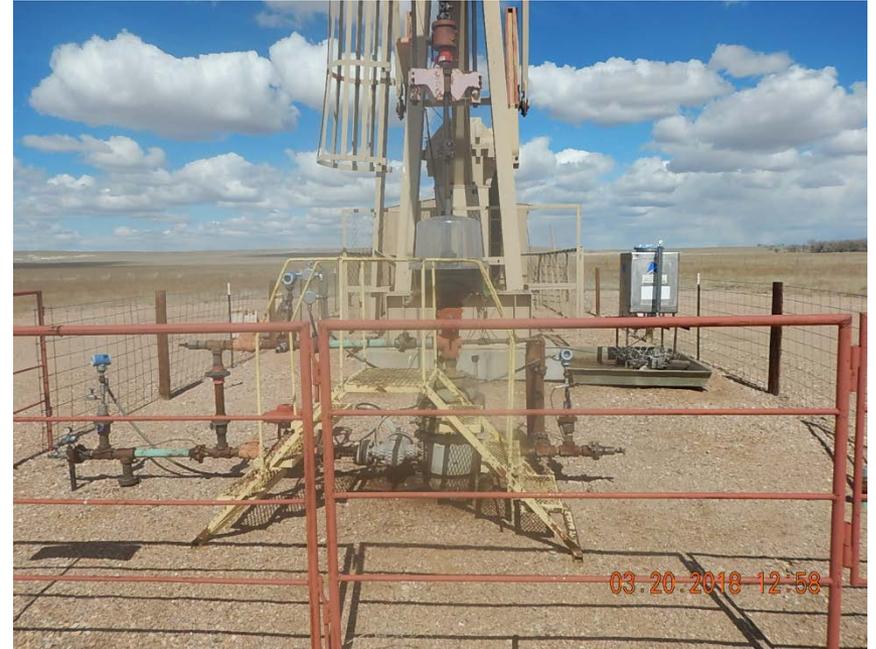
Photo 2: Wellhead, looking N

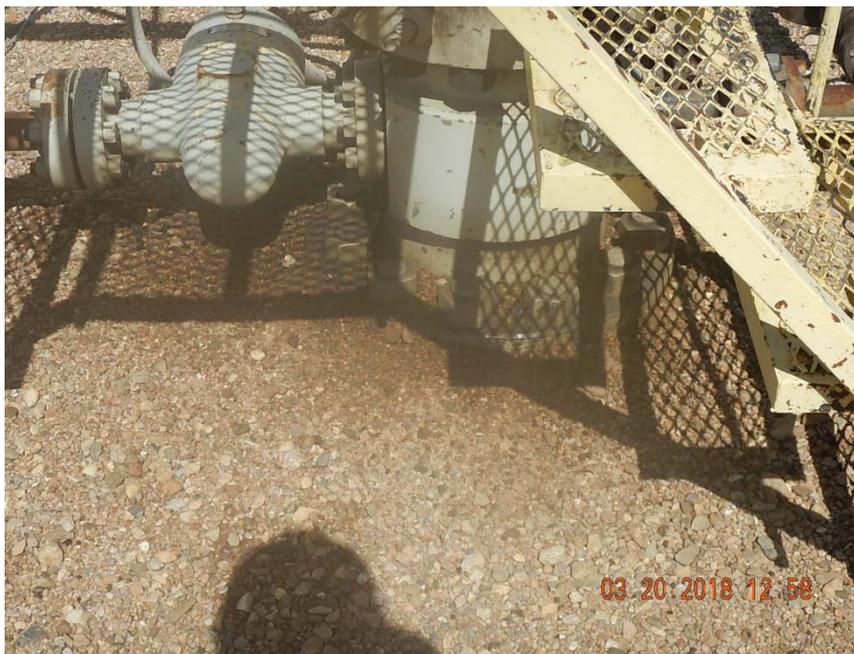
Photo 3: Stained soil at wellhead

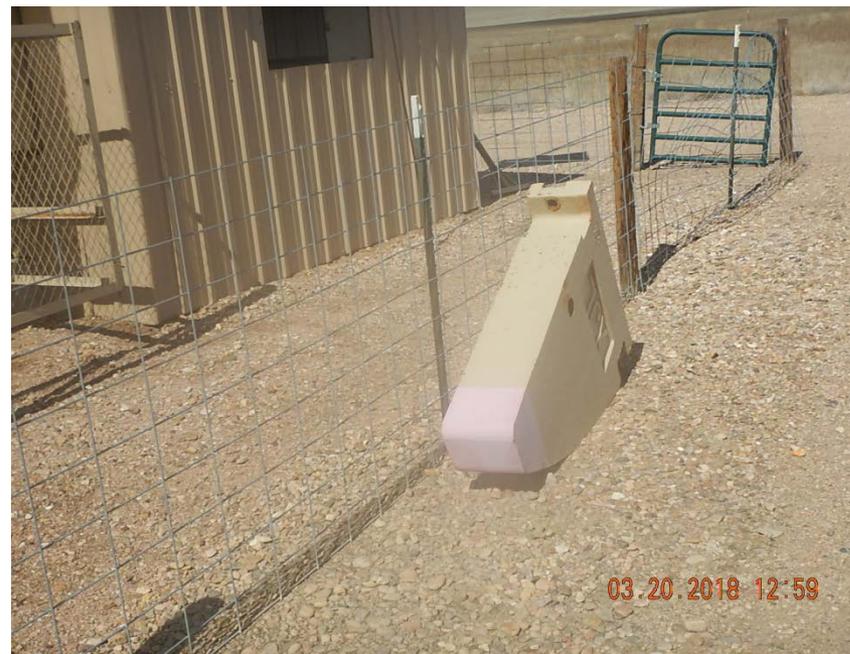
Photo 4: Unused equipment on E side of pump jack

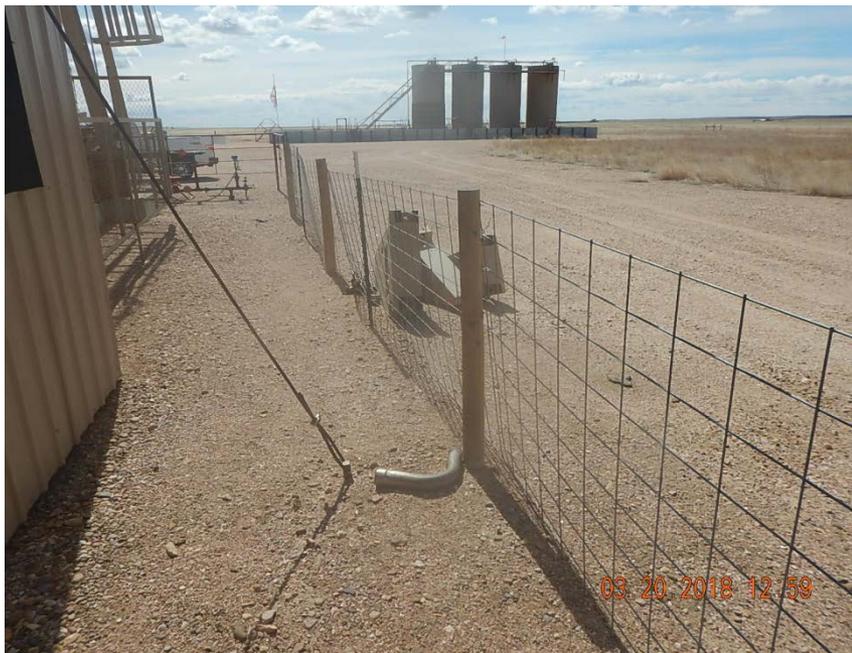
Photo 5: Unused equipment on W side of pump jack

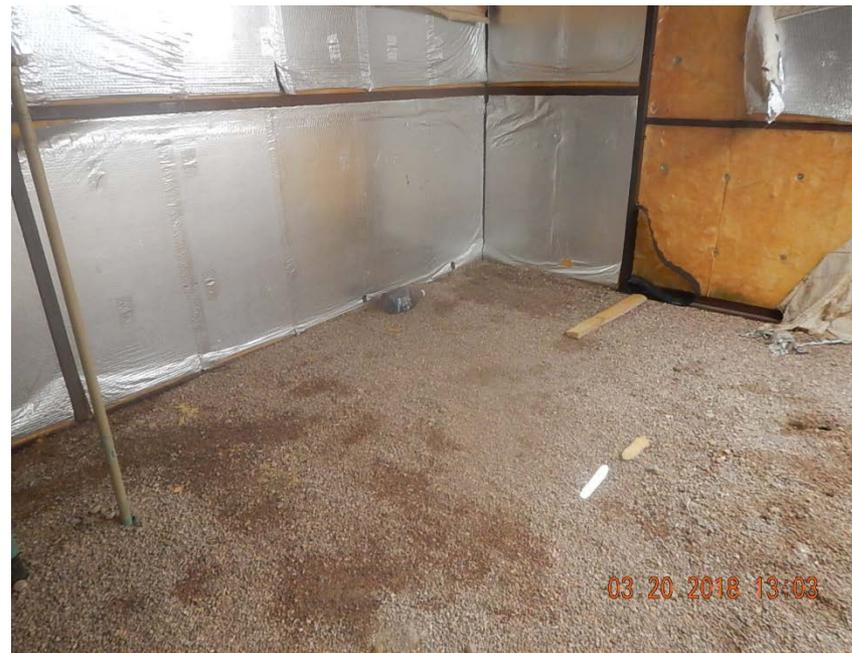
Photo 6: Debris in treater house

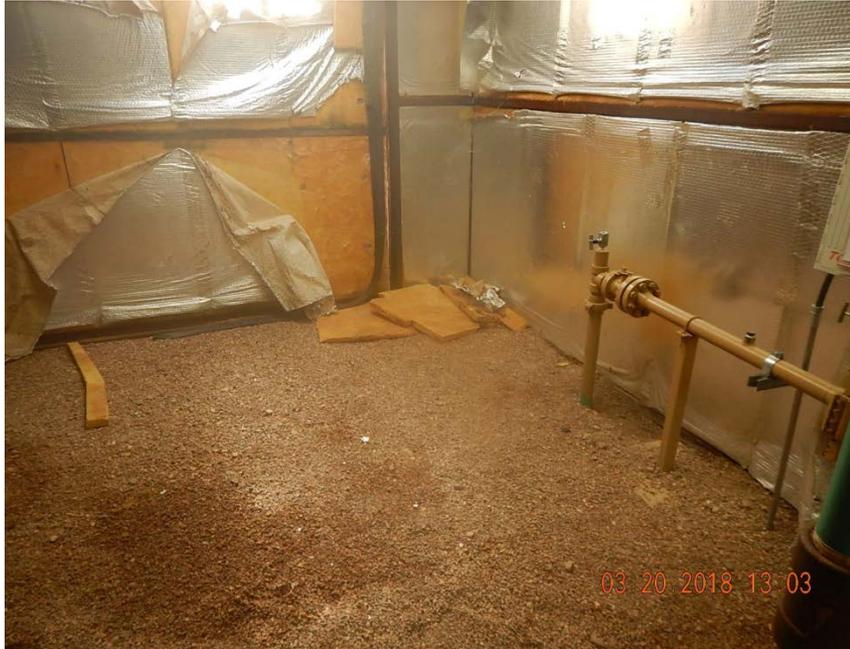
Photo 7: Debris in treater house

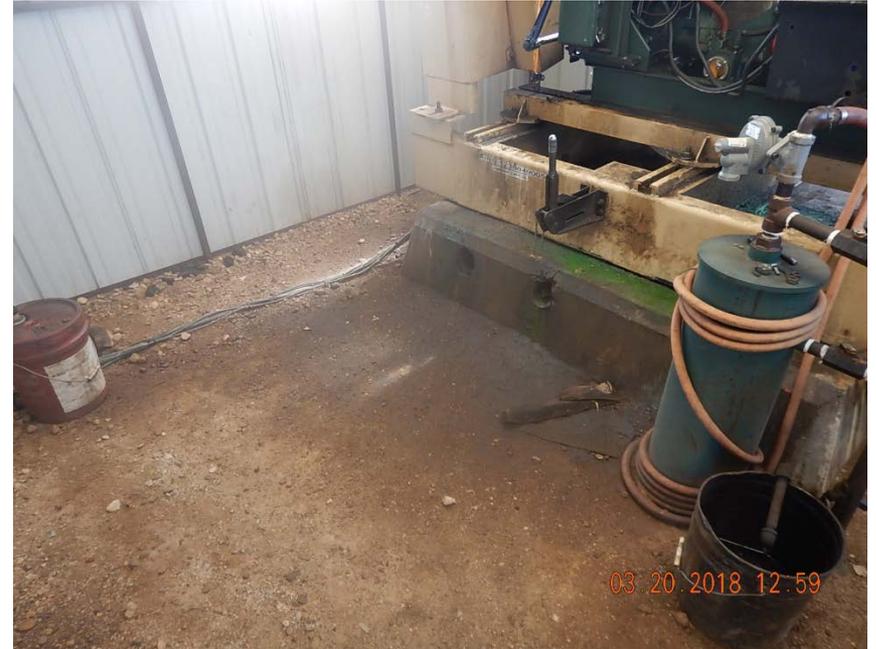
Photo 8: Stained soil at engine

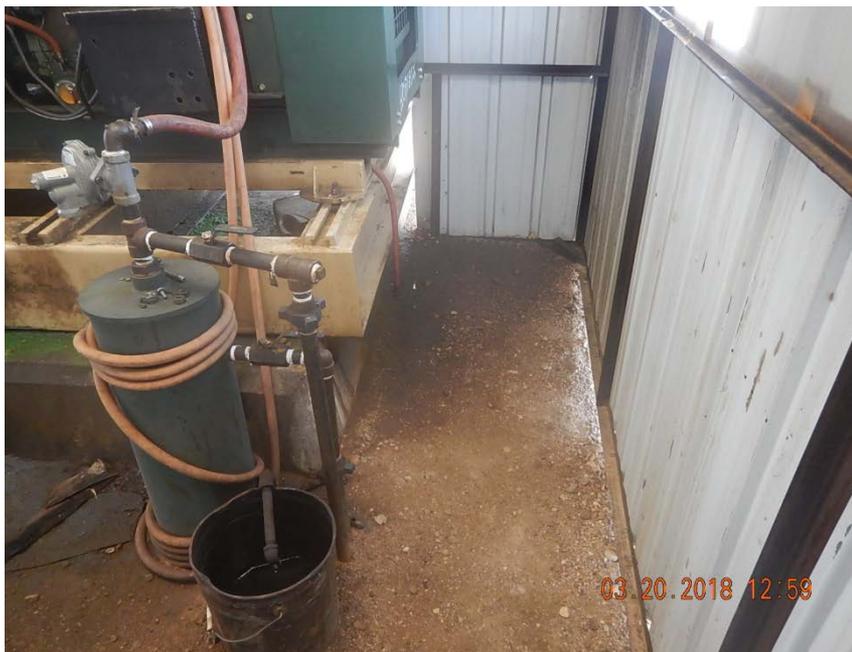
Photo 9: Stained soil at engine

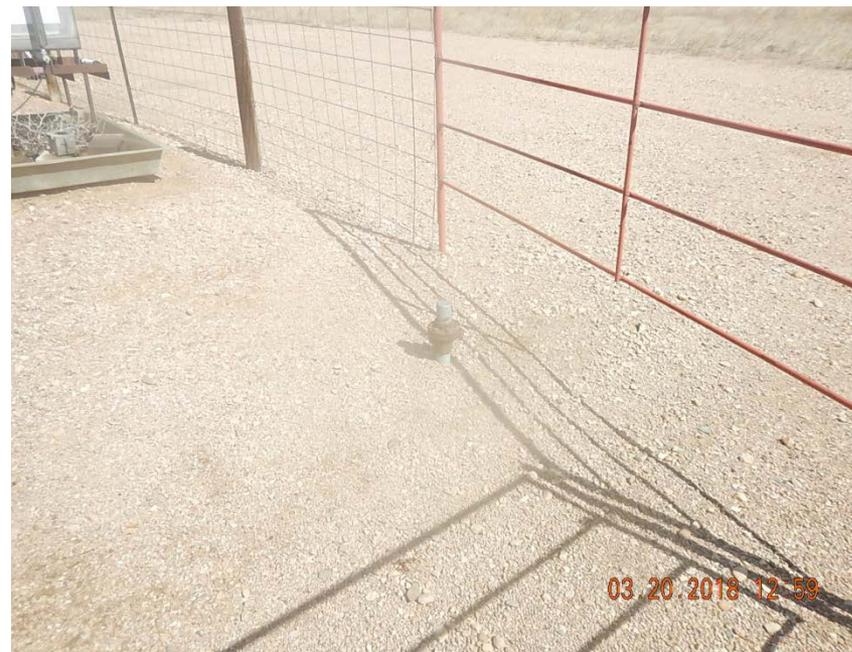
Photo 10: Riser at pumpjack (E of wellhead)

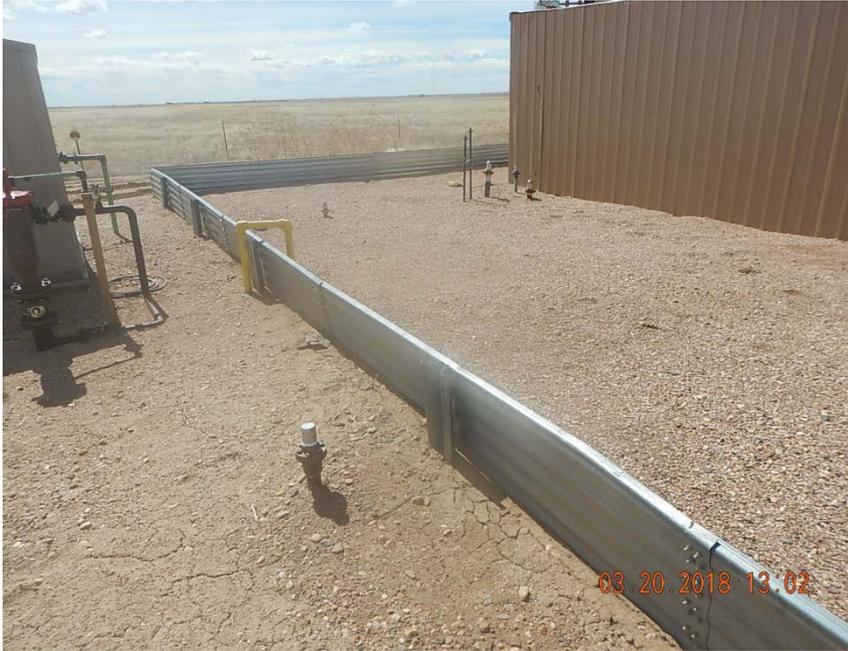
Photo 11: Risers E of treater house.
