Inspection Photos
Location Name: Ray #07-20
Location ID: 332436

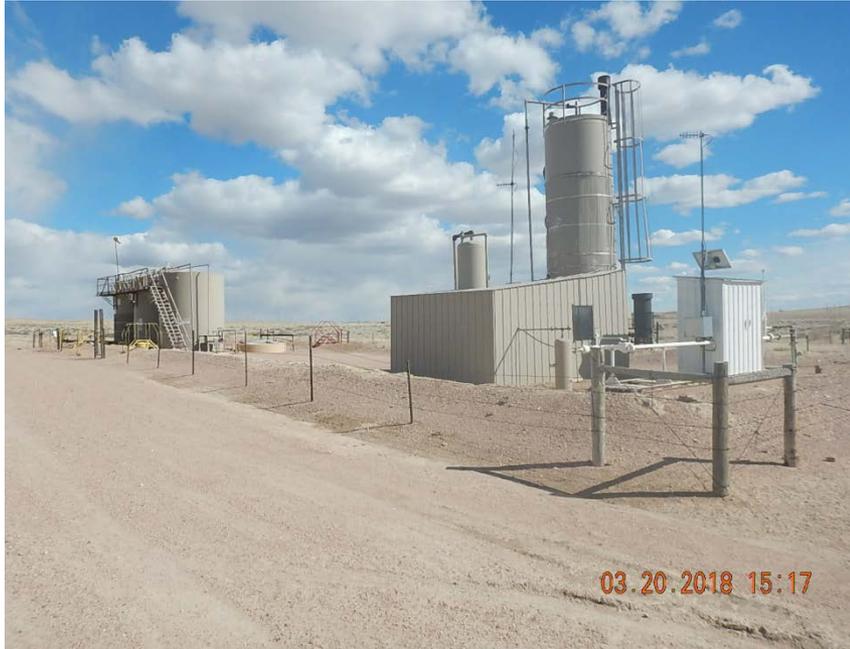
Photo 1: Location, looking SE

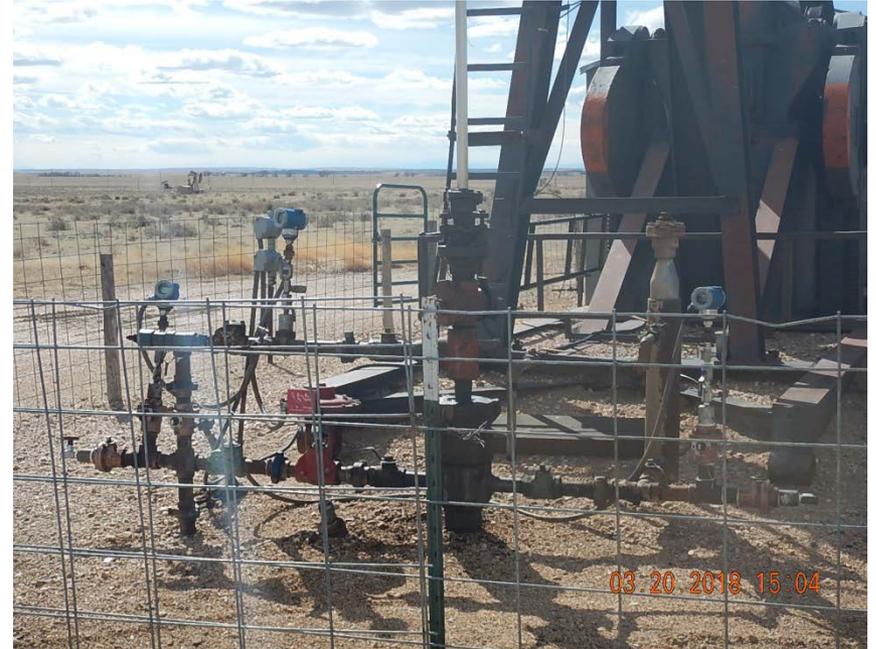
Photo 2: Wellhead, looking W

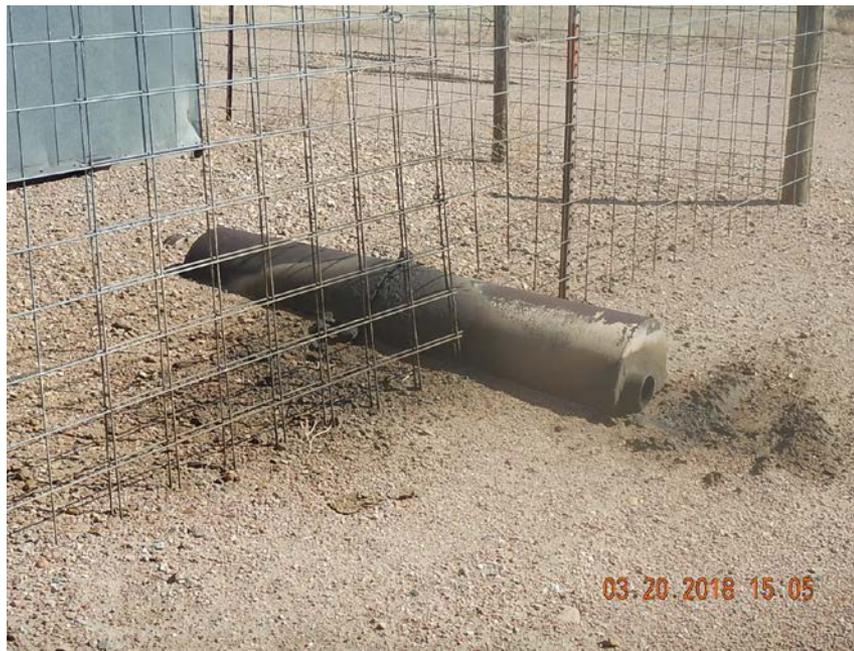
Photo 3: Stained soil at exhaust

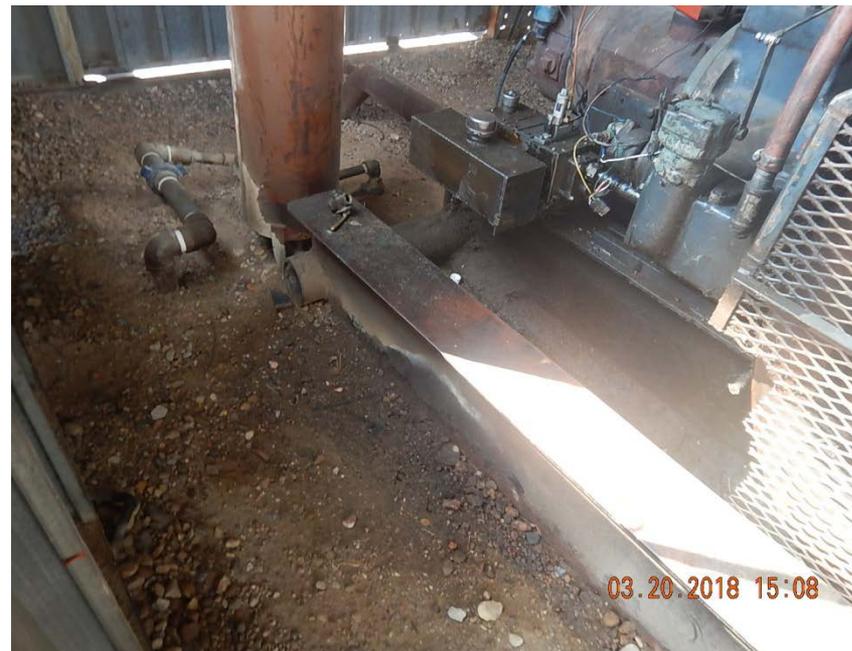
Photo 4: Stained soil at engine

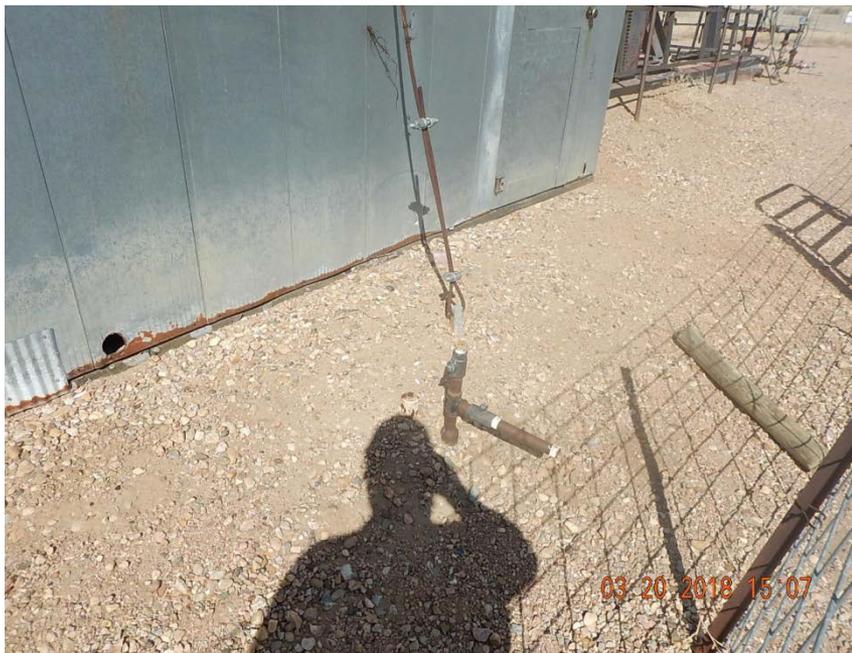
Photo 5: Riser, S of engine
