Inspection Photos

API# 071-06406

Operator: Timber Creek

Inspection Number: 680102758

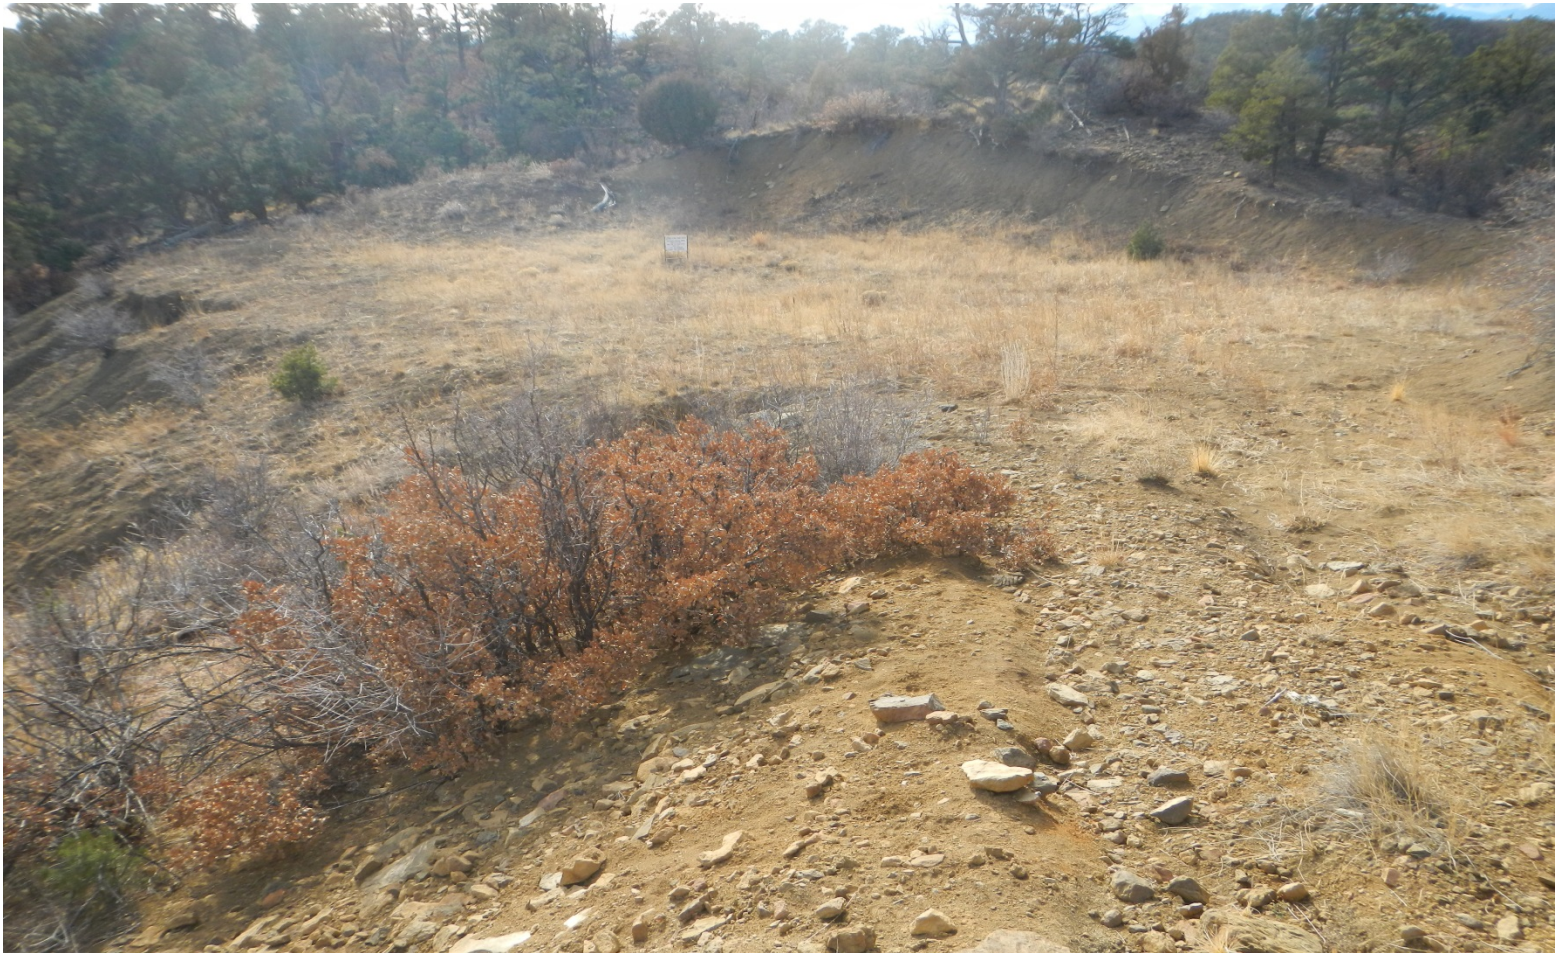
Photo#1:

Overview of Location to West. The Location, including well pad & access road, is not recontoured, decompacted, or revegetated.

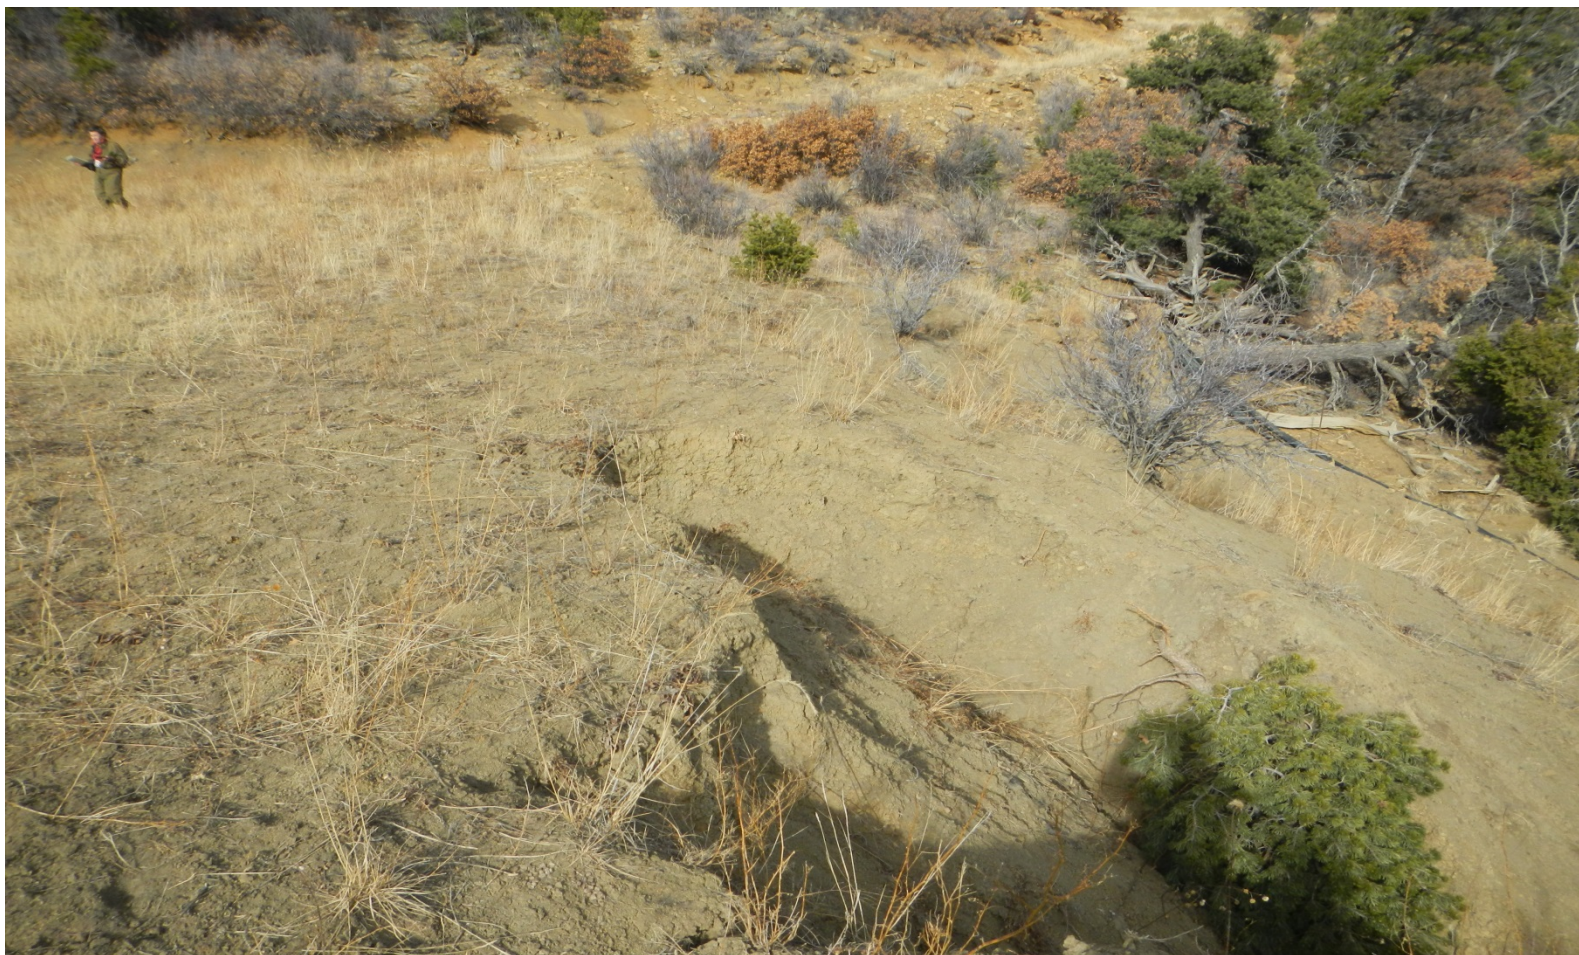
Photo#2:
View Northeast along severely eroded fill slope.

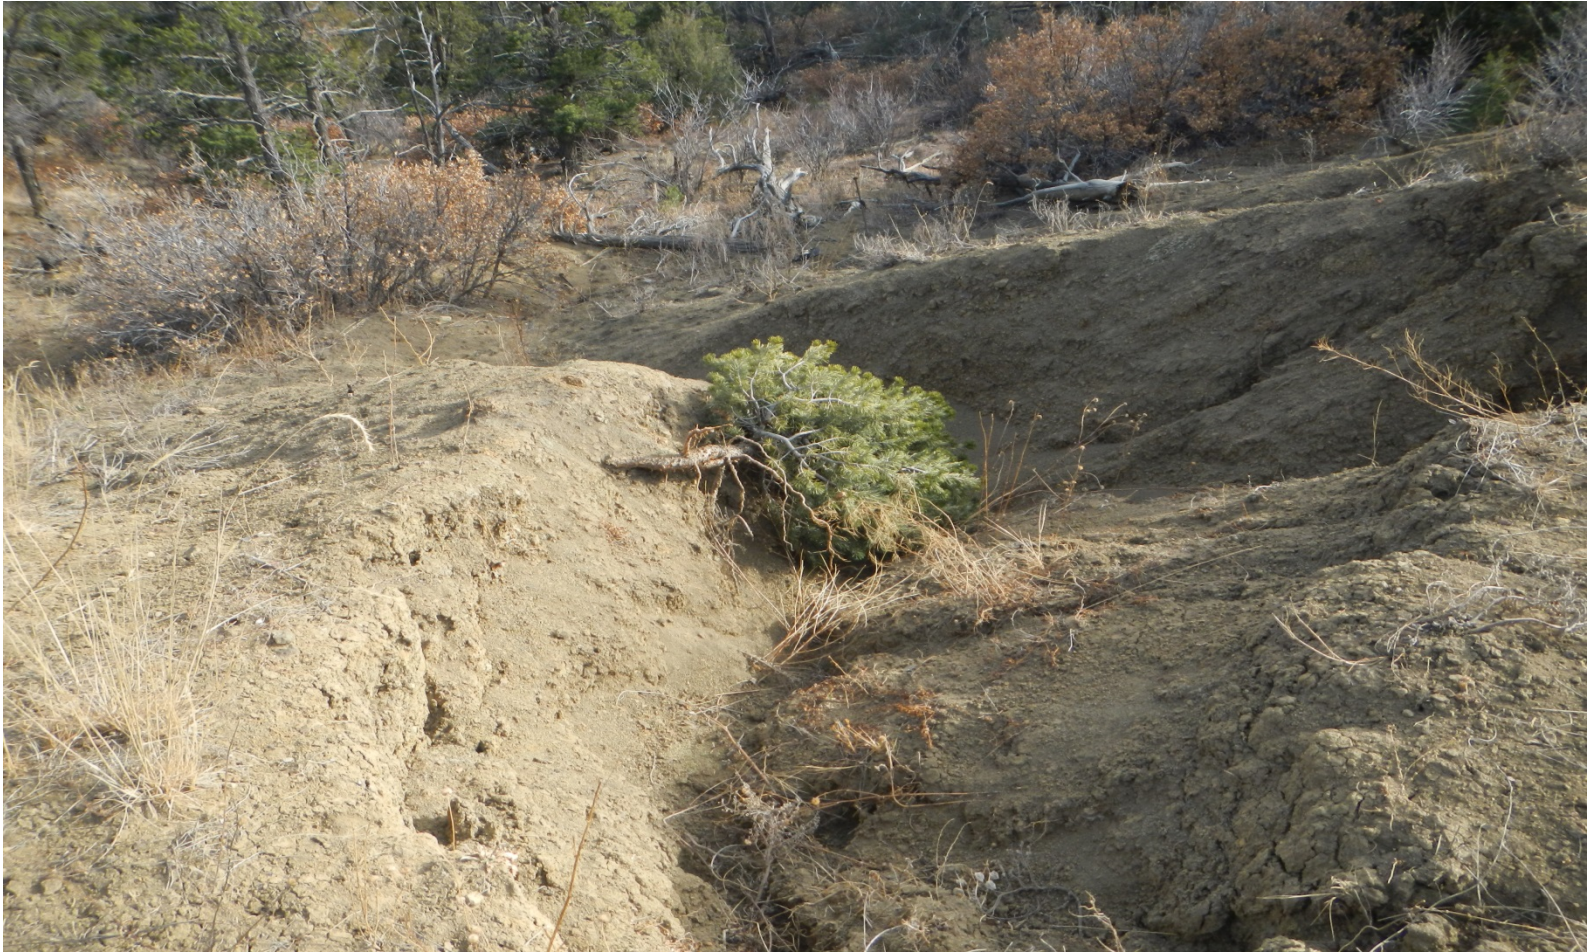
Photo#3:

View of severe erosion leading top to base of fill slope.

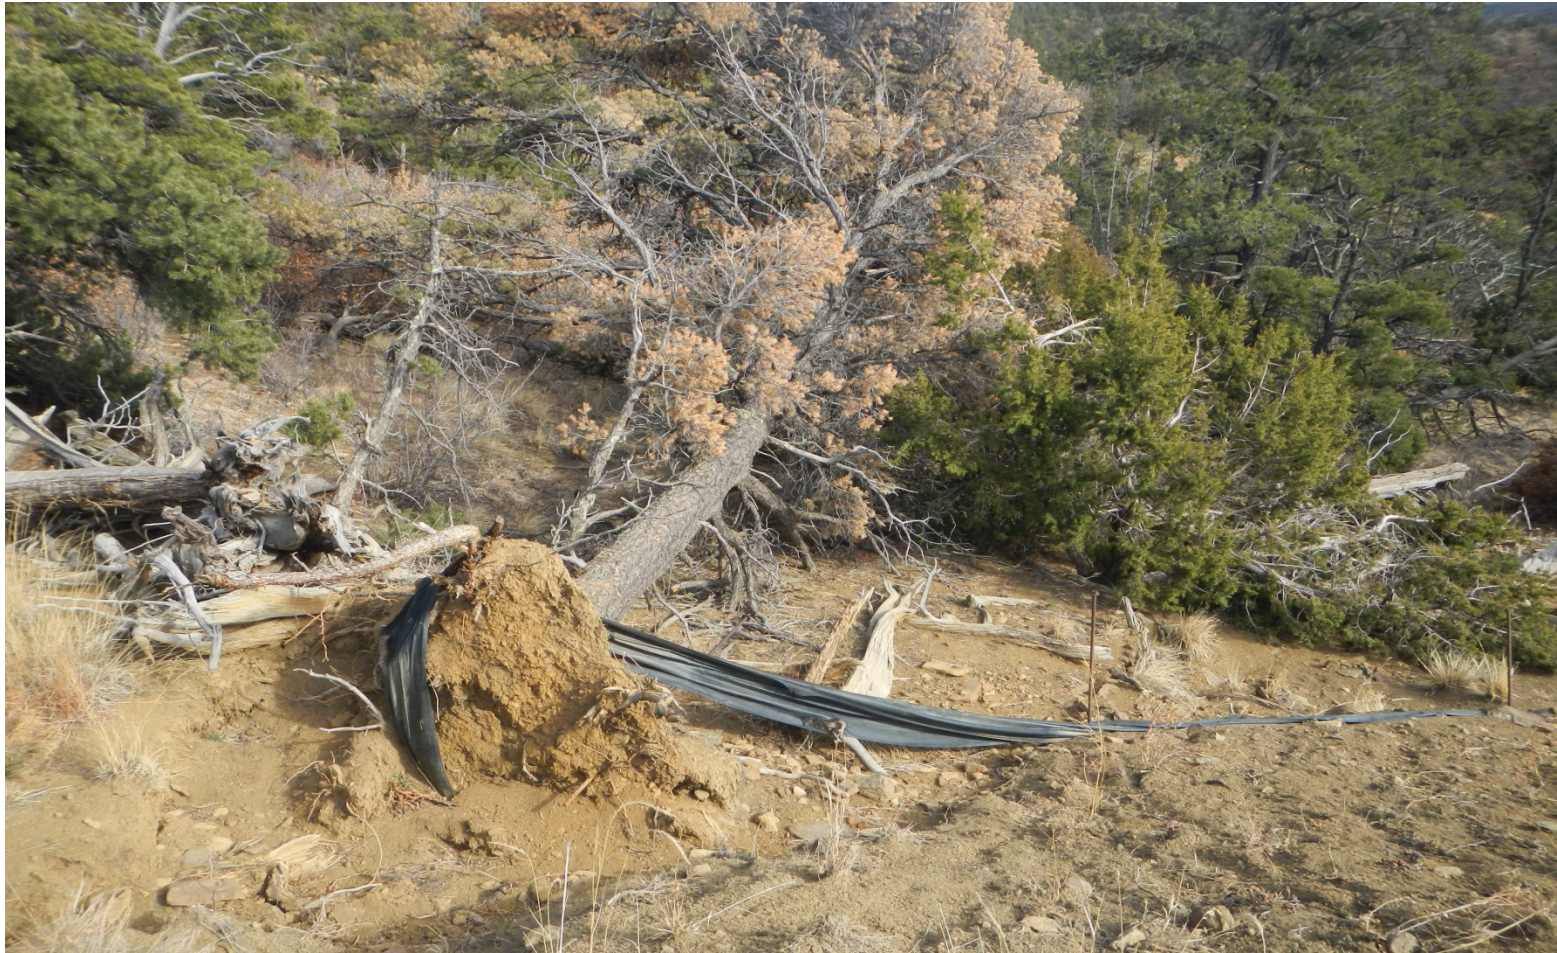
Photo#4:

View of tree at base of fill slope whose root system has been undermined to point of collapse & entangled with silt fence that has become debris.

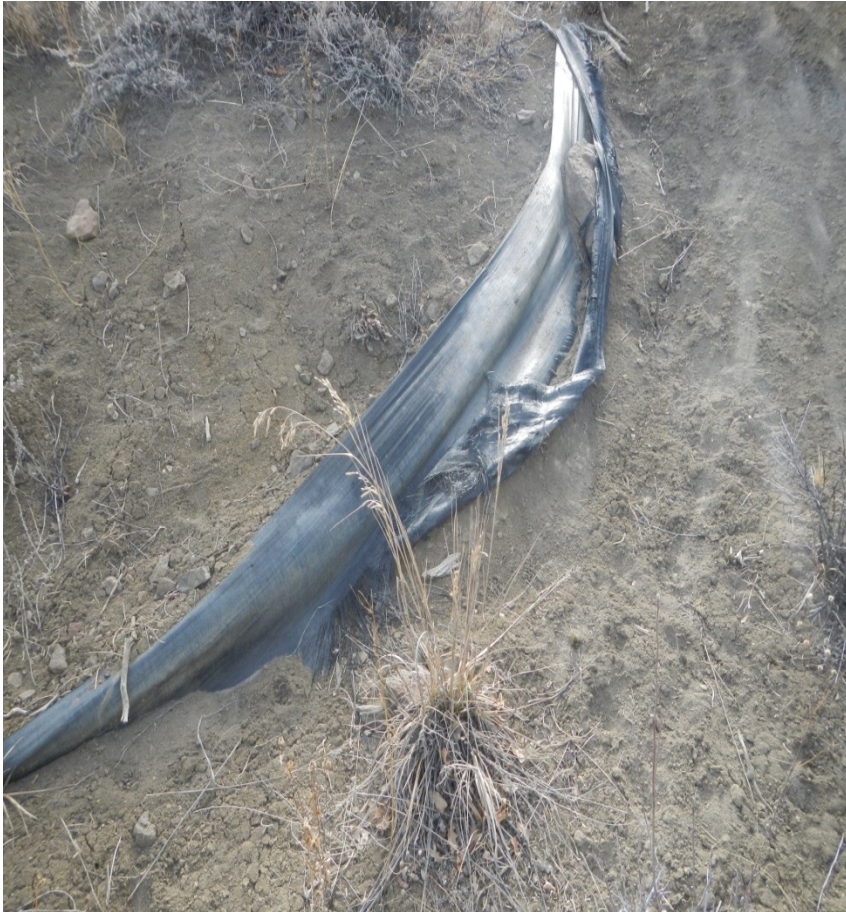
Photo#5:
Detail of silt fence debris along base of fill slope.

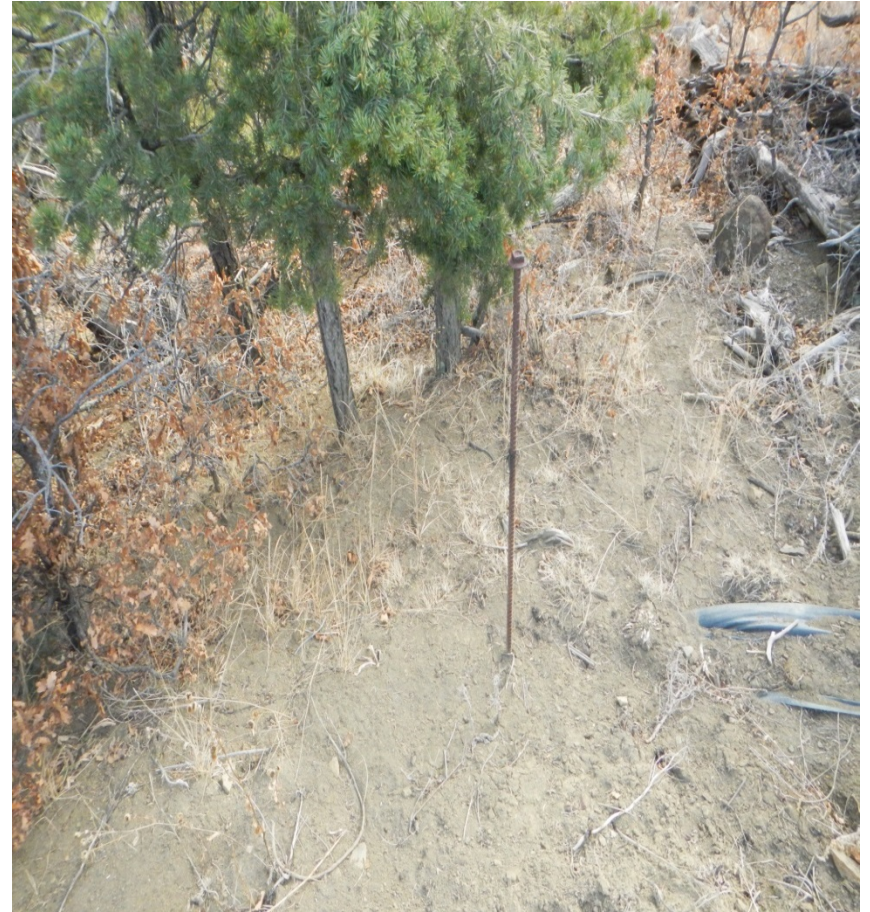
Photo#6:
Roof anchors, used as silt fence support still in place at base of fill slope.

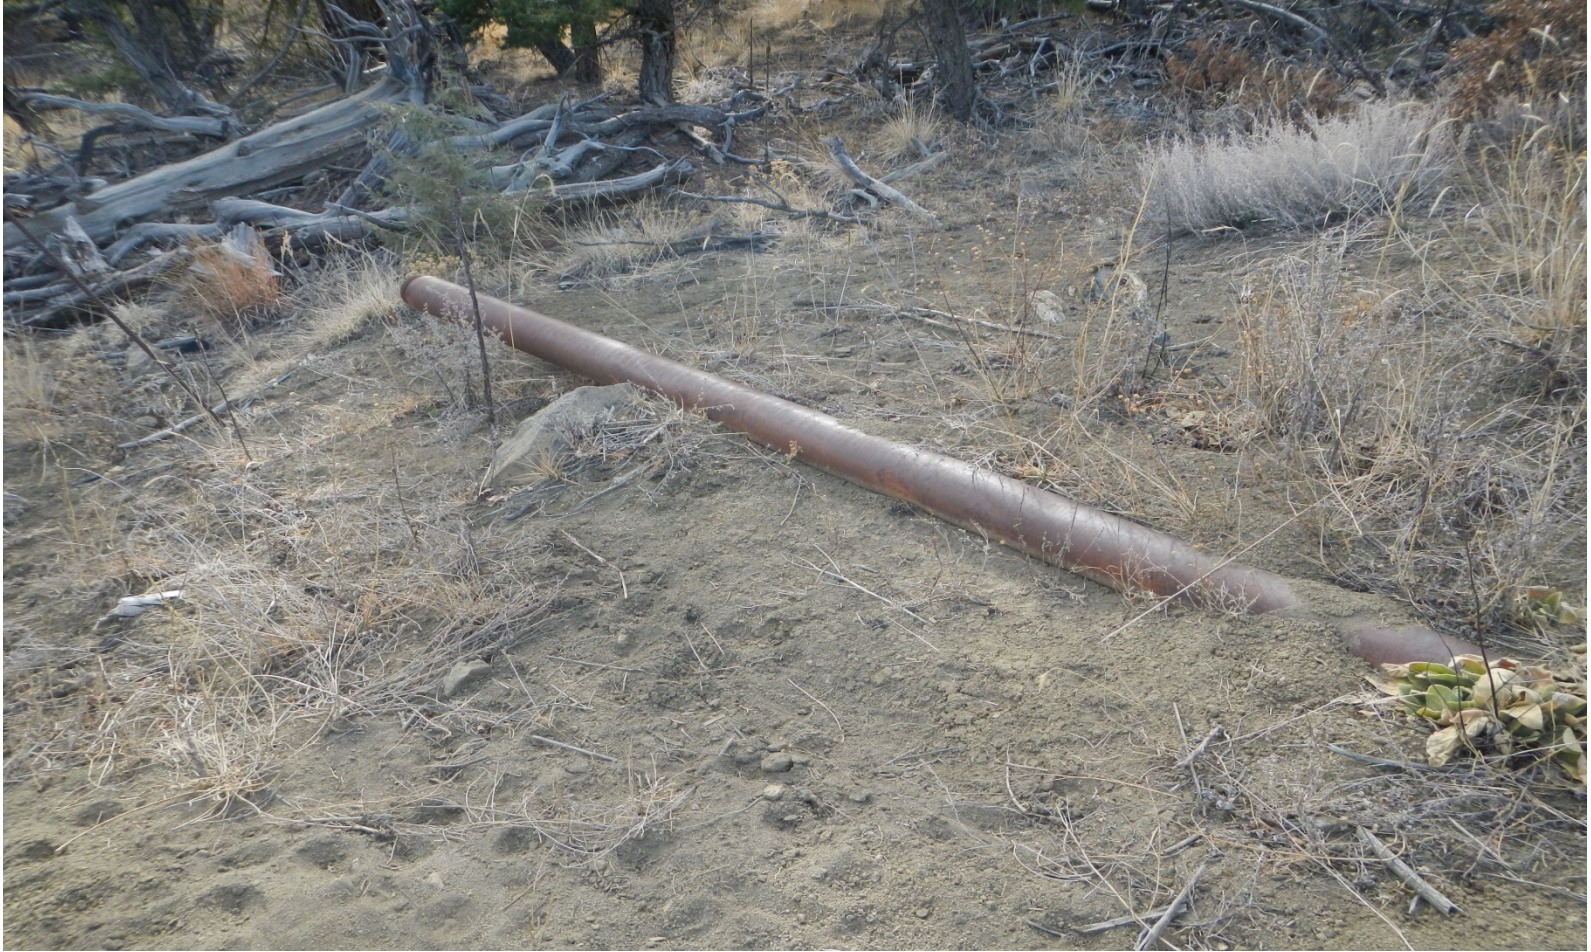
Photo#7:
Pipeline/ Drain? left on Southwest side of Location.

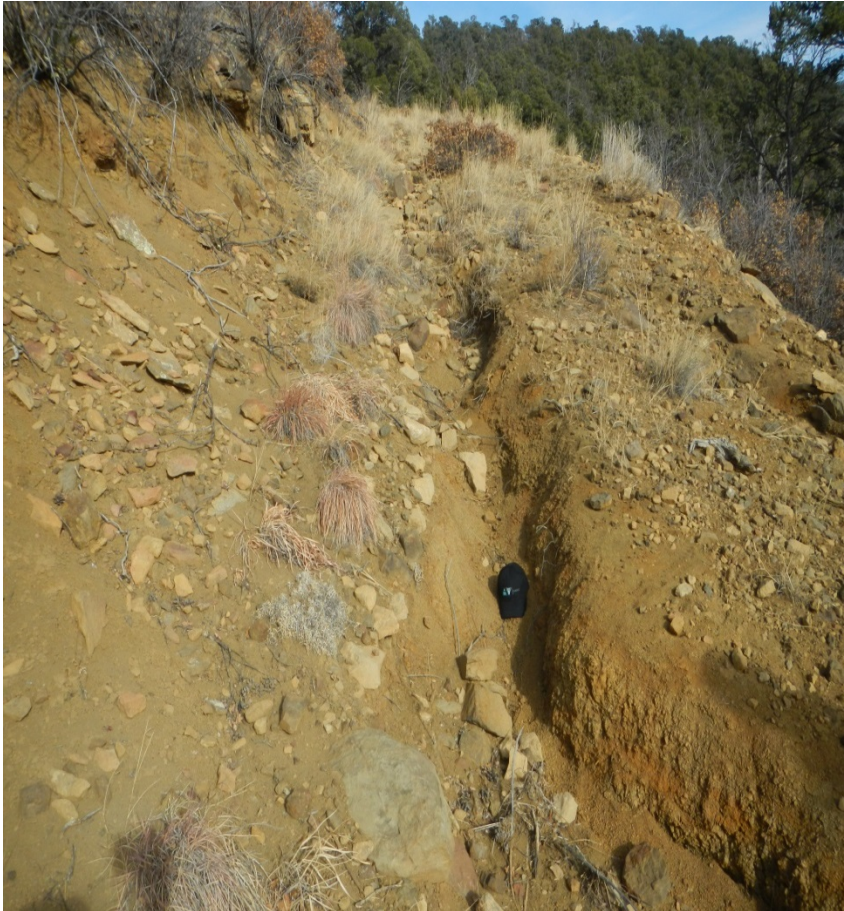
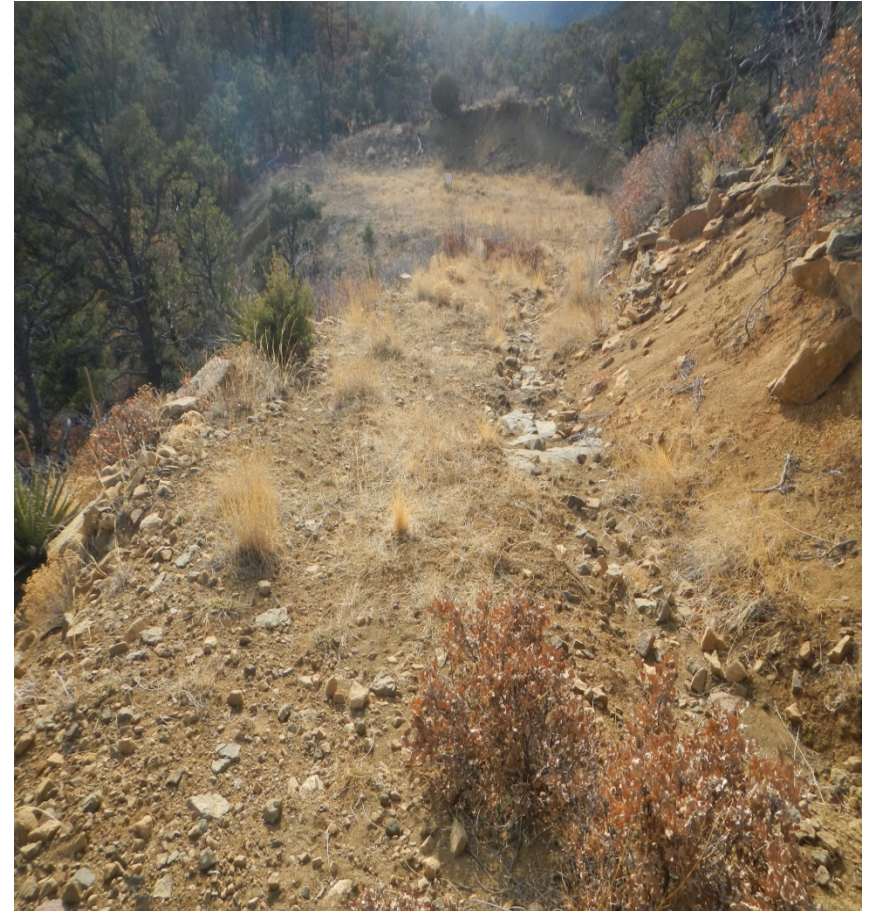
Photo#8:
Erosion is occurring on Access Rd.

Photo#9:
Refer to Photo#8 description.
