Construction and Stormwater Inspection

Operator: ENERPLUS RESOURCES (USA) CORPORATION - #10177

Location ID: 450827

Inspection Photos
Location Name: IRISH PAD
Location ID: 450827

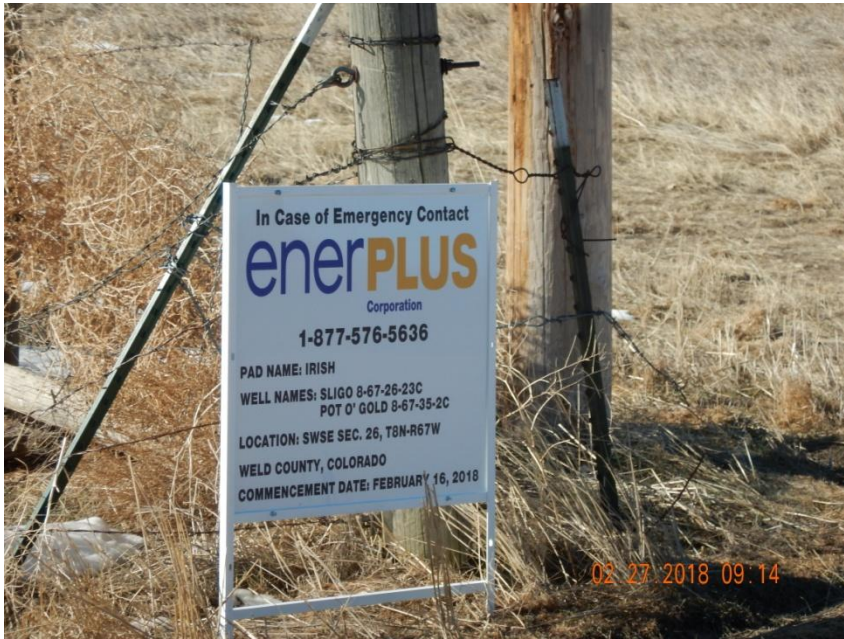
Photo 1. Photo taken from the entrance of location off CR 90 on February 27, 2018, facing South. Photo illustrates Operator sign.

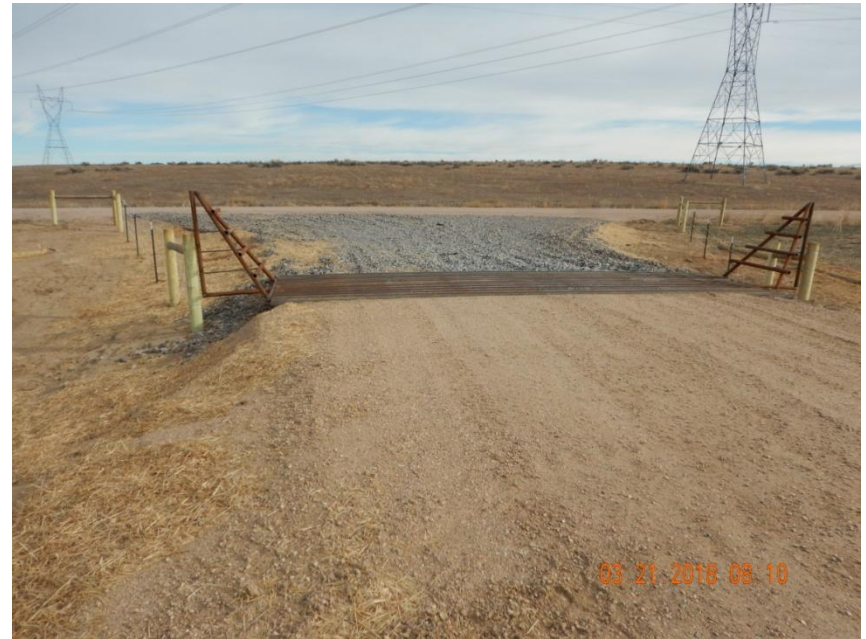
Photo 2. Photo taken from the location entrance, facing North. Operator has installed a vehicle tracking device and appears to be in proper functioning condition.

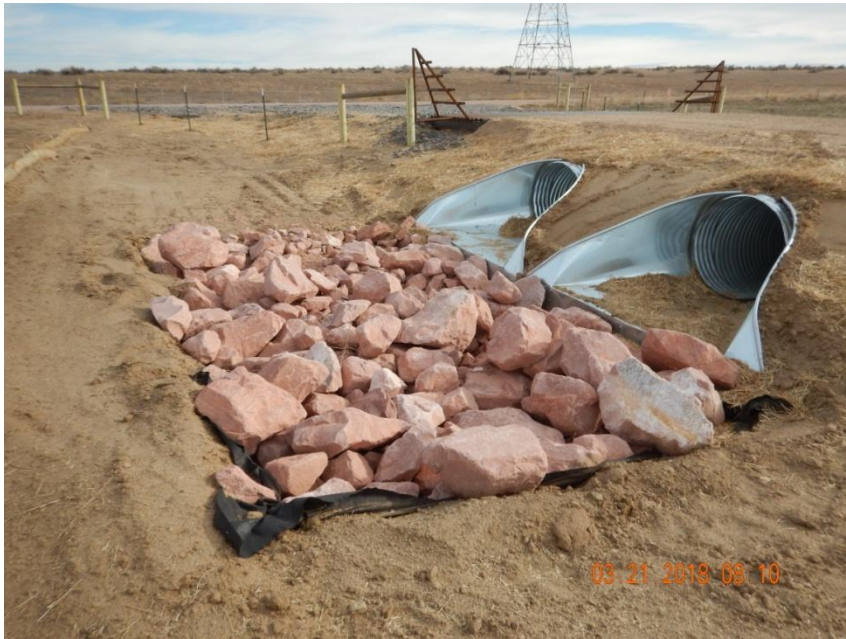
Photo 3. Photo taken from the location entrance, facing North. Operator has installed culverts with a stabilized outlet in conjunction to the roadside ditch.

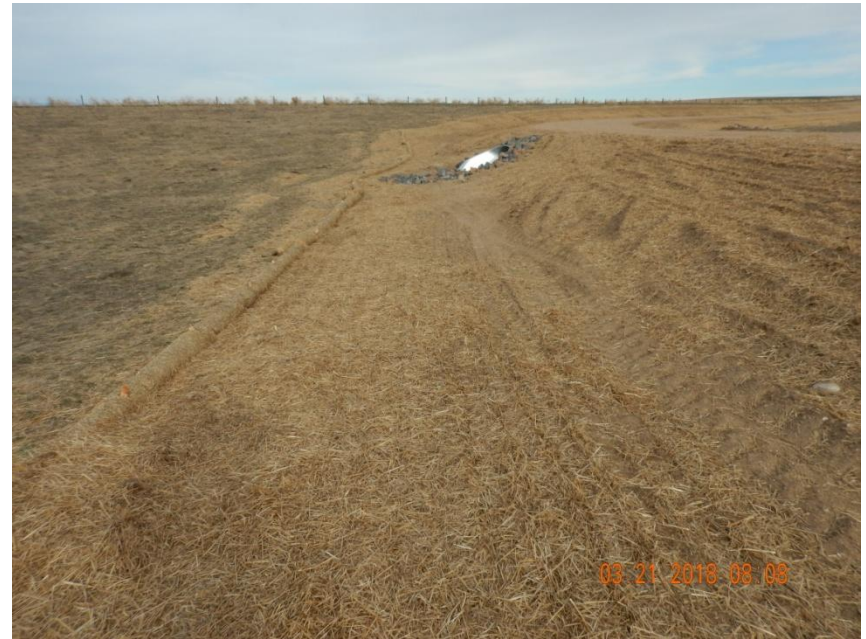
Photo 4. Photo taken from a portion of the access road, facing North. Operator has installed culverts with a stabilized outlet in conjunction to the roadside ditch, installed straw wattles, straw mulched and seeded the roadside ditch.

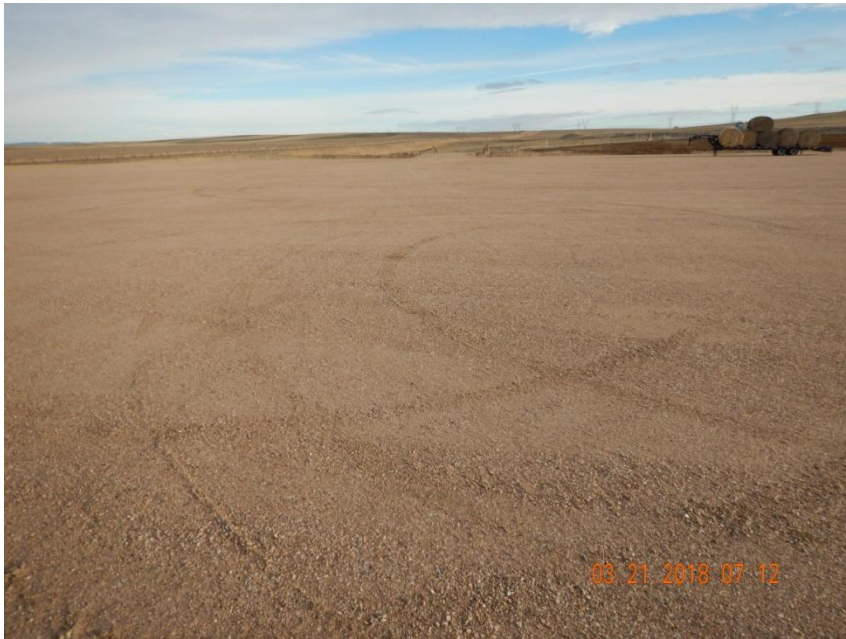
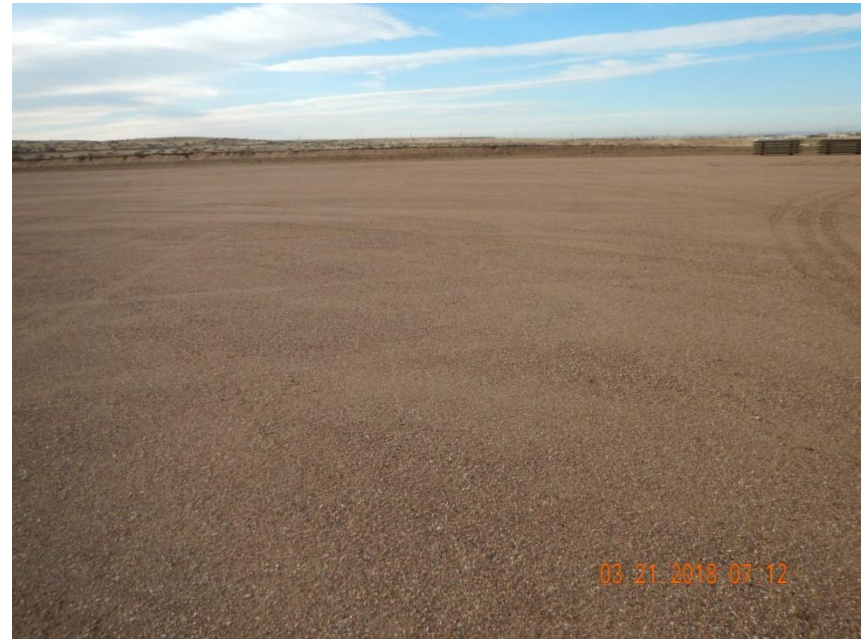
Photo 5. Photo taken from the approximate center of location, facing Northeast. Operator has installed and compacted gravel throughout the location.

Photo 6. Photo taken from the approximate center of location, facing South. See comments under Photo 5.

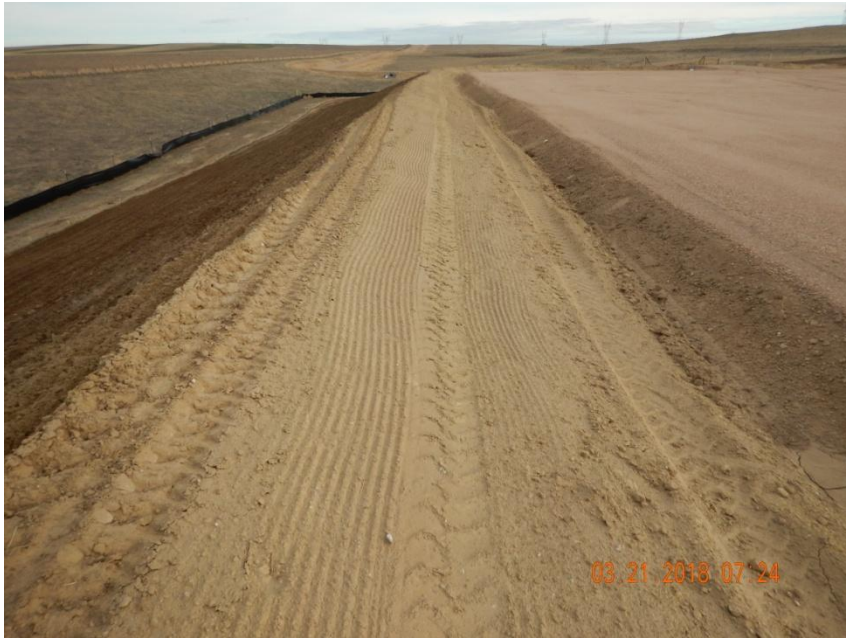
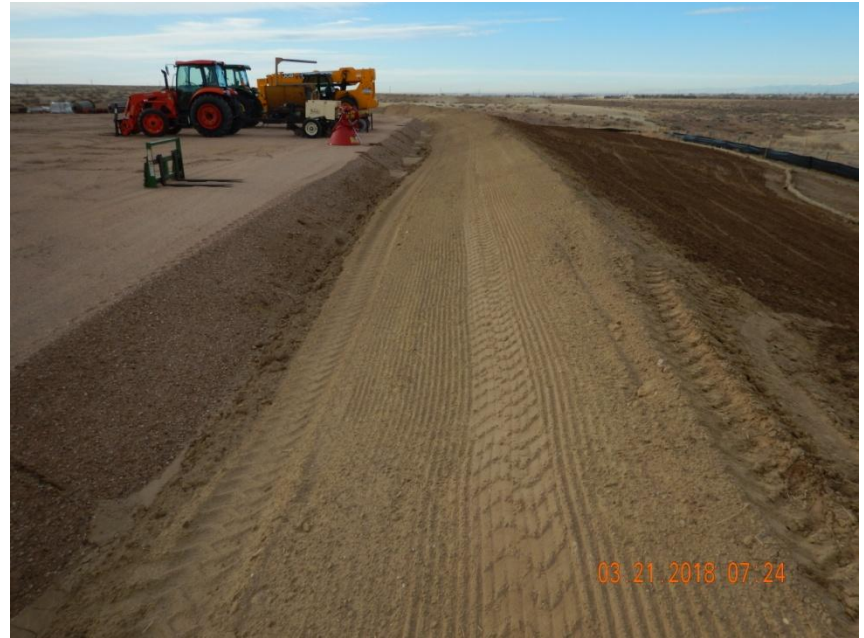
Photo 7. Photo taken from the western location, facing North. Operator has installed a moat system around the well pad perimeter. Fill and cut slopes have been seeded.

Photo 8. Photo taken from the western location, facing South. See comments under Photo 7.

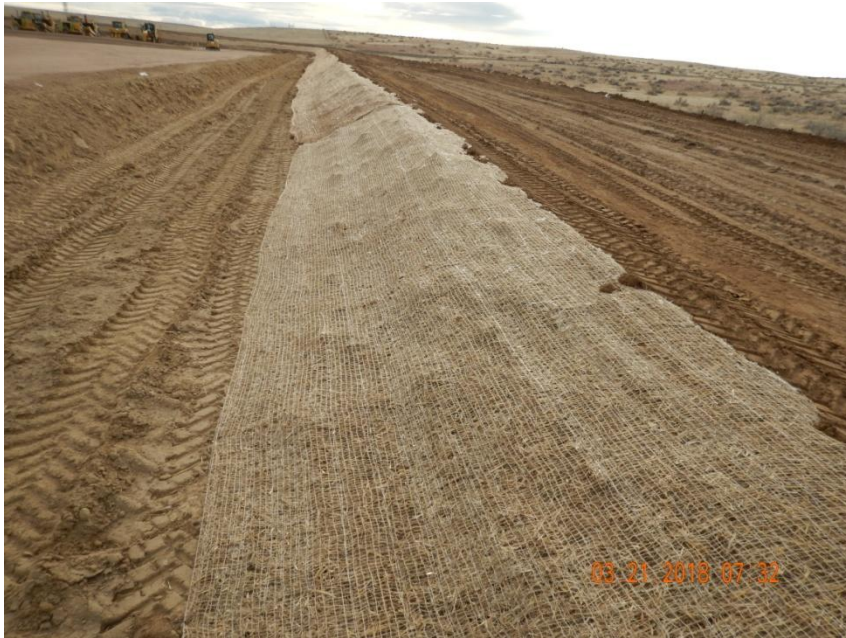
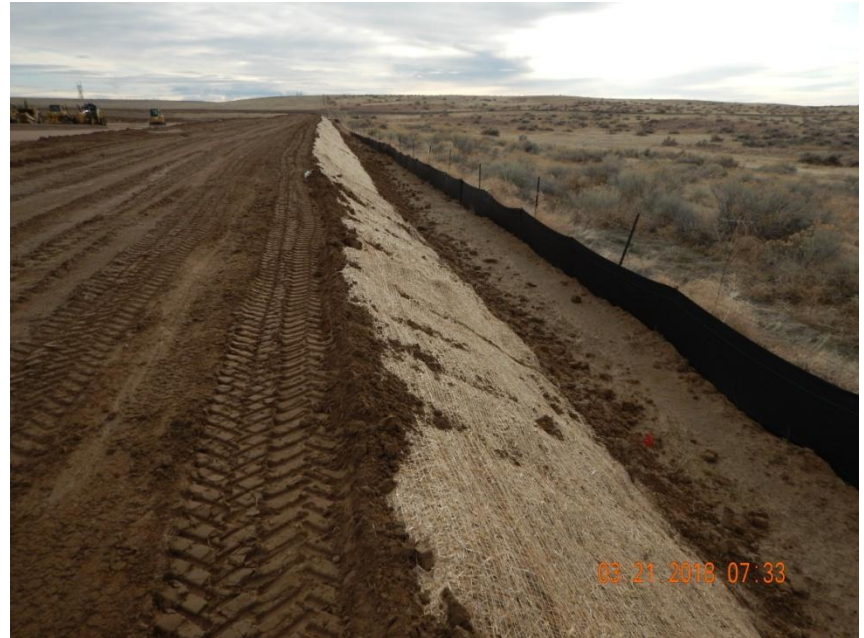
Photo 9. Photo taken from the southern location on the topsoil stockpile, facing East. Operator has seeded portions of the topsoil stockpile for long-term stabilization and protection of topsoil, and installed erosion control blankets along the fill slope of the topsoil stockpile.

Photo 10. Photo taken from the southern location on the topsoil stockpile, facing East. See comments under Photo 9.
