Inspection Photos

API: 05-067-08776

Operator: BP AMERICA PRODUCTION COMPANY

Inspection Date: 3/7/2018

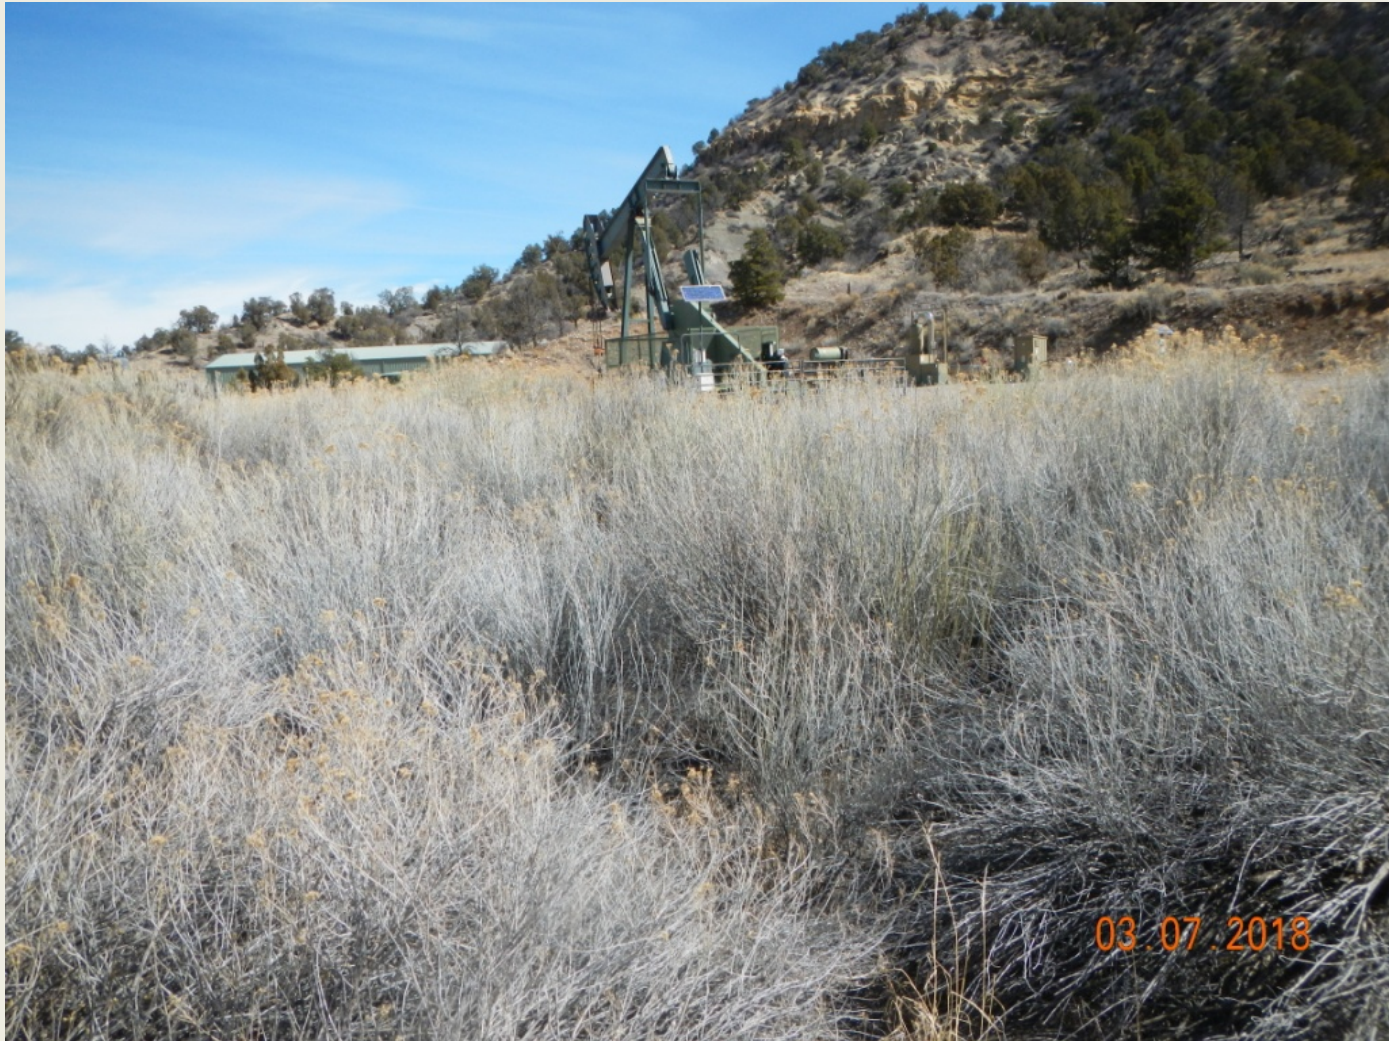
Photo 1. View of the project area from the southwestern corner facing center.

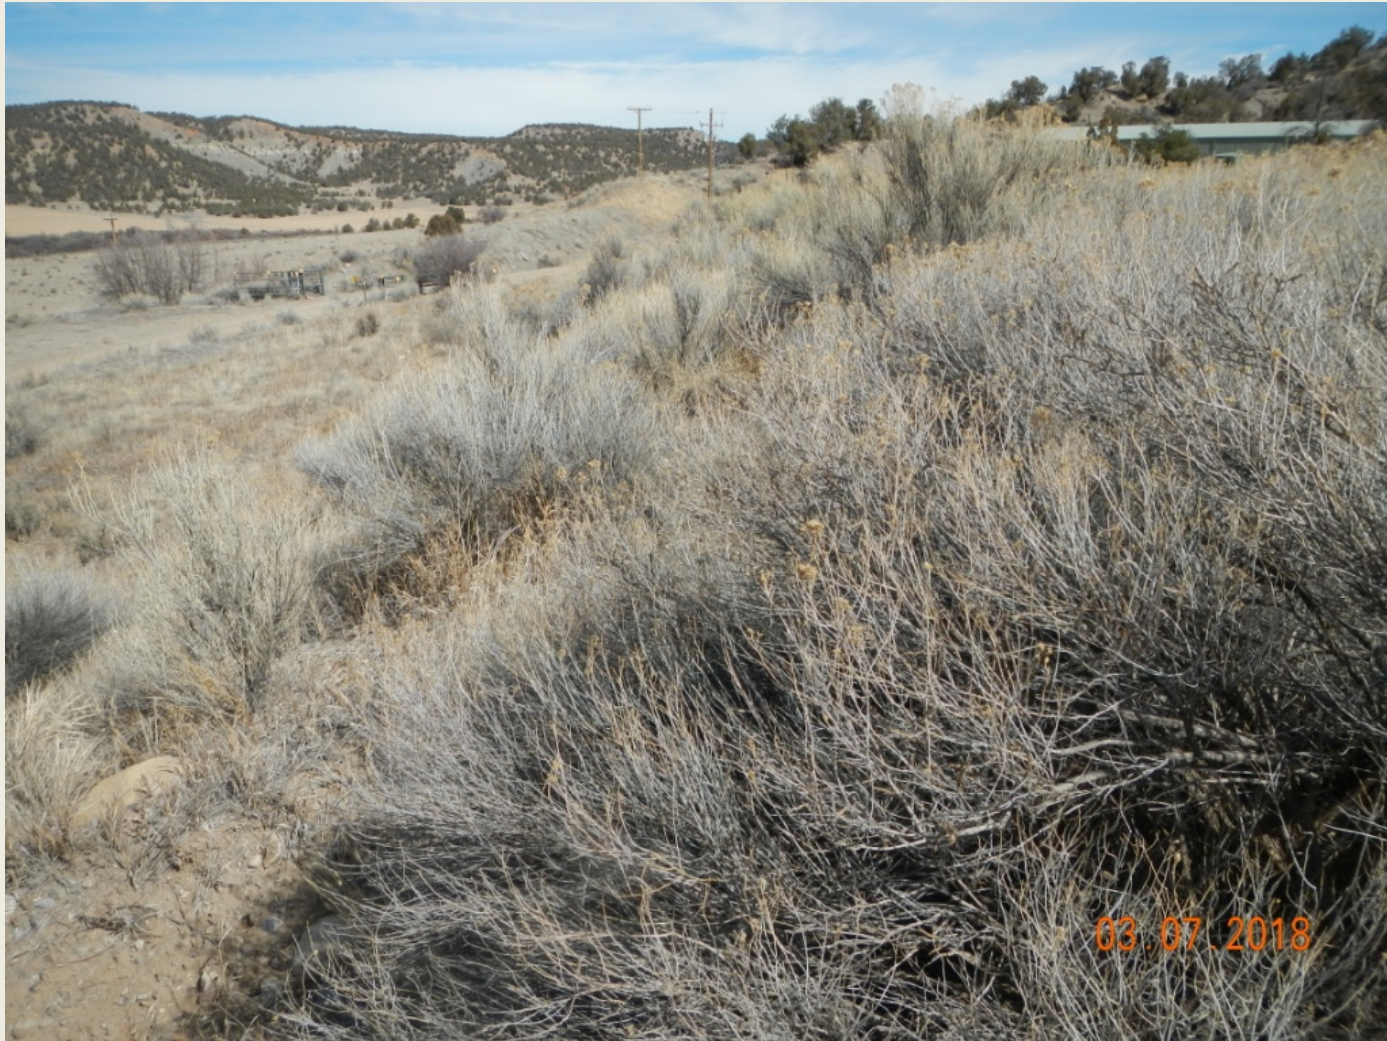
Photo 2. View of the western portion of the interim reclamation area from the northwestern corner facing westward. Revegetation is comprised of rubber rabbitbrush (*Chrysothamnus nauseosus*), smooth brome (*Bromus inermis*), and crested wheatgrass (*Agropyron cristatum*).

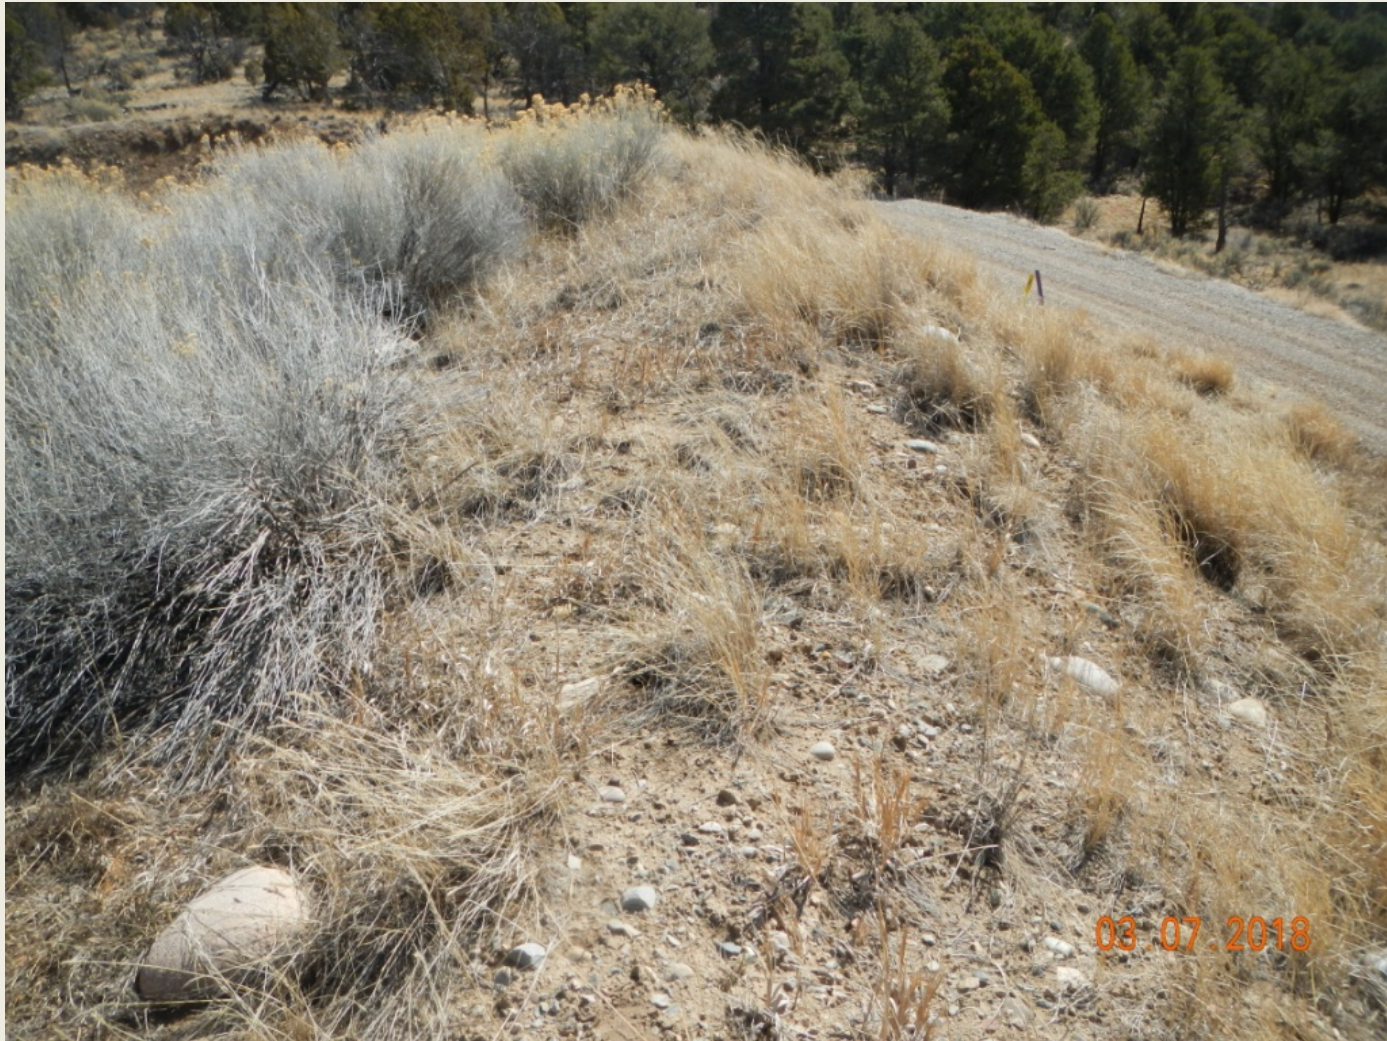
Photo 3. View of the southern portion of the project area from the southwestern corner facing eastward.

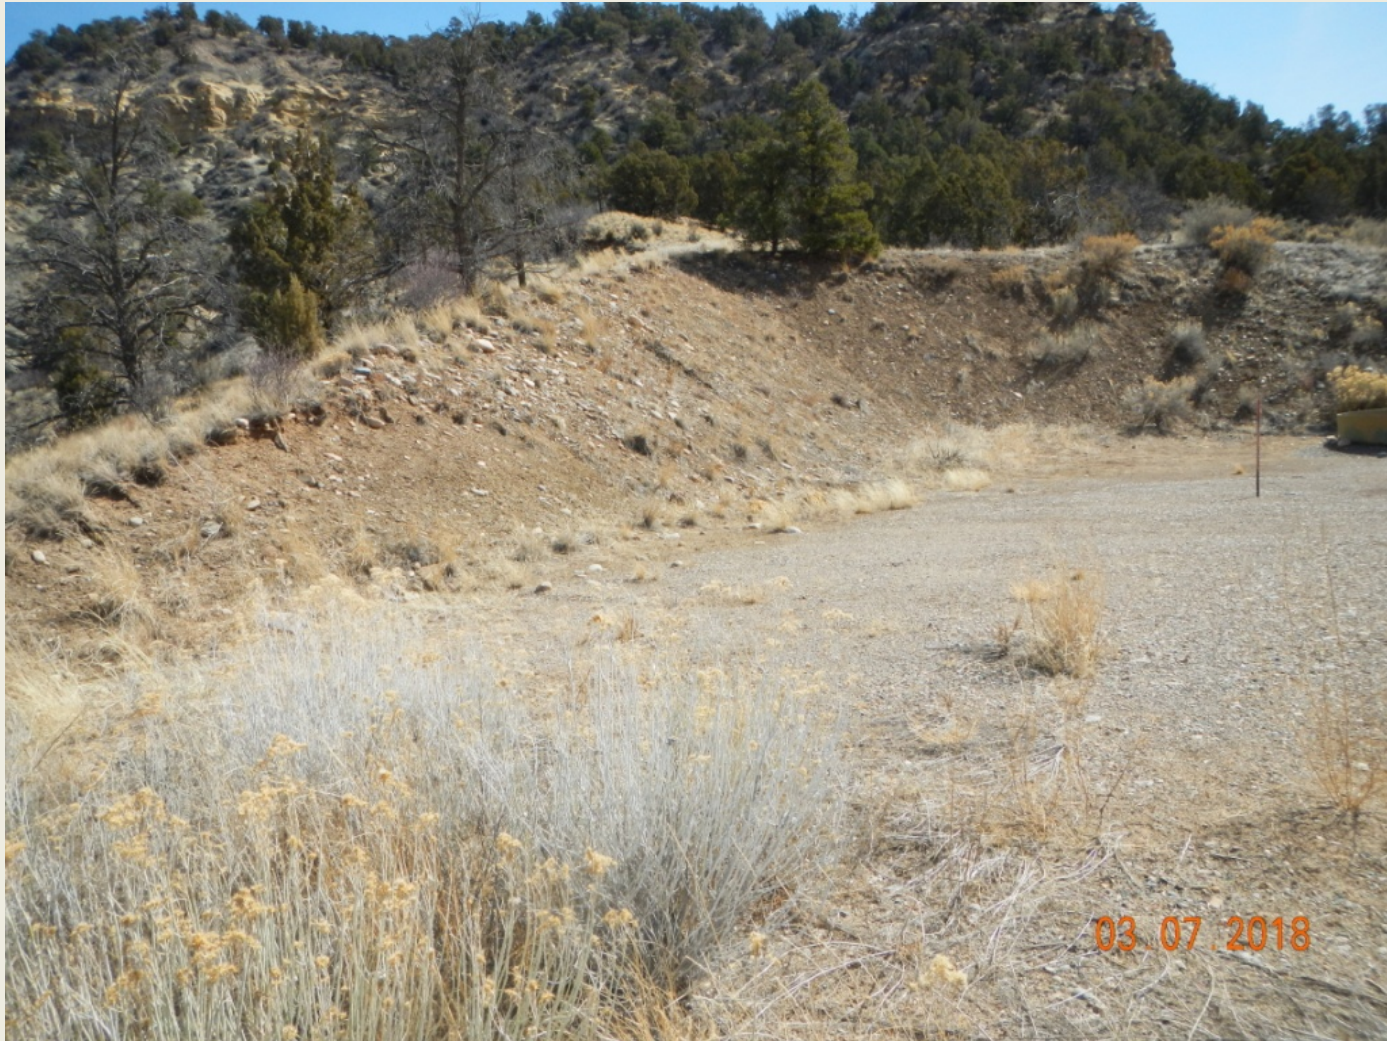
Photo 4. View of the northern portion of the project area from the northwestern corner facing eastward. Steep cut-slope supports sparse revegetation. This needs to be monitored and further slope stabilization measures taken if noticeable erosion is occurring.

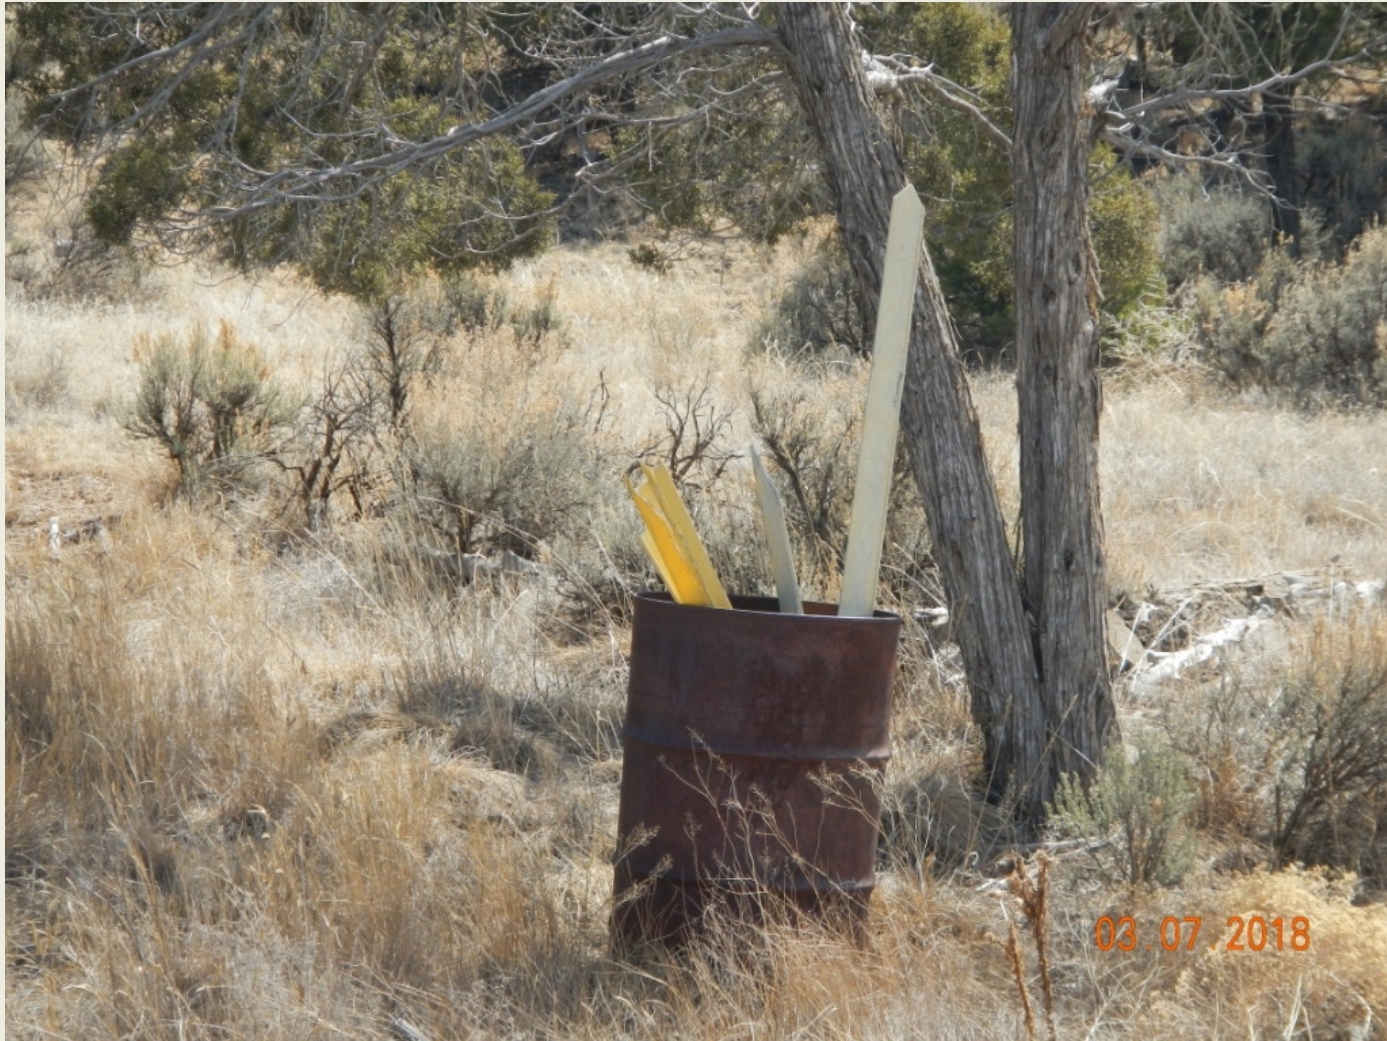
Photo 5. View of trash barrel on south side of access road. Needs to be removed.
