Inspection Photos
Location Name: A 14 OU Follow Up
Location ID: 440803

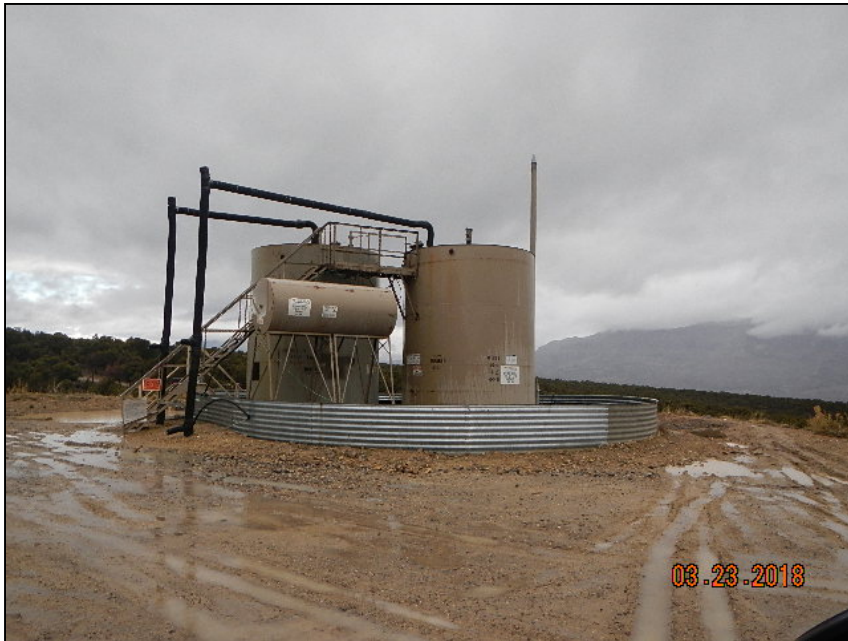
Photo 1. Repaired tank containment.

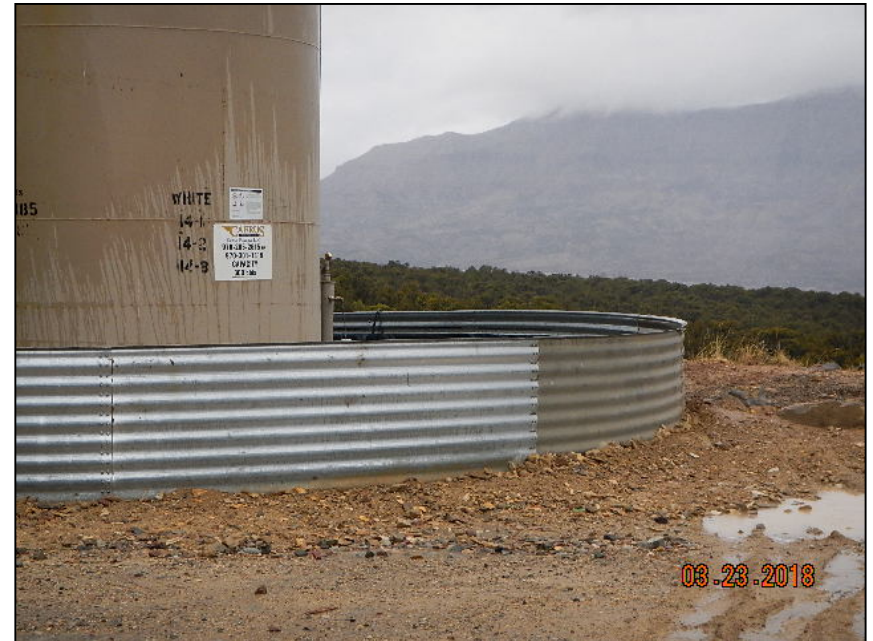
Photo 2. Repaired tank containment.
