# Inspection Photos

API: 05-067-08100

Operator: LOGOS OPERATING LLC

Inspection Date: 3/7/2018

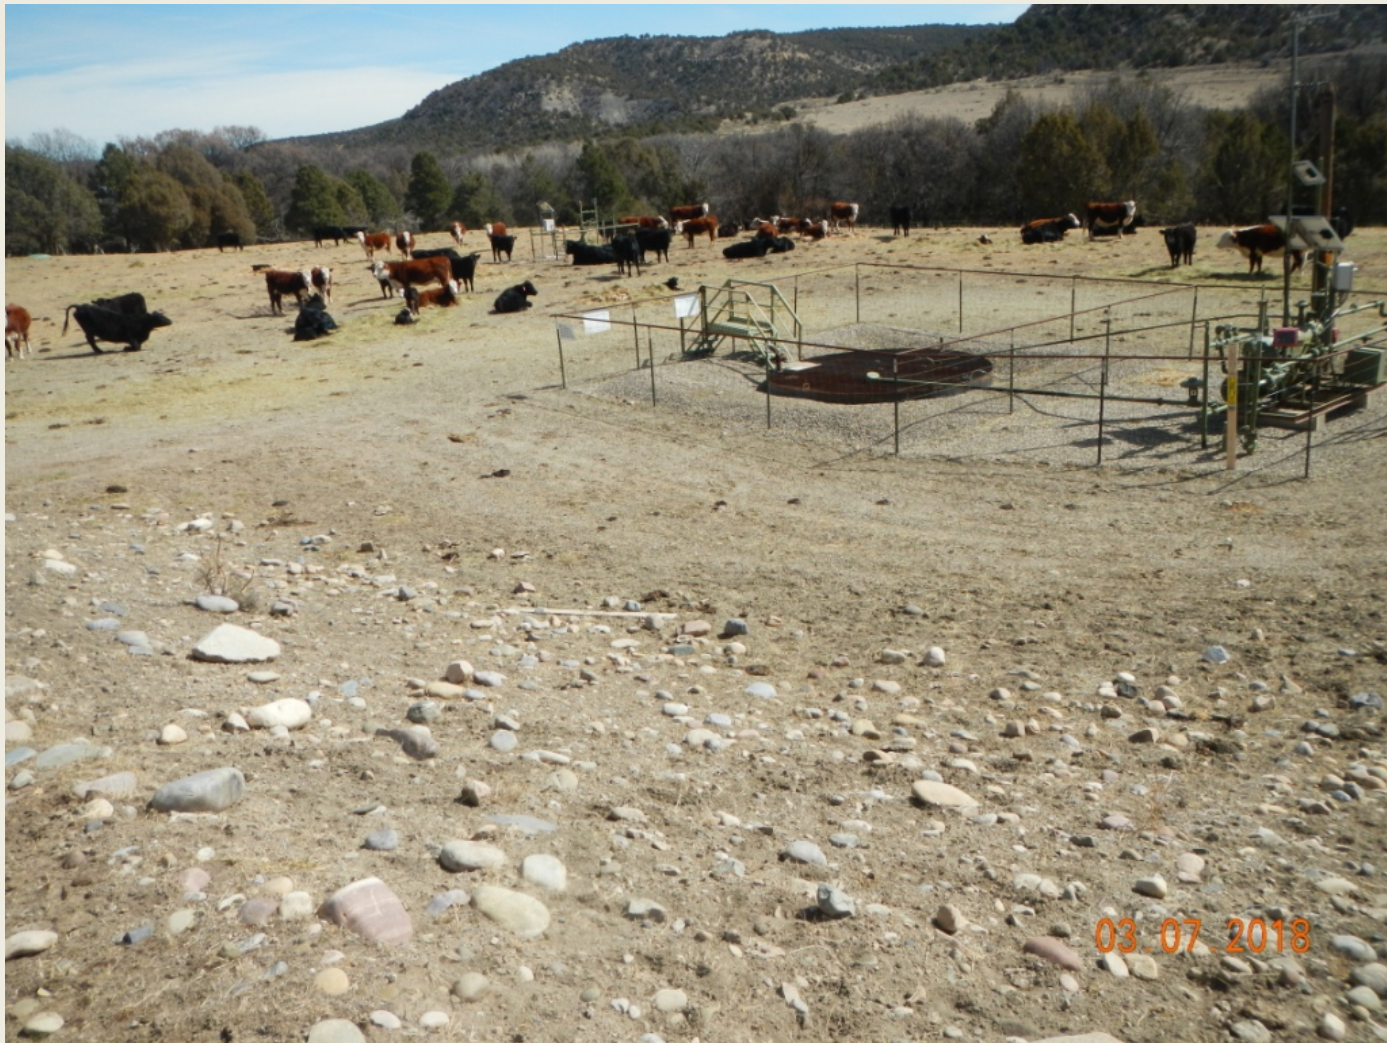
**Photo 1. View of the project area from the western corner facing center.**

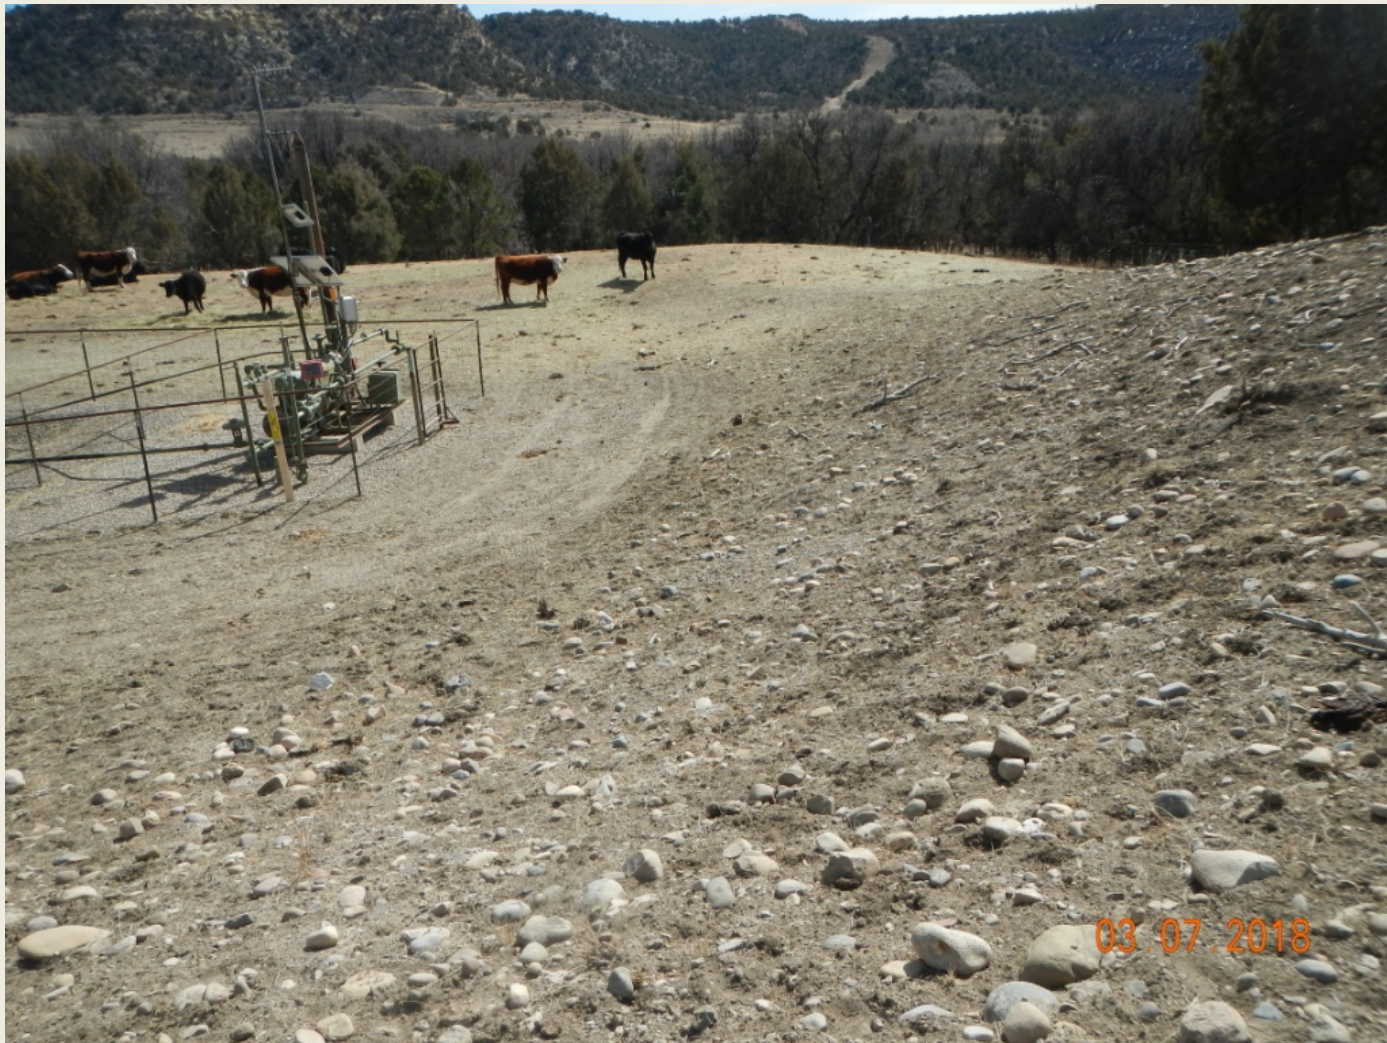
**Photo 2. View of the southwestern portion of the project area from the western corner facing southeastward. Revegetation is sparse and intensely grazed, not in identifiable form.**

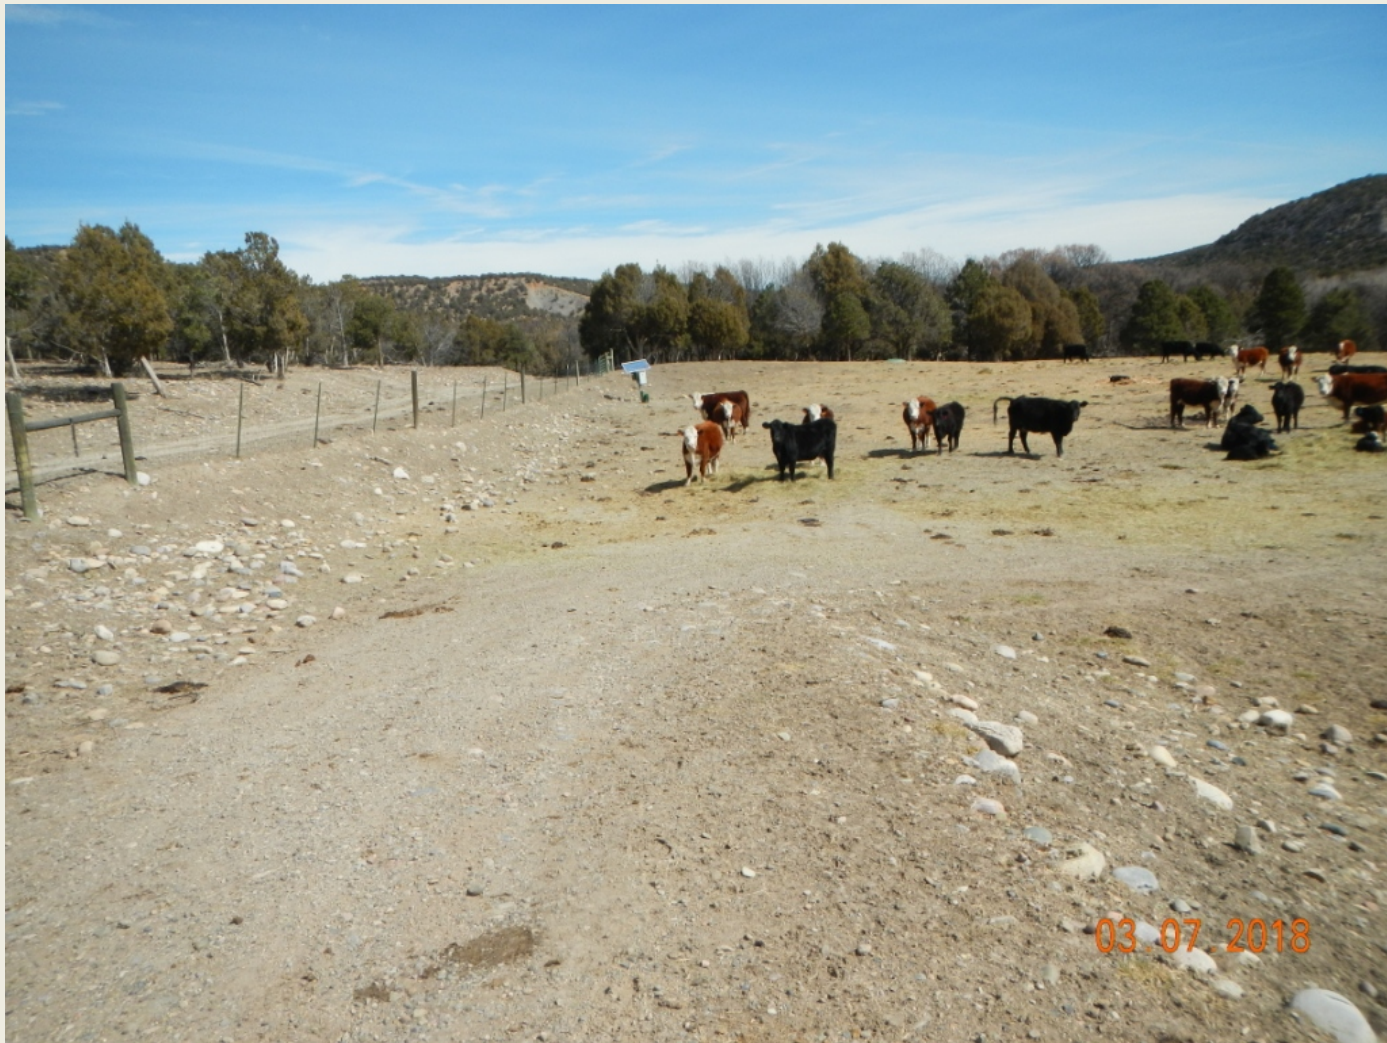
**Photo 3. View of the northwestern portion of the project area from the western corner facing northeastward.**

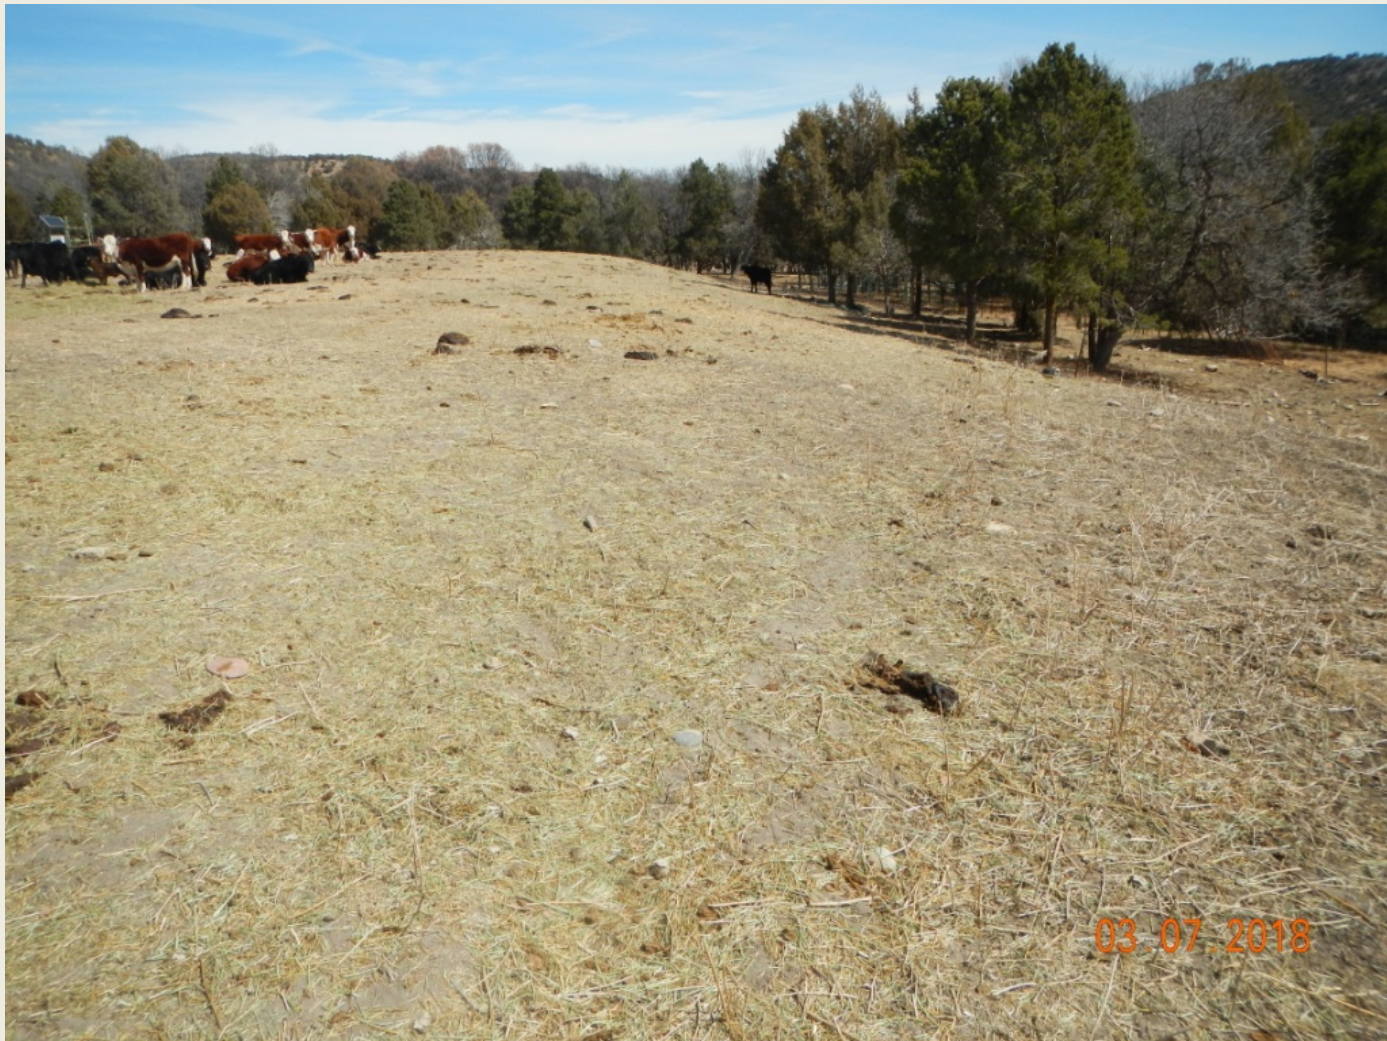
**Photo 4. View of the southeastern portion of the project area from the southern edge facing northeastward.**
