**Inspection Photos**  
**Location Name: Price-Degenhart 1**  
**API: 05-001-07346**  
**Inspection Date: March 8, 2018**

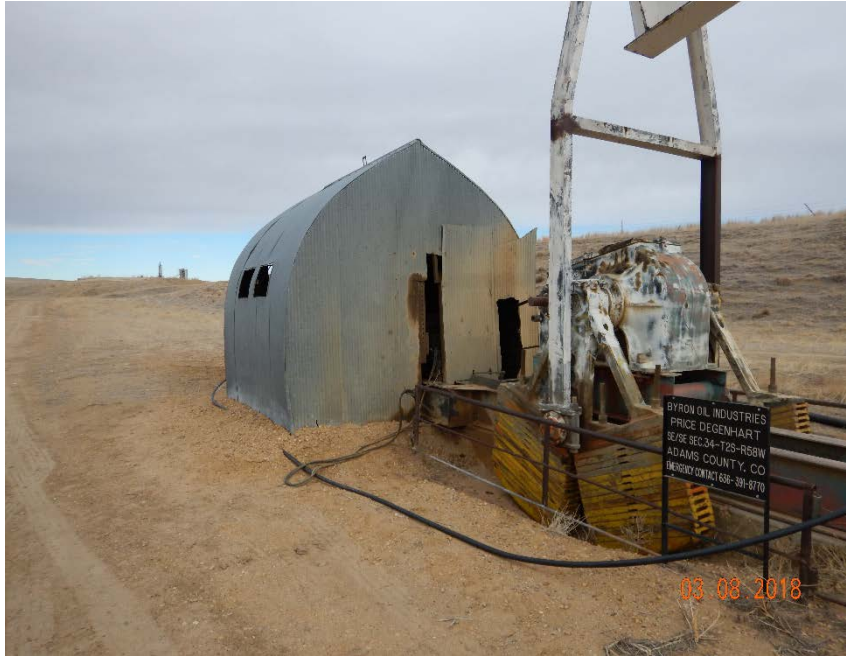
**Photo #1 – View of pump jack, prime mover shed, and well sign from SW.**

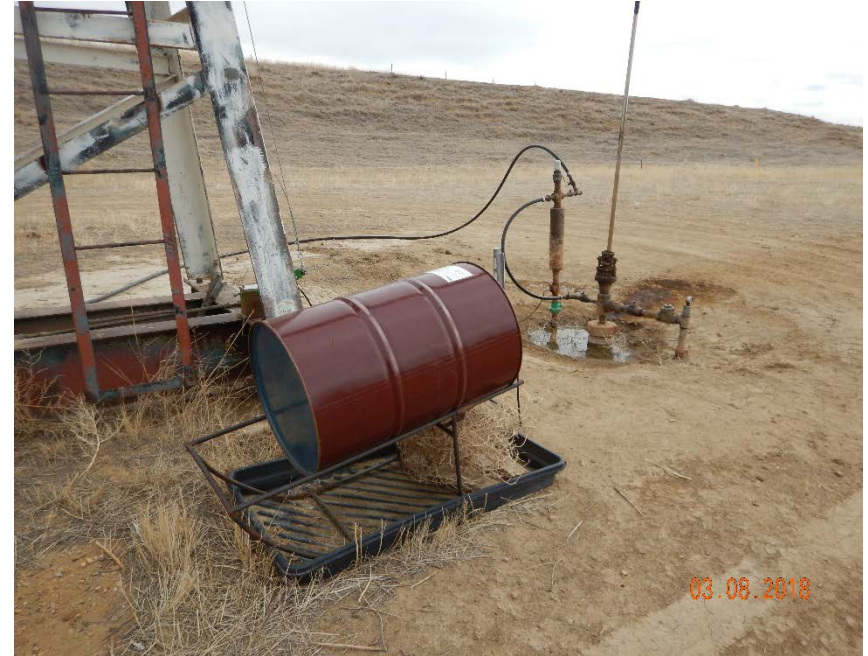
**Photo #2 – View of secondary containment device and wellhead from NW.**

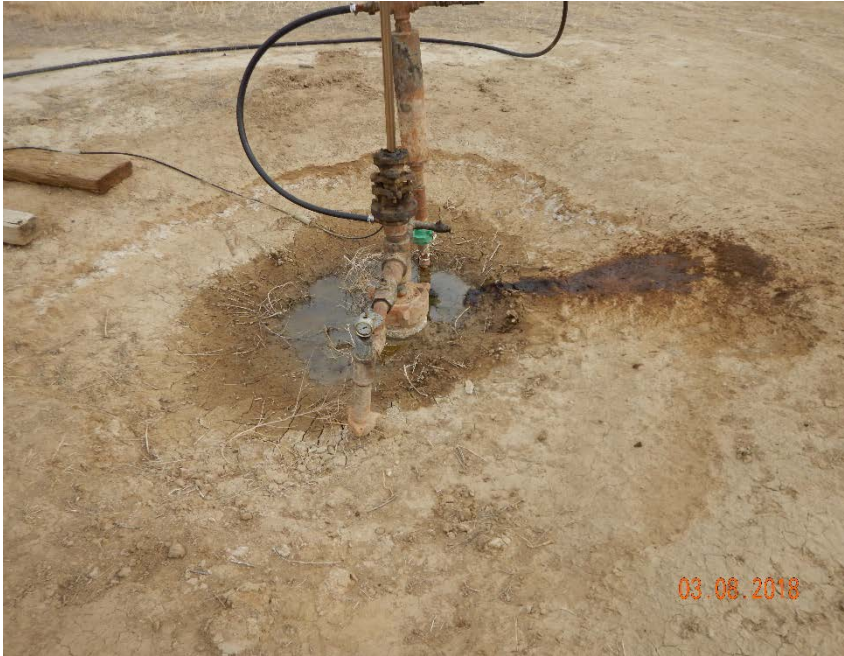
**Photo #3 – View of oily waste spray, puddle of water, and evaporite accumulation at wellhead from west.**

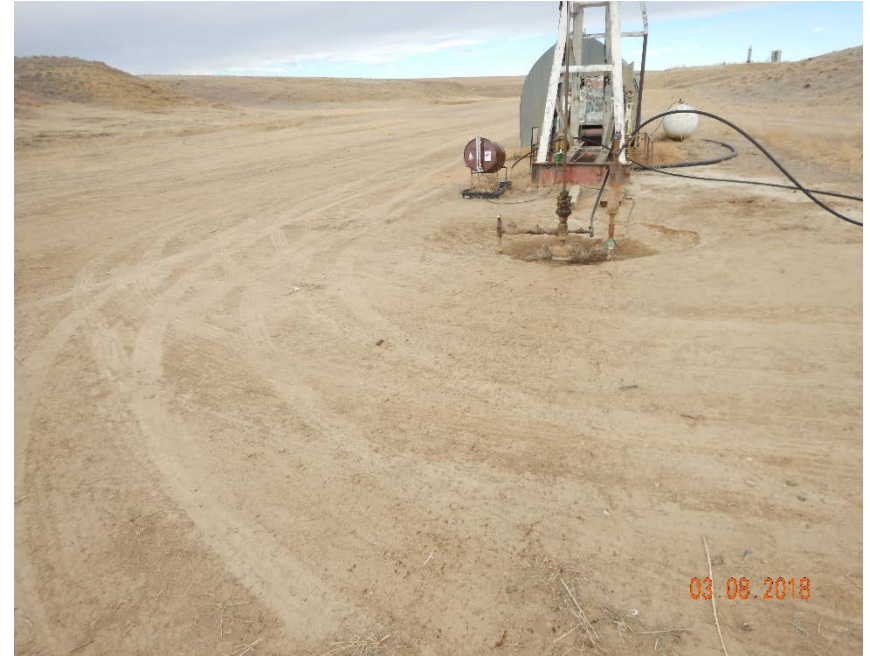
**Photo #4 – View from south of SE extent of oily waste spray from wellhead.**

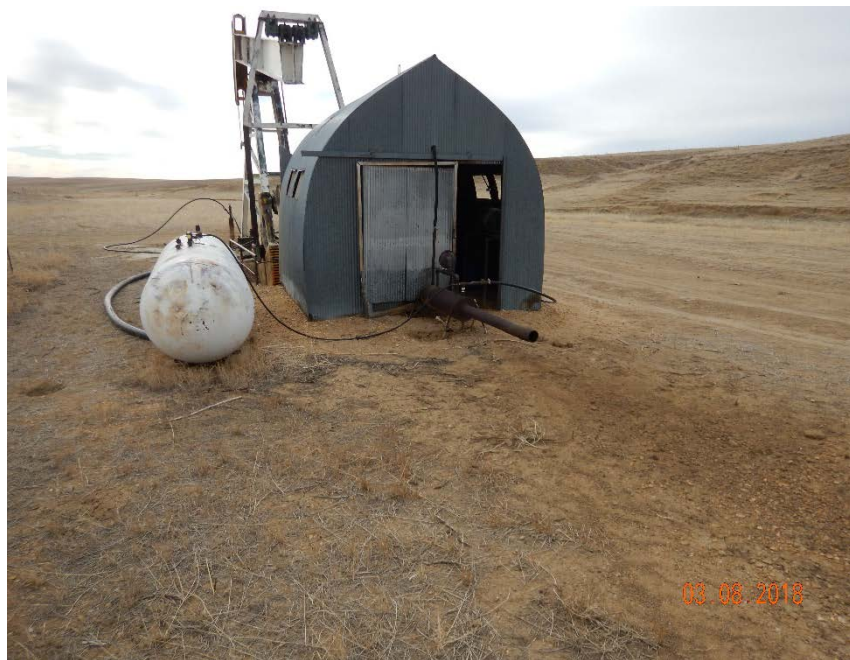
**Photo #5 – Accumulation of blow-through motor oil extending from prime mover exhaust.**

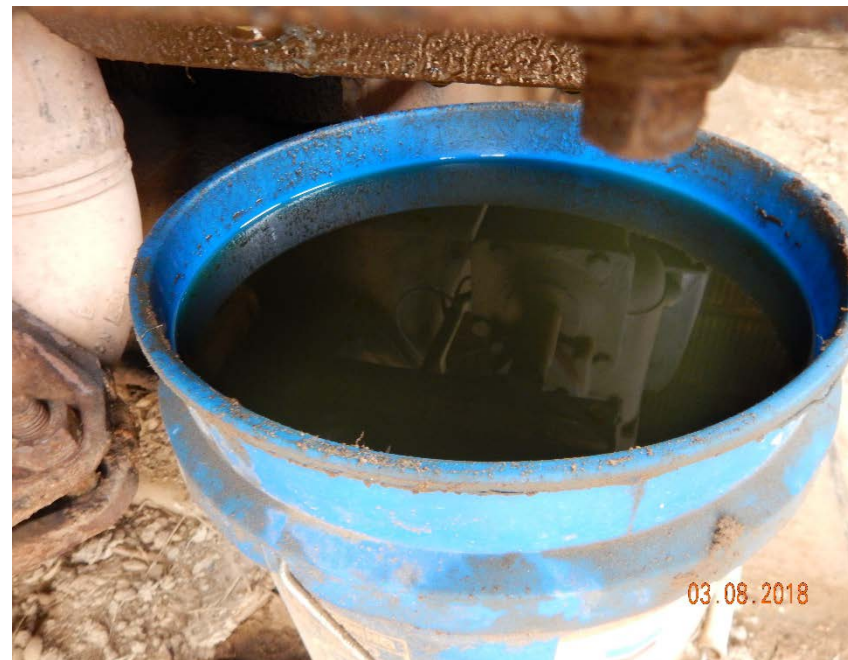
**Photo #6 – 5-gallon bucket beneath prime mover is being used to catch used motor oil.**

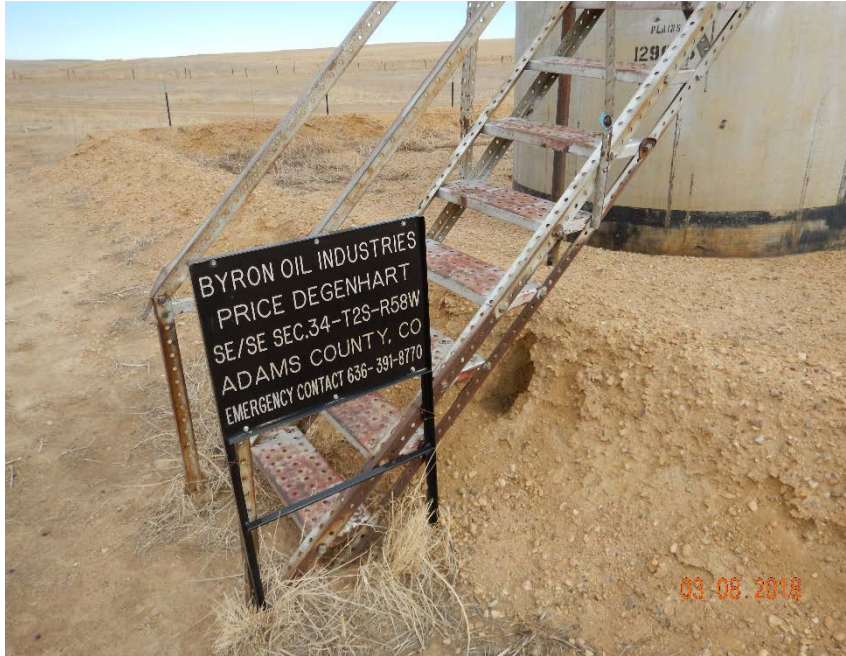
**Photo #7 – Battery sign. Note eroded/damaged pit berm and uncontrolled weed growth.**

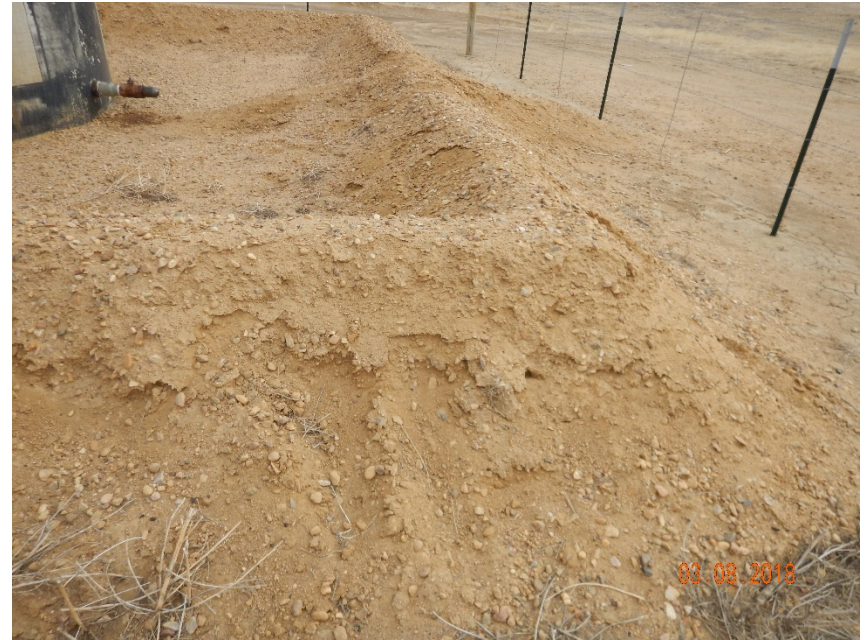
**Photo #8 – Eroded pit berm. Note accumulation of oily waste beneath valve (on SE side of crude oil AST).**

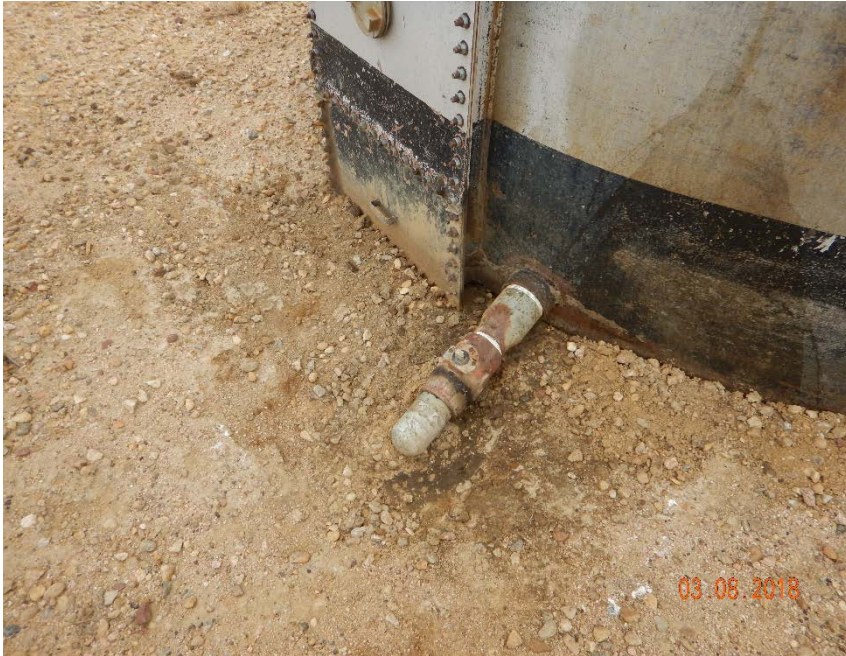
**Photo #9 – Accumulation of oily waste beneath valve on NW side of crude oil AST.**

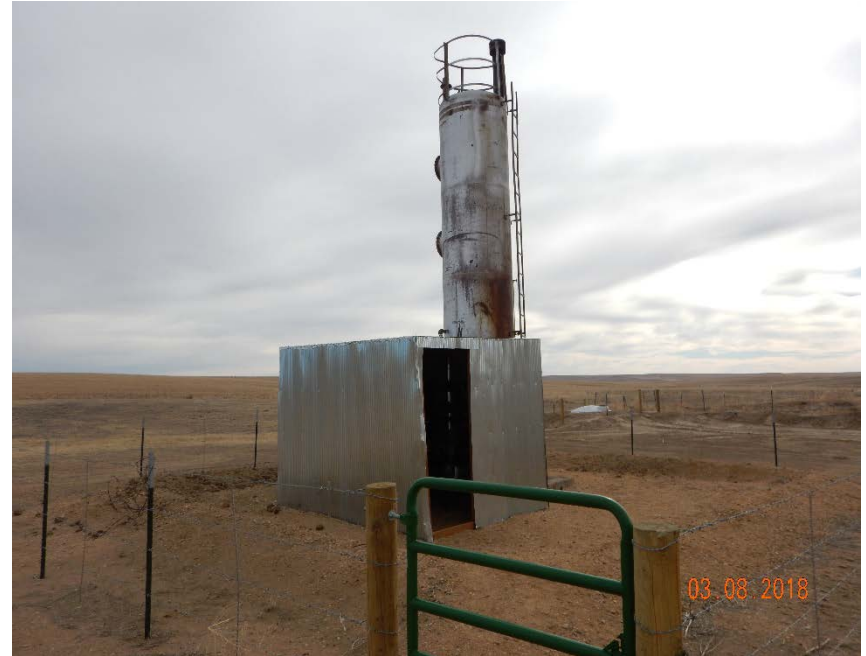
**Photo #10 – View of VHT shed from NE.**

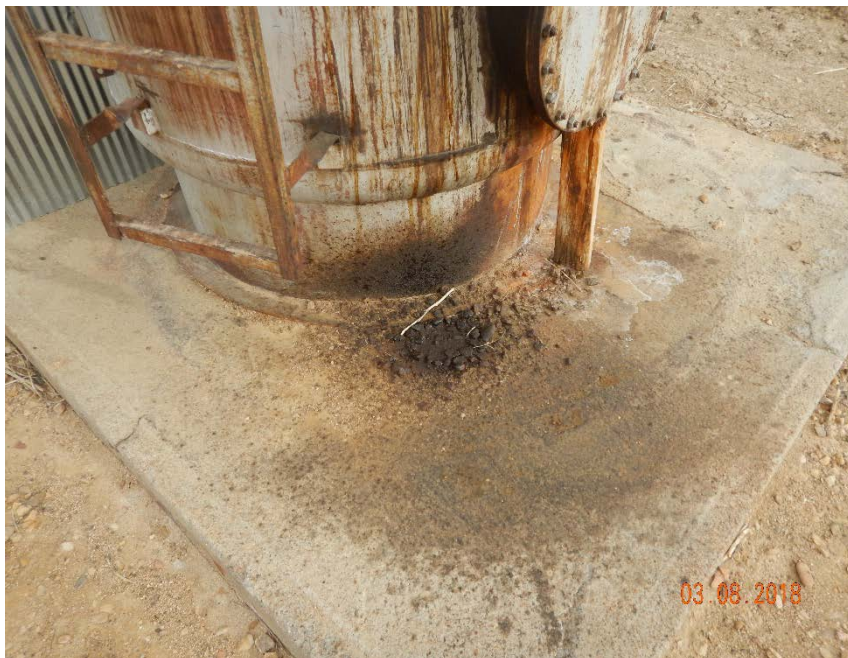
**Photo #11 – Accumulation of oily waste on SE side of VHT.**

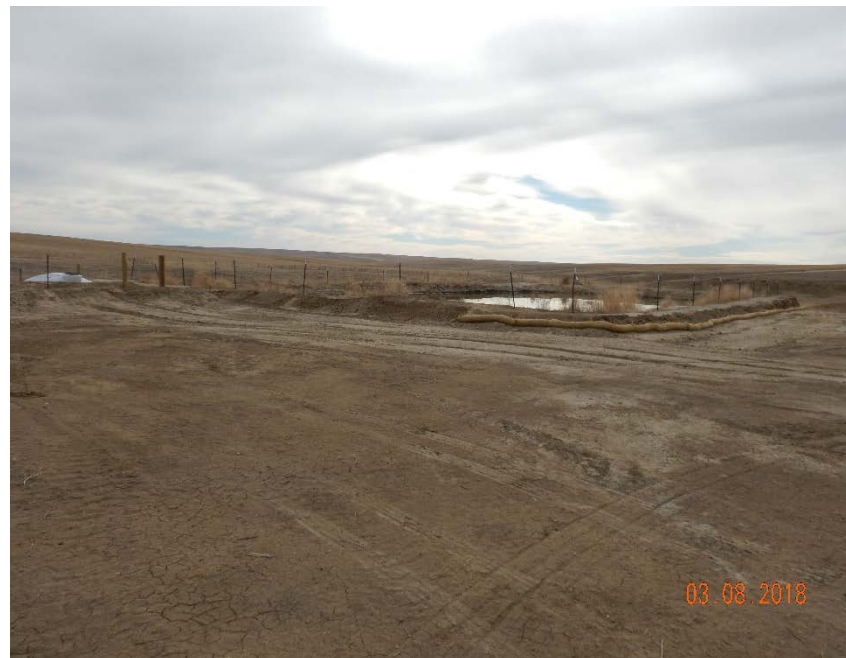
**Photo #12 – View of skim tank and produced water pit from NW.**

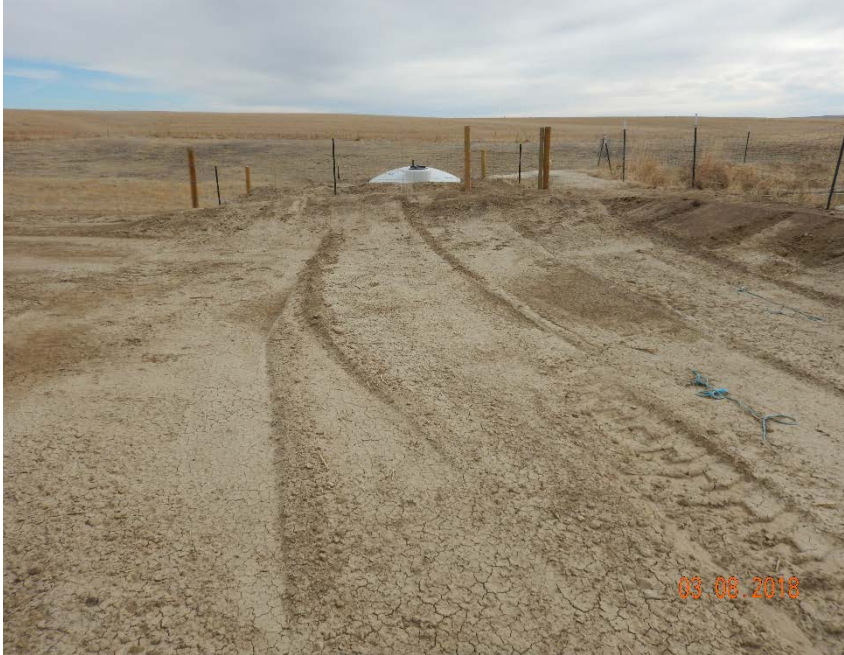
**Photo #13 – Former skim pit location has been backfilled.**

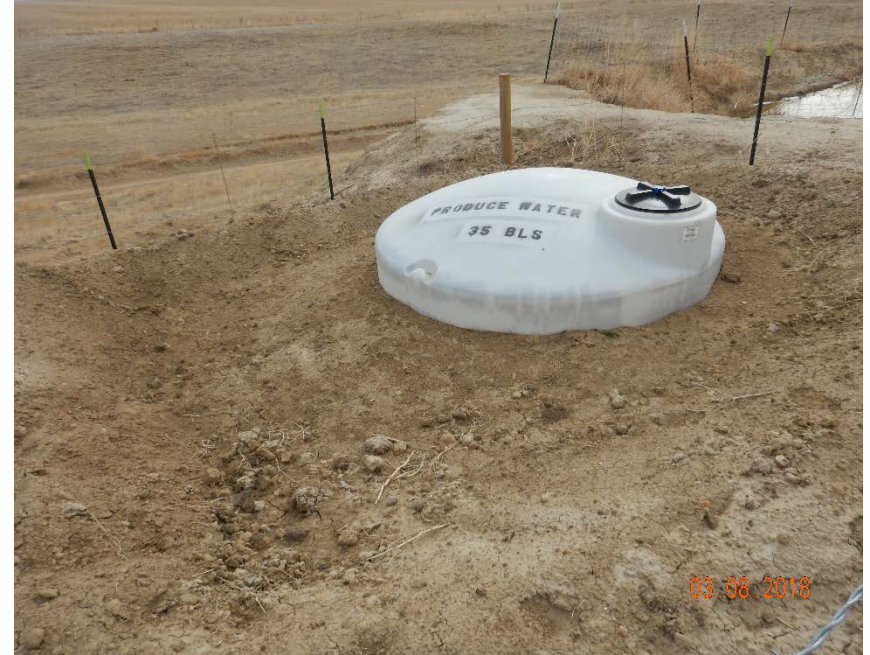
**Photo #14 – Skim tank lacks NFPA placard. Earthen berm is insufficient to contain pit contents plus precipitation.**

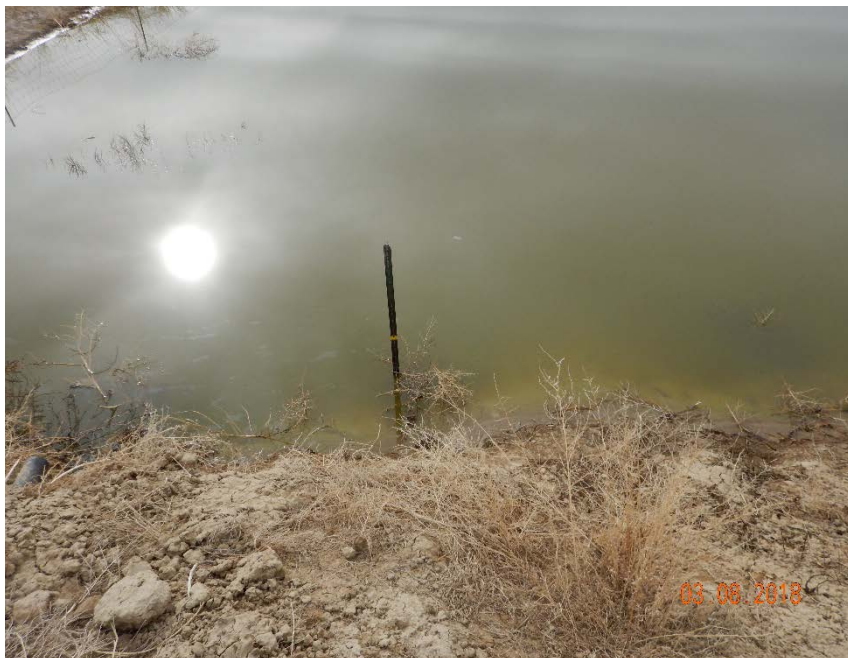
**Photo #15 – T-post has been installed at NE corner of produced water pit as a means of monitoring freeboard.**

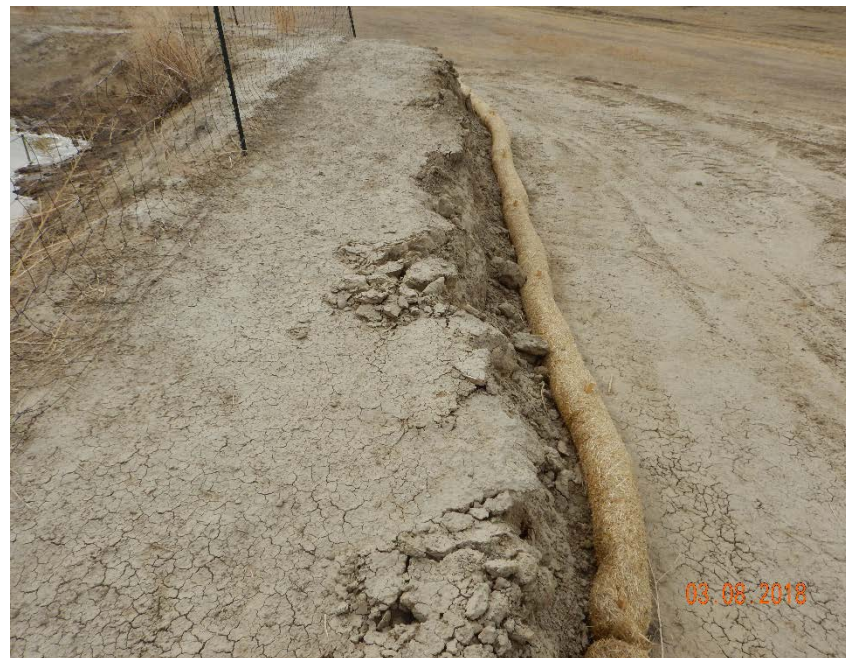
**Photo #16 – Straw waddle has been installed along west berm of produced water pit.**

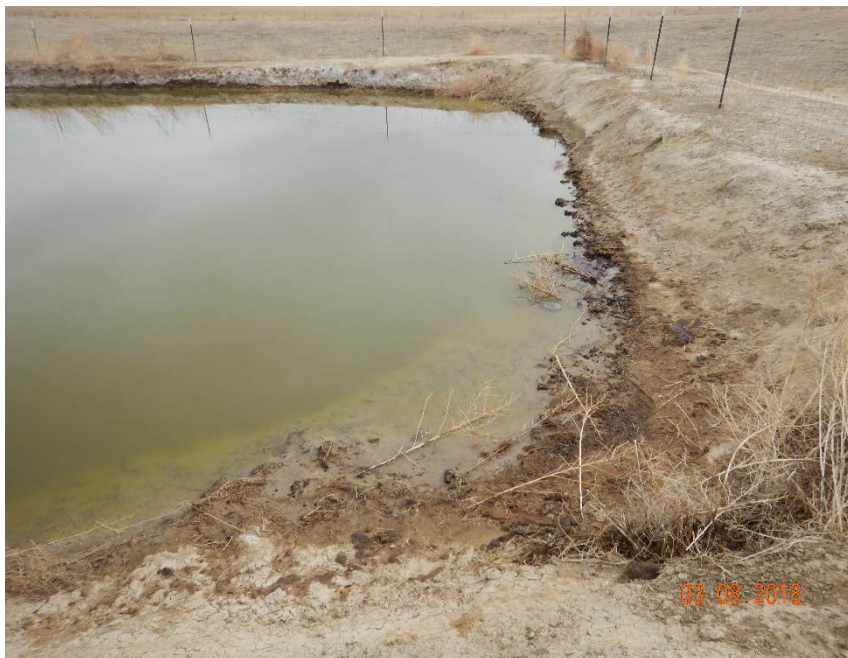
**Photo #17 – Oil-stained soil remaining inside of south pit berm.**

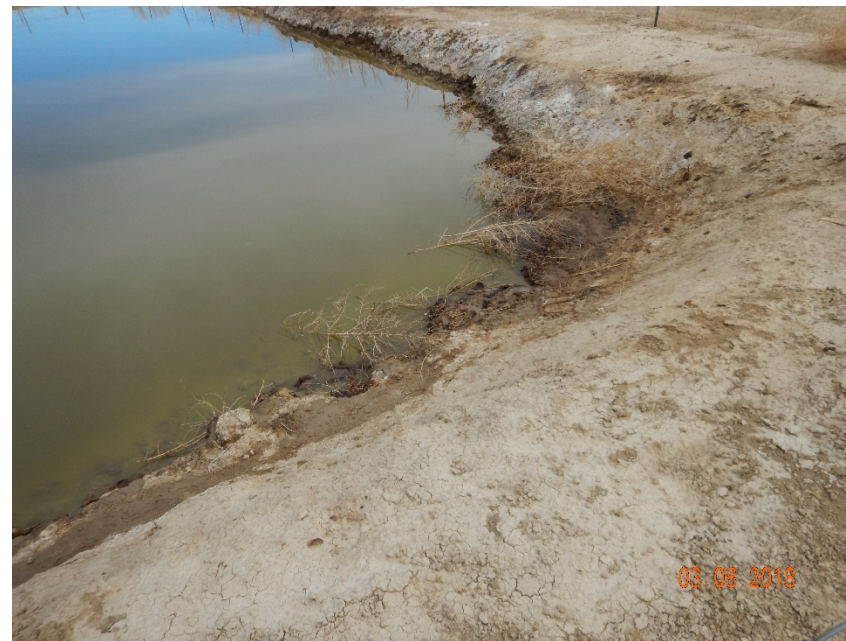
**Photo #18 – Accumulation of oily waste inside of SE corner of produced water pit.**

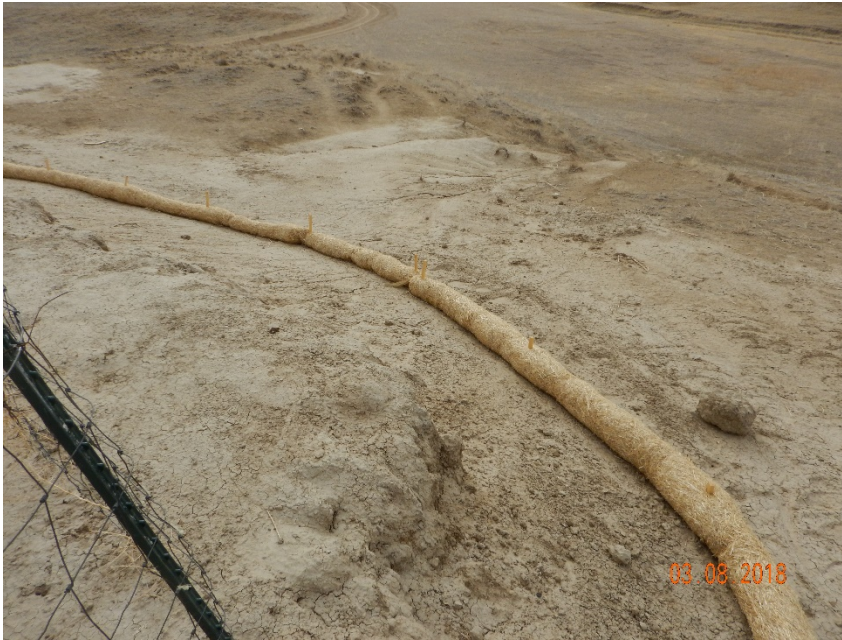
**Photo #19 – View of straw wattle at SW corner of produced water pit.**

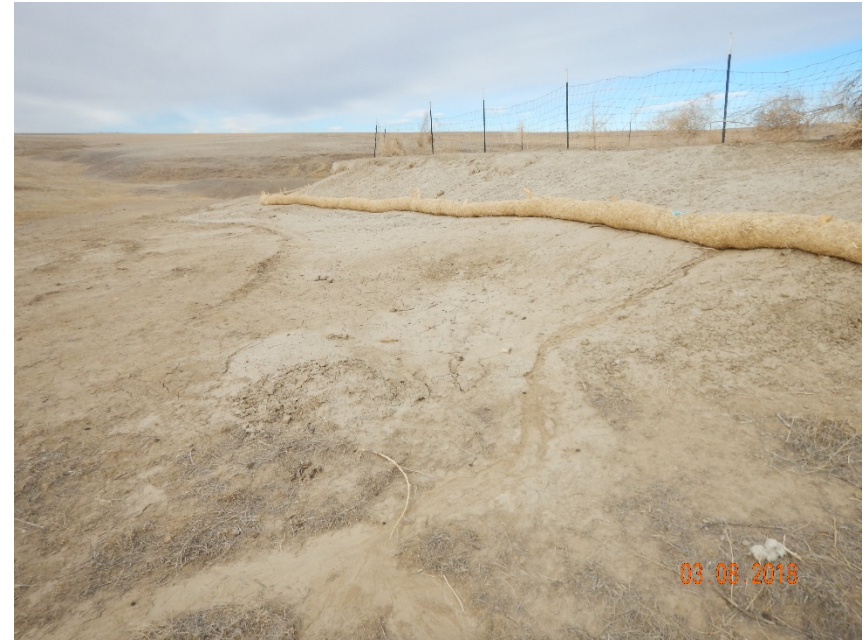
**Photo #20 - Straw wattle extending along south berm of produced water pit.**

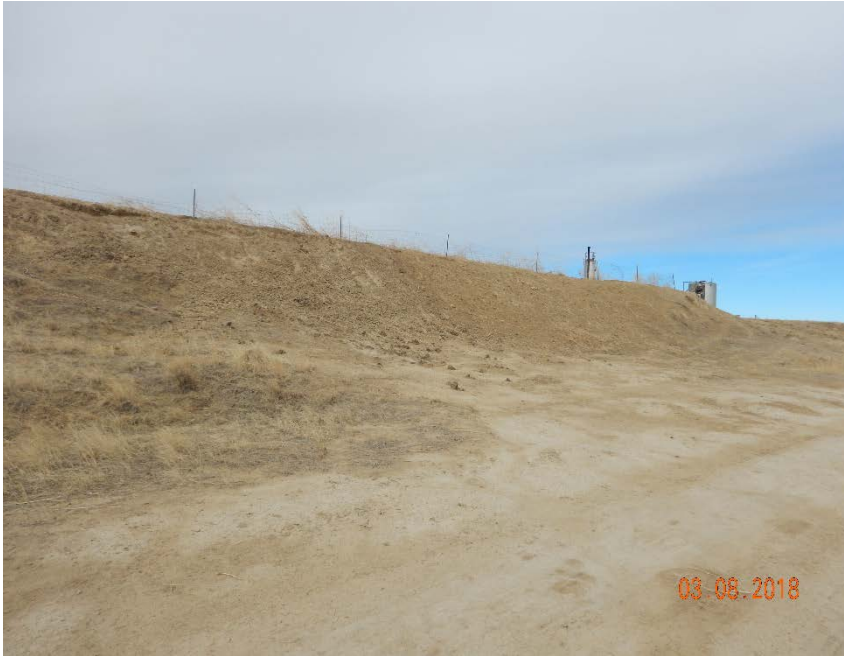
**Photo #21 – View of east produced water pit berm. Note evidence of sediment transport and absence of straw wattle.**

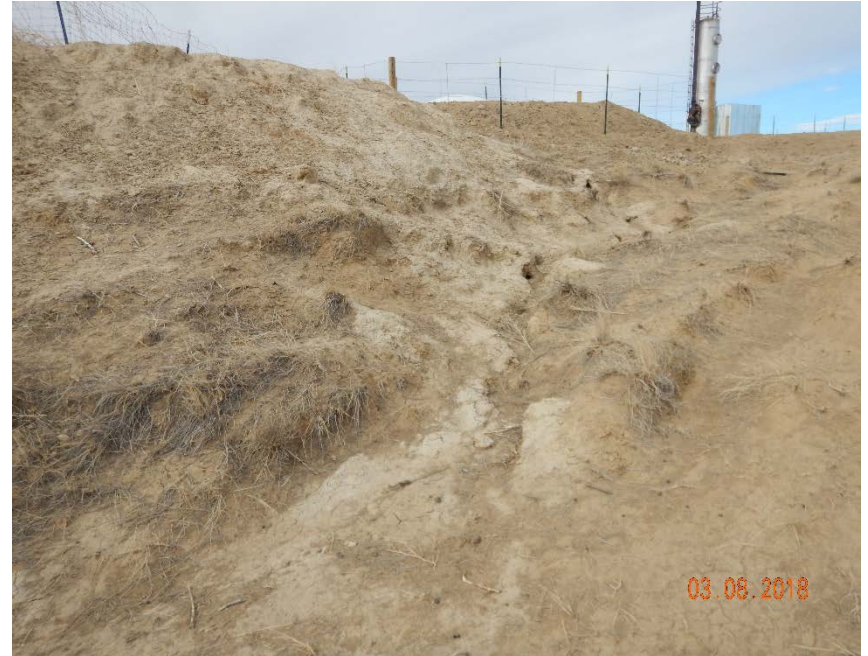
**Photo #22 – Erosion and sediment transport at NE corner of produced water pit.**

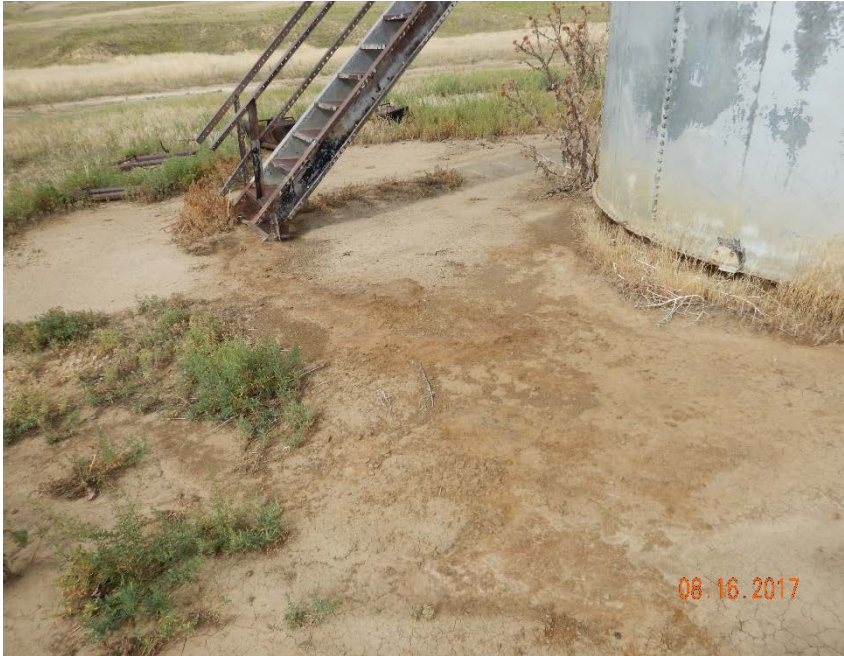
**Photo #23 – Field photo dated August 16, 2017** showing historical accumulation at area formerly underlying modular steel ASTs west of existing crude oil AST berm.

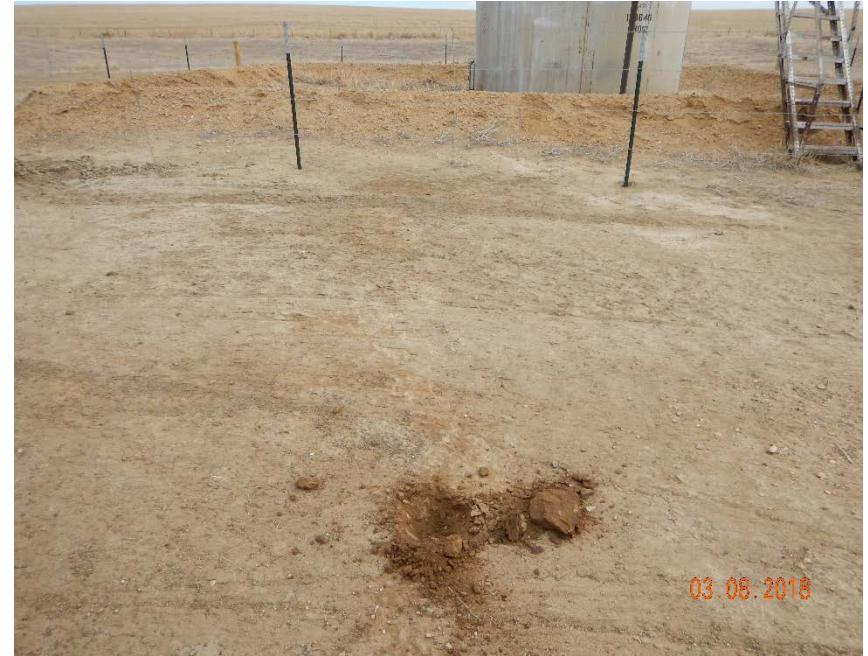
**Photo #24 – Photo from inspection date (March 8, 2018)** depicting oil-stained soil that remains in area west of existing crude oil AST berm.
