# Inspection Photos

API: 05-067-06911

Operator: BP AMERICA PRODUCTION  
COMPANY

Inspection Date: 3/7/2018

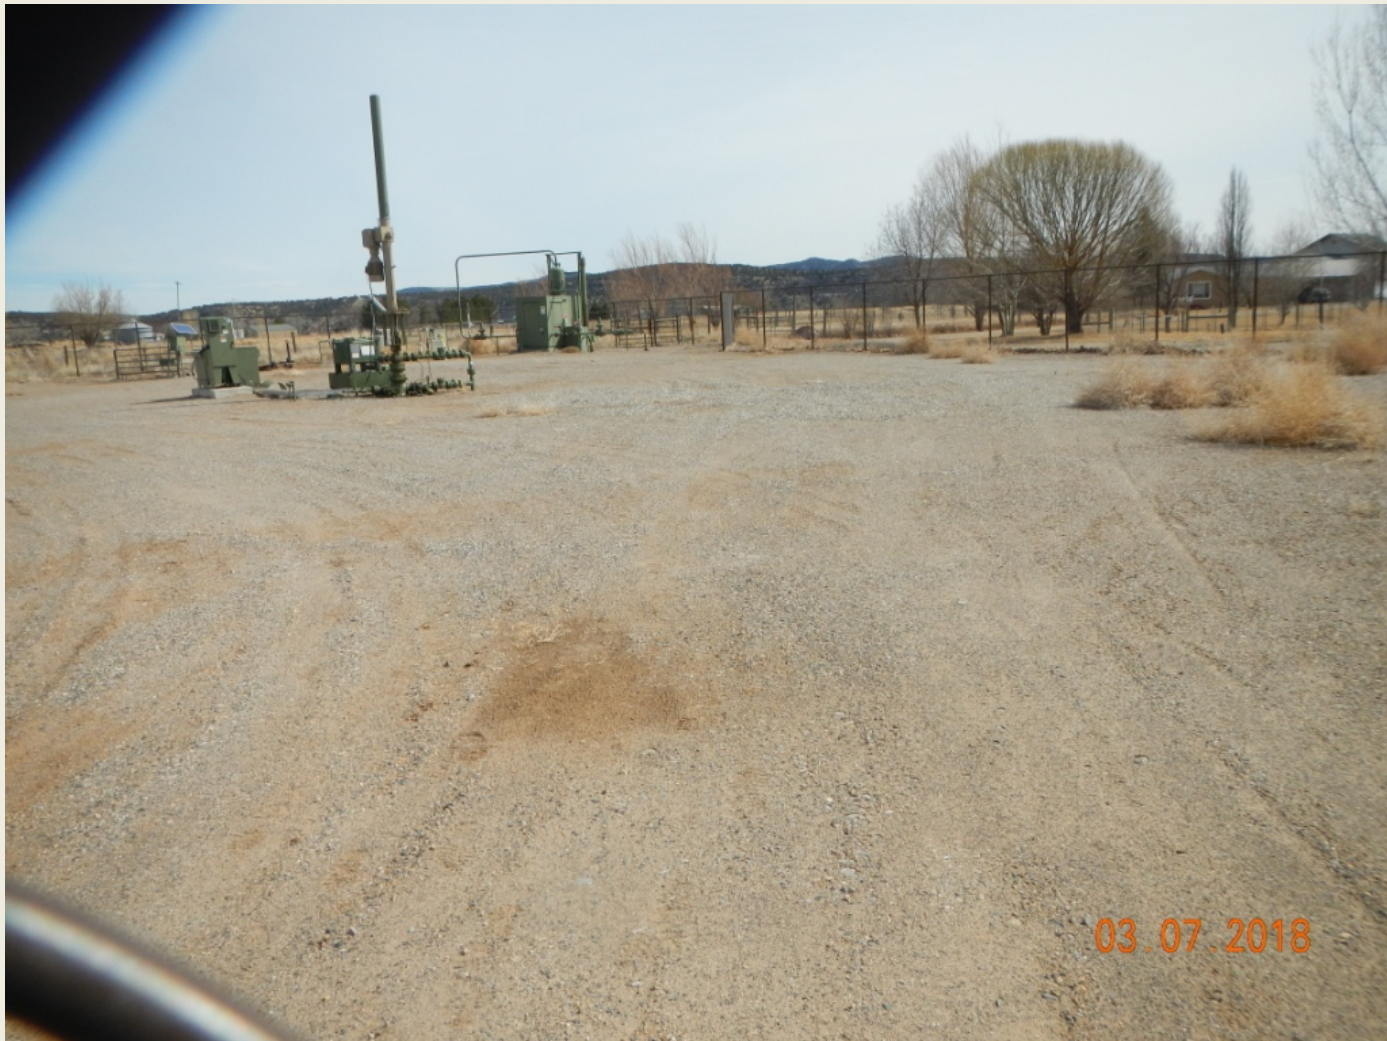
**Photo 1. View of the project area from the northwestern corner facing center.**

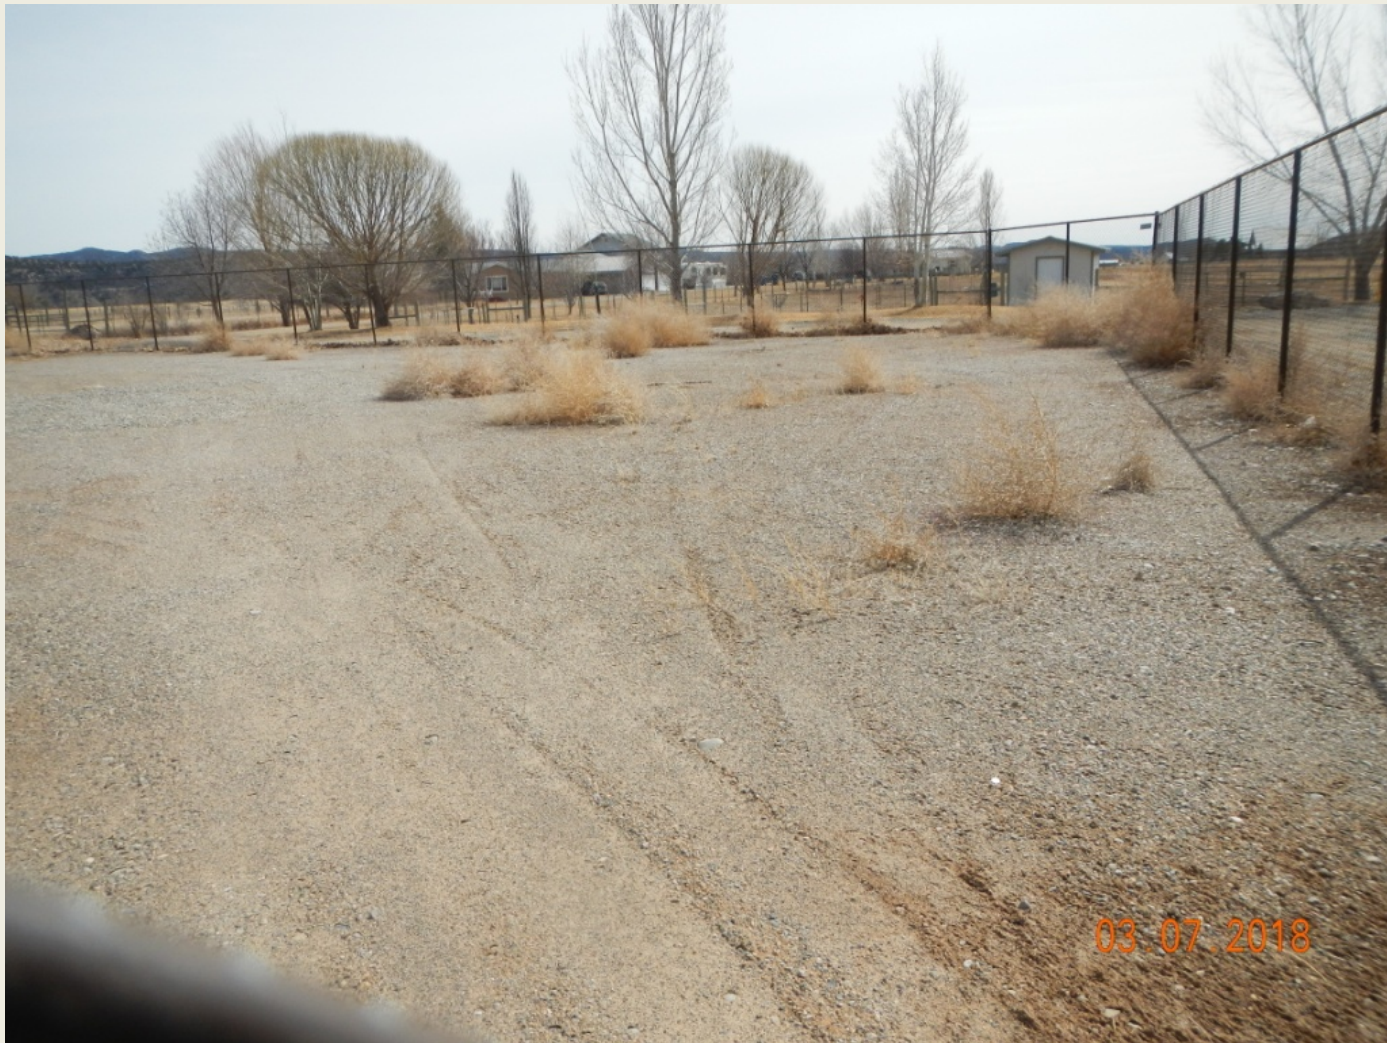
**Photo 2. View of the western portion of the interim reclamation area from the northwestern corner facing southward. Kochia debris scattered on well pad and along project boundaries needs removal.**

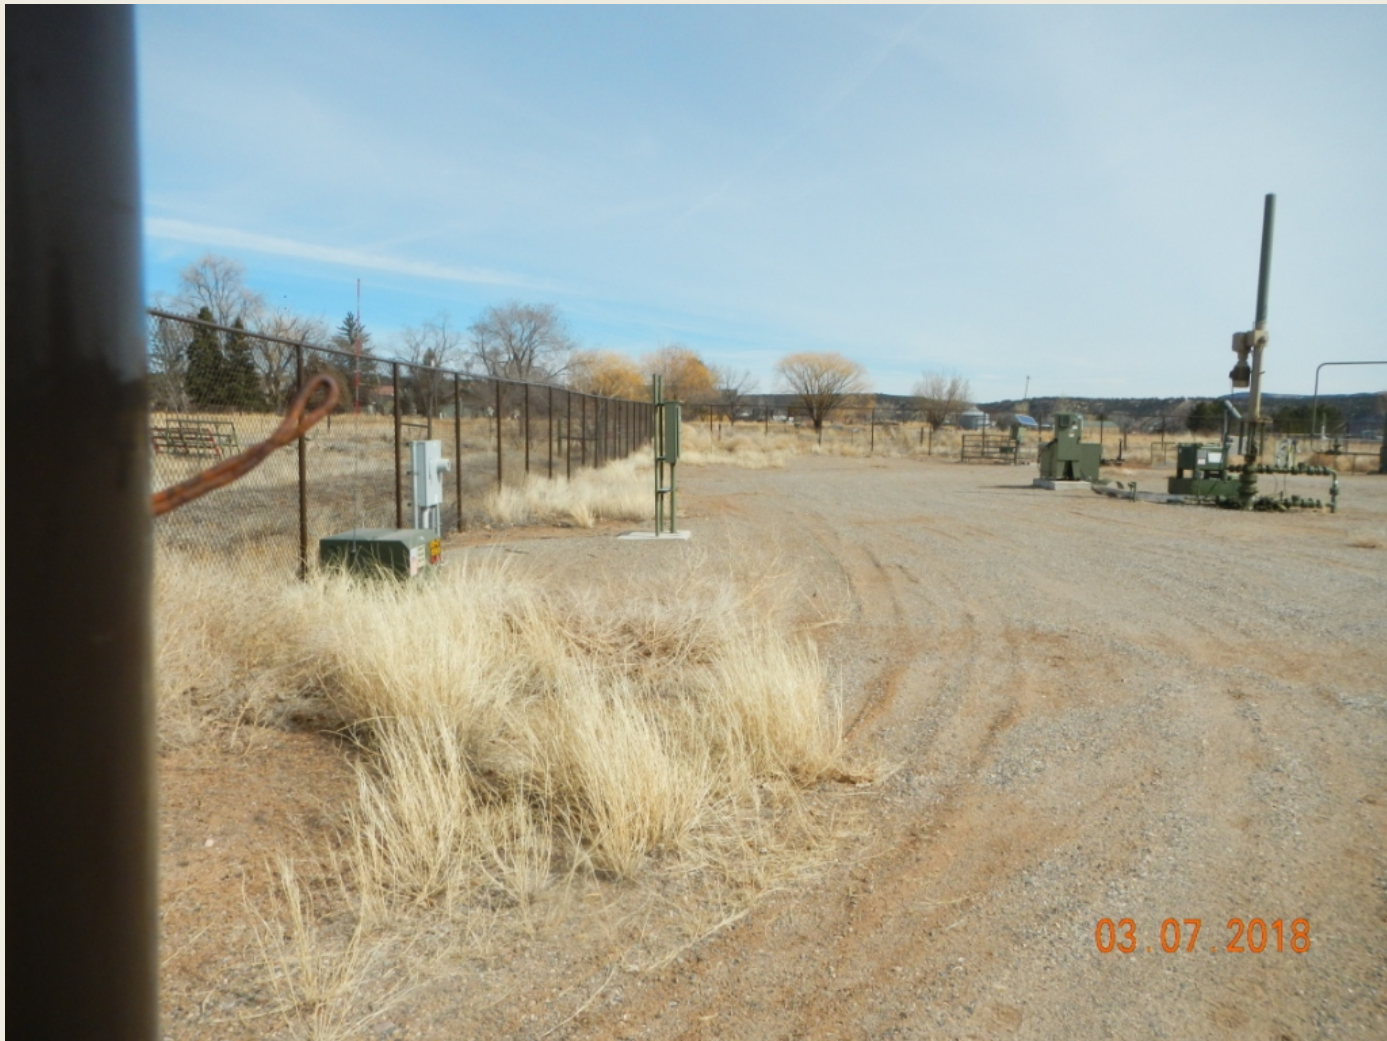
**Photo 3. View of the northern portion of the working area from the northwestern corner facing eastward. Grasses such as sand dropseed (*Sporobolus cryptandrus*) are established along the outer boundaries of the project area.**

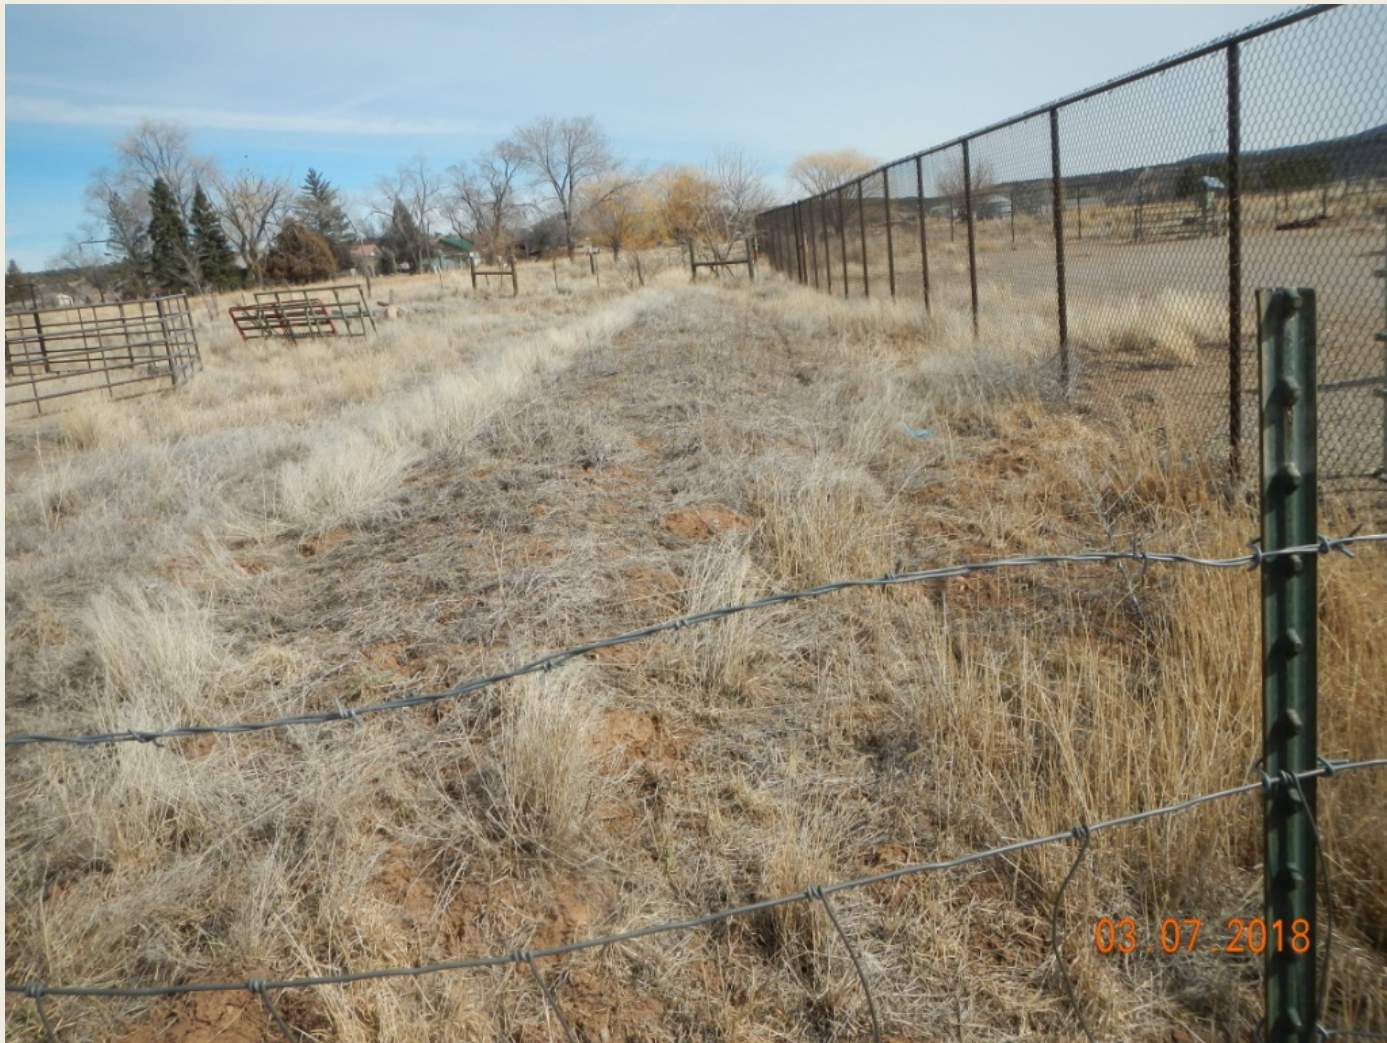
**Photo 4. View of the northern portion of the project area, outside of fenced working area, facing westward.**
