## Inspection Photos

Location Name: KAMMERZELL-65N66W 29NWNW

Location #: 329854

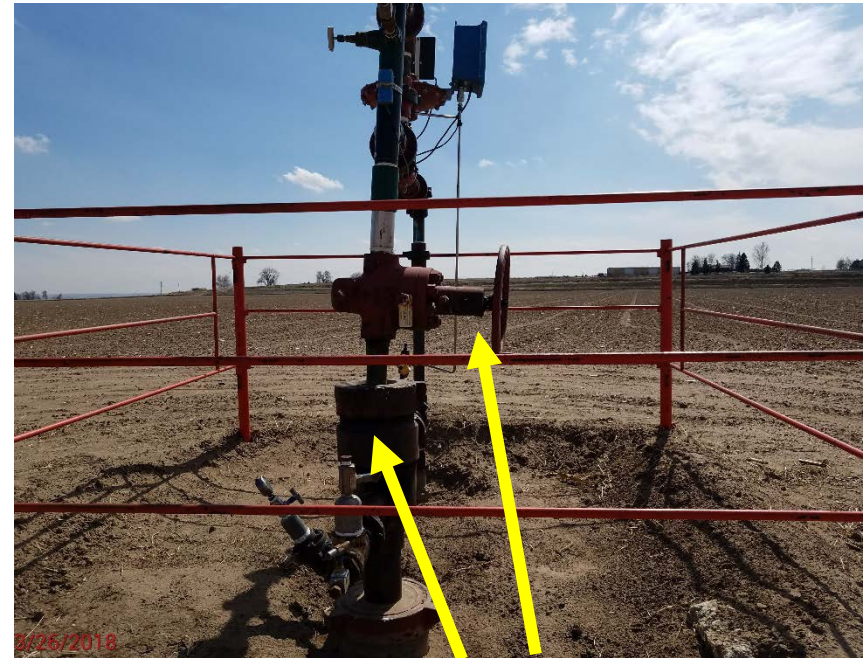
Kammerzell 29-4 H6 wellhead facing S. Casing head has audible leak with stain. Master valve stem appears to be dripping fluid

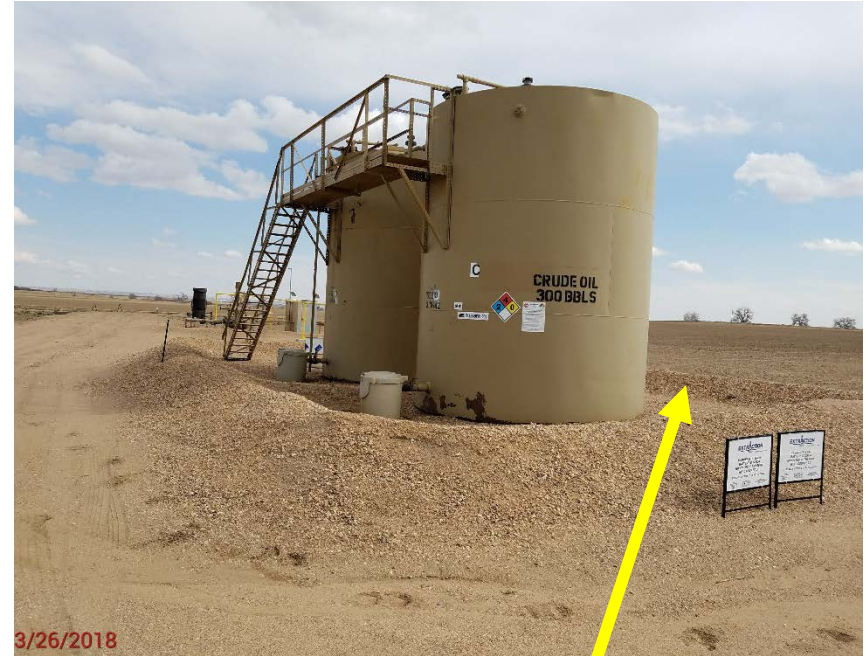
Tank Battery facing SE. Berms appear inadequate for containment.

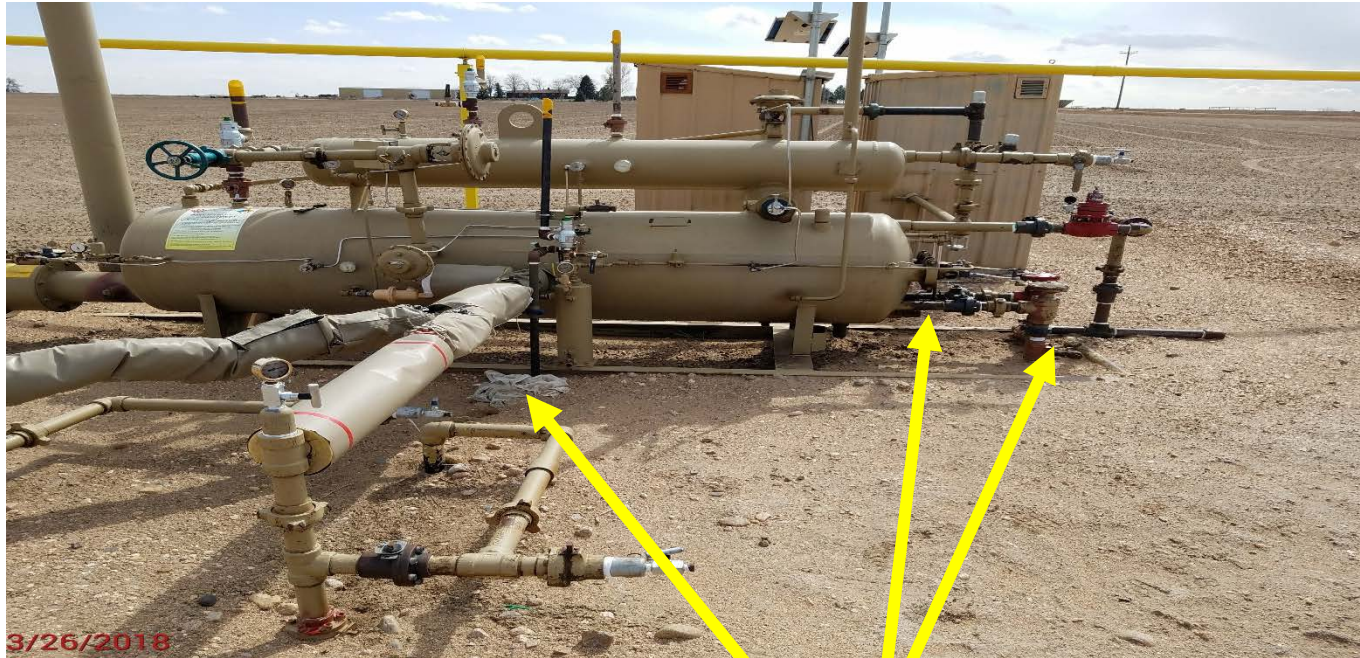
Separator facing S.

**Wet stains on dump lines.**

**Corrective Action: unused equipment & trash.**
