Inspection Photo
Lazier 23-15A
API# 045-11030
Inspection # 689300756

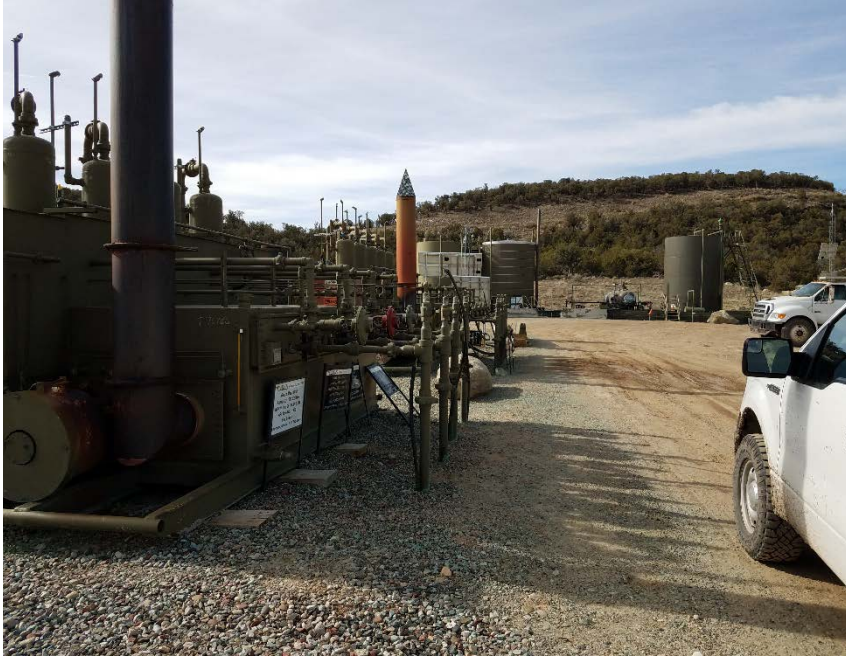
Location photo 3/30/18

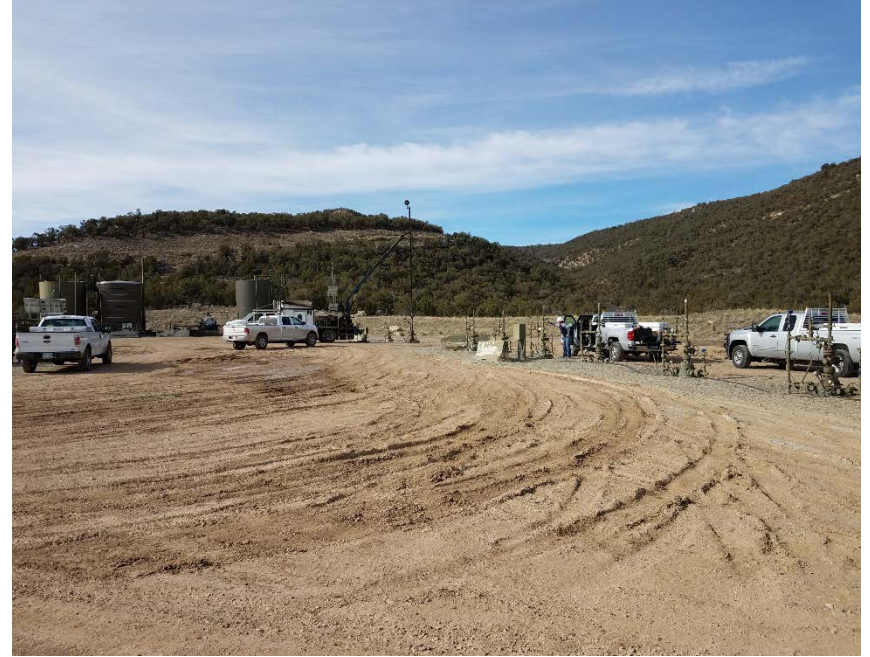
Location photo 3/30/18
