Inspection Photos  
Location Name: CROW POINT 34-18  
Facility ID # 127469

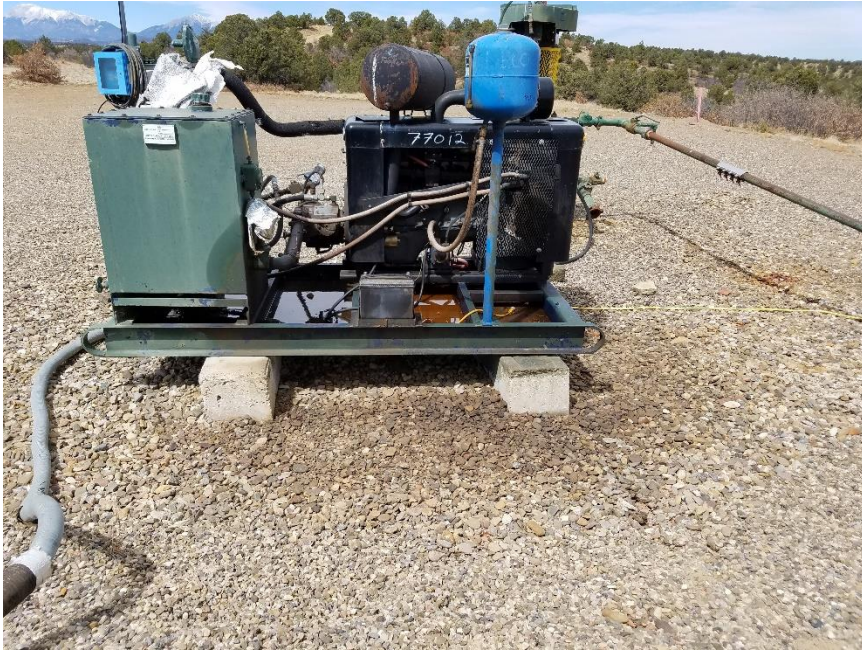
Photo 3. Stained soil around prime mover

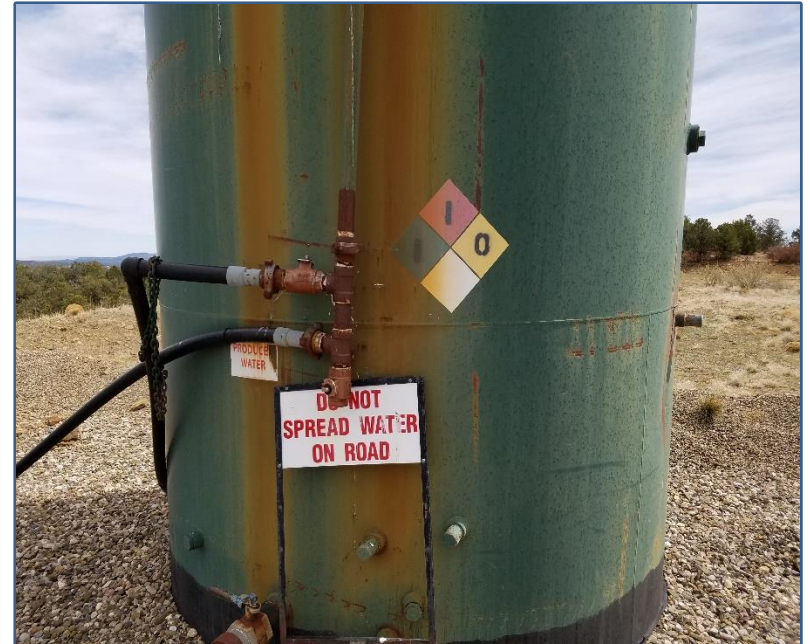
Photo 4. No tank capacity posted on tank
