Inspection Photos
Location Name: Hotchkiss Federal 1289 #18-31
API: 05-051-06071

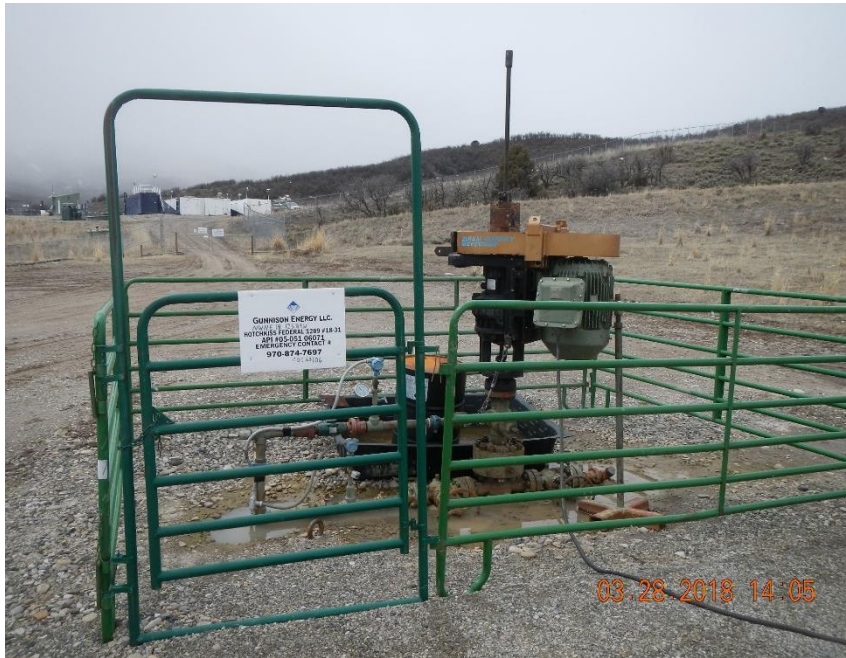
Hotchkiss Federal 1289 #18-31 well head and pump.

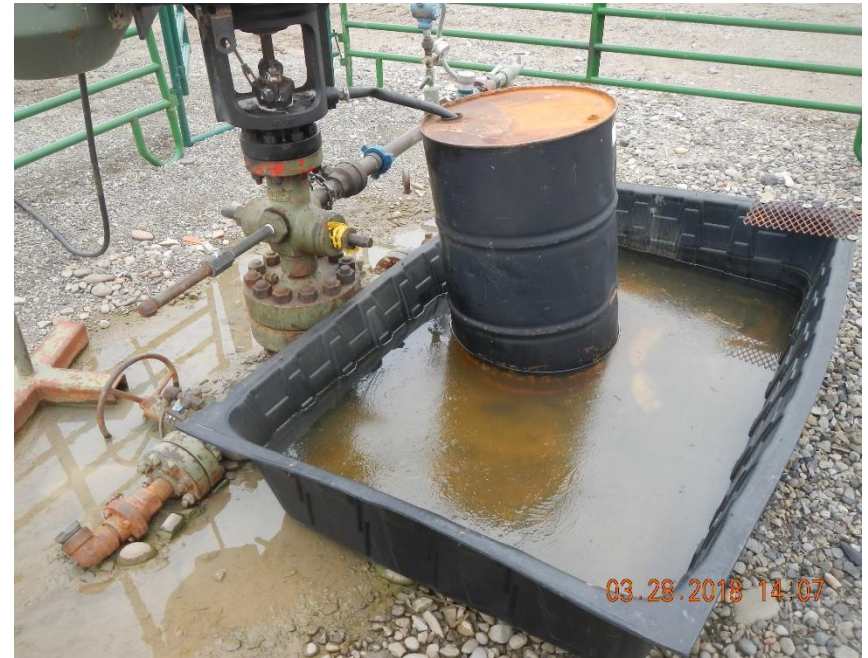
Oil drain to 55 gal. drum in secondary containment.

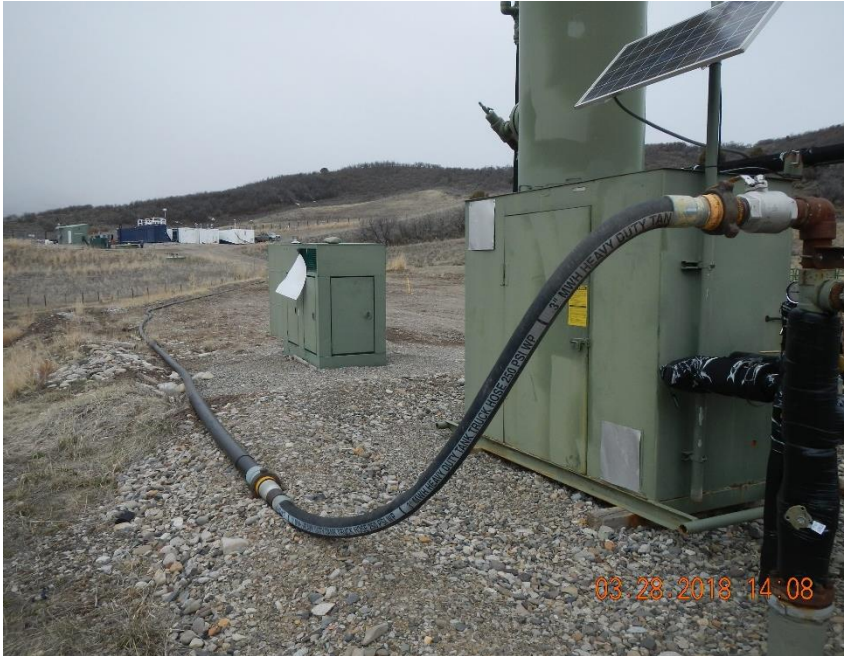
Vertical separator with produced water line.

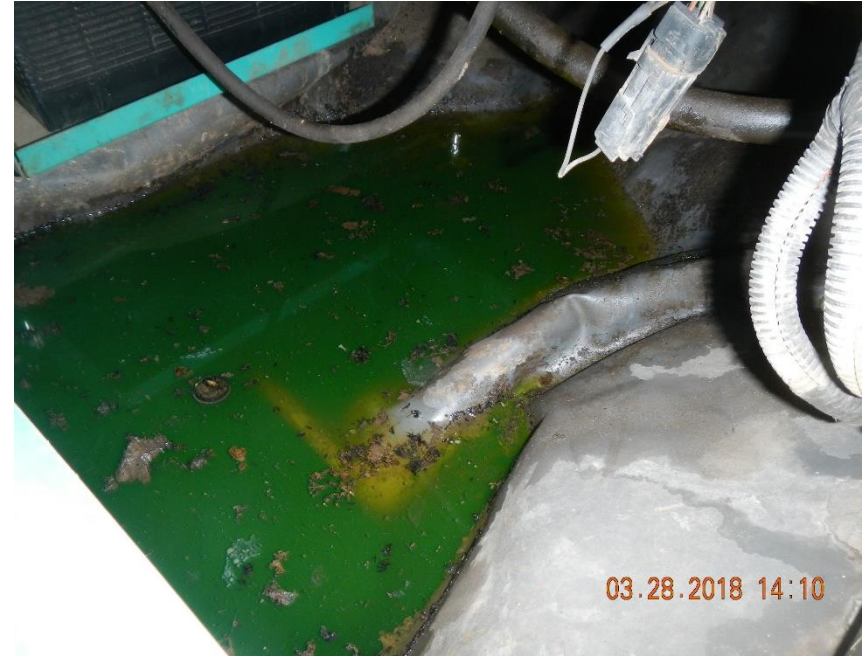
Antifreeze leak under generator engine.
