Inspection Photos
Location Name: DGU Hotchkiss Federal 1289 #18-H2
API: 05-051-06104

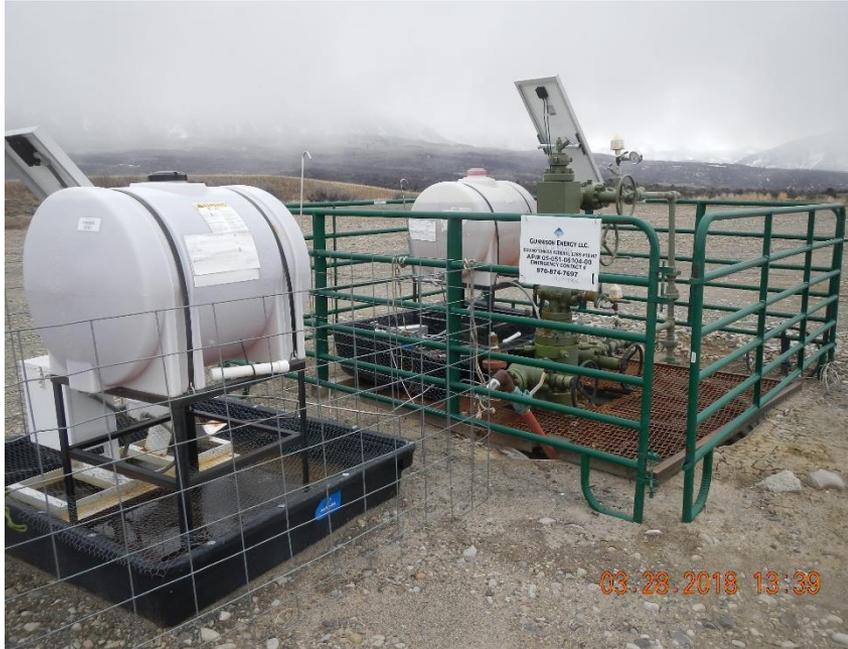
DGU Hotchkiss Federal 1289 #18-H2 well head and ancillary equipment.

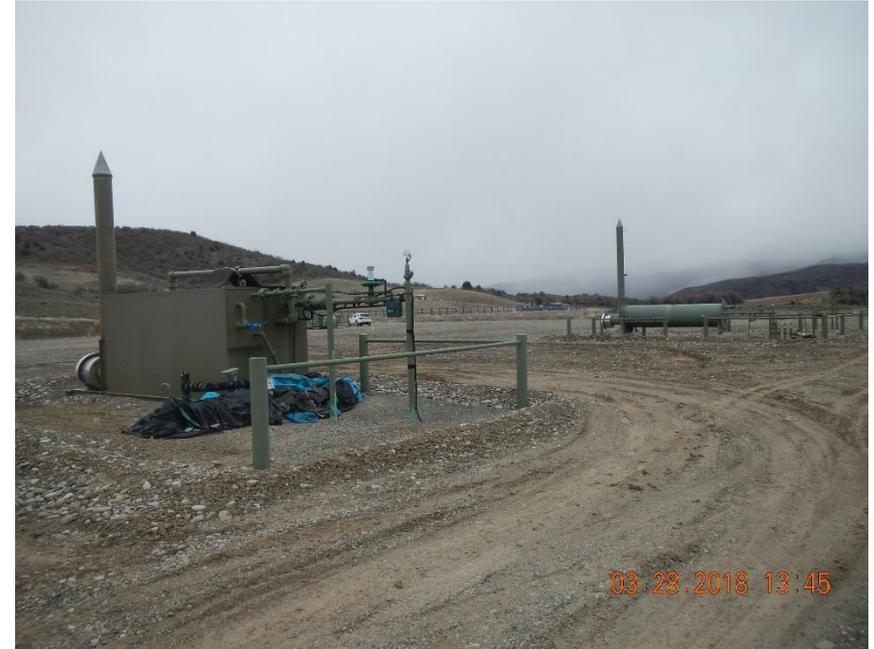
Location ID #427218 production equipment.

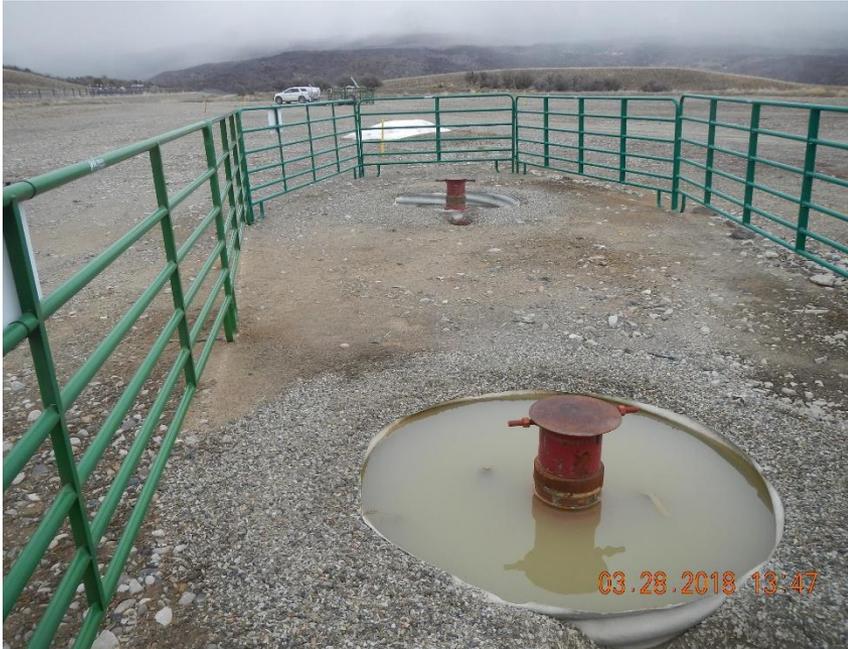
DGU Federal 1289 #18-CS1 and CS2 wells.

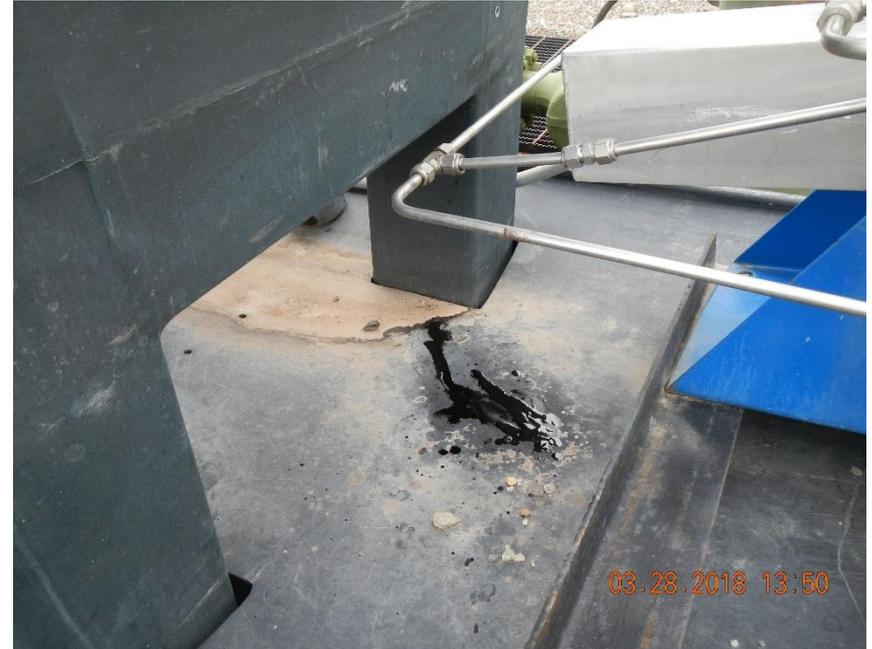
Stainless tubing on chemical injection system at DGU Hotchkiss Federal 1289 #18-H1 leak.

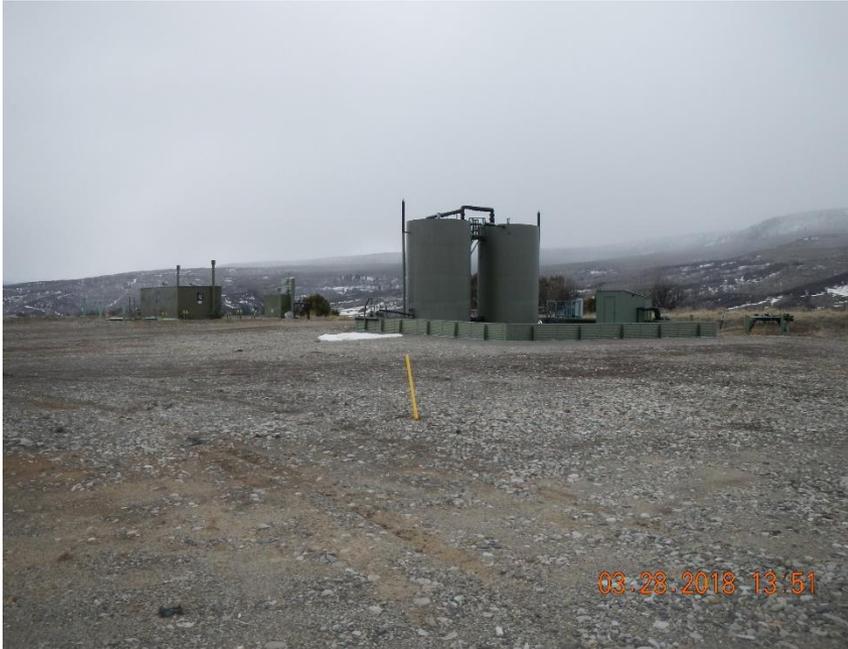
Location ID #427218 tank battery.

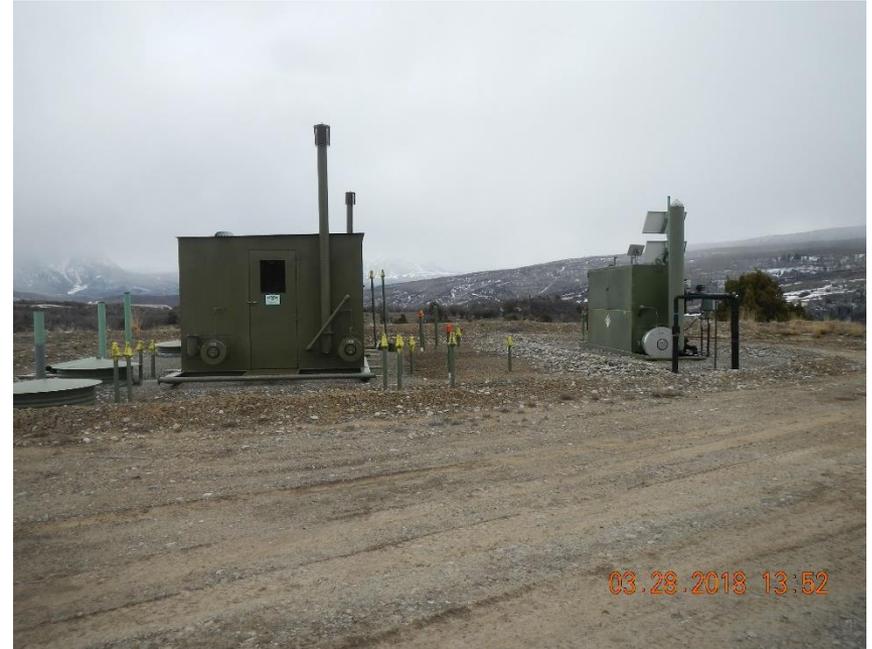
Unused risers spray painted.
