Inspection Photos

API: 05-067-07874

Operator: BP AMERICA PRODUCTION
COMPANY

Inspection Date: 3/7/2018

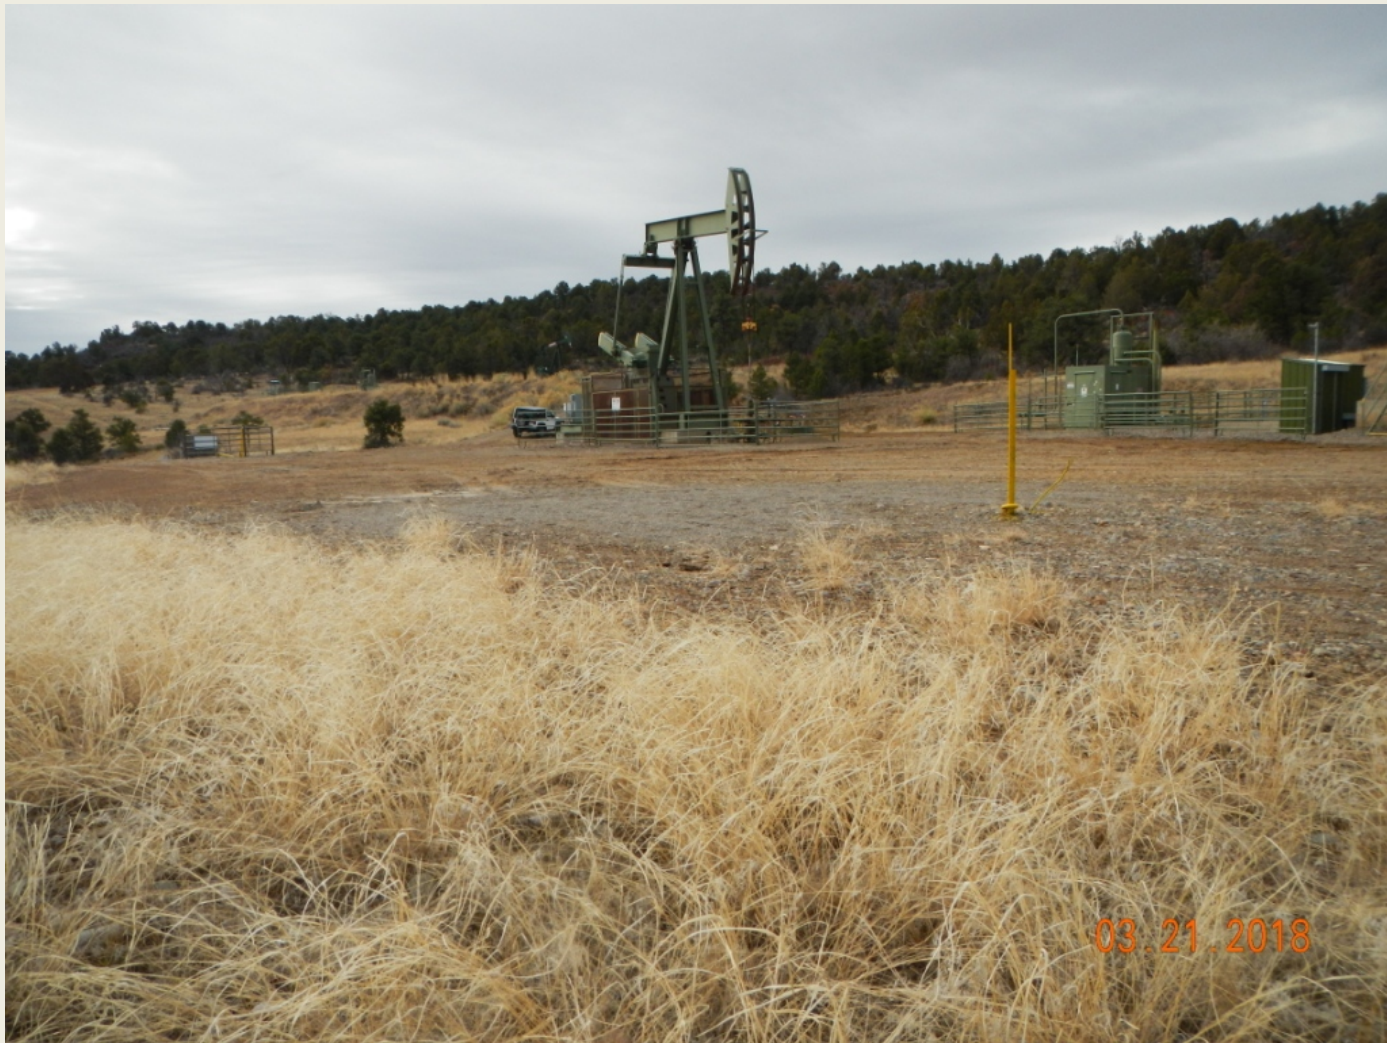
Photo 1. View of the project area from the northern corner facing center.

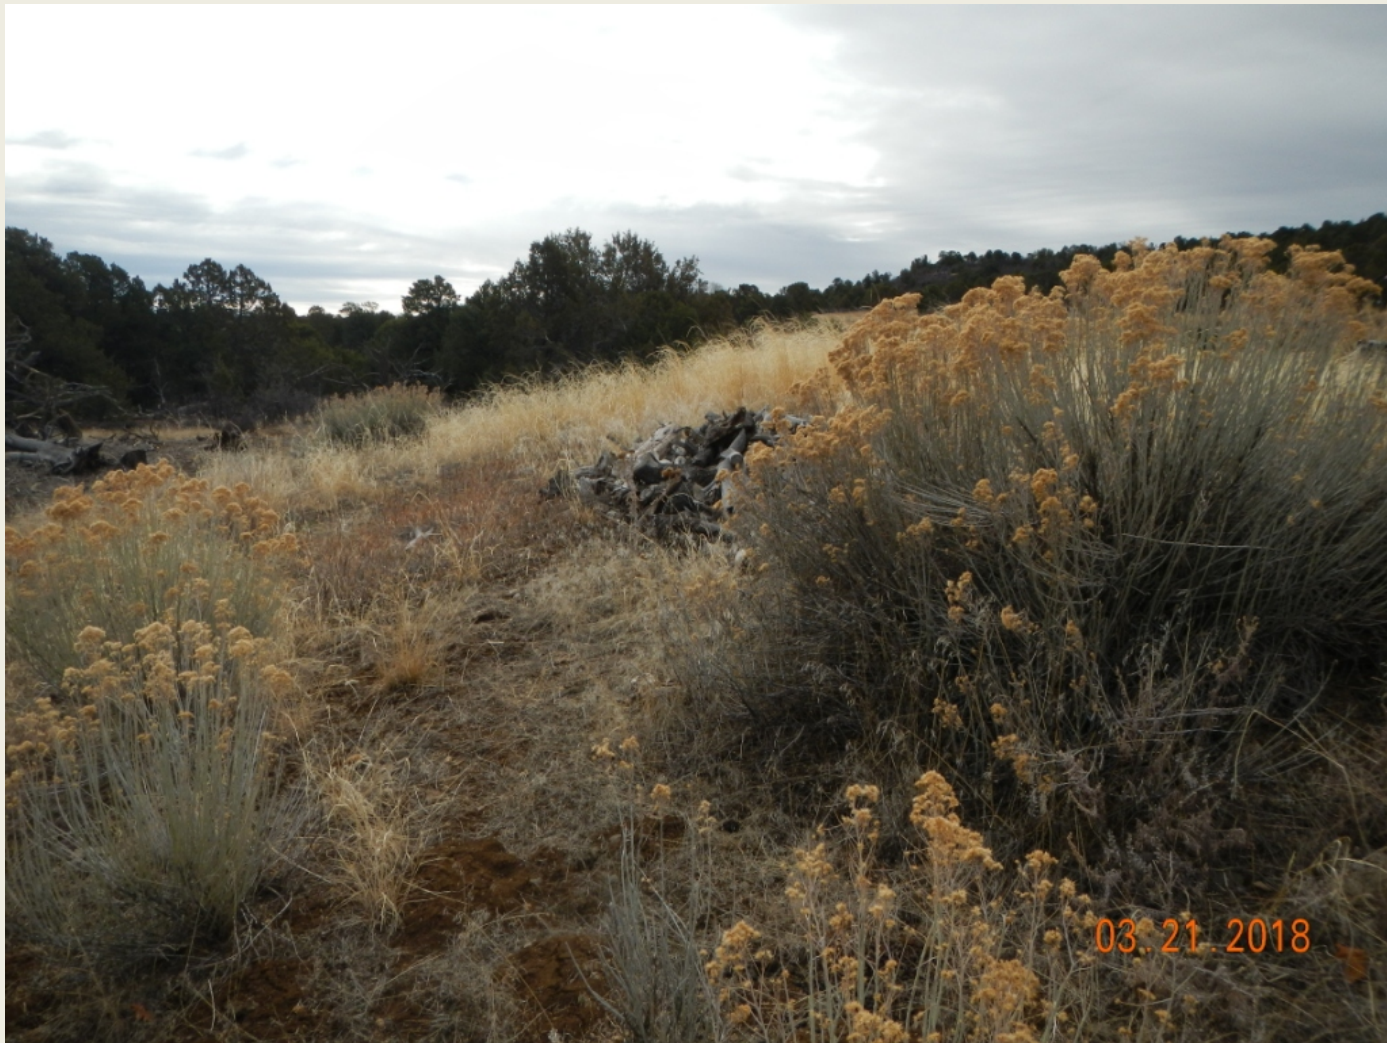
Photo 2. View of the northeastern portion of the interim reclamation area from the northern corner facing southeastward. Revegetation is progressing with sand dropseed (*Sporobolus cryptandrus*), intermediate wheatgrass (*Thinopyron intermedium*), smooth brome (*Bromus inermis*), as well as rubber rabbitbrush (*Chrysothamnus nauseosus*).

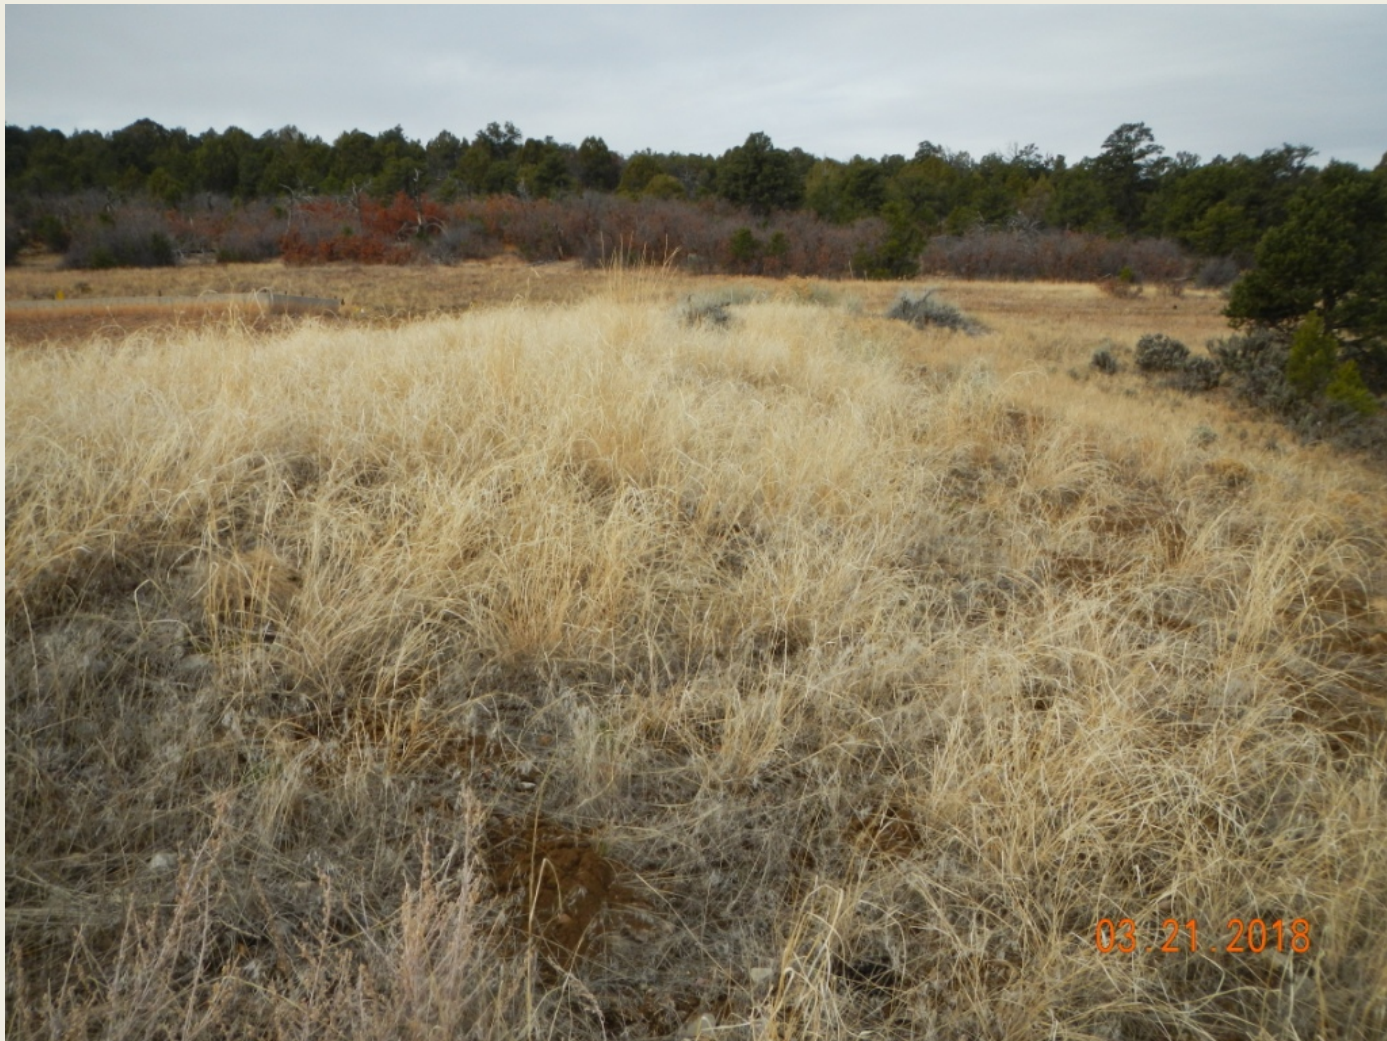
Photo 3. View of the northwestern portion of the interim reclamation area from the northern corner facing southwestward.

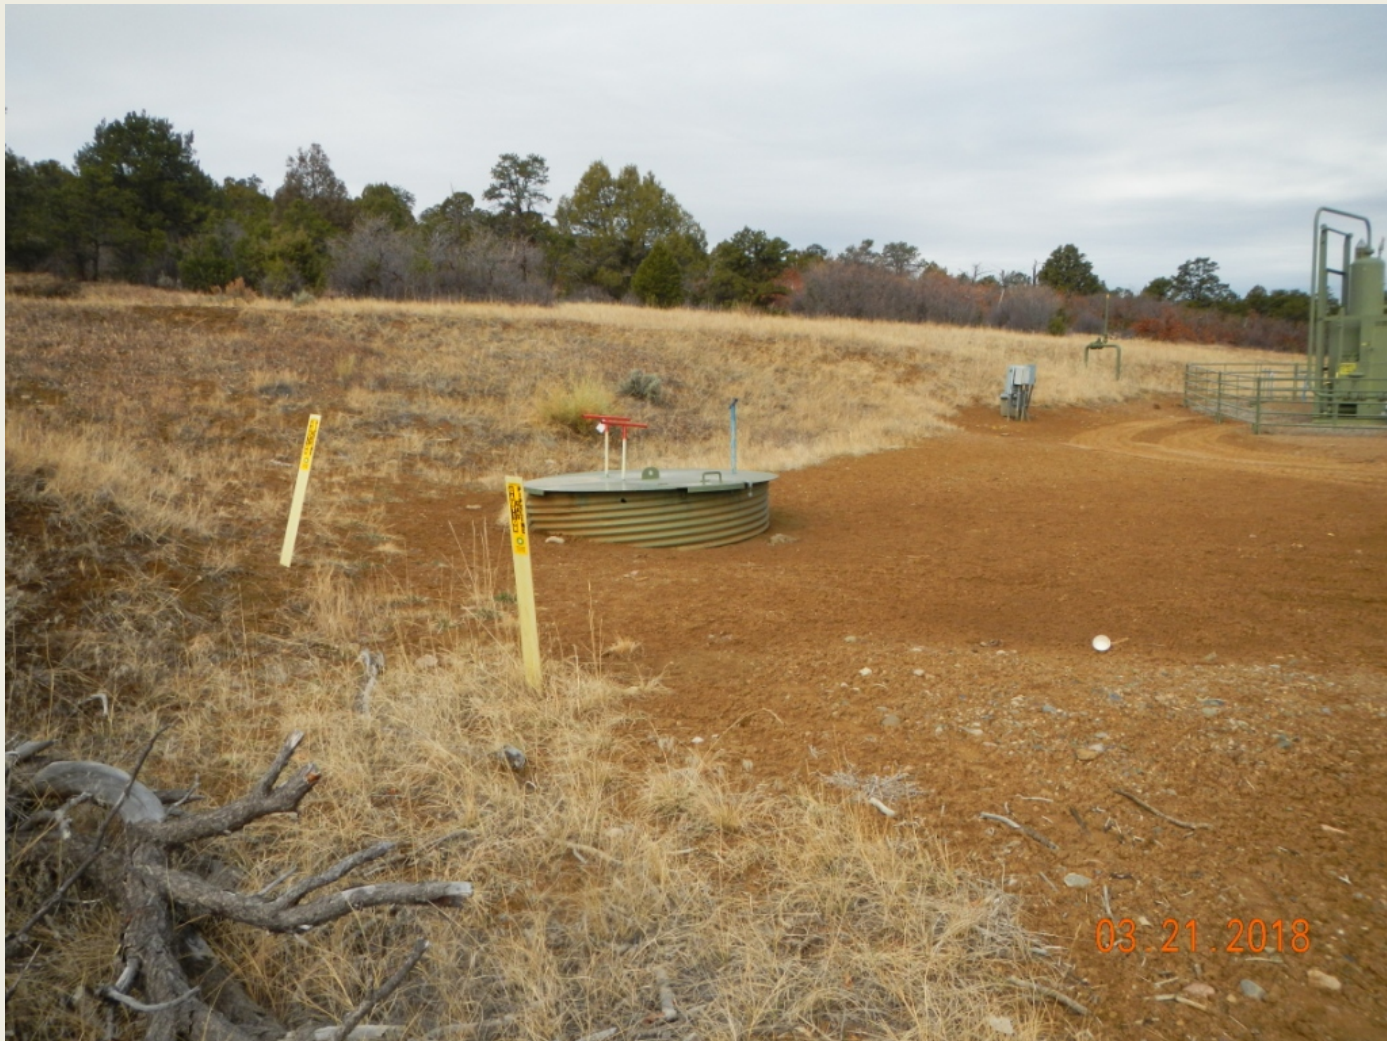
Photo 4. View of the southwestern cut-slope from the southern corner facing northwestward.

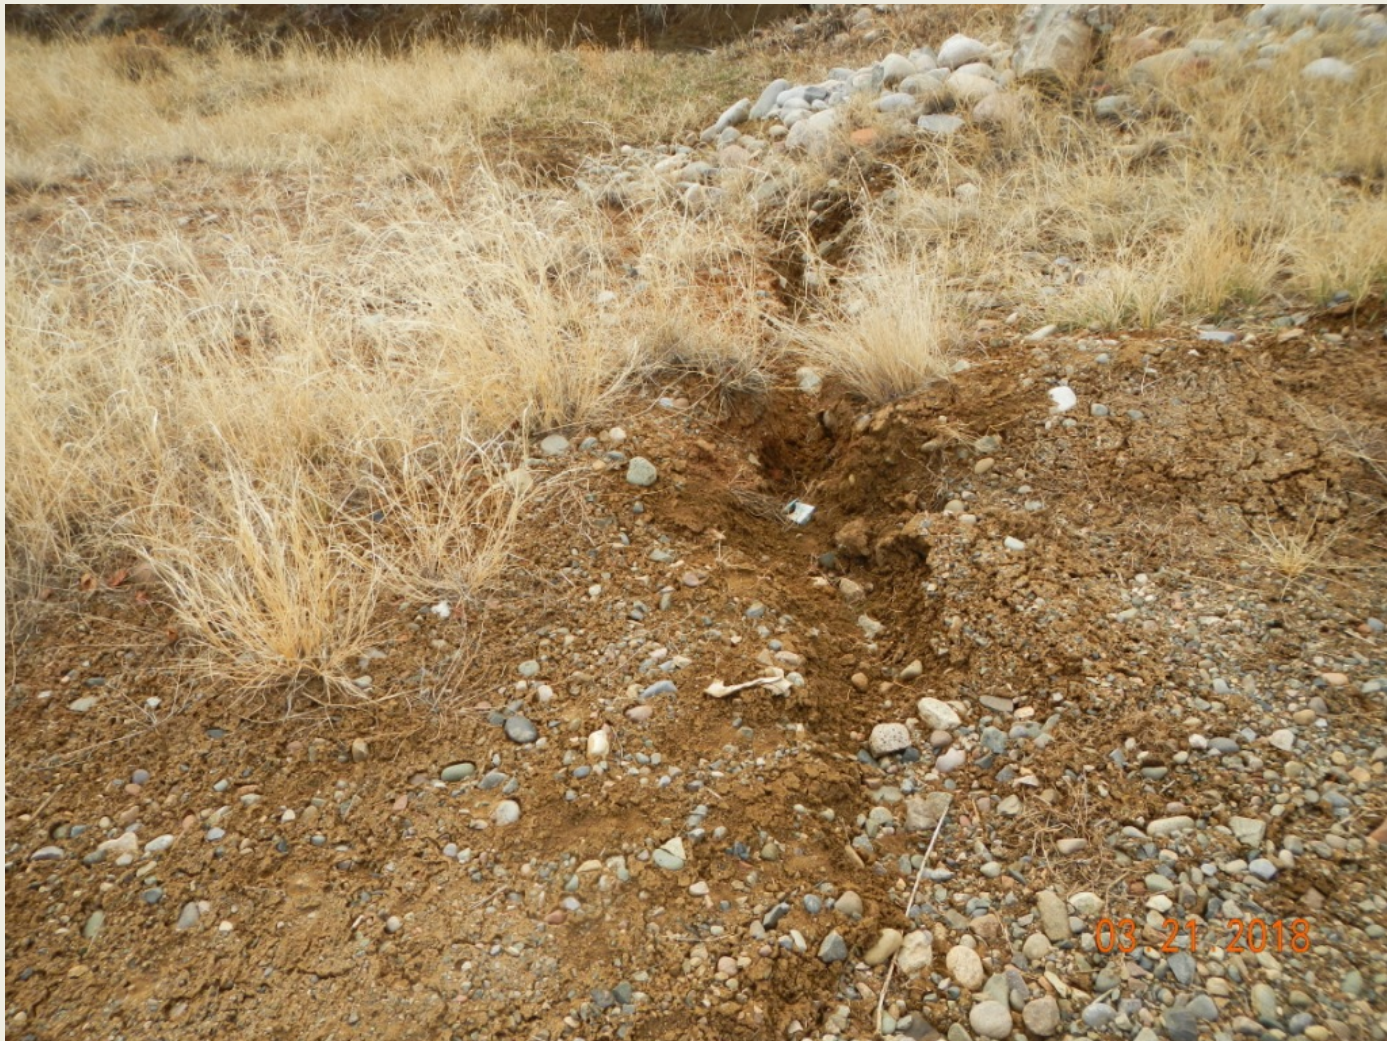
Photo 5. View of erosion occurring along the eastern edge of the well pad where stormwater flows from the well pad into a drainage. Stormwater controls are placed here, but additional stabilization is needed.

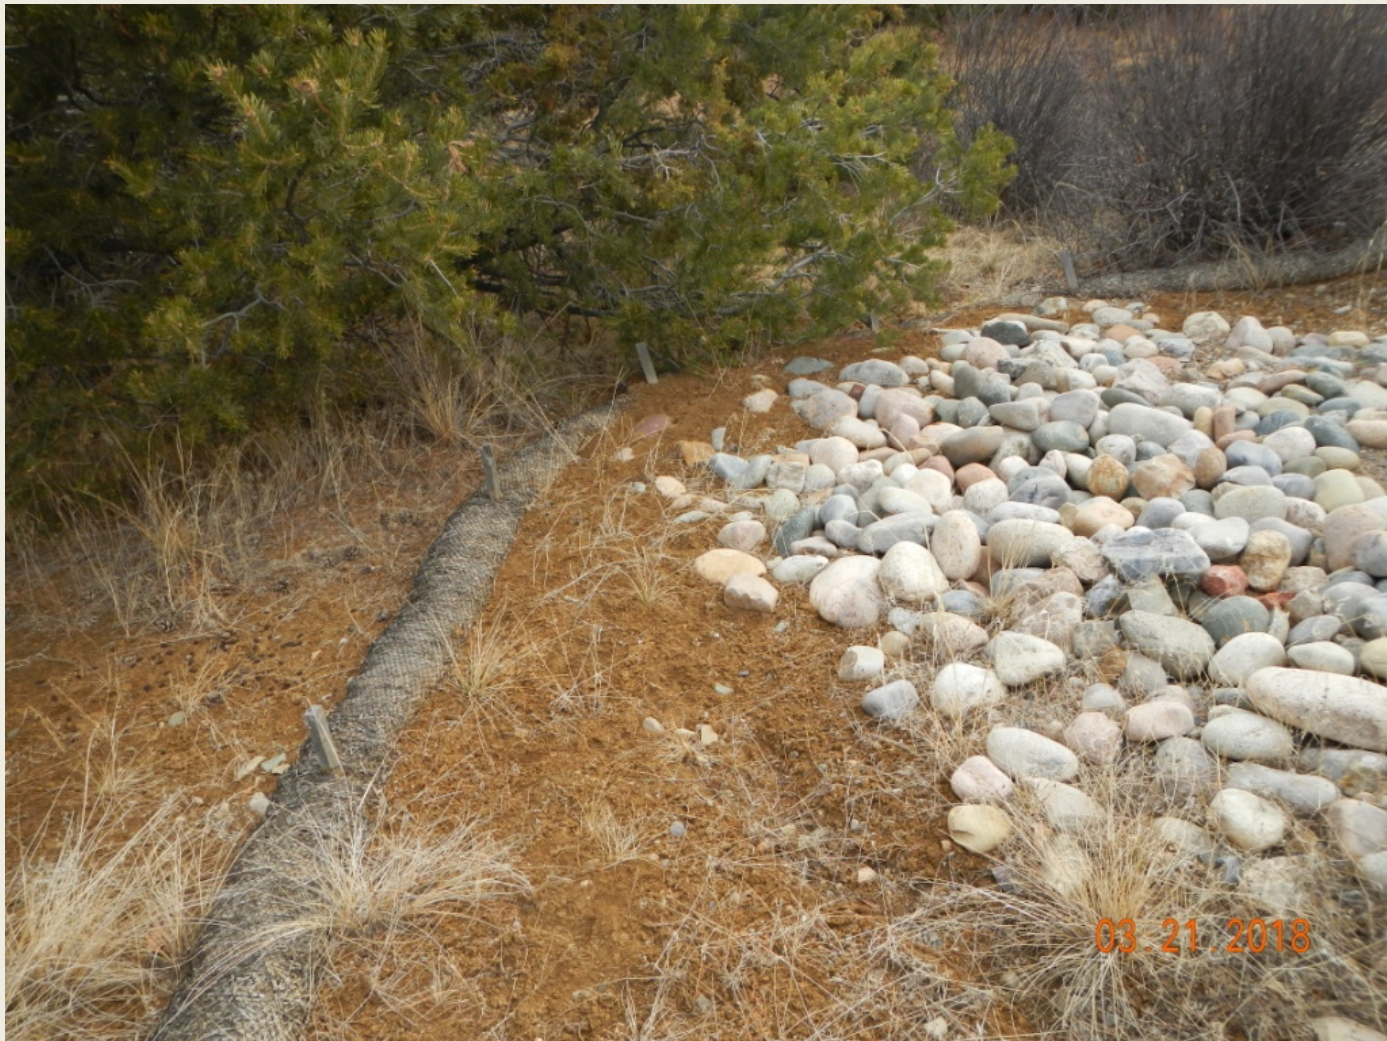
Photo 6. View of stormwater controls in the northeastern portion of the project area, that are filling with sediment and need maintenance.
