# Inspection Photos

API: 05-067-08885

Operator: BP AMERICA PRODUCTION  
COMPANY

Inspection Date: 3/21/2018

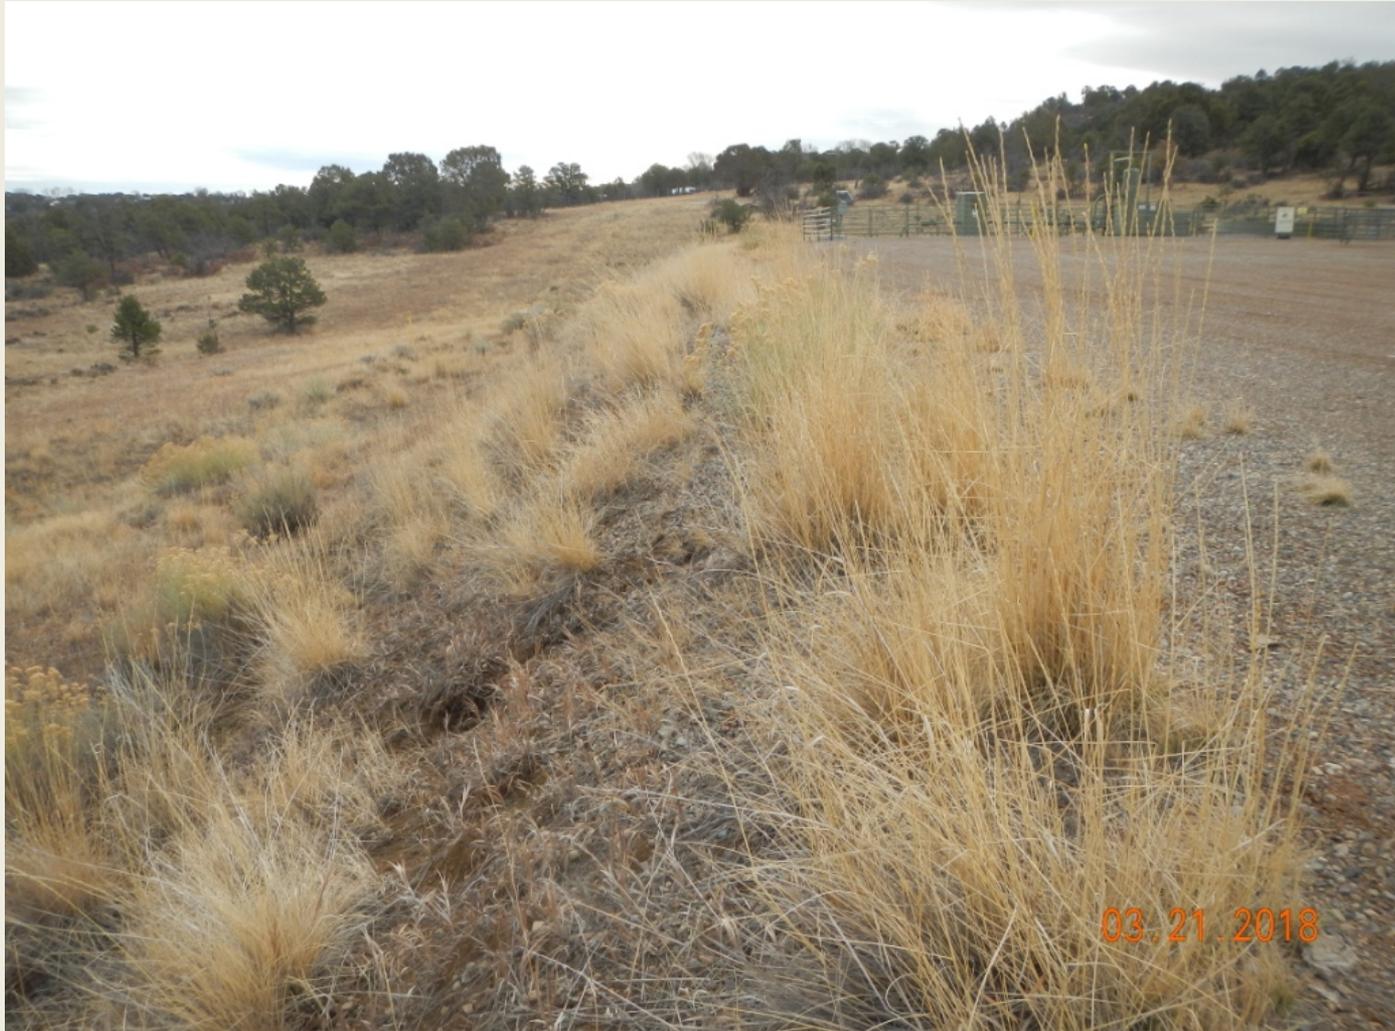
**Photo 1. View of the northern portion of the project area from the northwestern corner facing eastward.**

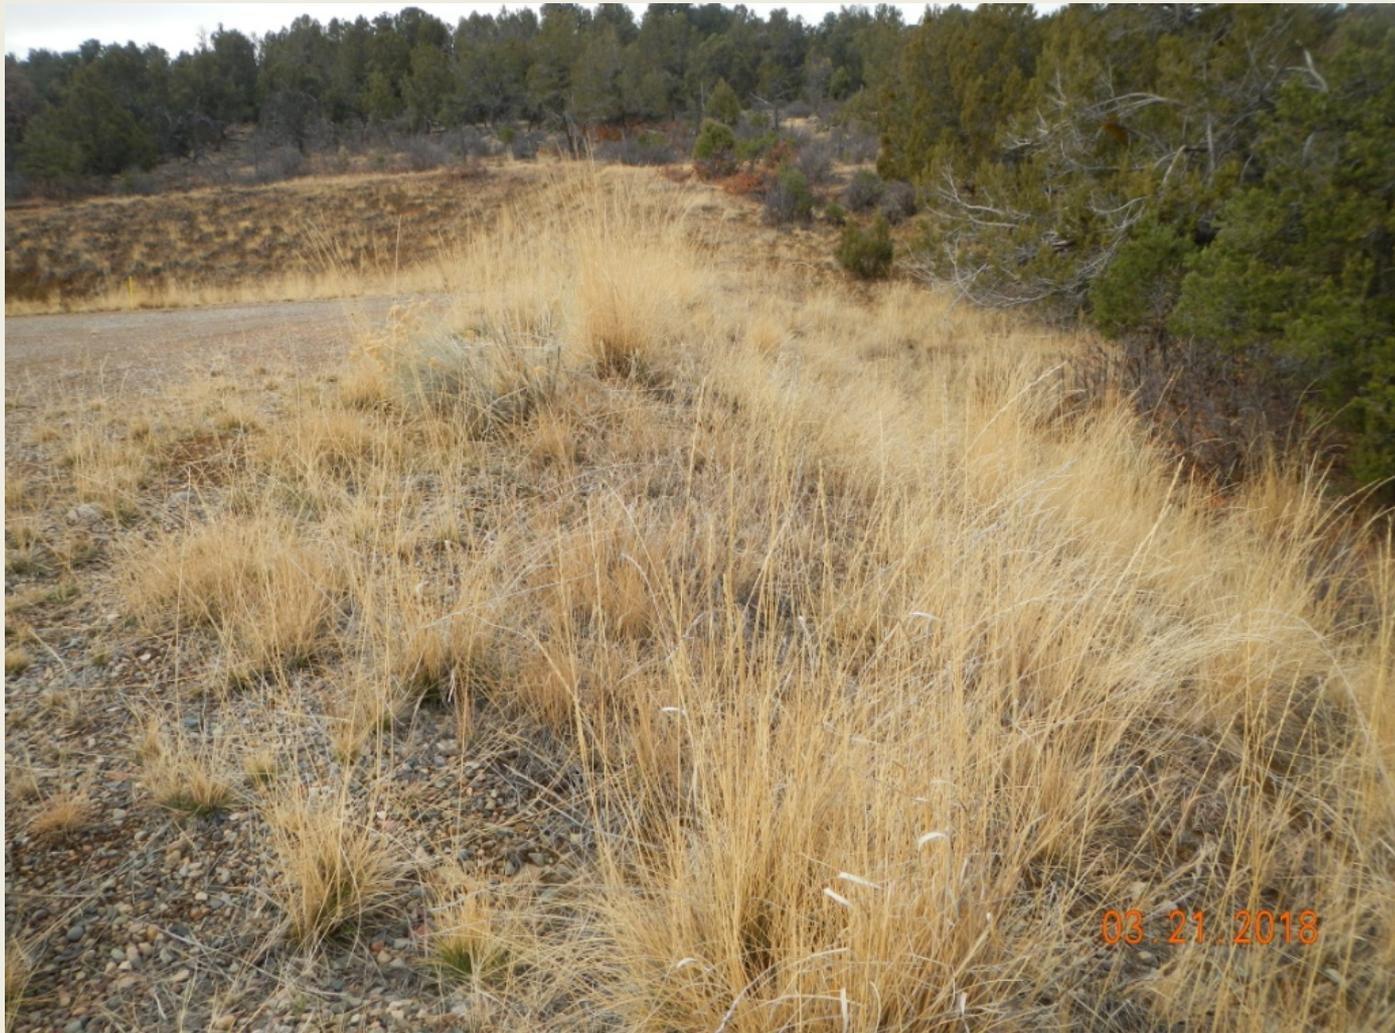
**Photo 2. View of the western portion of the interim reclamation area from the northwestern corner facing southward. Revegetation is progressing with sand dropseed (*Sporobolus cryptandrus*), intermediate wheatgrass (*Thinopyron intermedium*), and western wheatgrass (*Pascopyrum smithii*).**

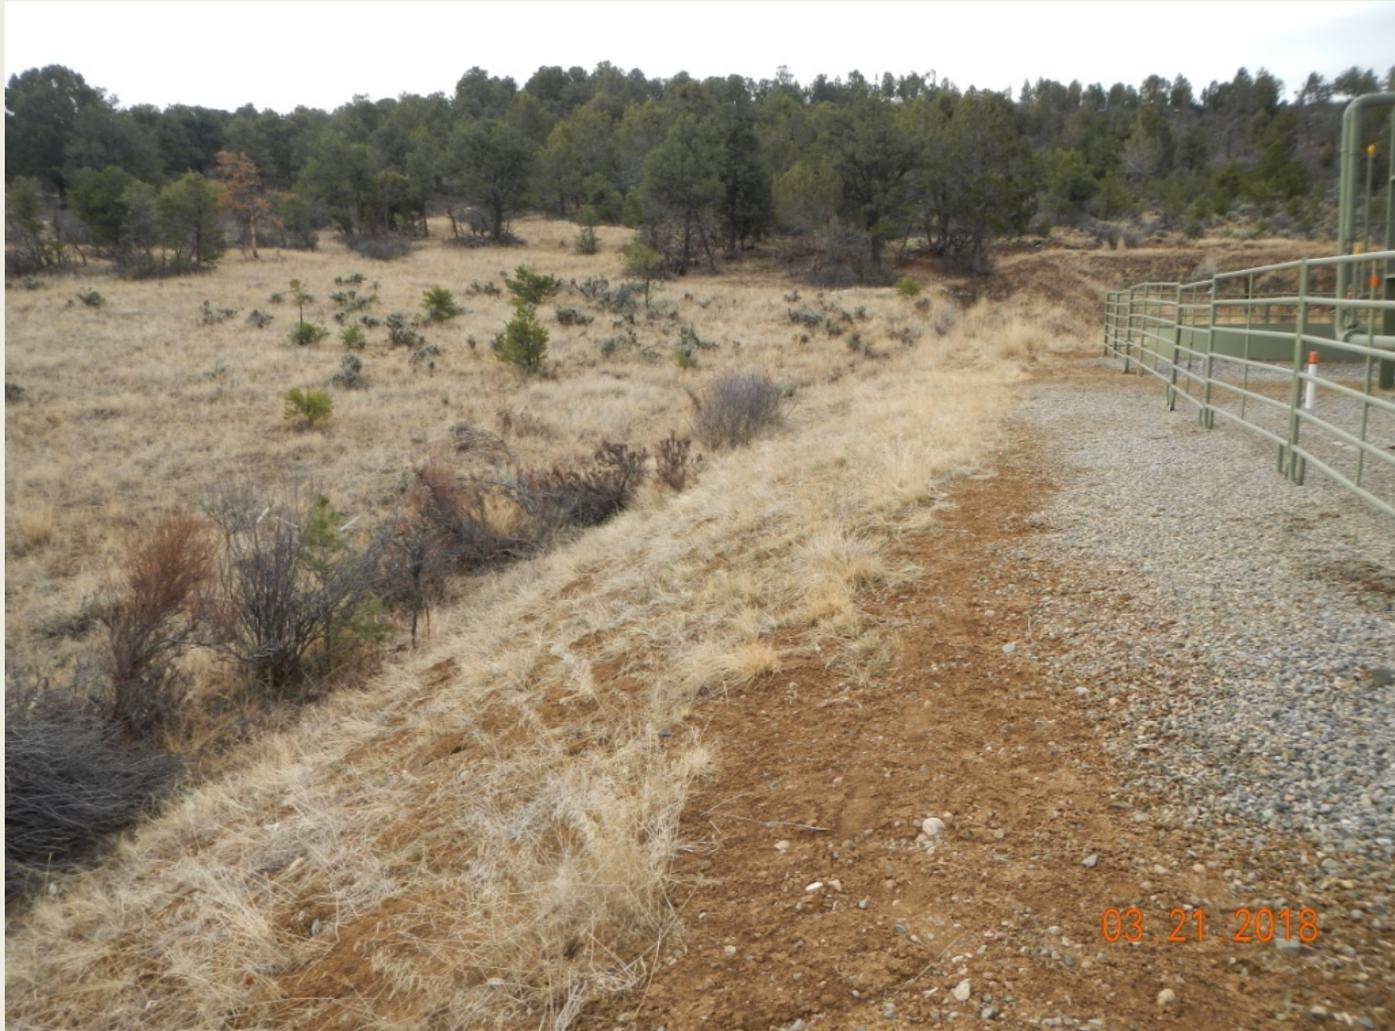
**Photo 3. View of the eastern portion of the interim reclamation area from the northern corner facing southwestward.**

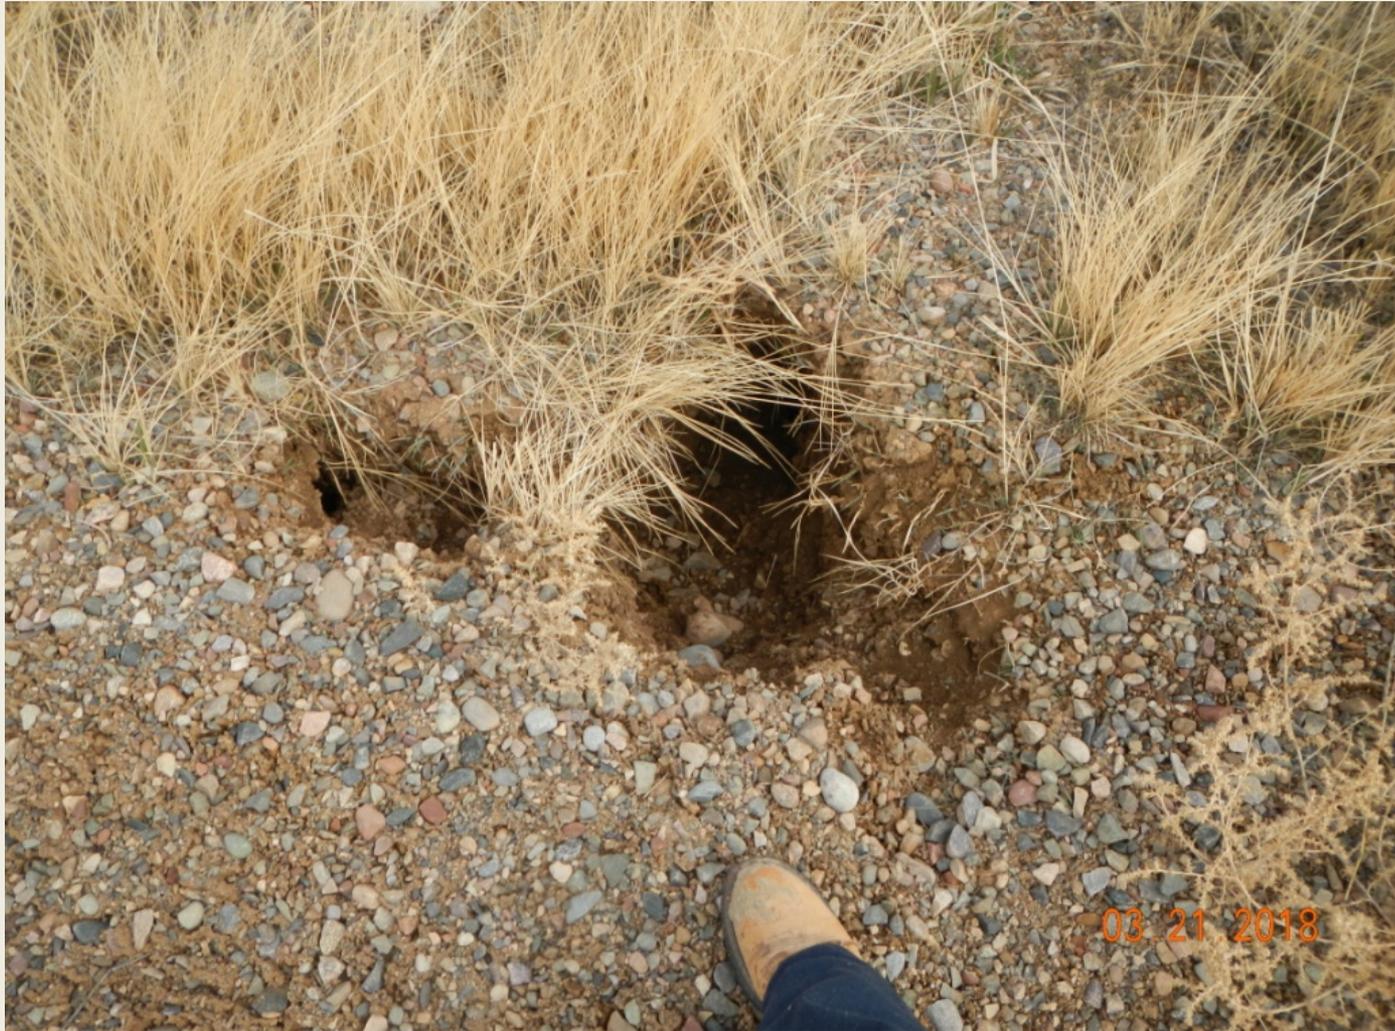
**Photo 4. View of erosional tunneling that is starting to occur within the northern fill slope.**

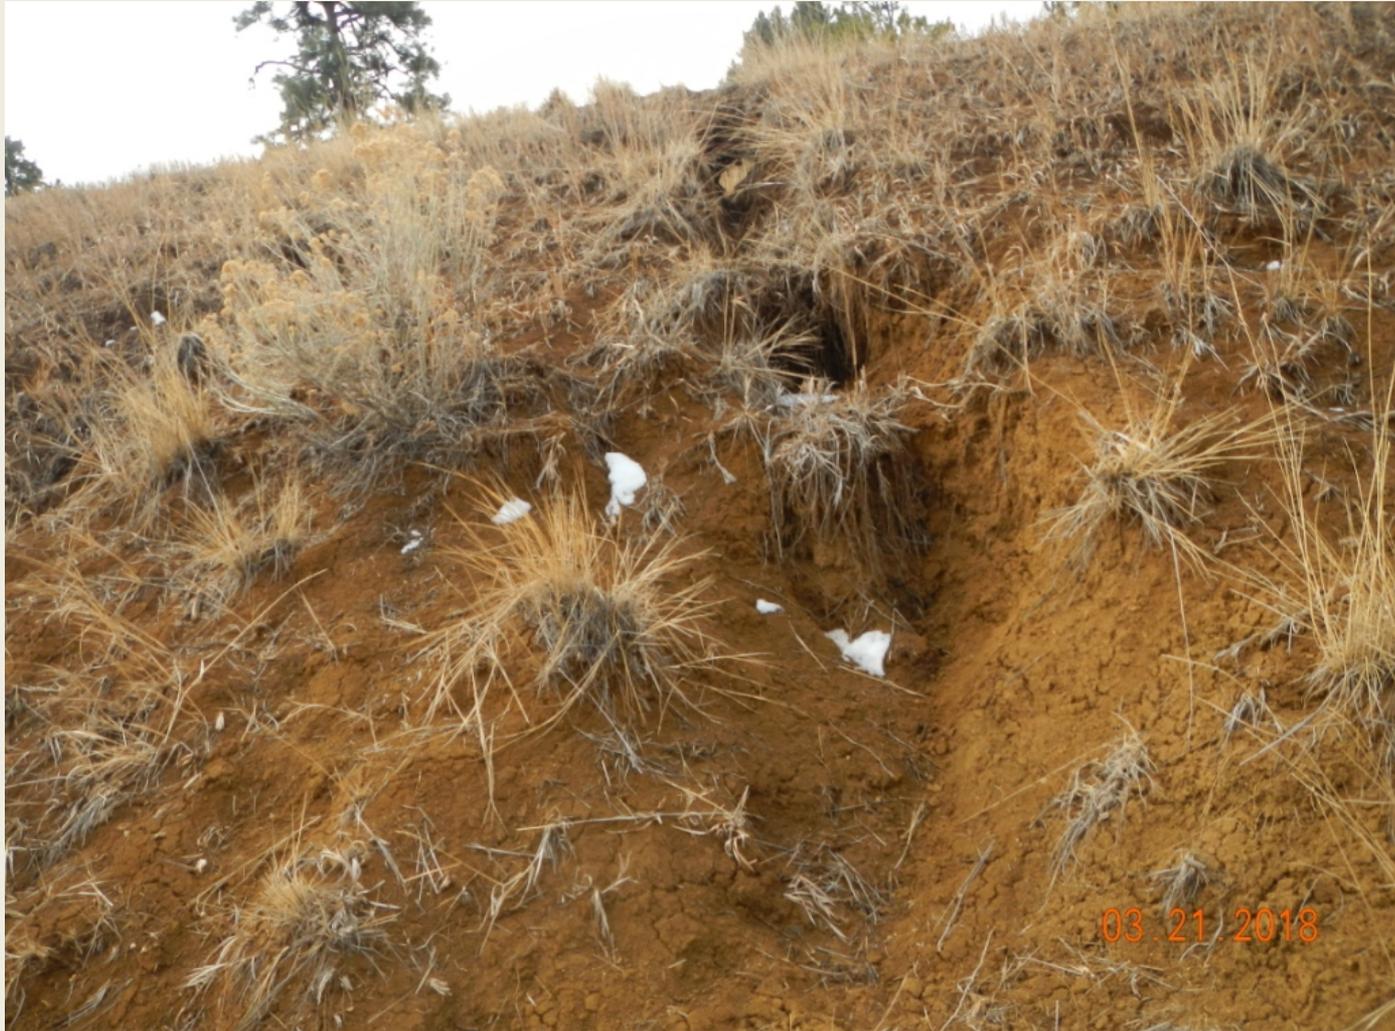
**Photo 5. View of erosional channeling in the southern cut-slope Stabilization measures are needed here.**
