# Inspection Photos

API: 05-067-07855

Operator: BP AMERICA PRODUCTION  
COMPANY

Inspection Date: 3/21/2018

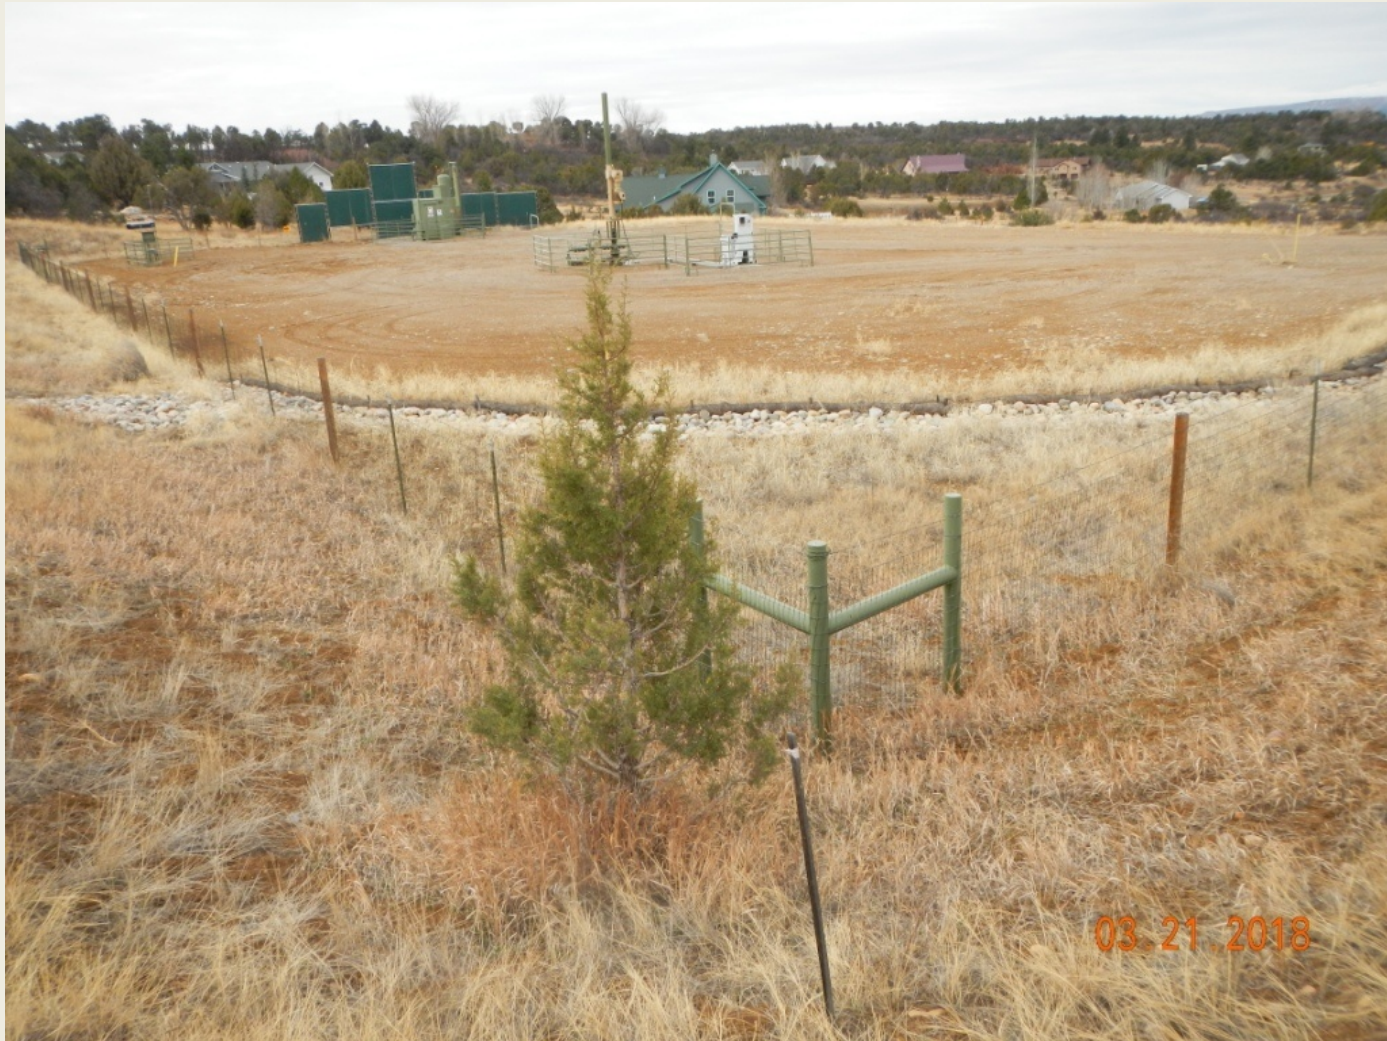
**Photo 1. View of the project area from the northeastern corner facing center. Erosion controls are in place and appear to be functioning.**

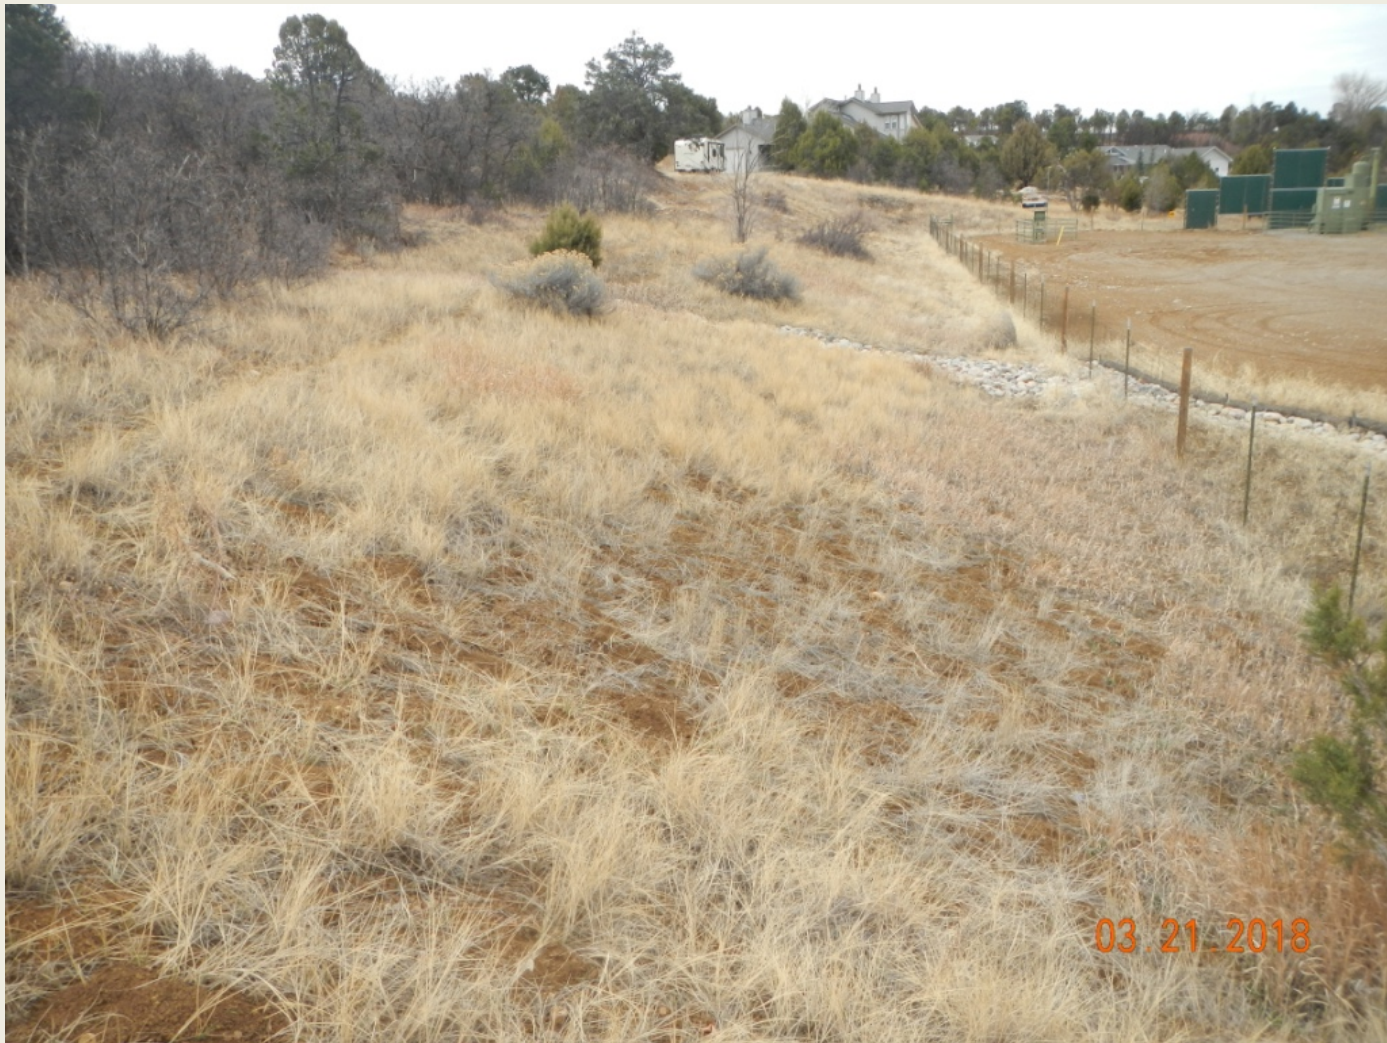
**Photo 2. View of the eastern portion of the interim reclamation area from the northeastern corner facing southward. Revegetation is progressing with western wheatgrass (*Pascopyrum smithii*) and smooth brome (*Bromus inermis*).**

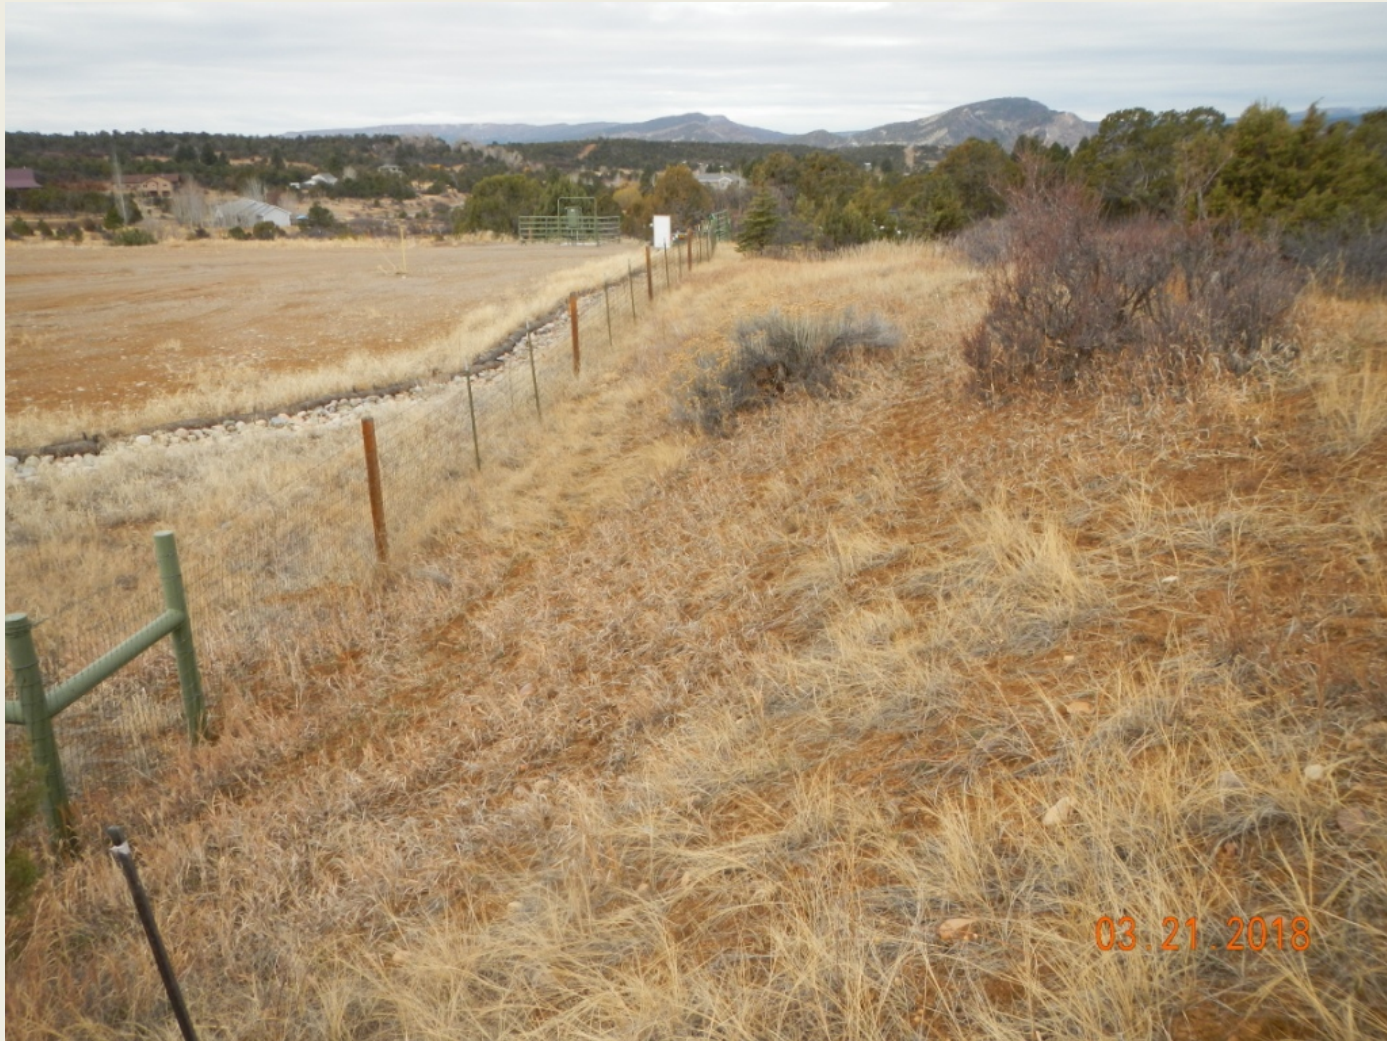
**Photo 3. View of the northern portion of the interim reclamation area from the northeastern corner facing westward.**

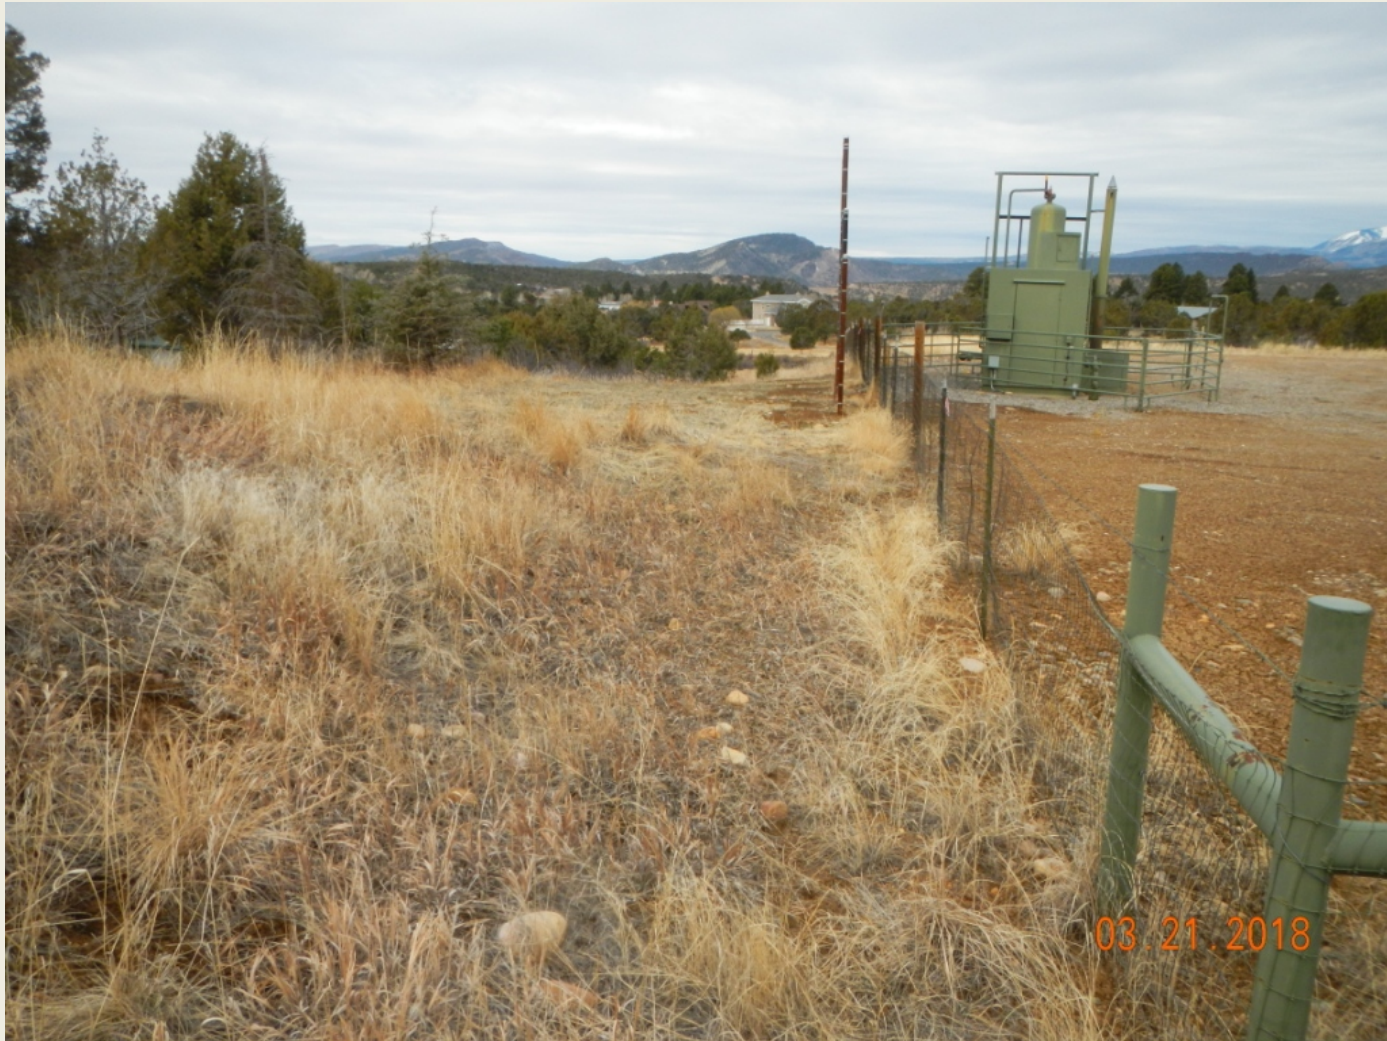
**Photo 4. View of the southern portion of the project area from the southeastern corner facing westward.**

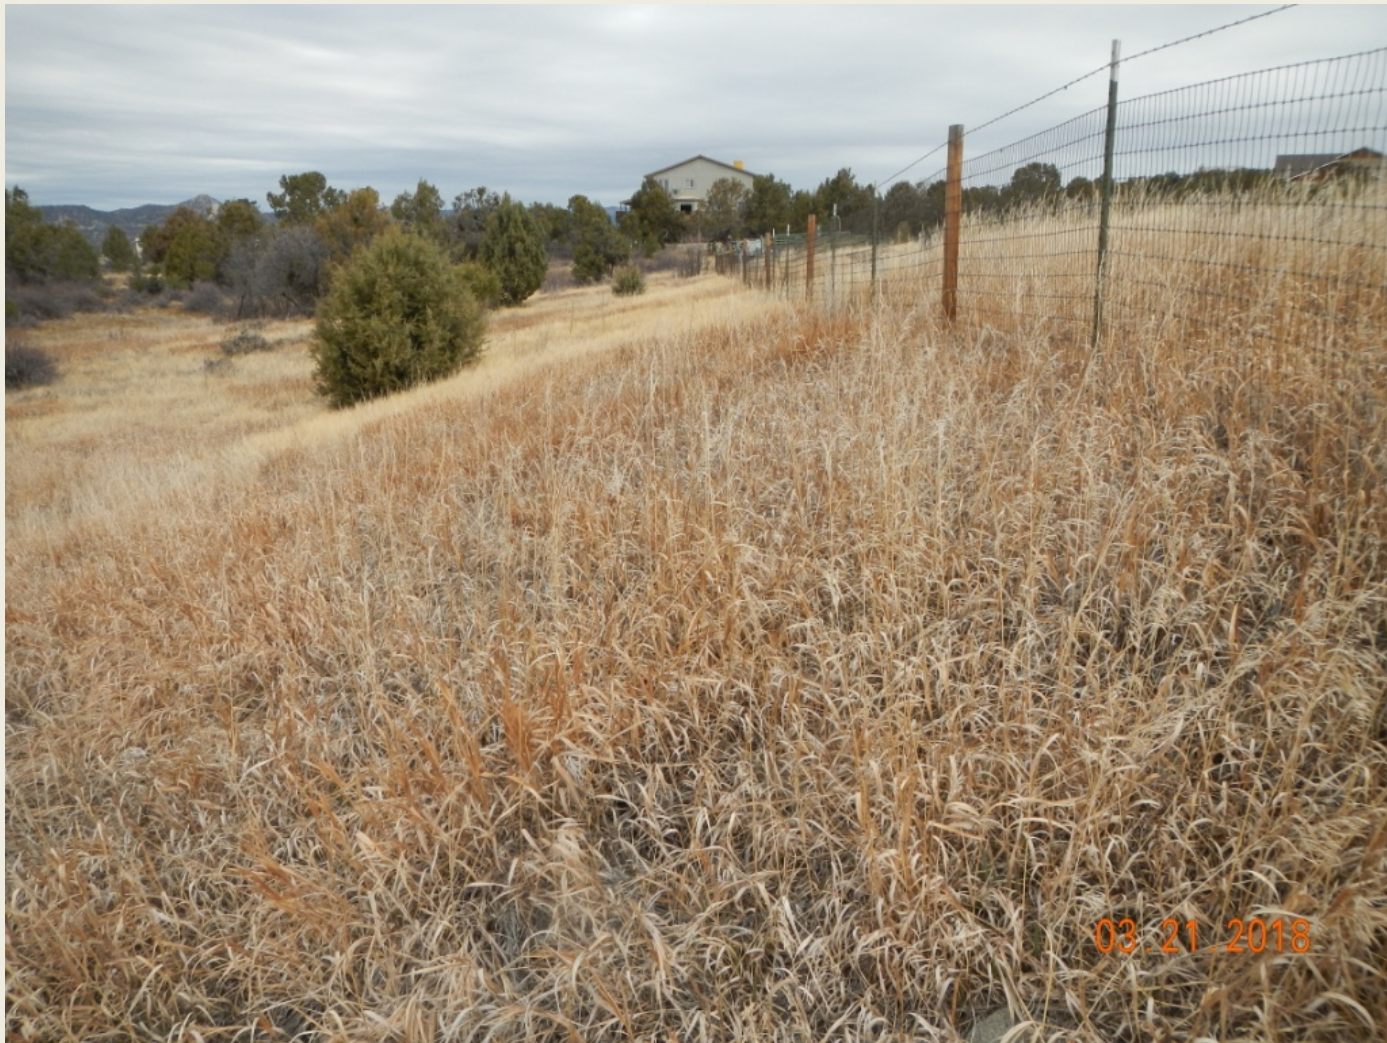
**Photo 5. View of the western portion of the project area from the southwestern corner facing northward.**

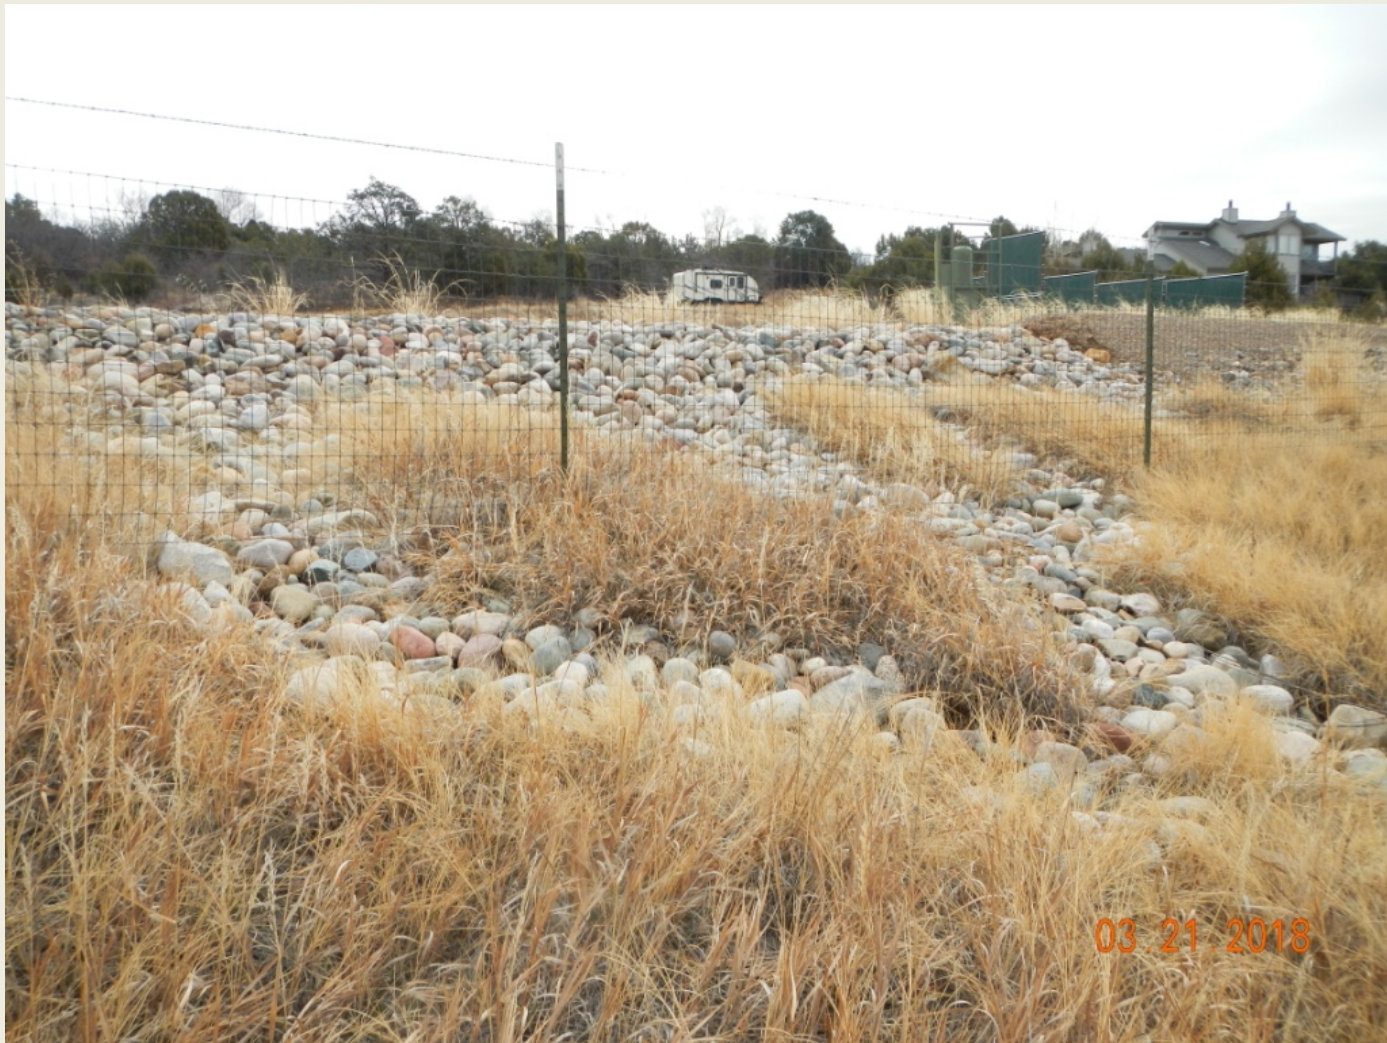
**Photo 6. View of erosion controls in the western project area, appear to be functioning at this time.**
