Inspection Photos

API: 05-067-08752

Operator: BP AMERICA PRODUCTION
COMPANY

Inspection Date: 3/21/2018

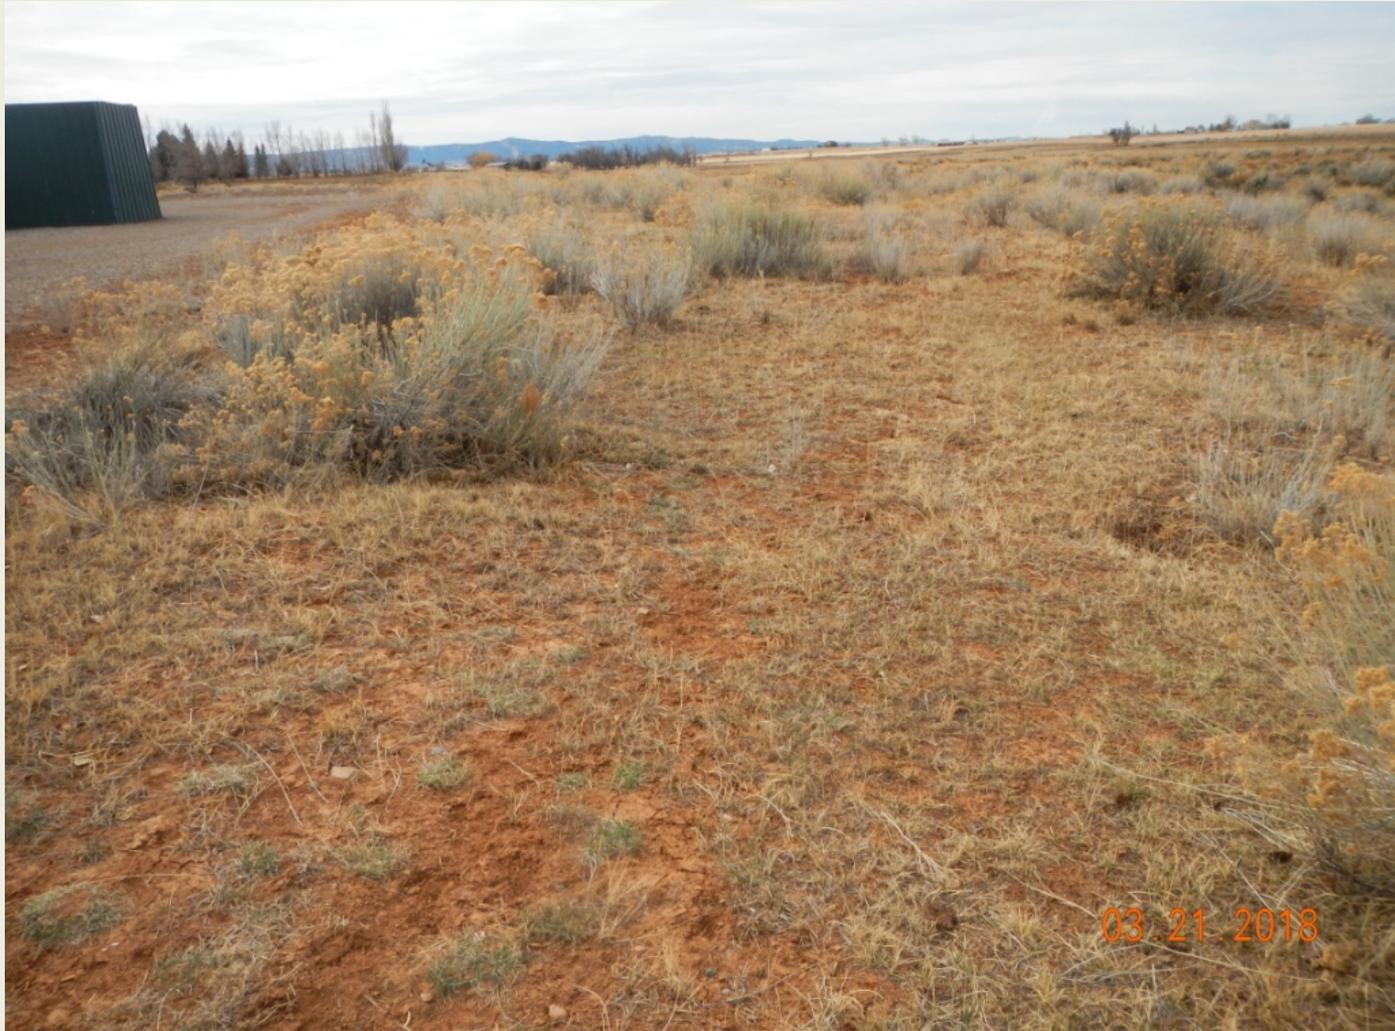
Photo 2. View of the eastern portion of the interim reclamation area from the northwestern corner facing southward. Revegetation is progressing with western wheatgrass (*Pascopyrum smithii*) and rubber rabbitbrush (*Chrysothamnus nauseosus*).
