Inspection Photos

API: 05-067-08285

Operator: BP AMERICA PRODUCTION
COMPANY

Inspection Date: 3/21/2018

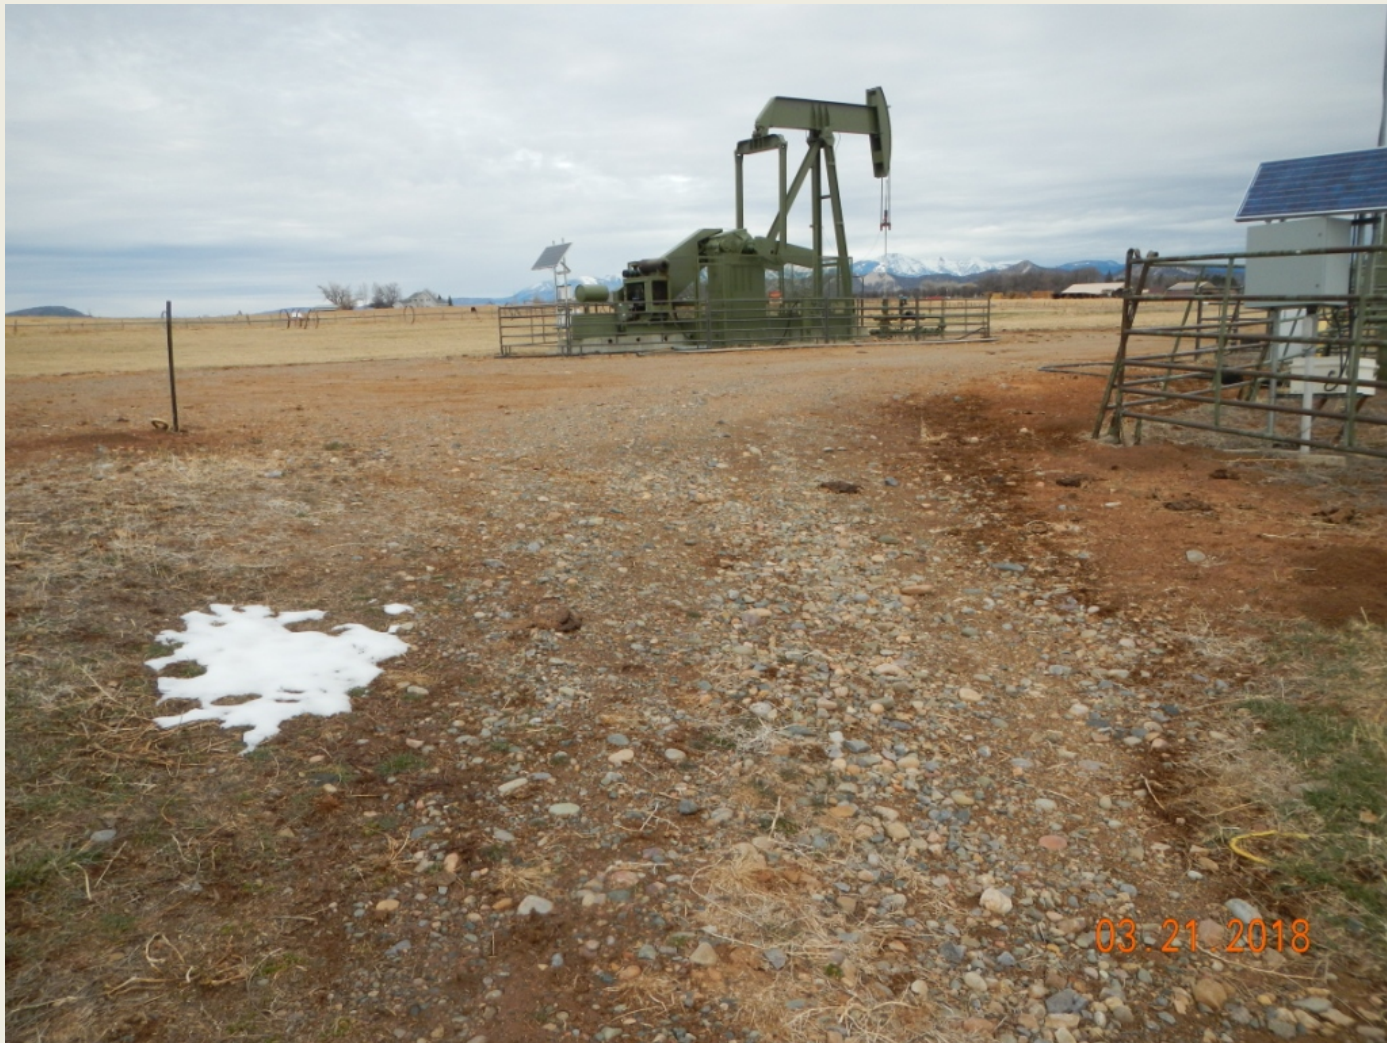
Photo 1. View of the project area from the southwestern corner facing center.

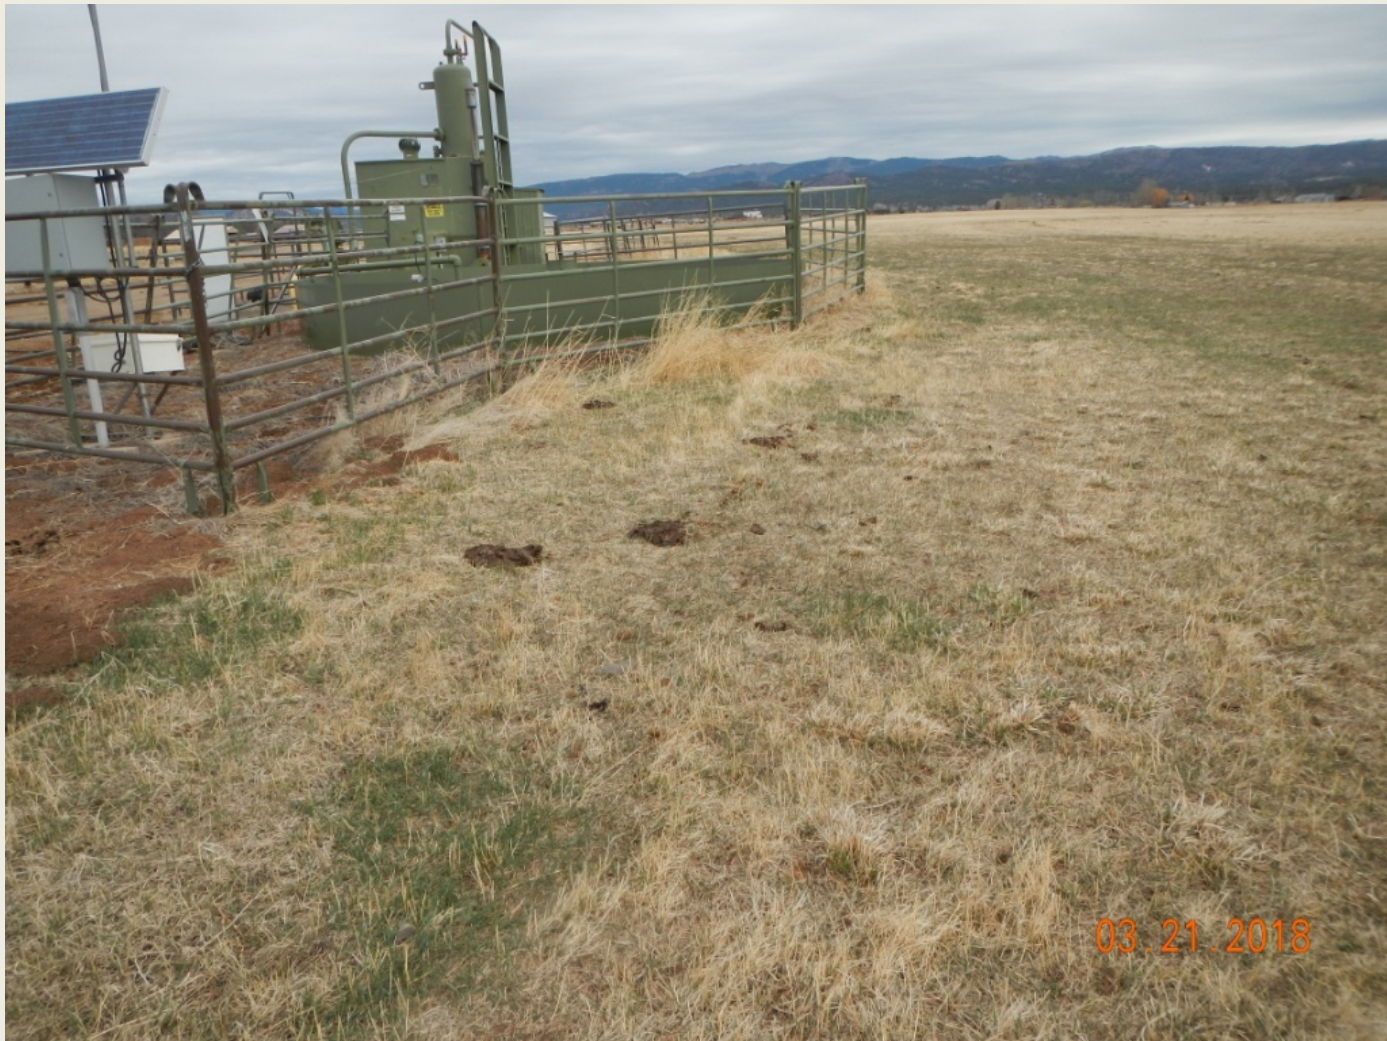
Photo 2. View of the eastern portion of the interim reclamation area from the southeastern corner facing northward. Revegetation is progressing with irrigated grasses, not in identifiable form.

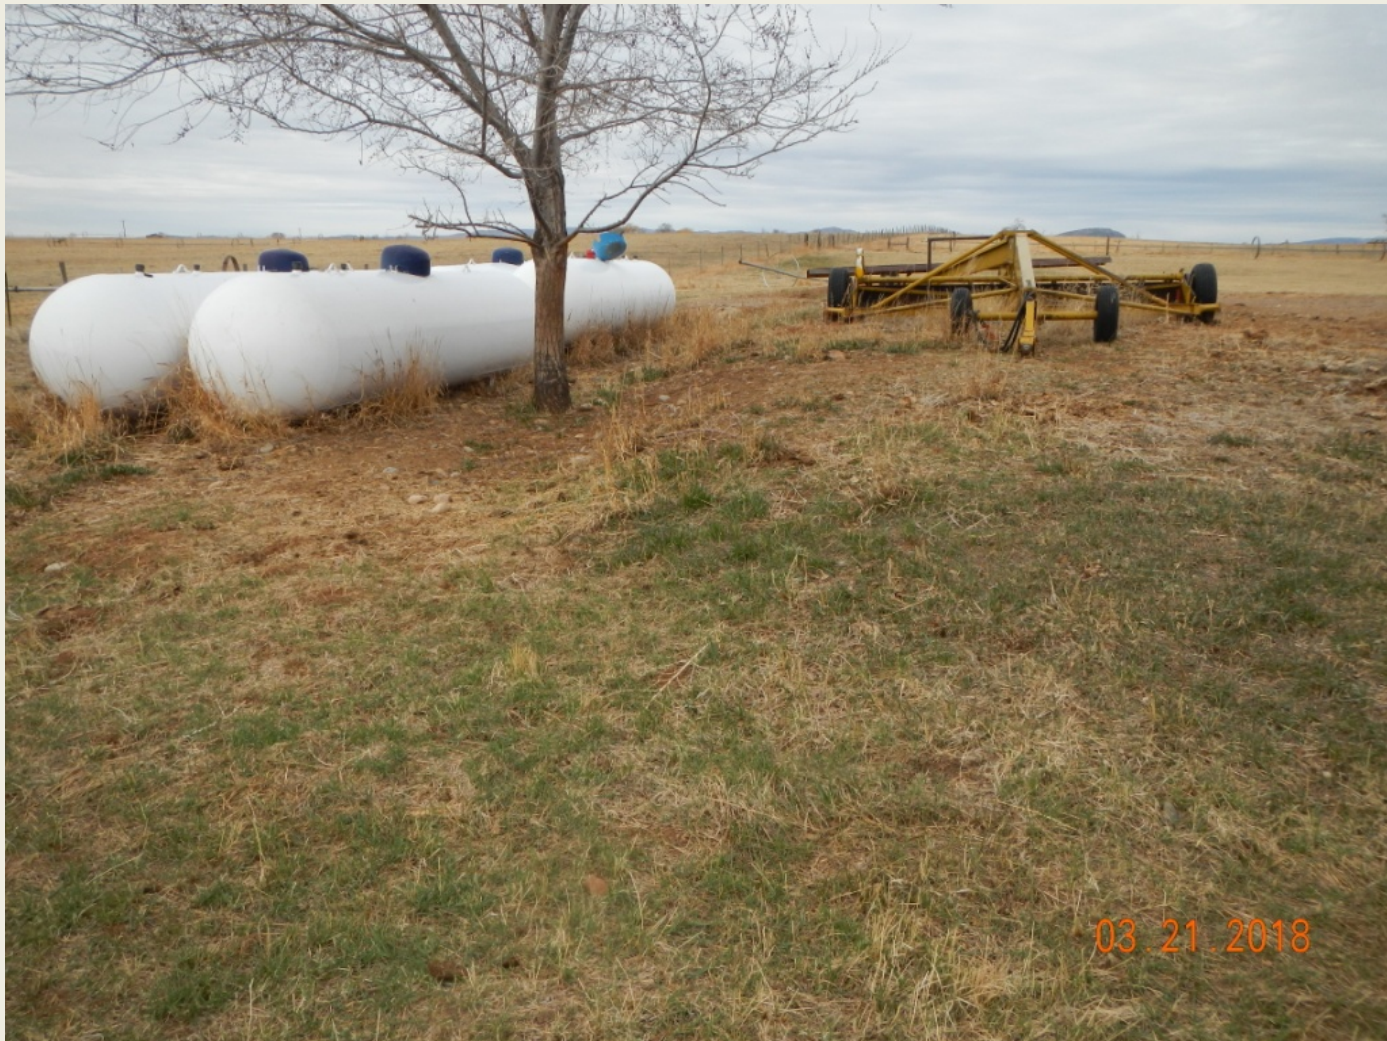
Photo 3. View of the southern portion of the project area from the southeastern corner facing westward.

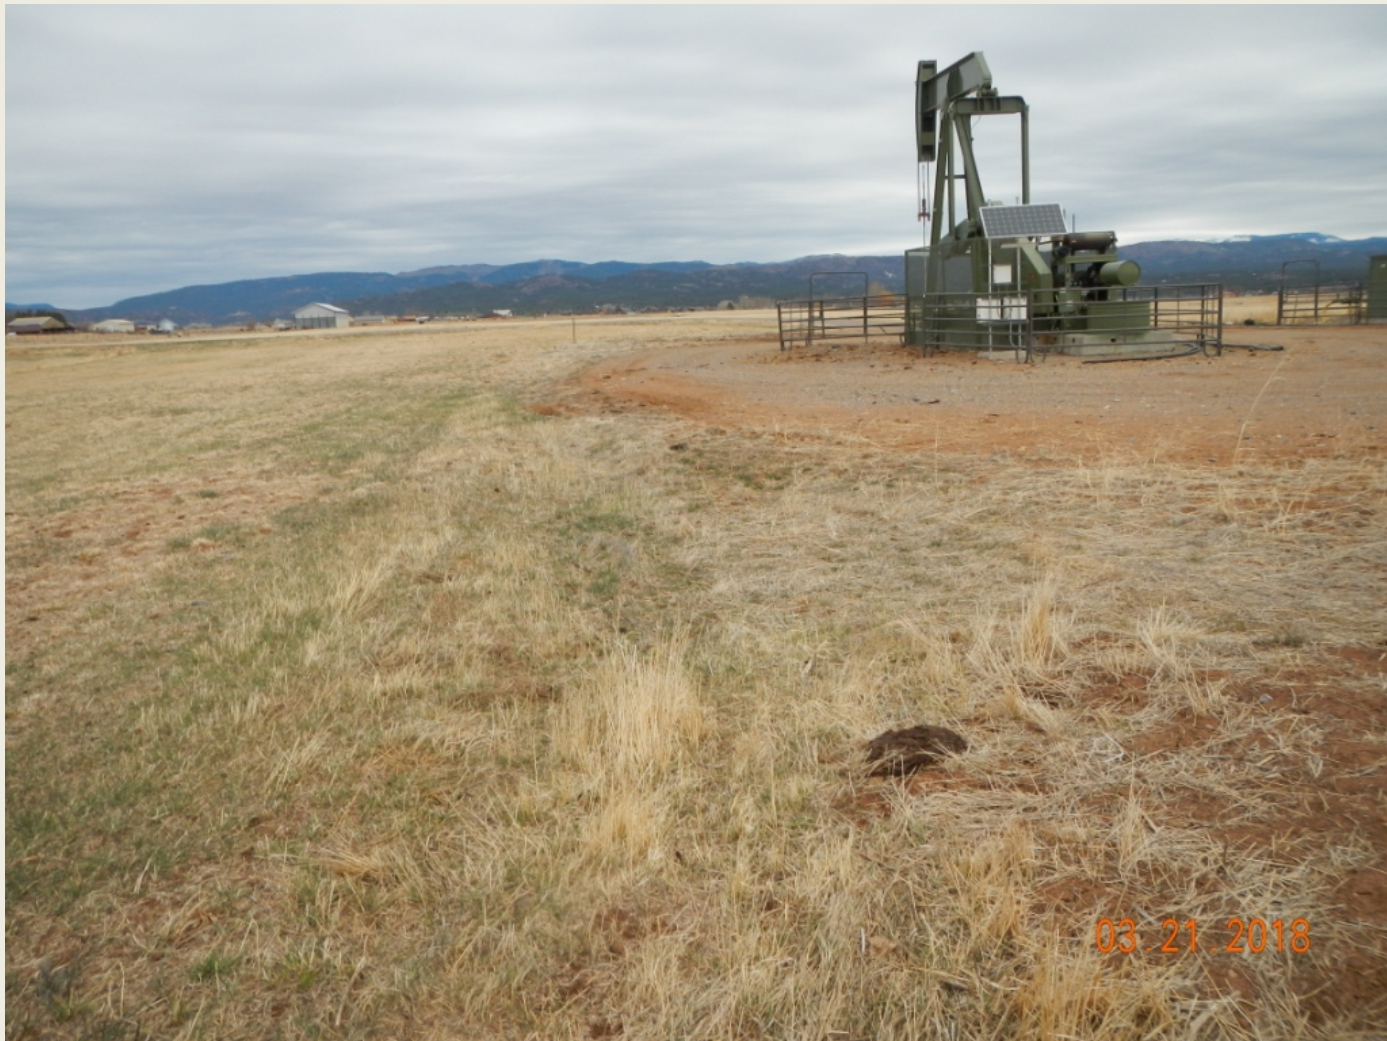
Photo 4. View of the southwestern portion of the project area from the southwestern corner facing northward.
