Inspection Photos
Location Name: Behring #23-7
Location: 332096

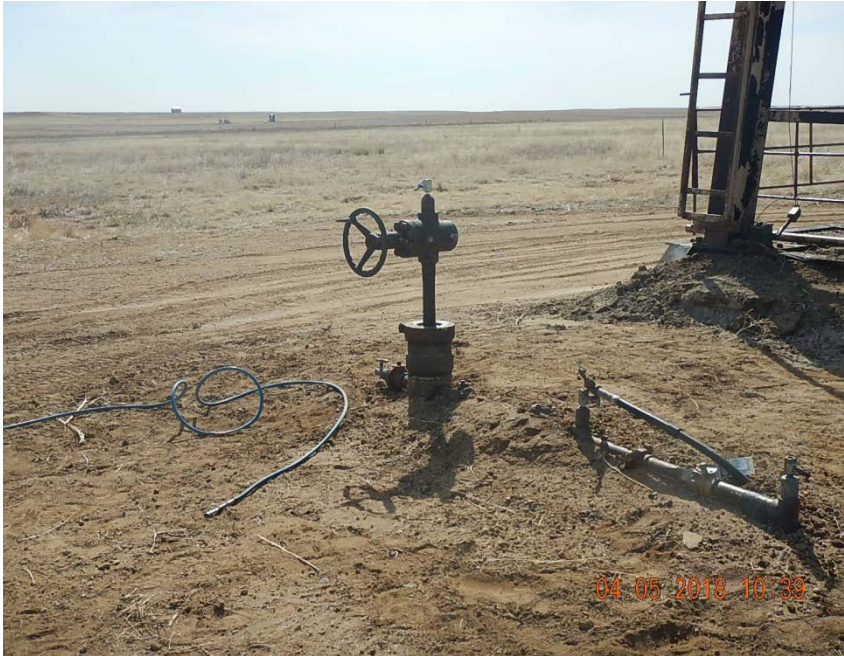
Photo 1: Wellhead, looking SE

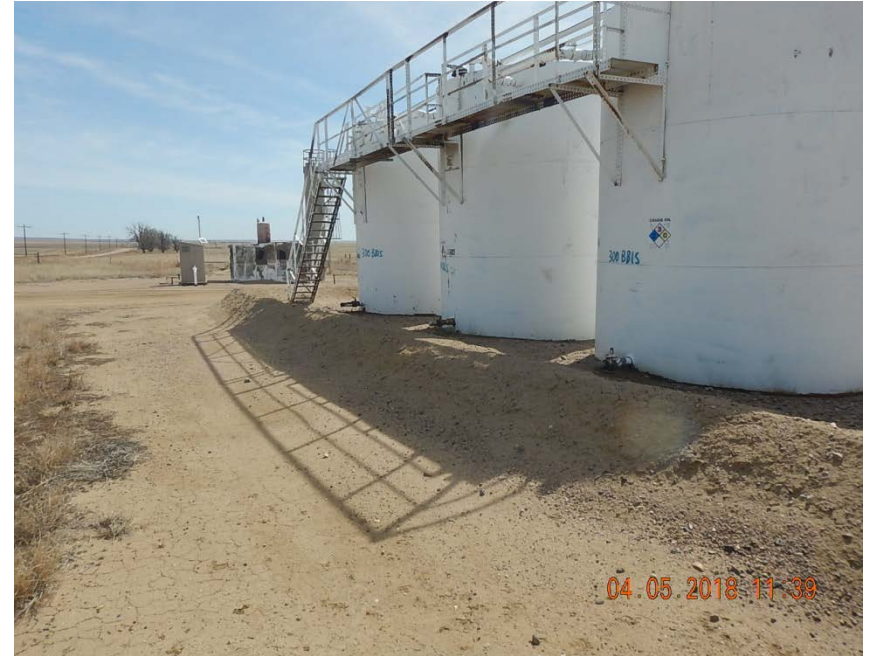
Photo 2: Location, looking E

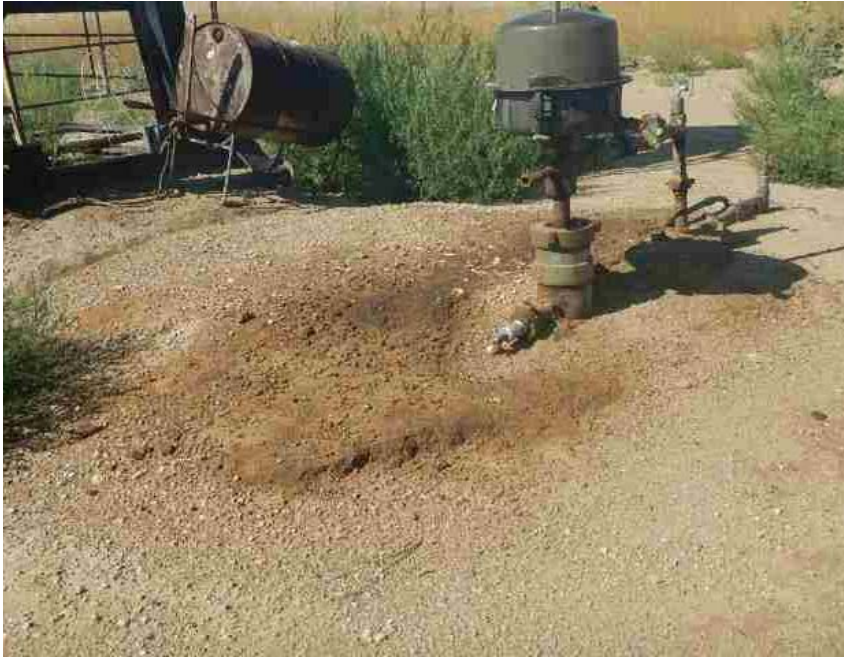
Photo from prior inspection for comparison

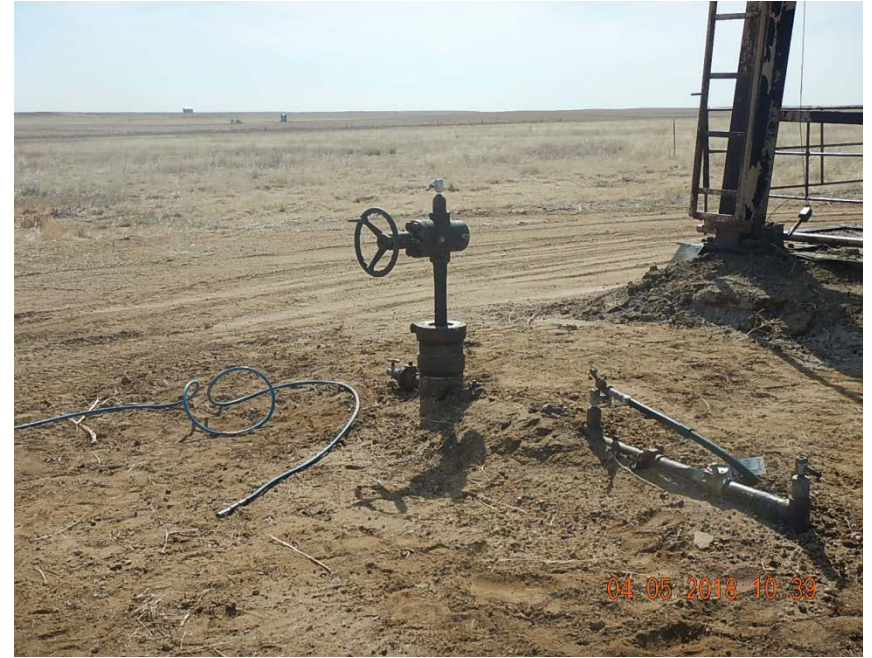
Photo 3: Stained soil removed

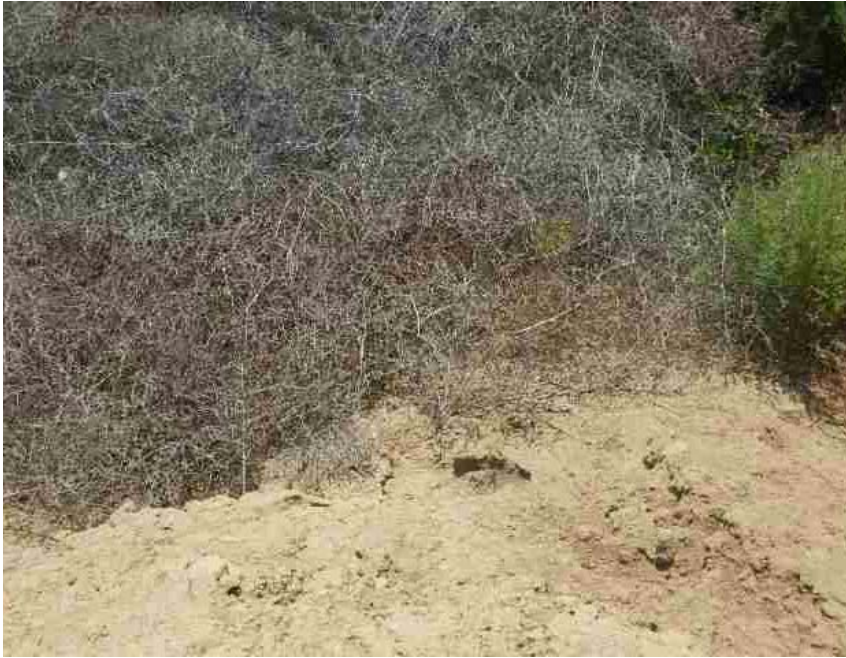
Photo from prior inspection for comparison

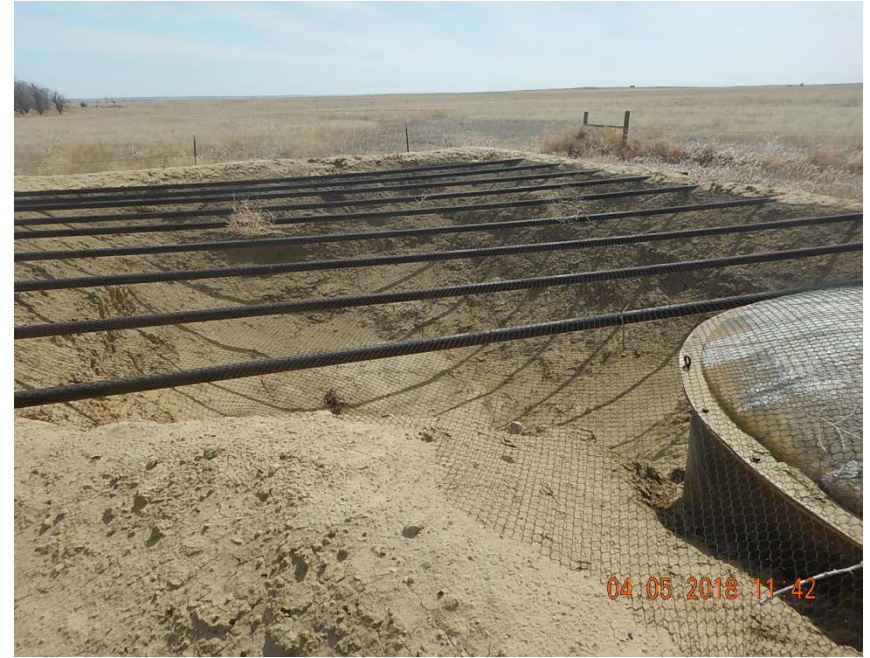
Photo 4: Weeds removed

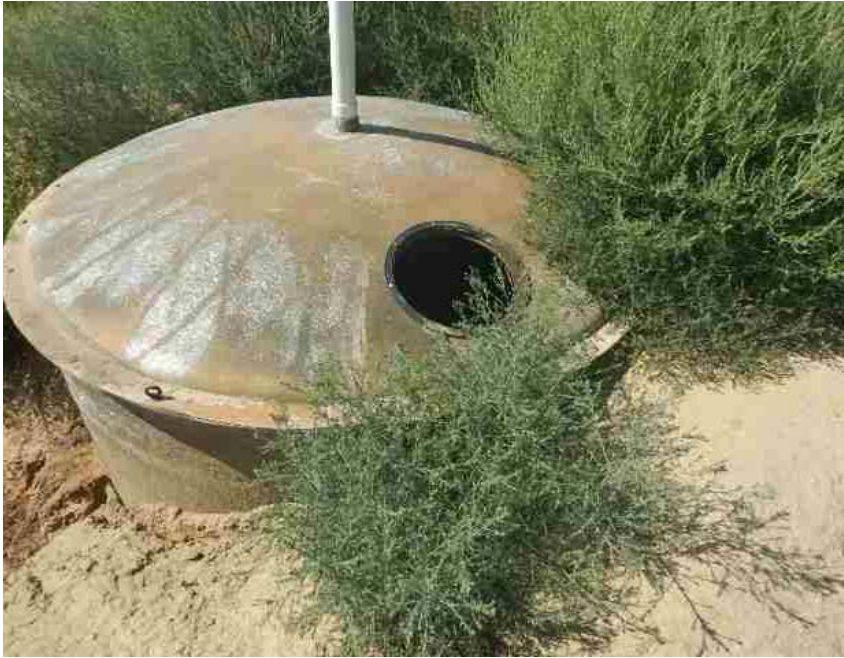
Photo from prior inspection for comparison

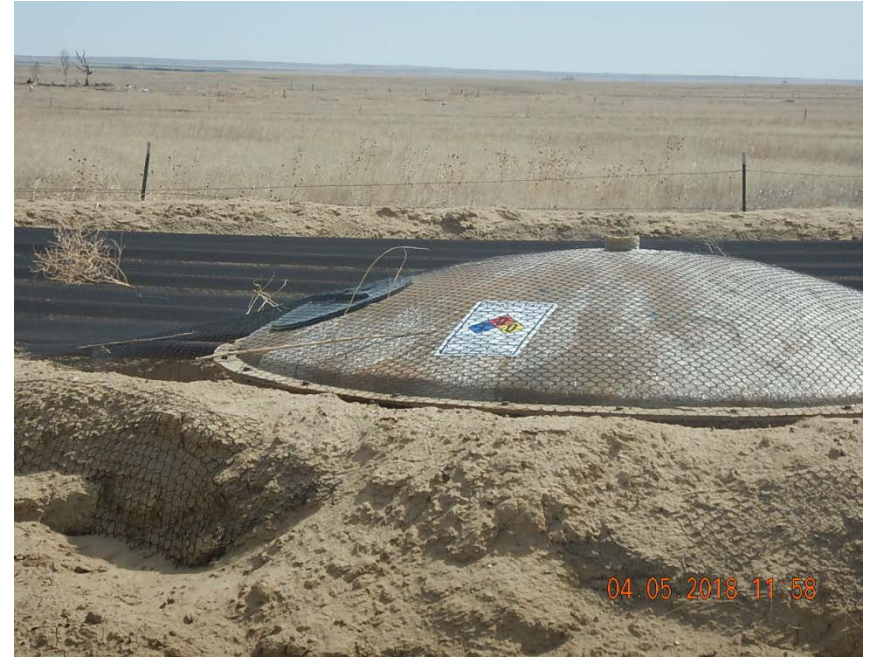
Photo 5: Tank is covered, labeled

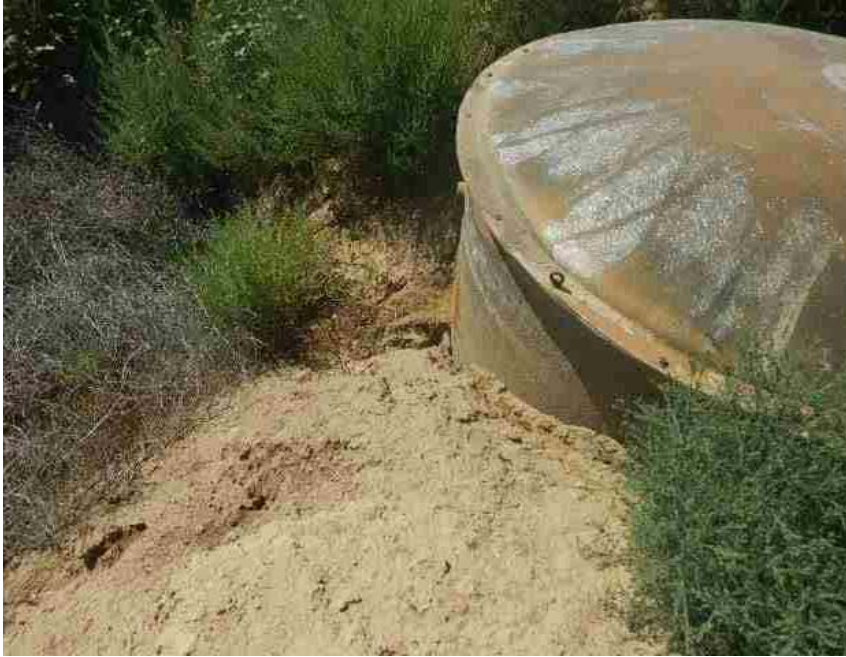
Photo from prior inspection for comparison

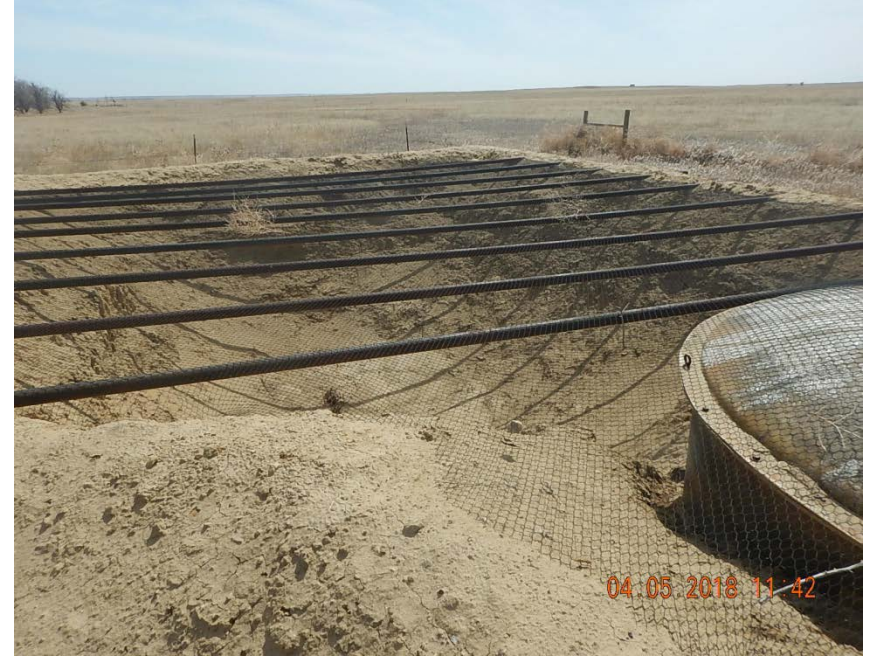
Photo 6: Stained soil removed

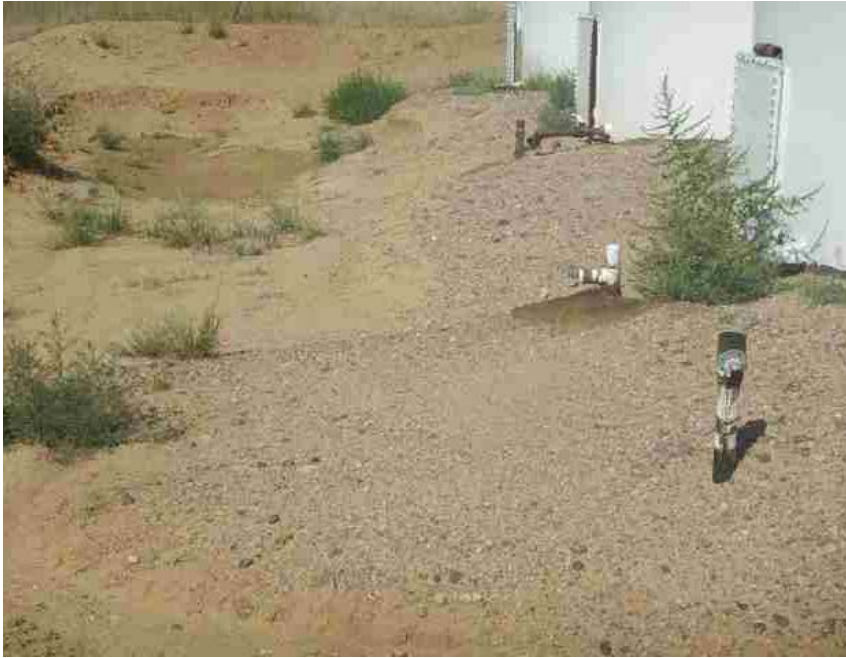
Photo from prior inspection for comparison

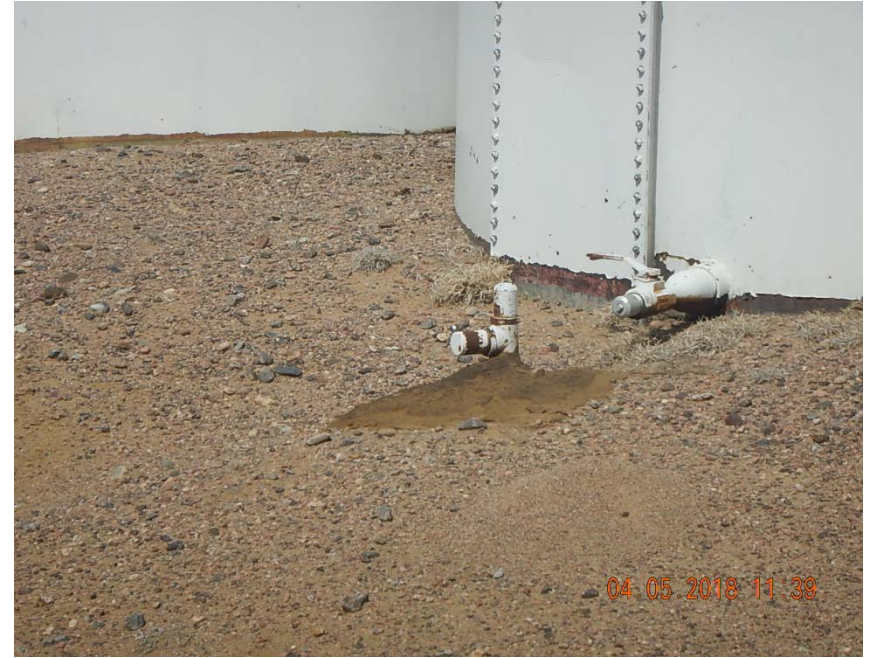
Photo 7: Stained soil at riser.

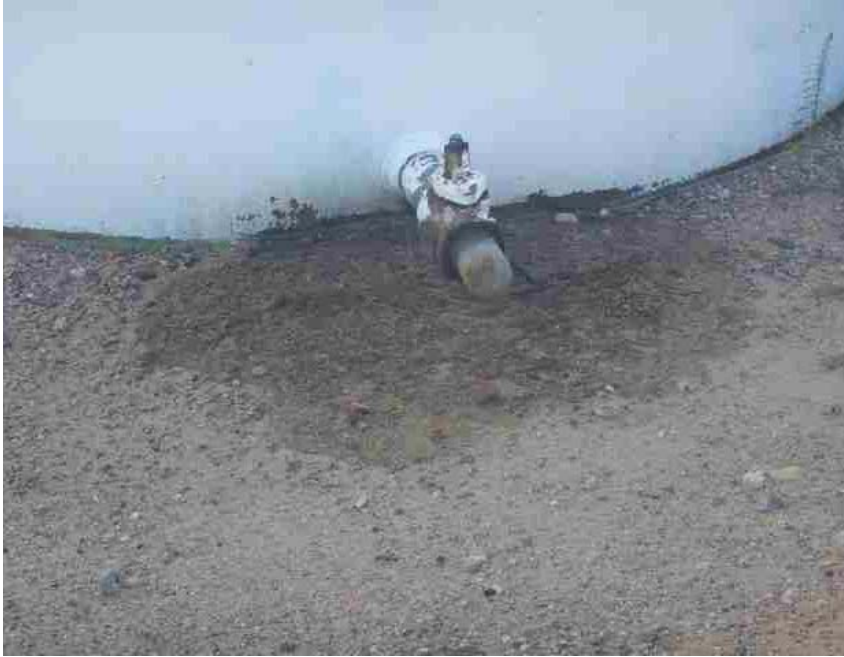
Photo from prior inspection for comparison

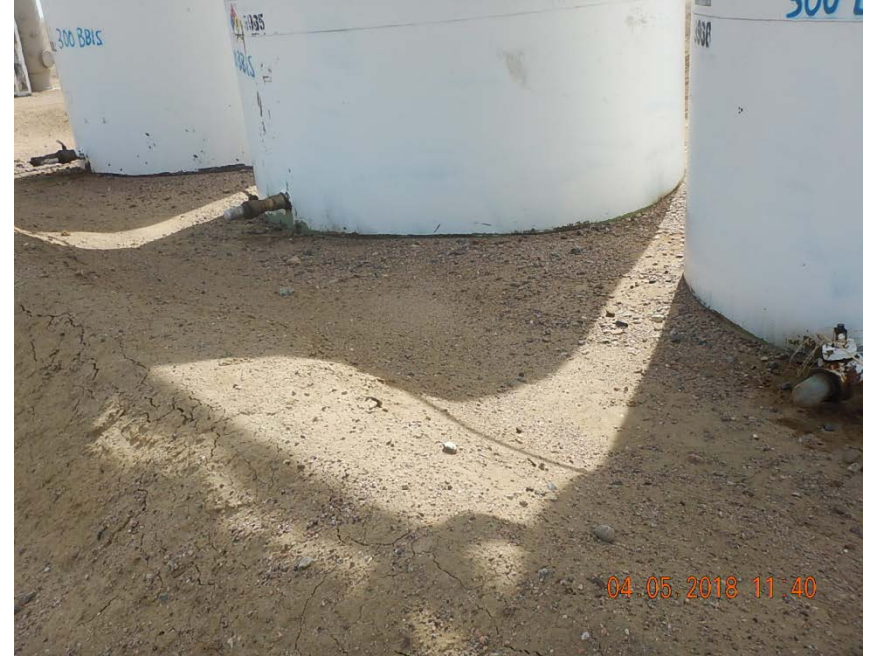
Photo 8: Stained soil at loadout

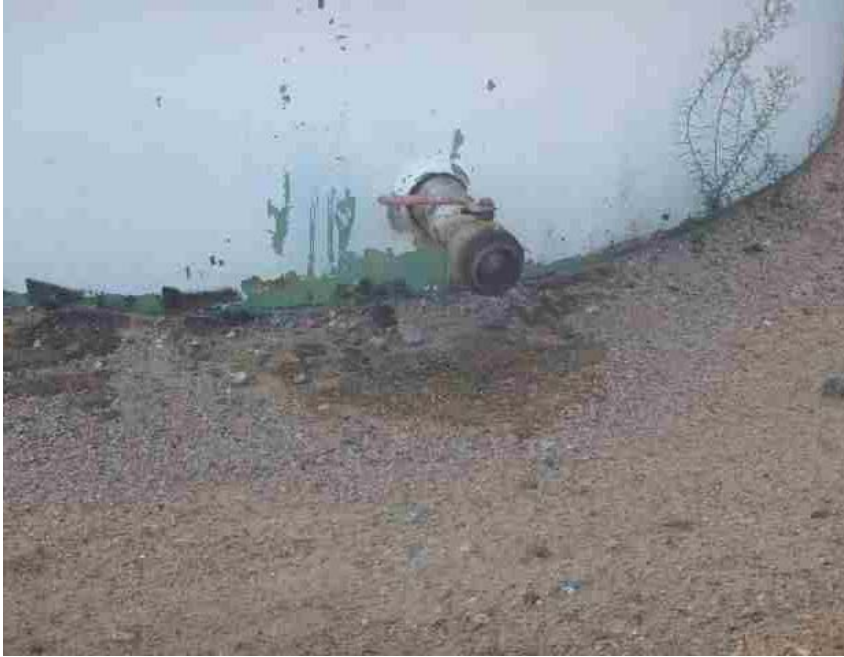
Photo from prior inspection for comparison

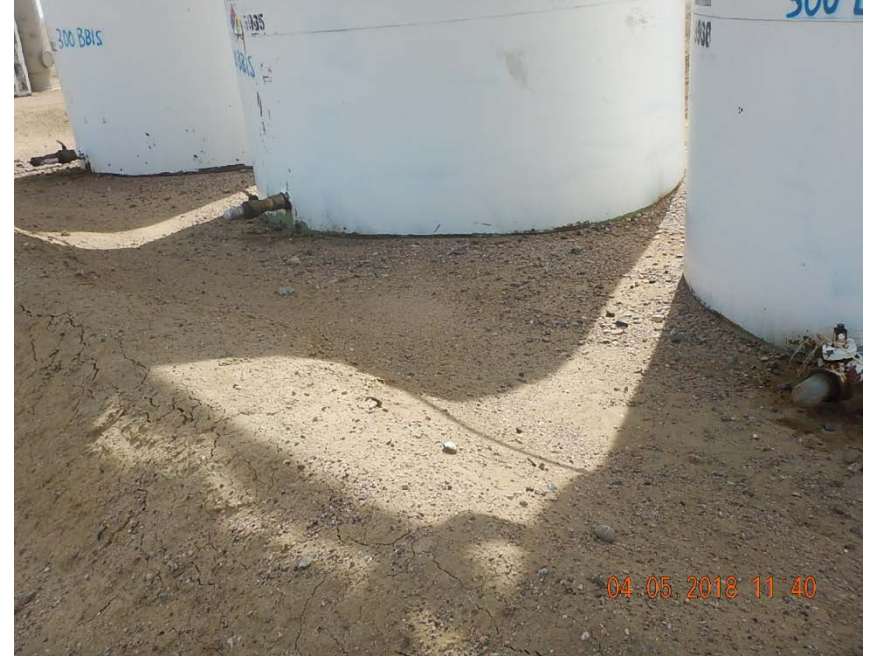
Photo 9: Stained soil at loadout.

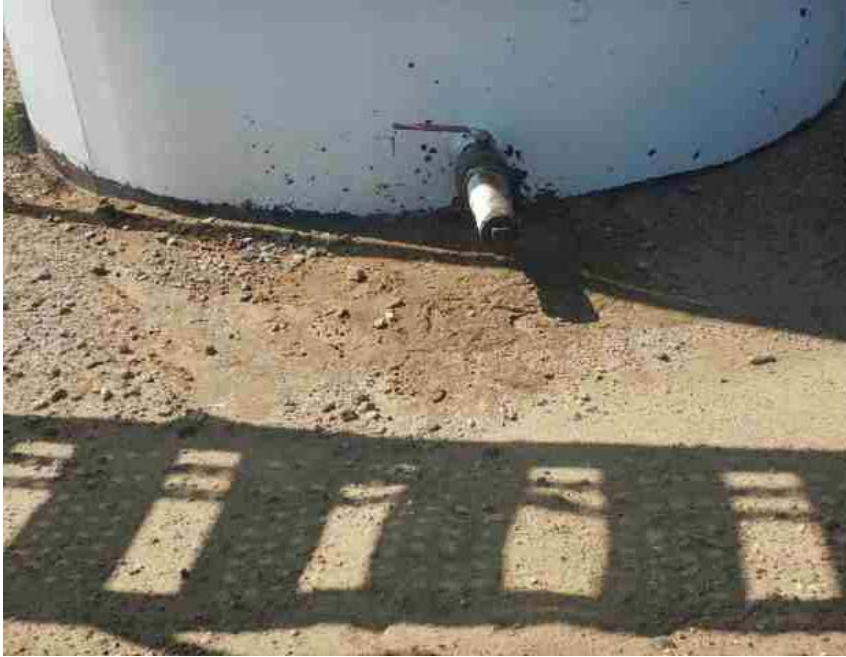
Photo from prior inspection for comparison

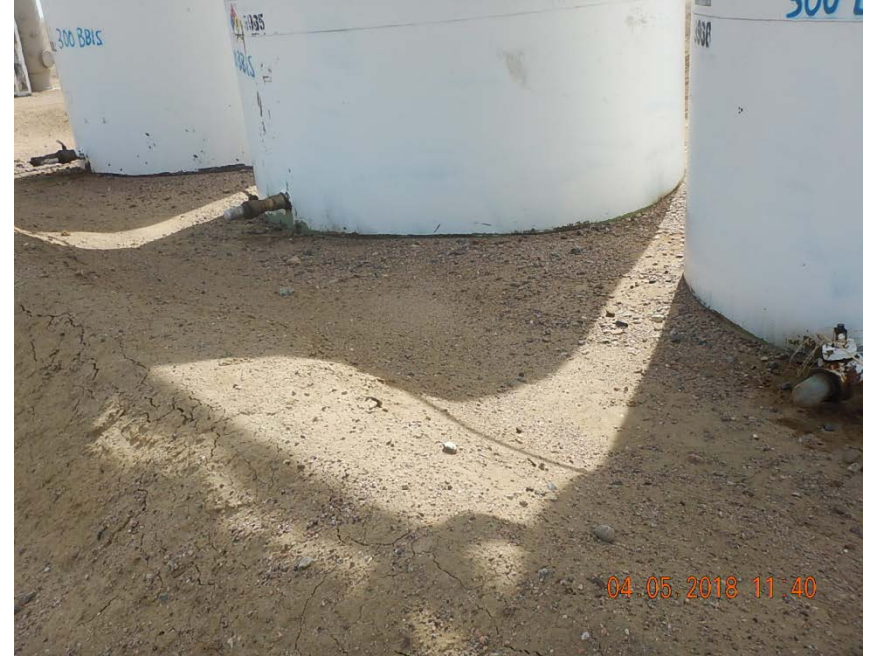
Photo 10: Stained soil at loadout.

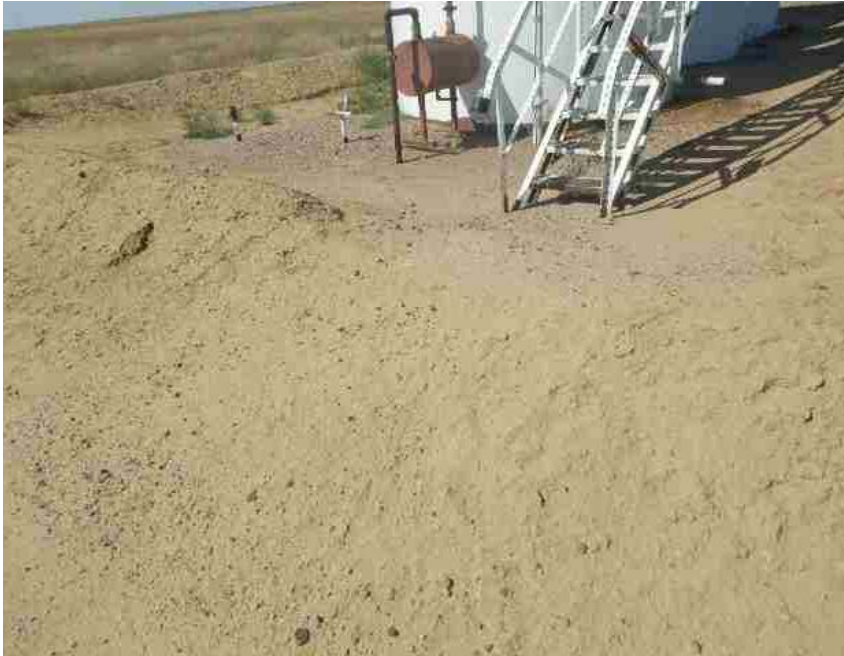
Photo from prior inspection for comparison

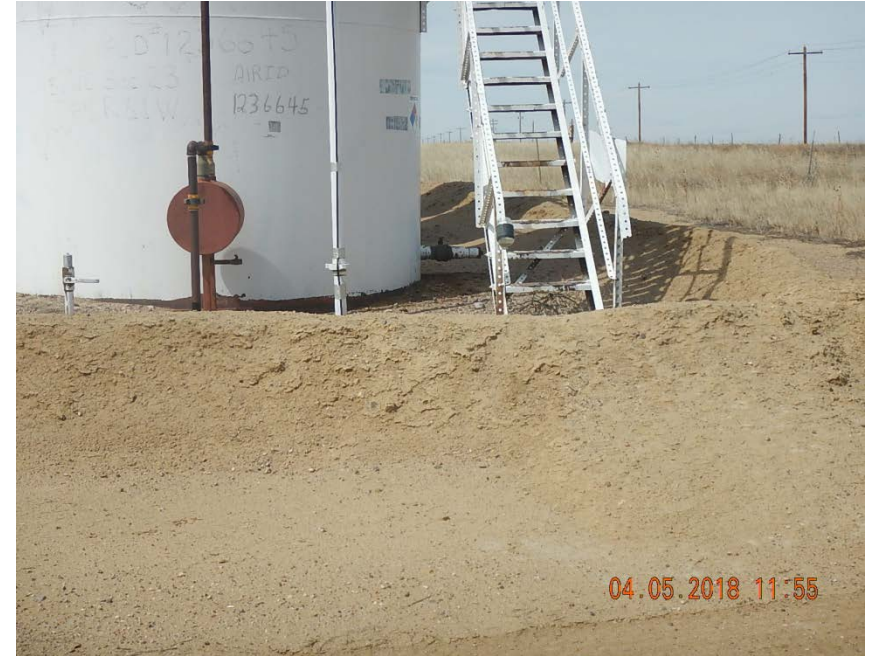
Photo 11: Berms built up.

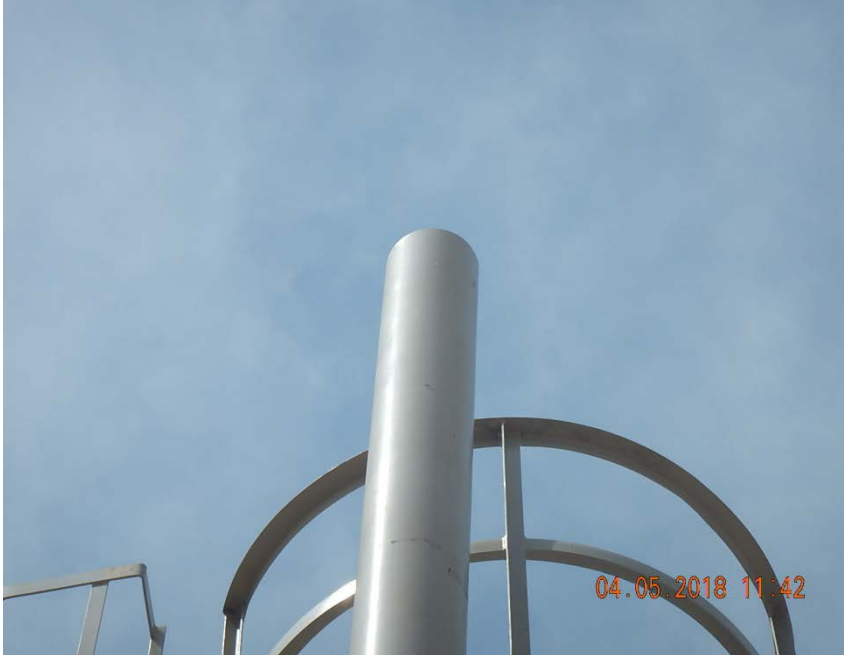
Photo 12: No screen on stack

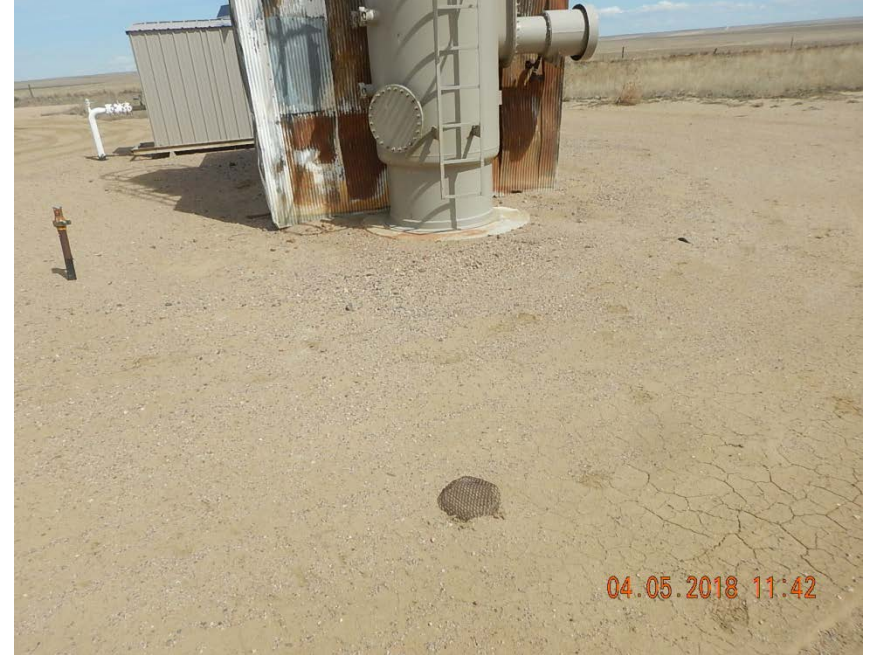
Photo 13: Screen on ground, near treater

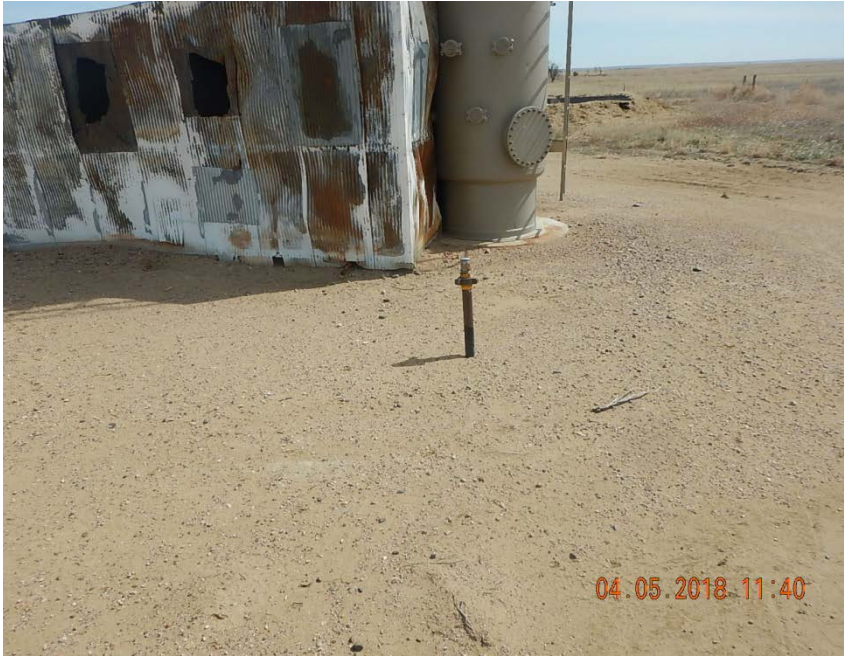
Photo 14: Riser near treater
