Inspection Photos
Location Name: Hendershot #1
Location ID: 317497

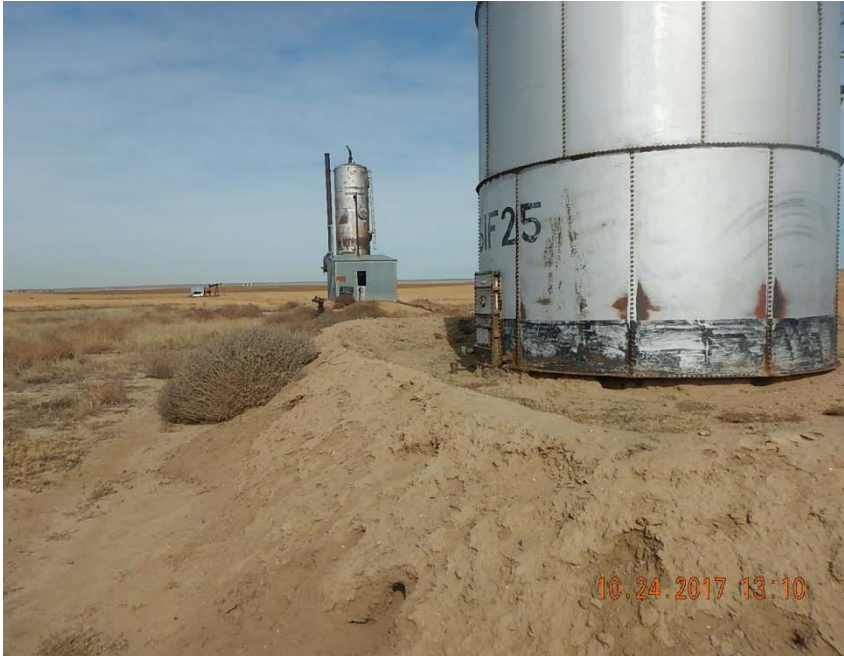
Photo 1: Location, looking N

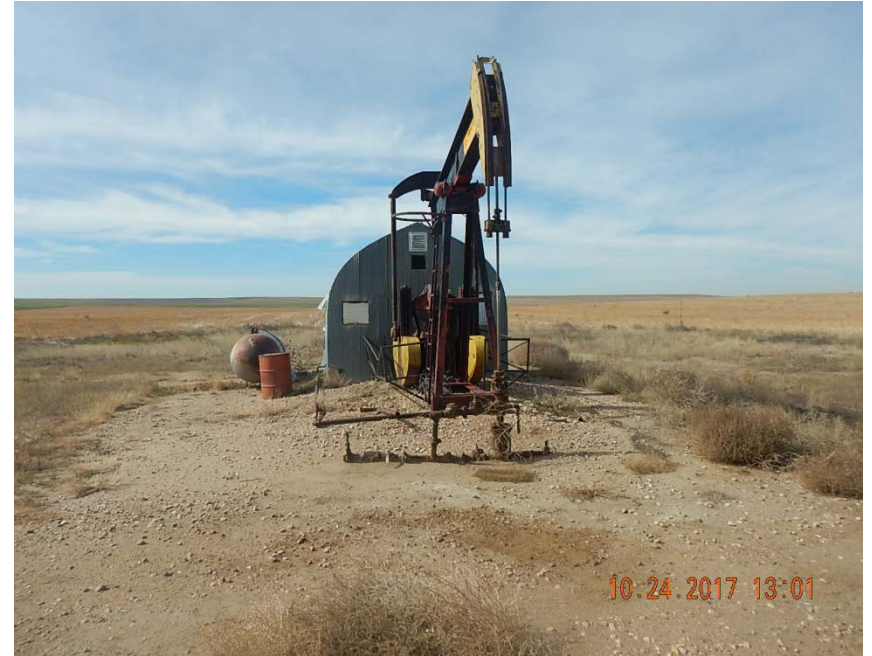
Photo 2: Wellhead, looking W

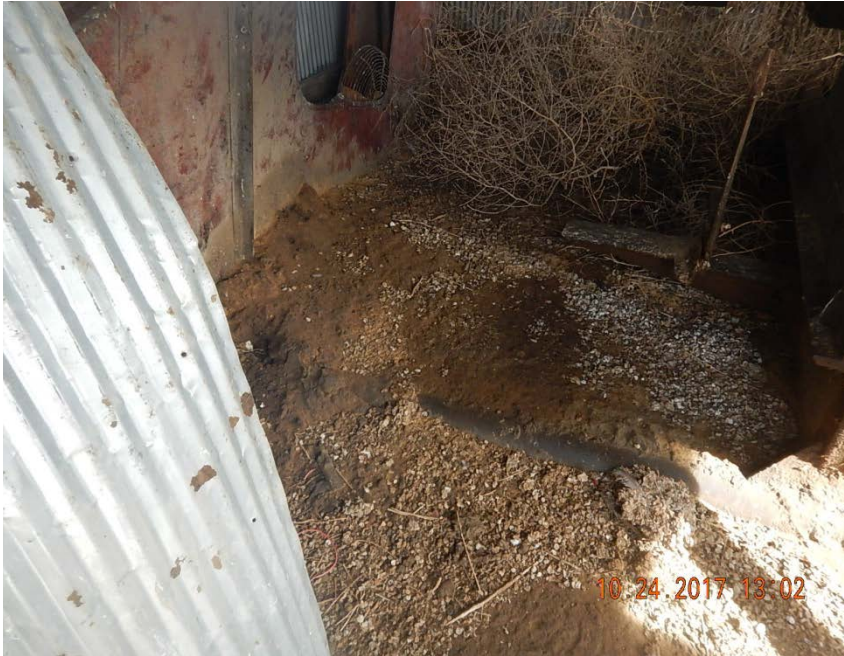
Photo from prior inspection for comparison

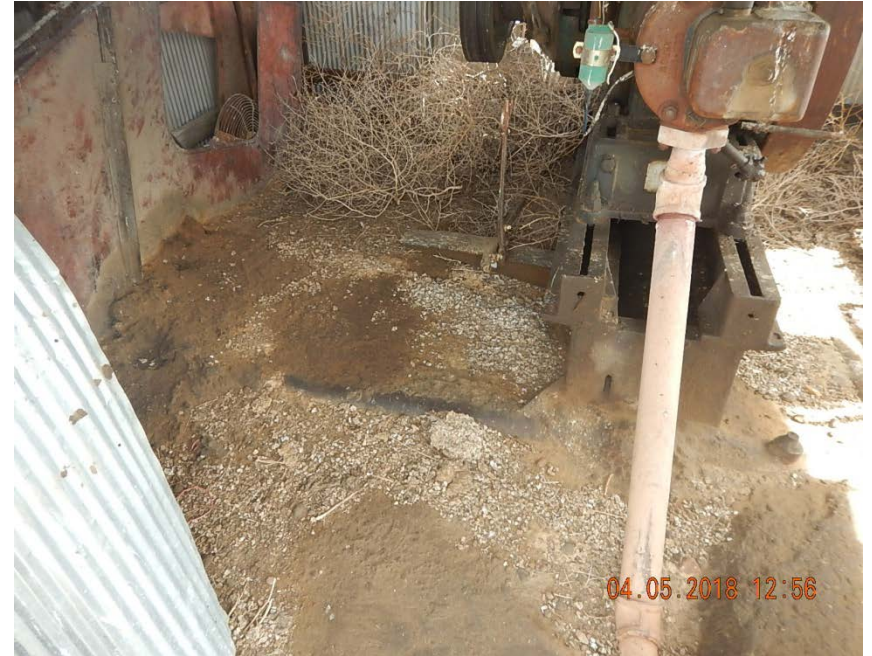
Photo 3: Stained soil in engine house

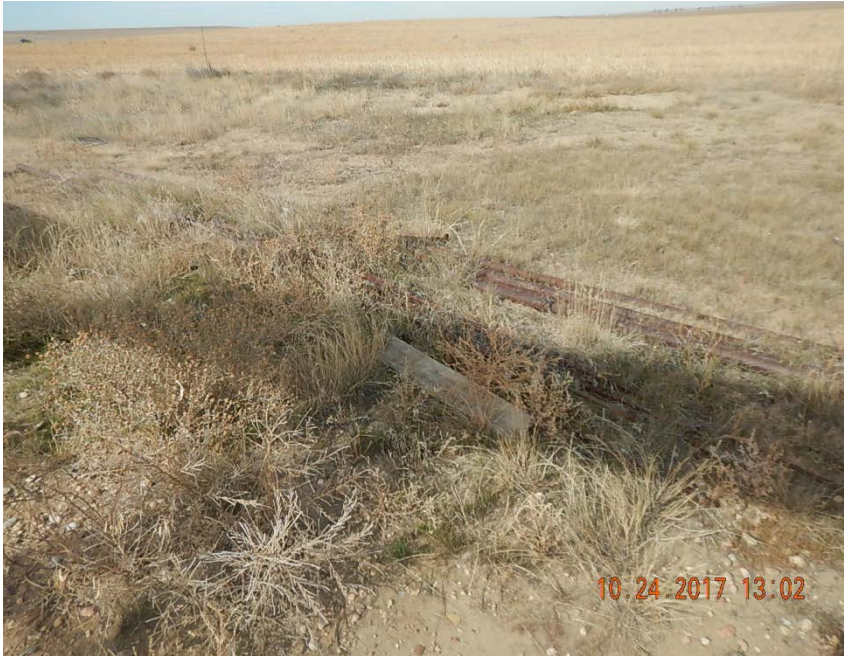
Photo from prior inspection for comparison

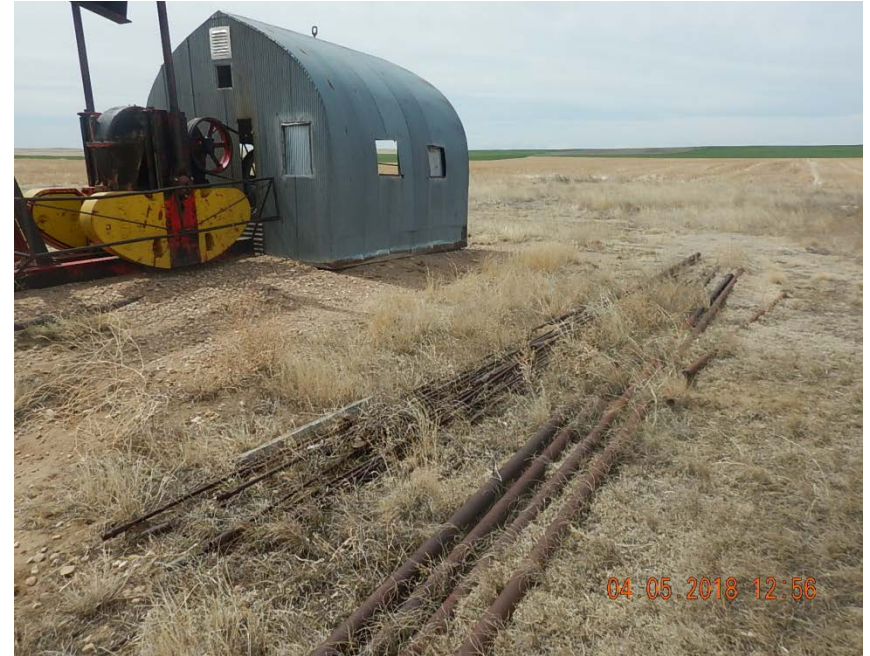
Photo 4: Unused pipe at wellhead

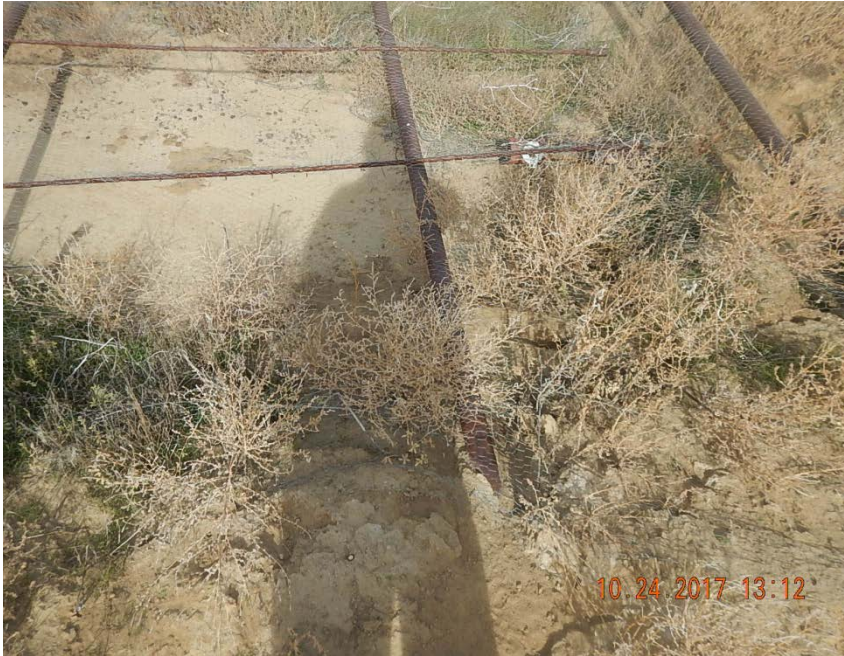
Photo from prior inspection for comparison

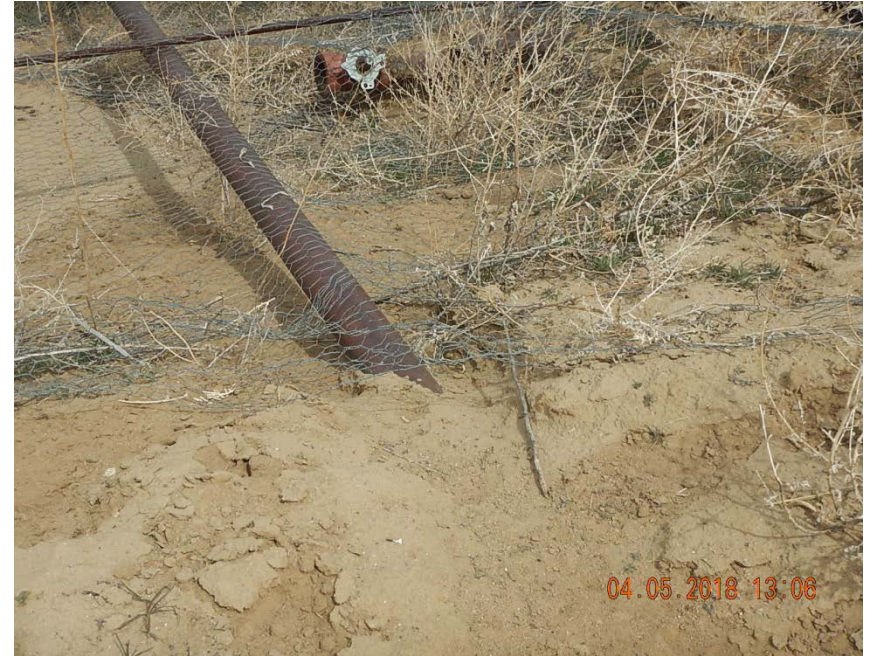
Photo 5: Gap under netting

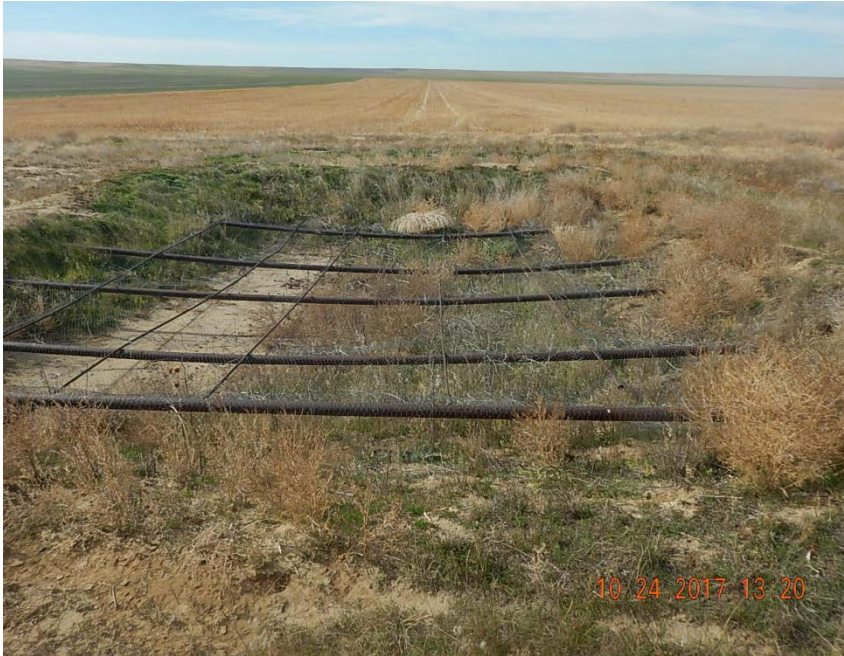
Photo from prior inspection for comparison

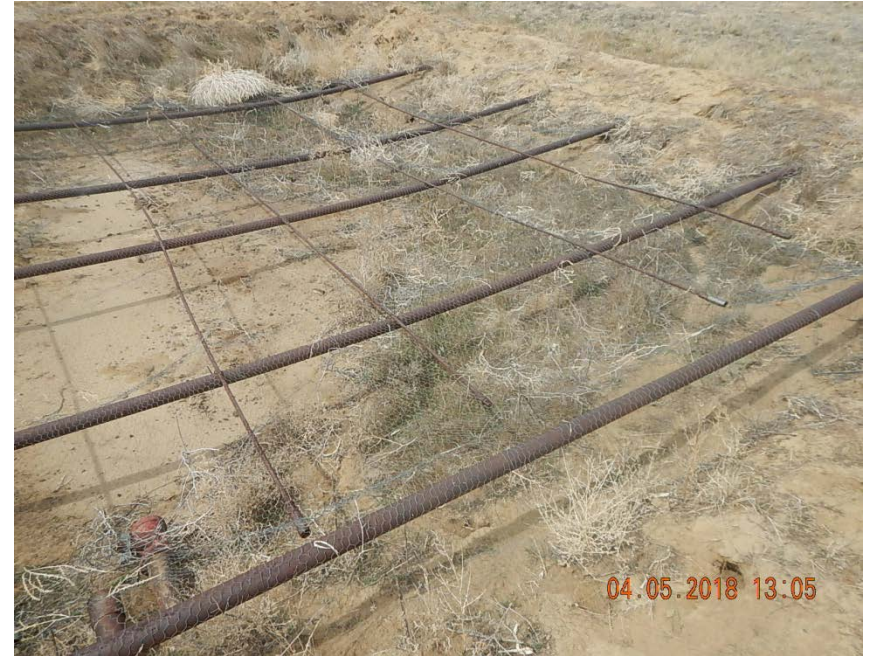
Photo 6: Weeds in pit

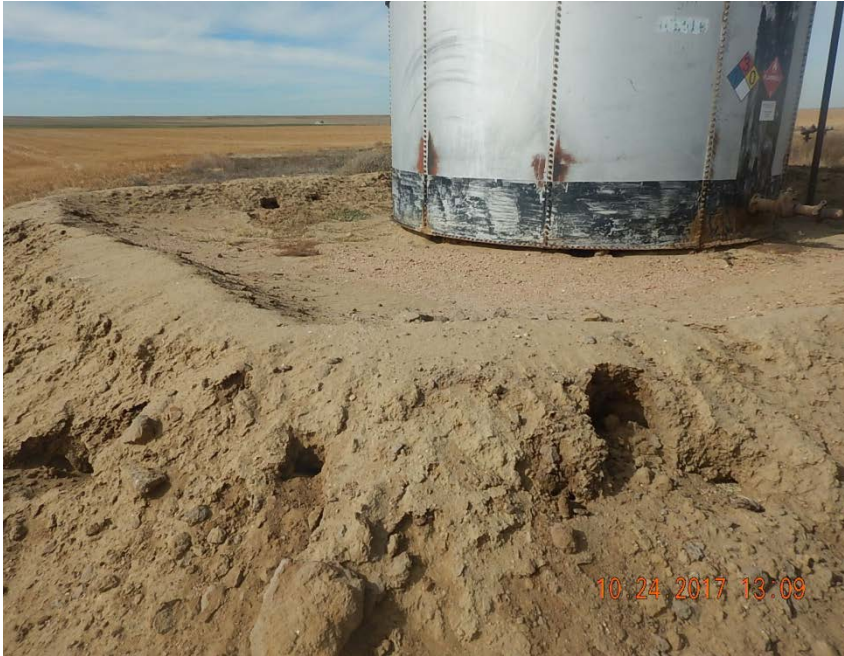
Photo from prior inspection for comparison

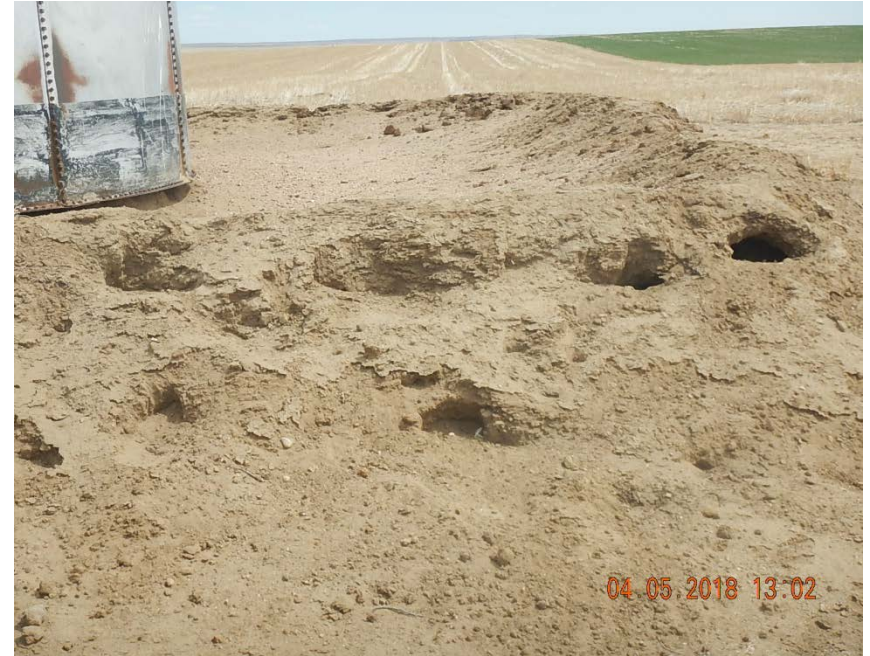
Photo 7: Burrows in berms

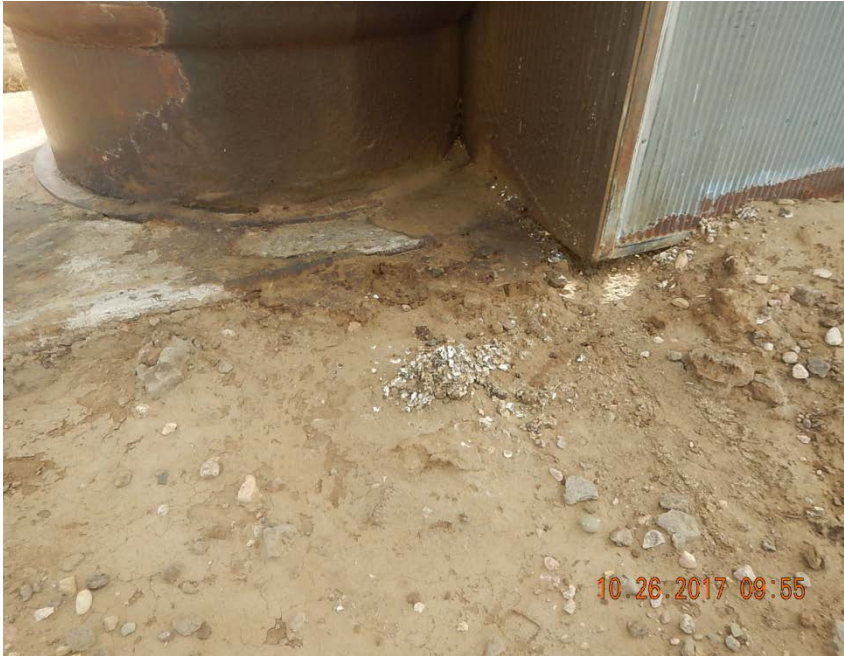
Photo from prior inspection for comparison

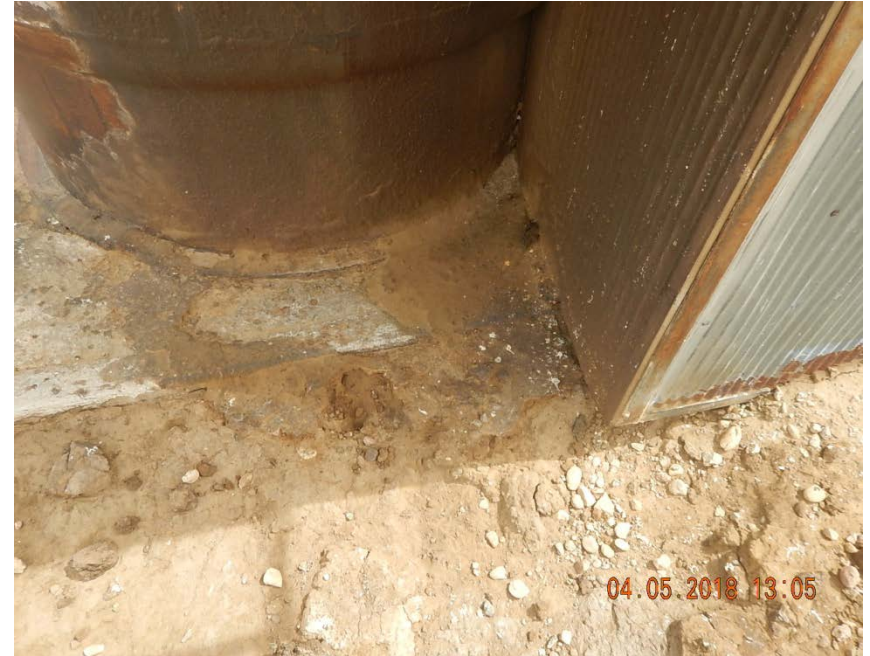
Photo 9: Stained soil at vessel

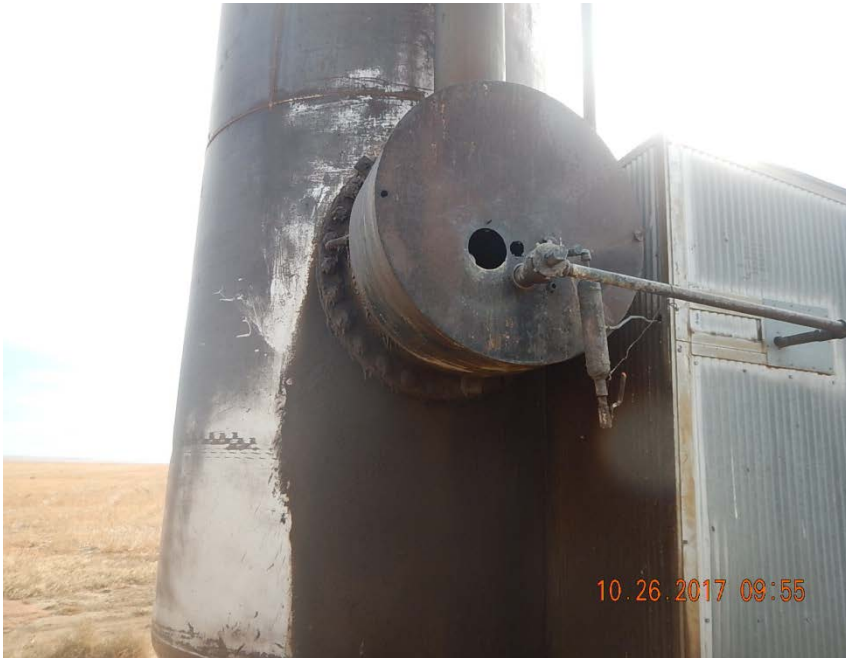
Photo from prior inspection for comparison

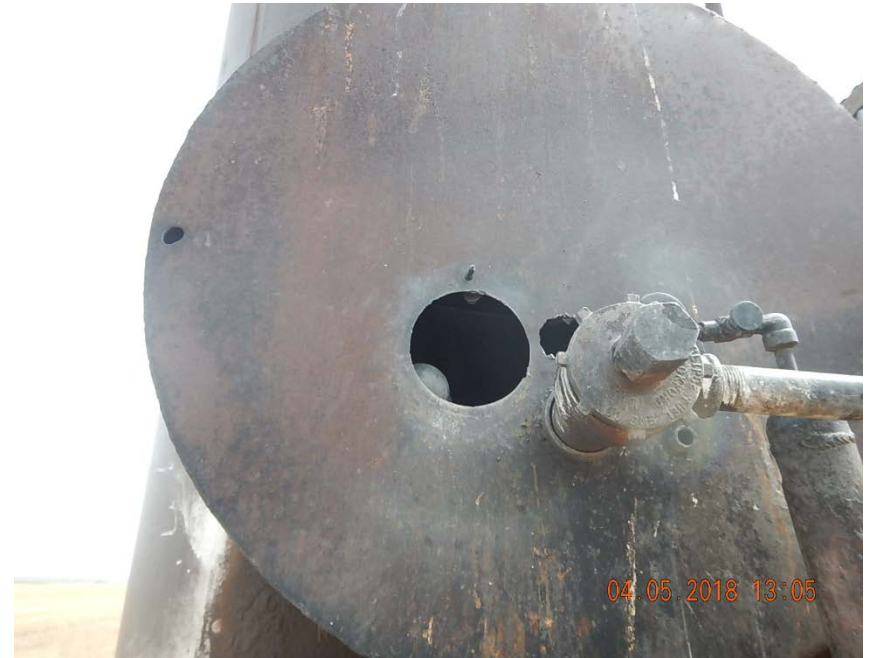
Photo 10: Wildlife egress
