Interim Reclamation and Stormwater Inspection

April 5, 2018

Operator: CUB CREEK ENERGY- #10542

Location ID: 446104

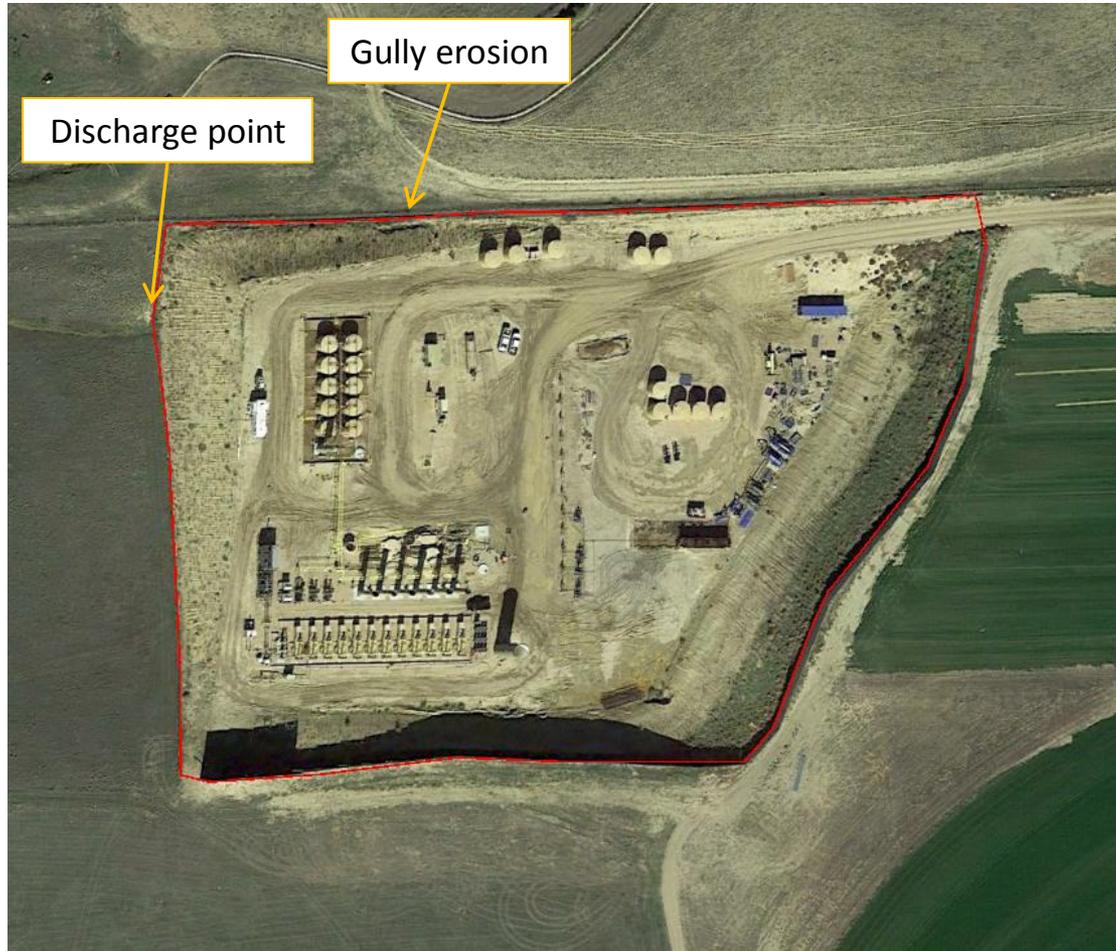
Google Earth aerial imagery taken October 14, 2017, illustrating the total disturbance of approximately 6.7 acres (red line). This location is not in compliance with the approved Form 2A for the permitted disturbance area of 5.0 acres. This location is not in compliance with Rule 1002.f.(2); Operator failed to control stormwater runoff in a manner that minimizes erosion, transport of sediment offsite, and site degradation.

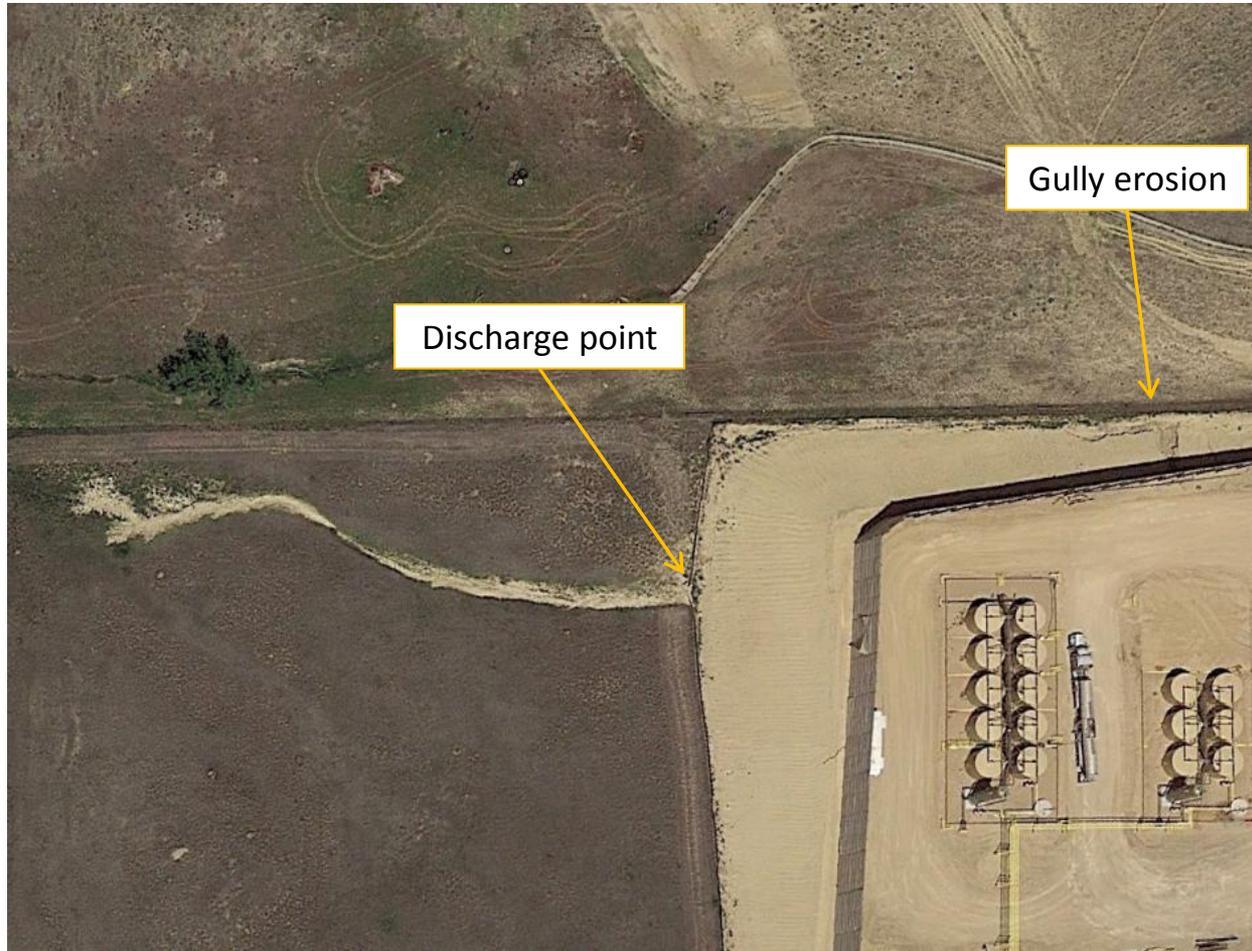
Google Earth aerial imagery taken June 9, 2017, illustrating active gully erosion discharging off location.

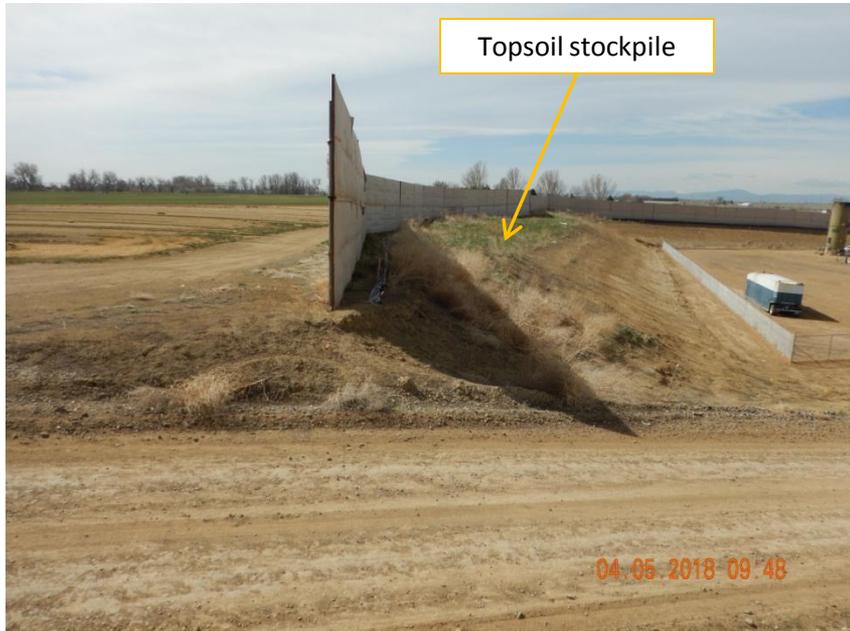
Photo 1. Photo taken from the entrance of the location, facing South. Appears topsoil was salvaged and stored along the eastern perimeter of the location. Note: Kochia weeds (*Kochia scoparia*) and weed debris were observed along portions of the location and was not managed and controlled. Kochia established on the fill slopes and topsoil stockpile.

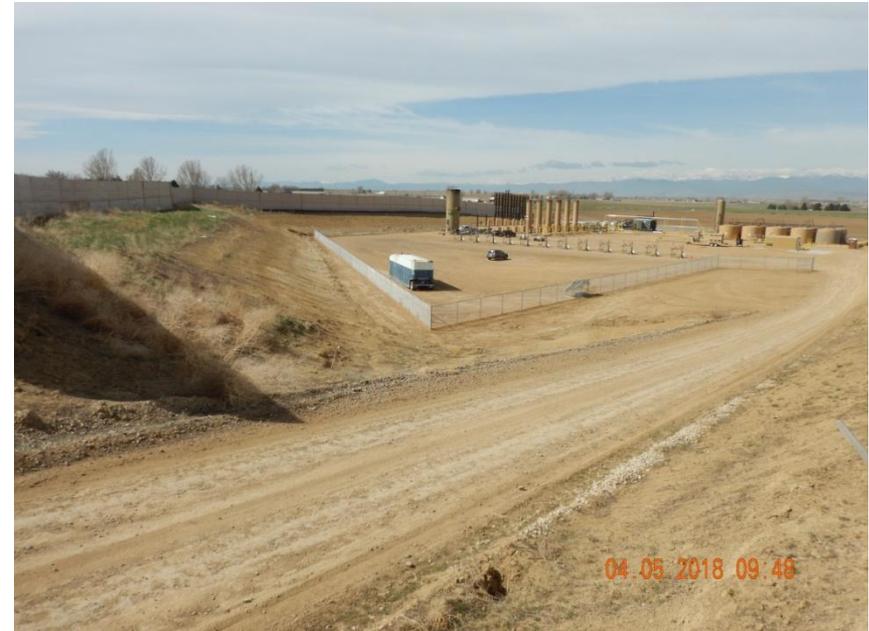
Photo 2. Photo taken from the entrance of the location, facing Southwest. Photo illustrates the Operator has failed to conduct interim reclamation on areas not needed for production operations. There a

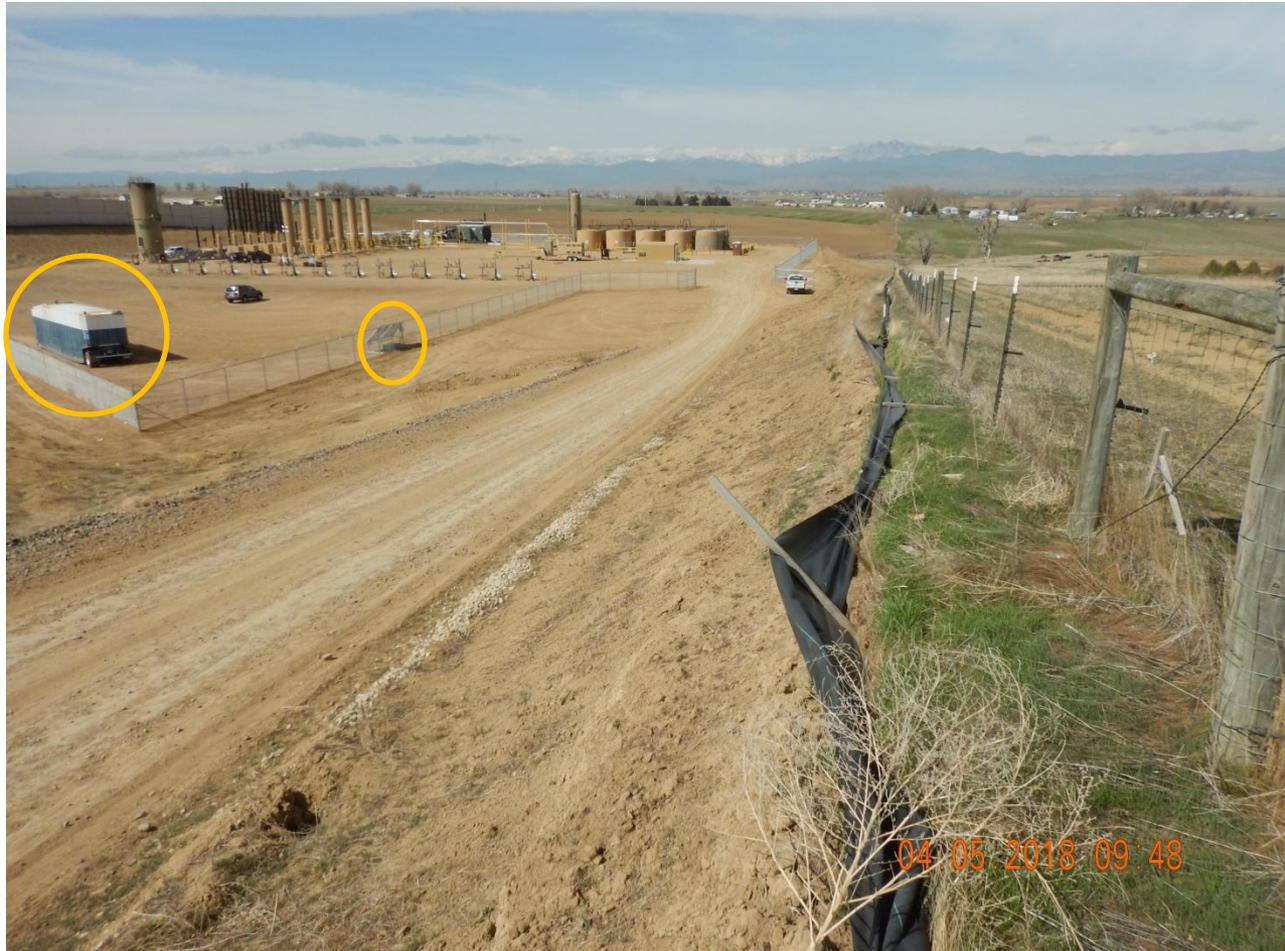
Photo 3. Photo taken from the entrance of the location, facing West. Operator has failed to maintain stormwater BMPs. Silt fence BMP in disrepair throughout the entire location. Also, there appeared to be other equipment stored along the eastern well pad location. Operator shall remove this equipment if it is not being used for production operations.

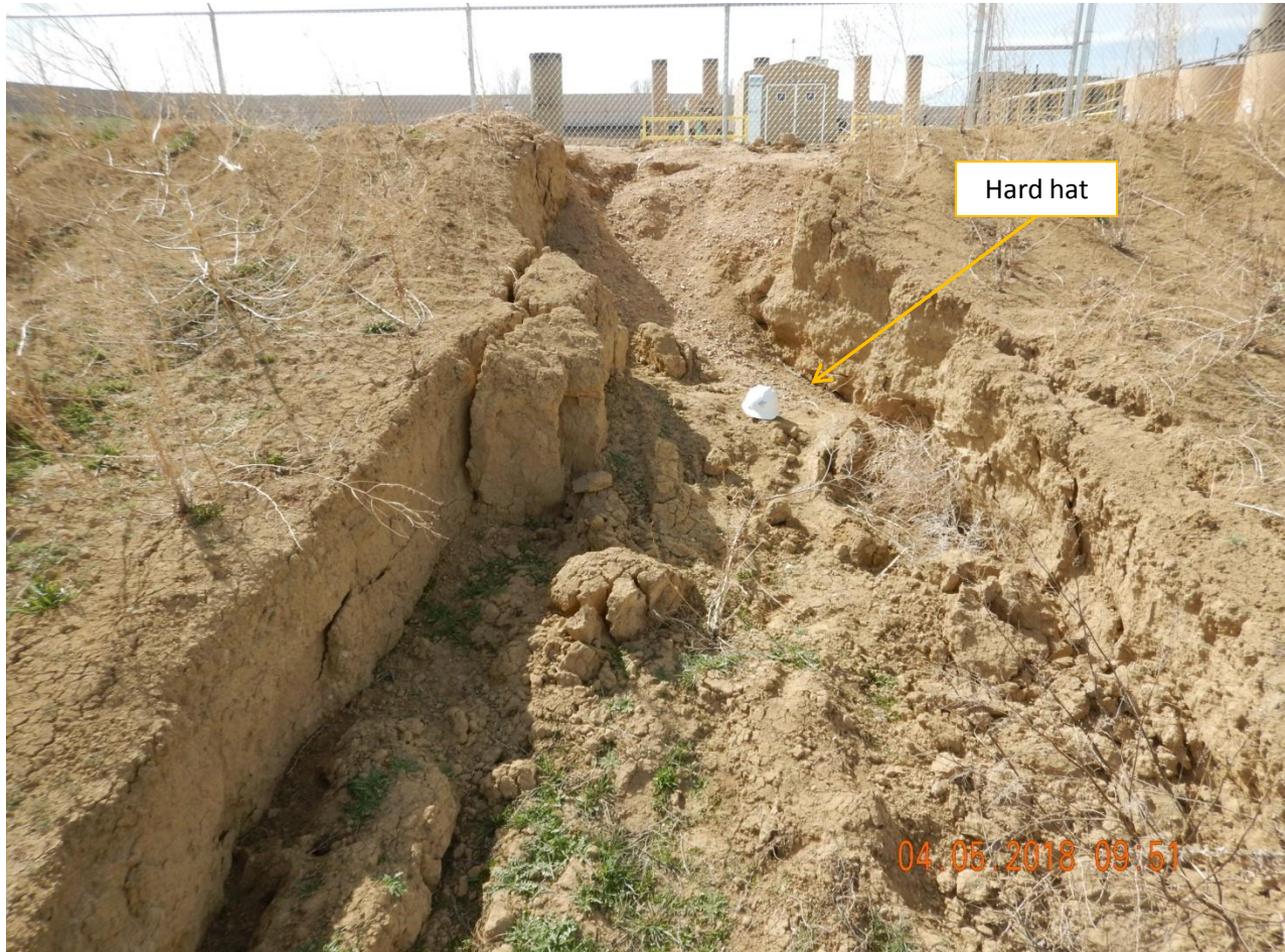
Photo 4. Photo taken from the northern location, facing South. Gully erosion up to three feet deep along the northern fill slopes. Sediment discharge off location was observed along the northwestern location- see Photo 7.

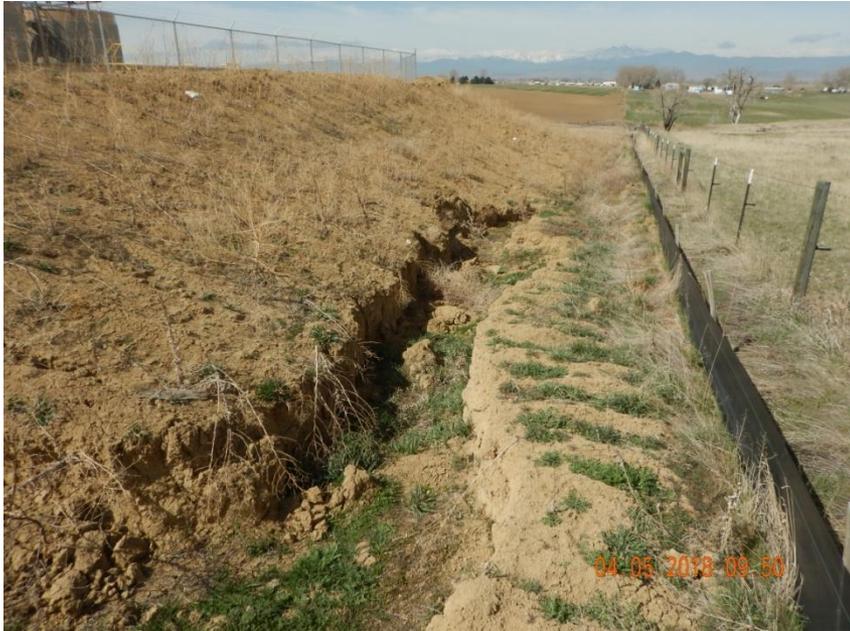
Photo 5. Photo taken from the gully erosion, facing West. See comments under Photo 4.

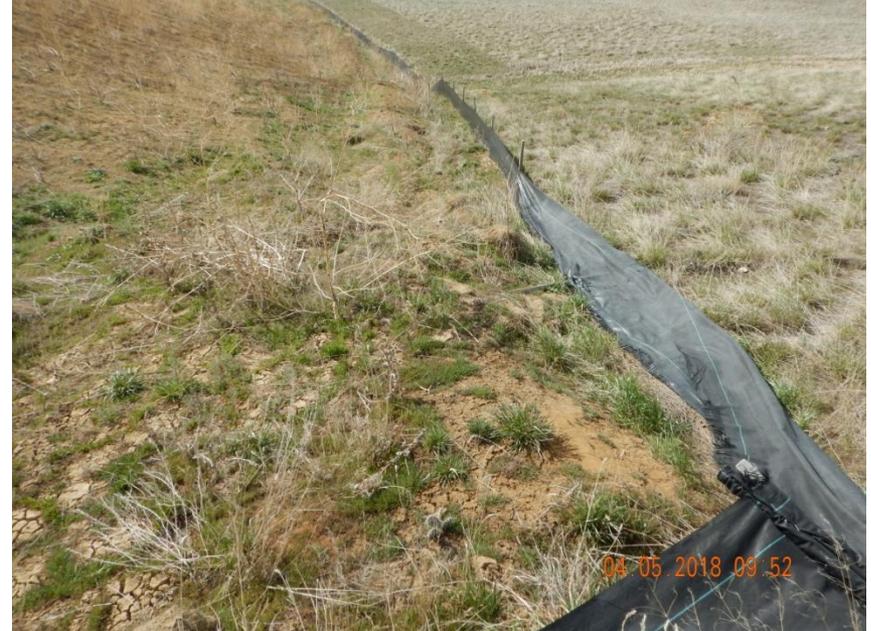
Photo 6. Photo taken from the northwestern location, facing South. See comments under Photo 3.

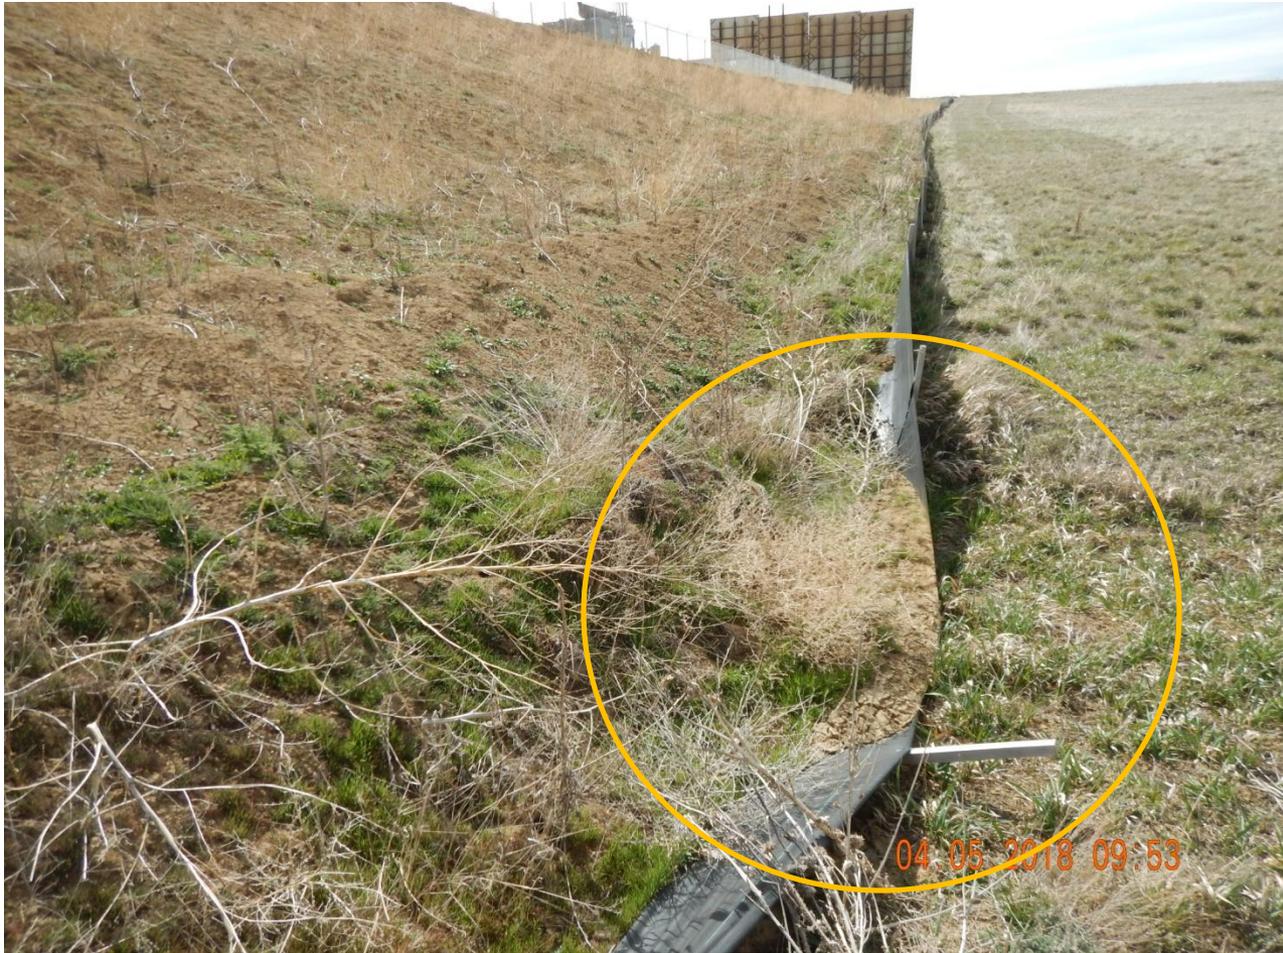
Photo 7. Photo taken from the discharge point along the northwestern location, facing South. Sediment discharge from gully erosion damaged the silt fence and discharged off location.

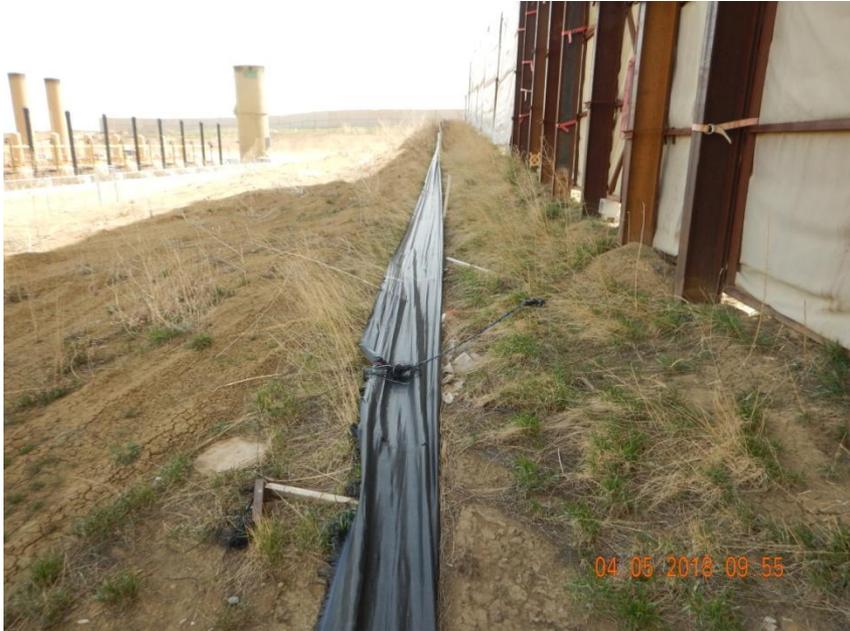
Photo 8. Photo taken from the southwest location, facing East. See comments under Photo 3.

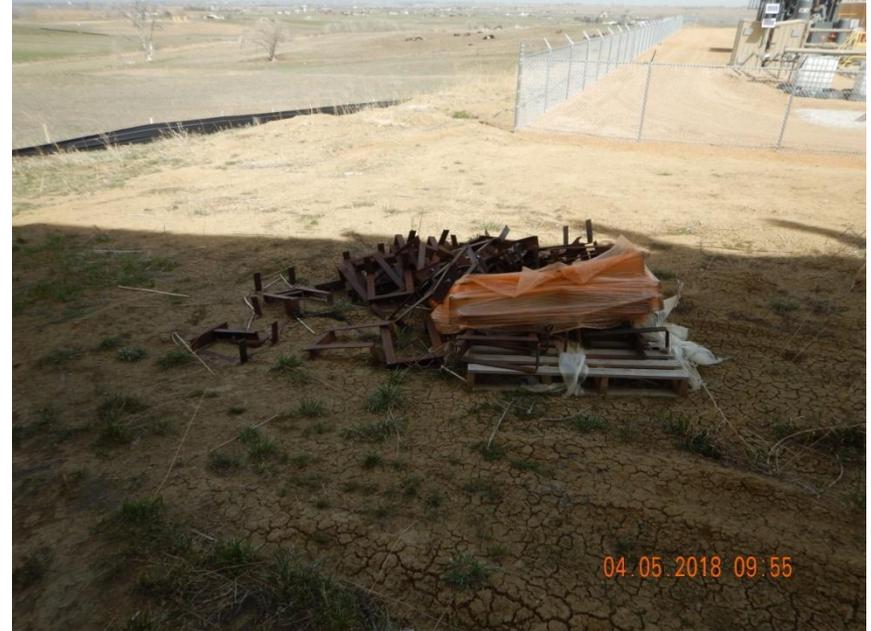
Photo 9. Photo taken from the southwest location, facing North. Remove unused equipment per Rule 603.f.

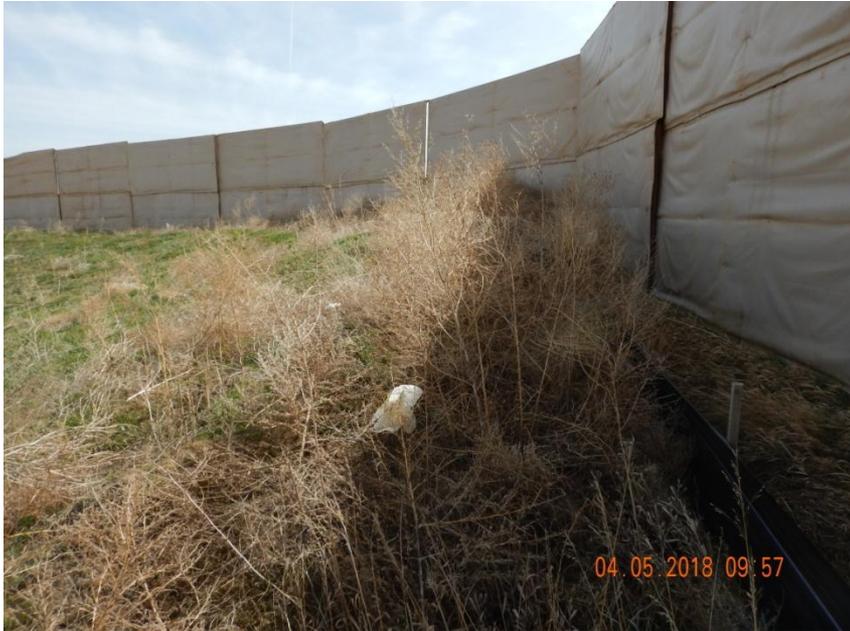
Photo 10. Photo taken from the southeastern location, facing East. Photo illustrates Kochia establishment and weed debris.

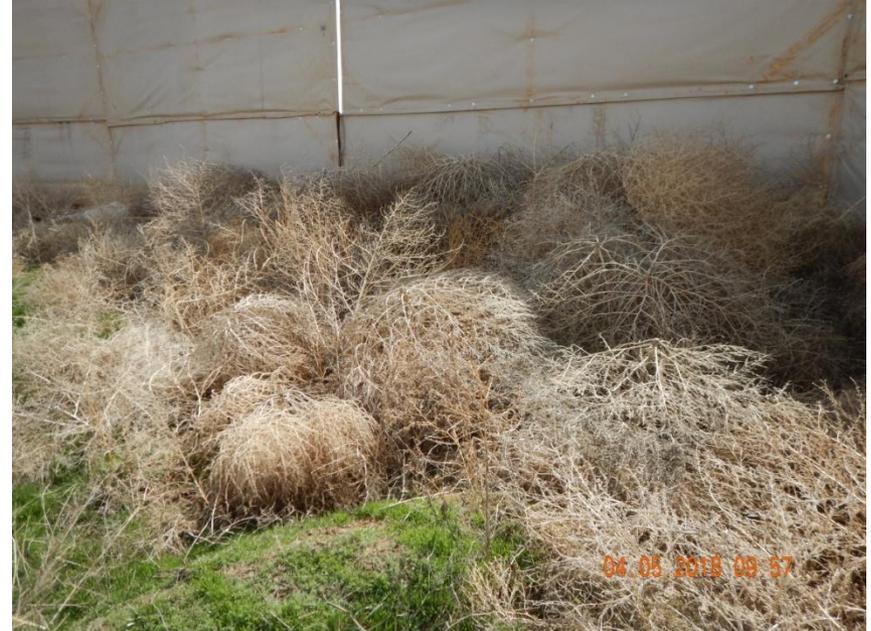
Photo 11. Photo taken from the southeastern location, facing East. See comments under Photo 10.

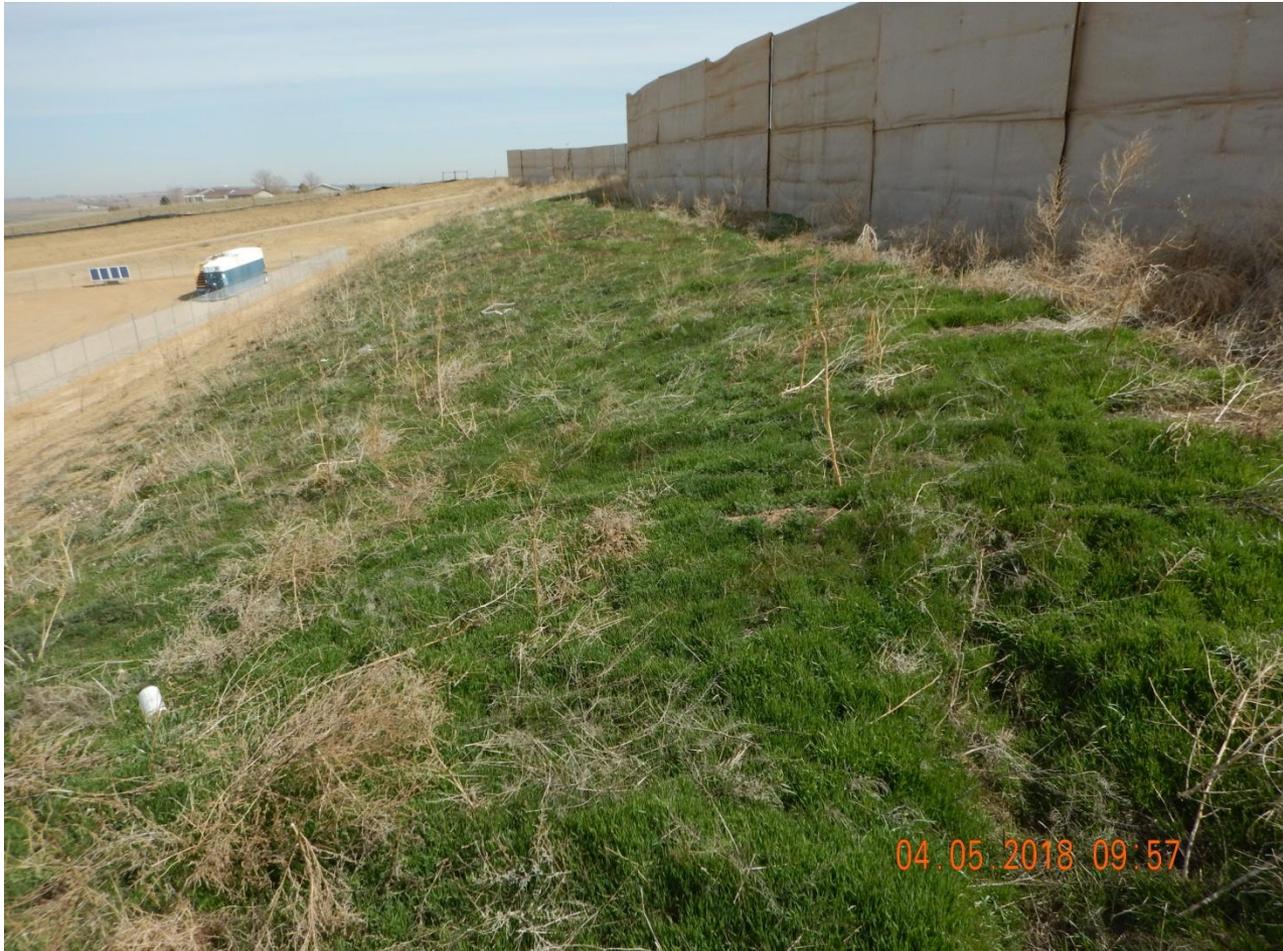
Photo 12. Photo taken from the northeastern location along the topsoil stockpile, facing North. Operator has failed to prevent weed establishment on the topsoil stockpile per Rule 1002.c. Photo illustrates cheatgrass and Kochia establishment throughout the entire topsoil stockpile.

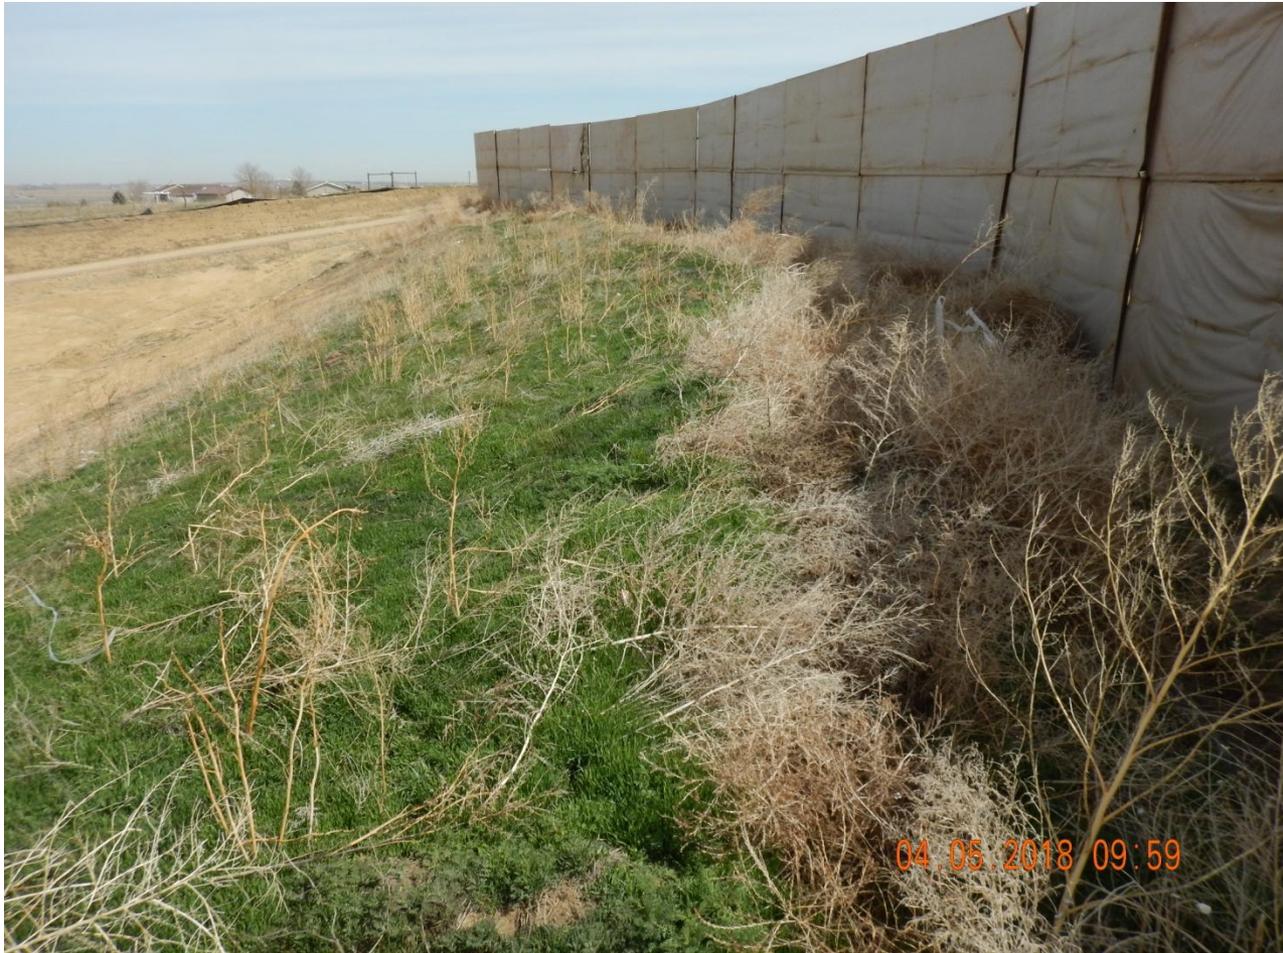
Photo 13. Photo taken from the eastern location along the topsoil stockpile, facing North. See comments under Photo 12.
