Interim Reclamation Inspection

April 5, 2018

Operator: CRESTONE PEAK RESOURCES OPERATING LLC- #10633

Location ID: 435070

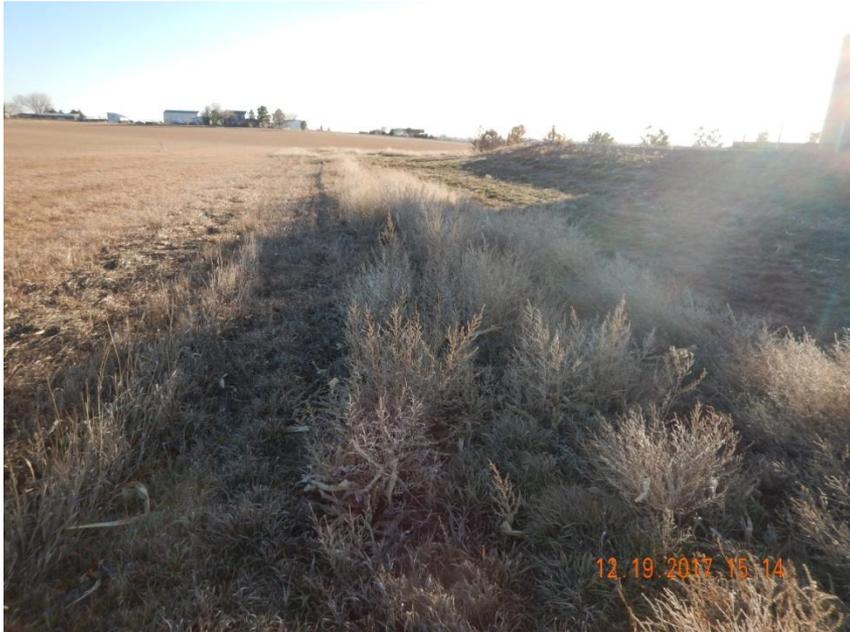
Photo 1. Photo taken from the eastern location on December 19, 2017, facing South. Interim reclamation areas are not reflective of reference area vegetative levels. Kochia (*Kochia scoparia*) is the dominate vegetative growth throughout the southern interim reclamation area. Some portions appear to be mowed while other portions have not been controlled.

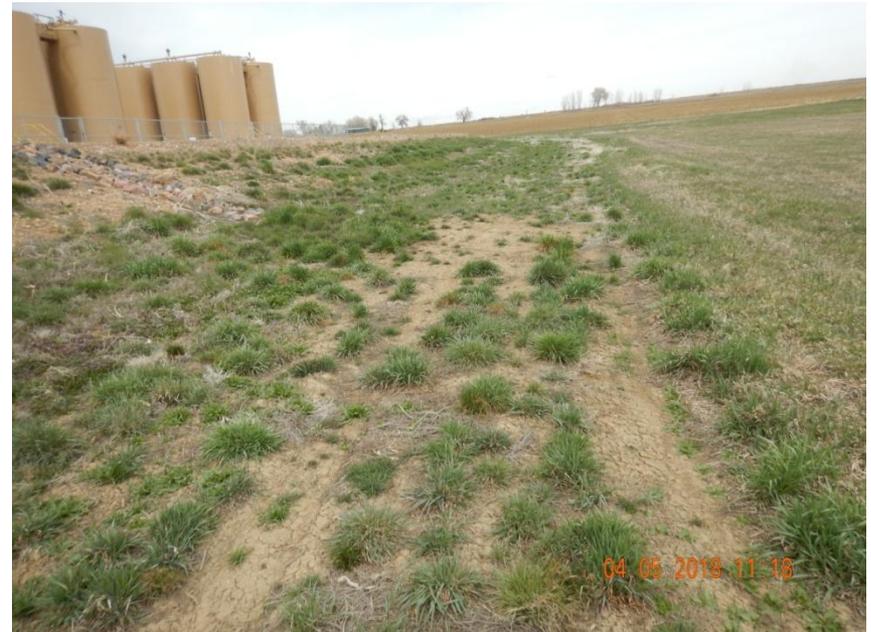
Photo 2. Photo taken from the eastern location on April 5, 2018, facing North. Appears the Operator has mowed Kochia since the previous inspection. Does not appear the Operator has performed the other required interim reclamation activities due on or before April 30, 2018.

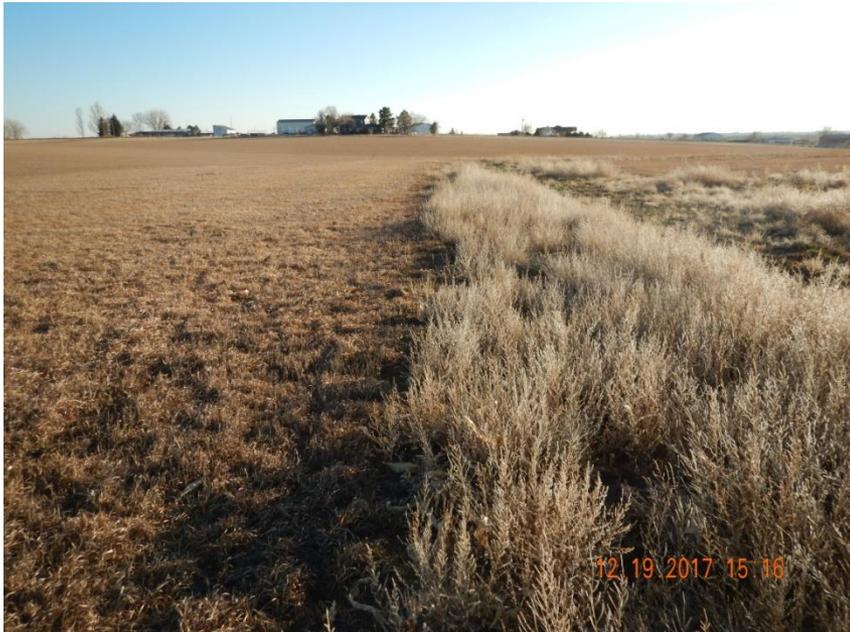
Photo 3. Photo taken from the southeastern location on December 19, 2017, facing South. See comments under Photo 1.

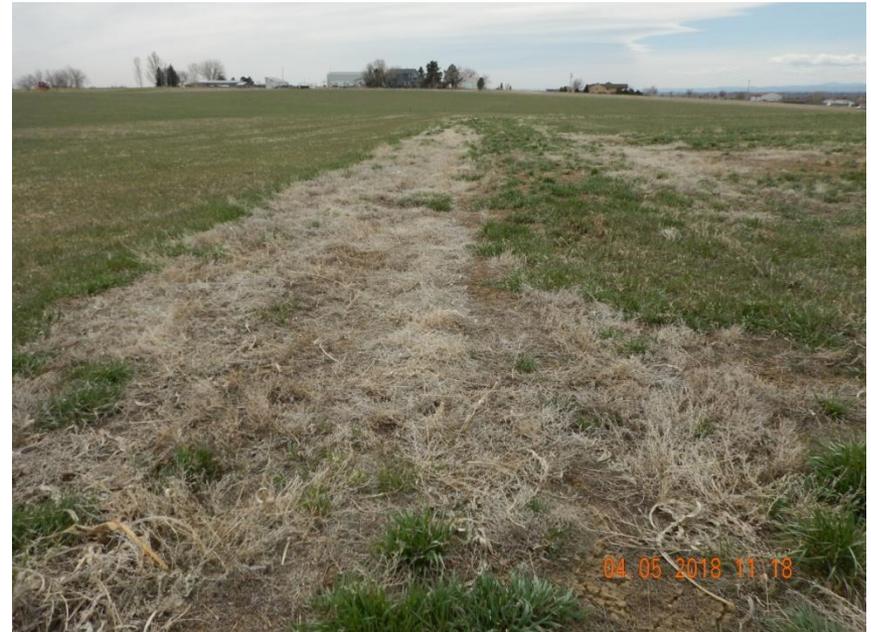
Photo 4. Photo taken from the southeastern location on April 5, 2018, facing South. See comments under Photo 2.

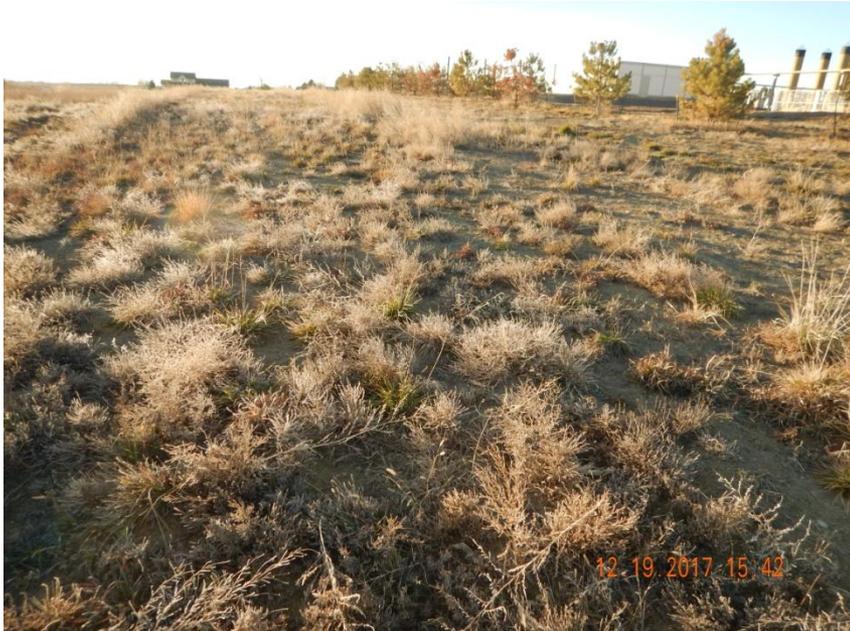
Photo 5. Photo taken from the southeastern location on December 19, 2017, facing West. See comments under Photo 1.

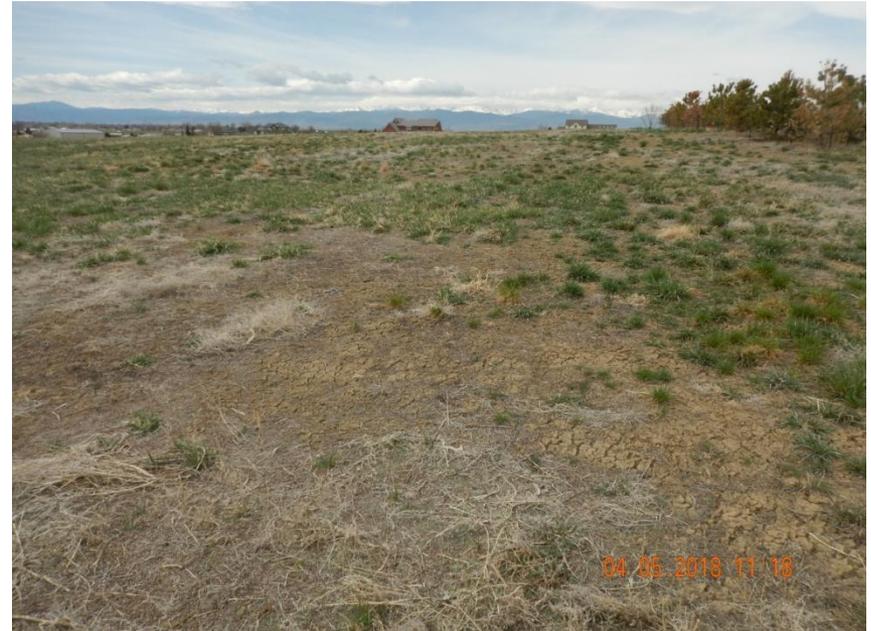
Photo 6. Photo taken from the southeastern location on April 5, 2018, facing West. See comments under Photo 2.

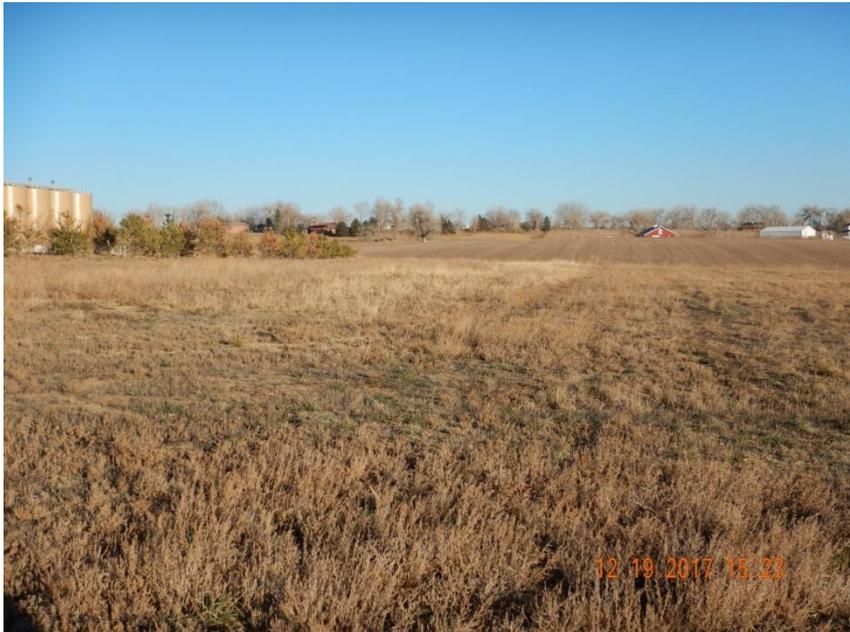
Photo 7. Photo taken from the southwestern location on December 19, 2017, facing East. See comments under Photo 1.

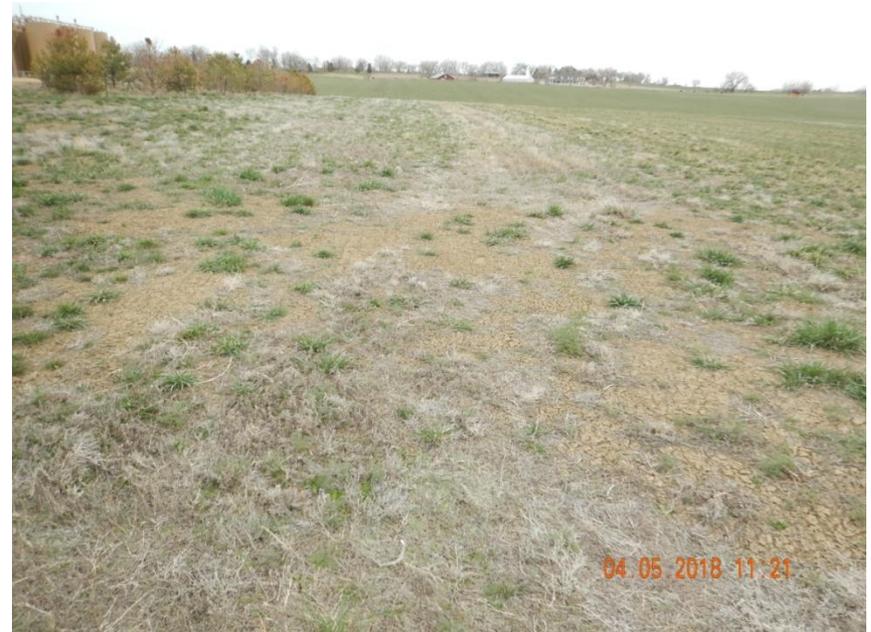
Photo 8. Photo taken from the southwestern location on April 5, 2018, facing East. See comments under Photo 2.

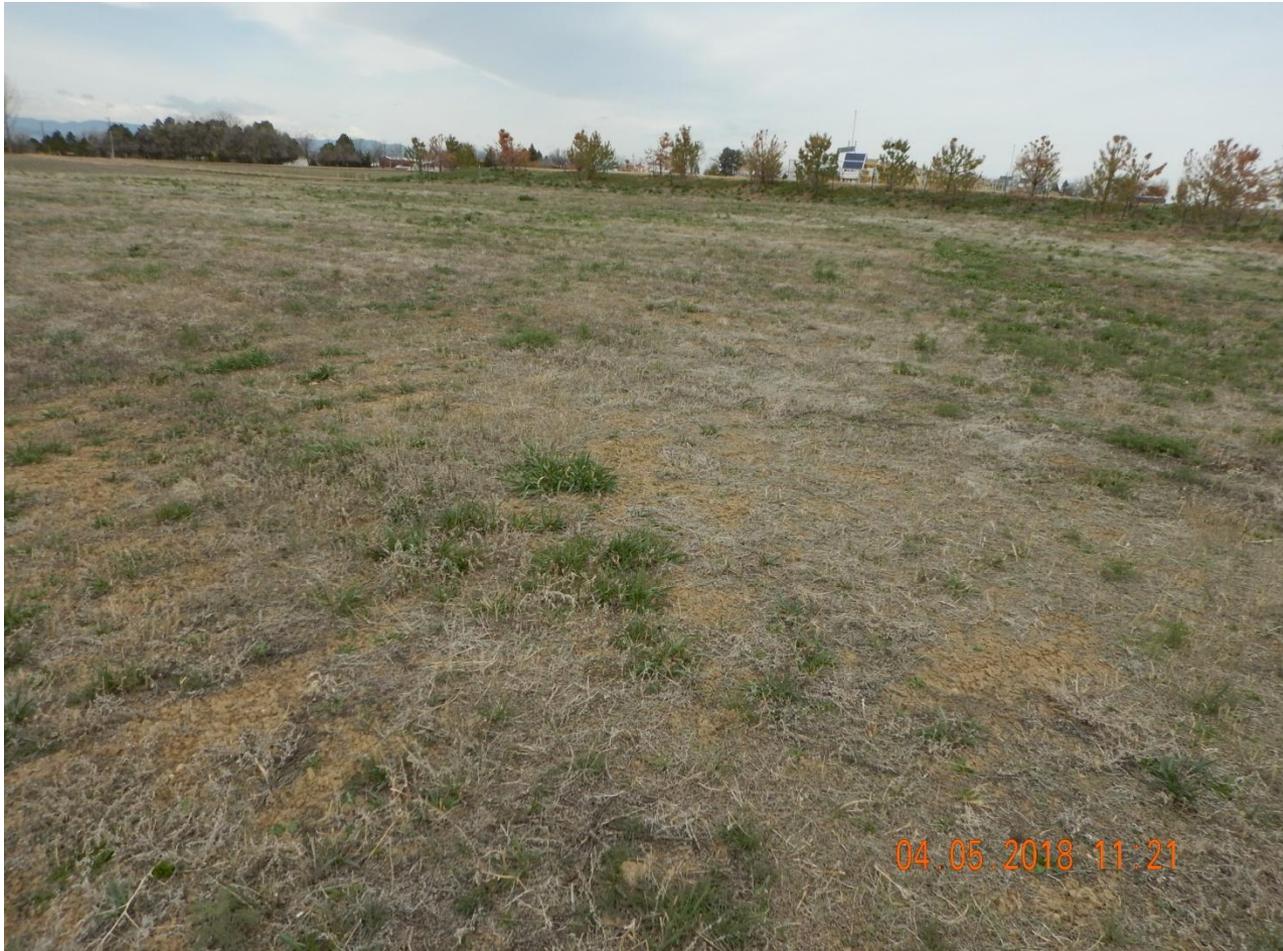
Photo 9. Photo taken from the southwestern location on April 5, 2018, facing Northwest. Photo illustrates the lack of desirable germination establishment which is not reflective of reference areas. See Photo 14 of a reference area vegetative photo.

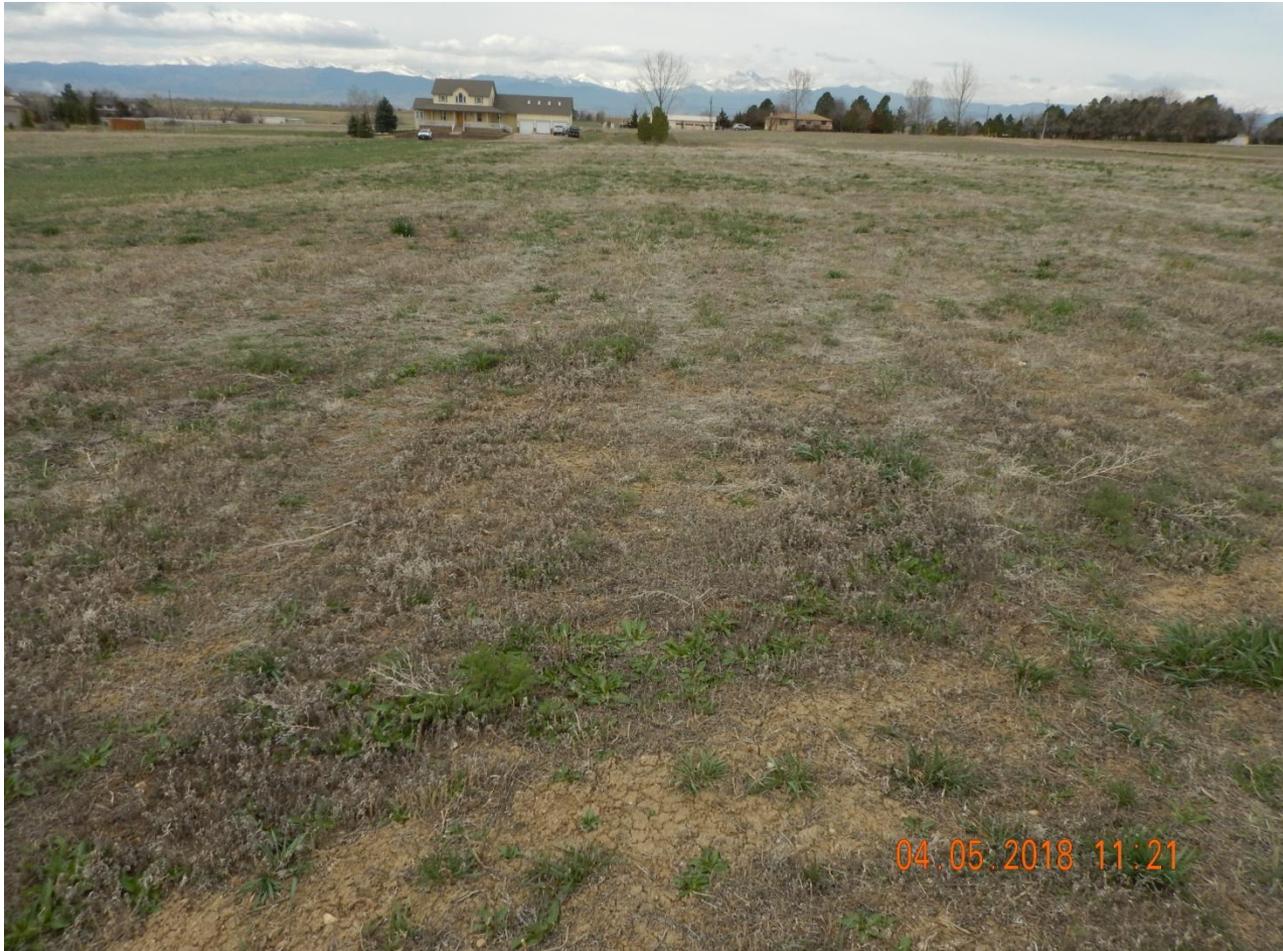
Photo 10. Photo taken from the southwestern location on April 5, 2018, facing West. See comments under Photo 9.

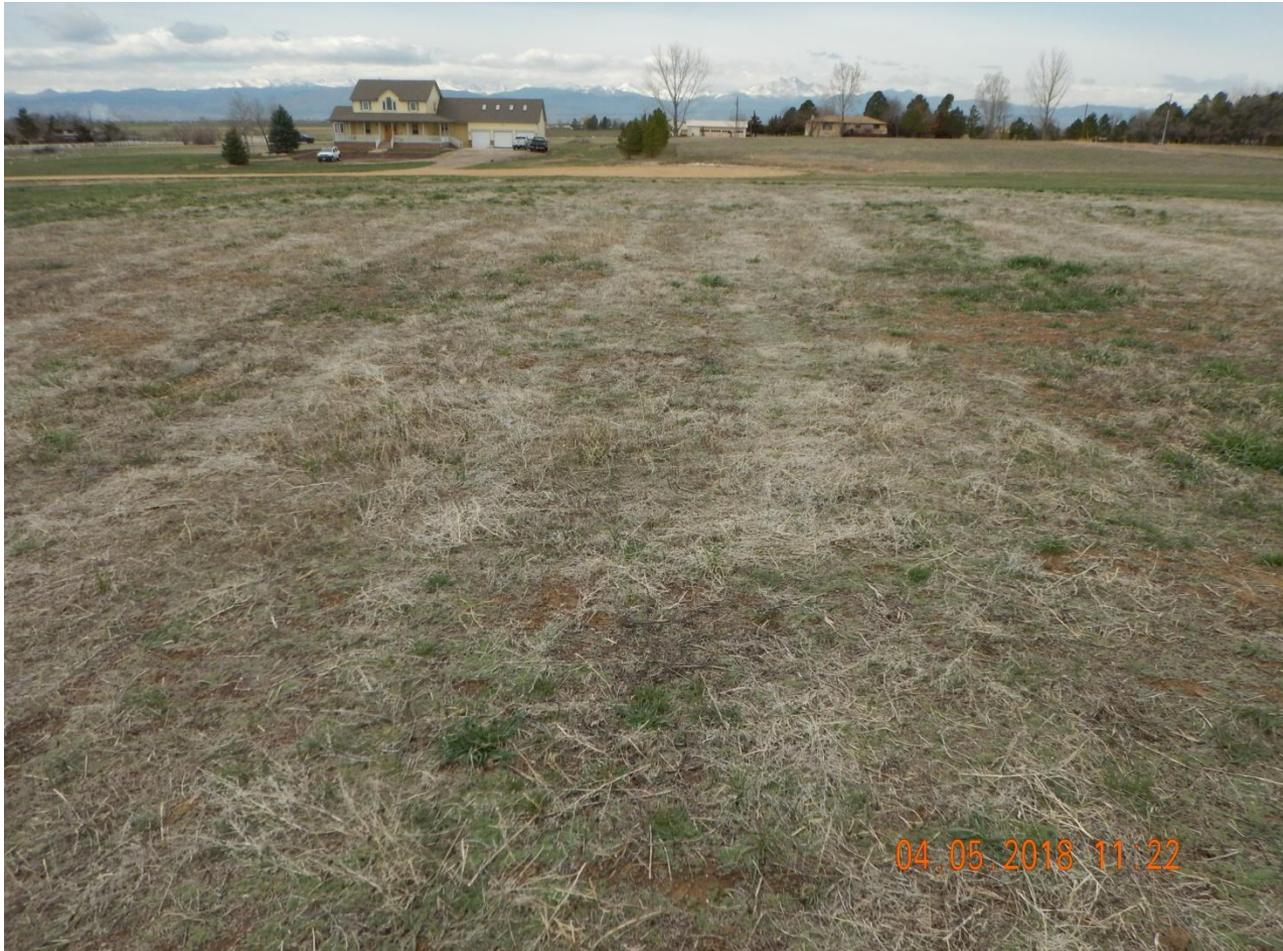
Photo 11. Photo taken from the southwest location on April 5, 2018, facing West. See comments under Photo 9.

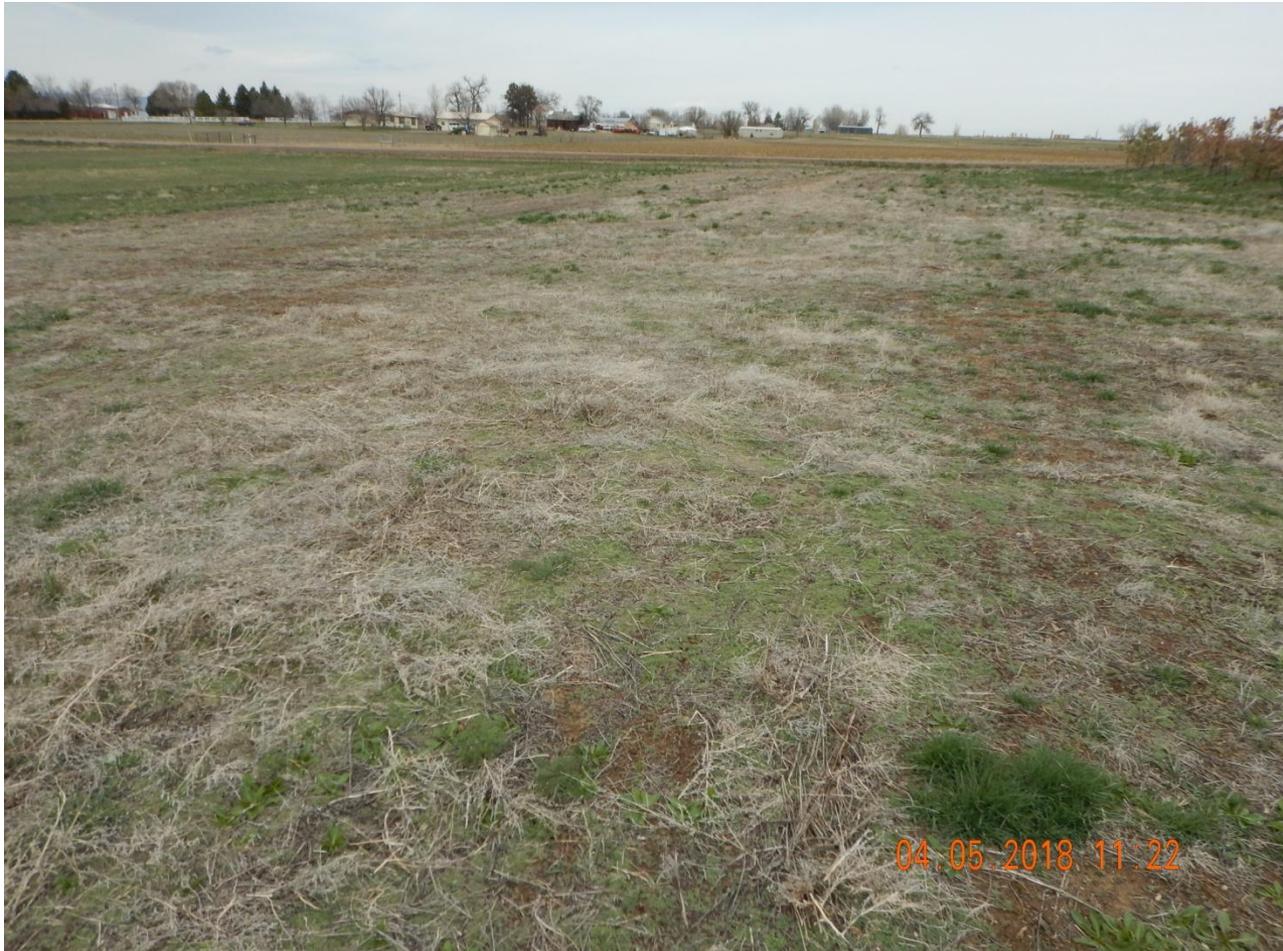
Photo 12. Photo taken from the southwest location on April 5, 2018, facing North. See comments under Photo 9.

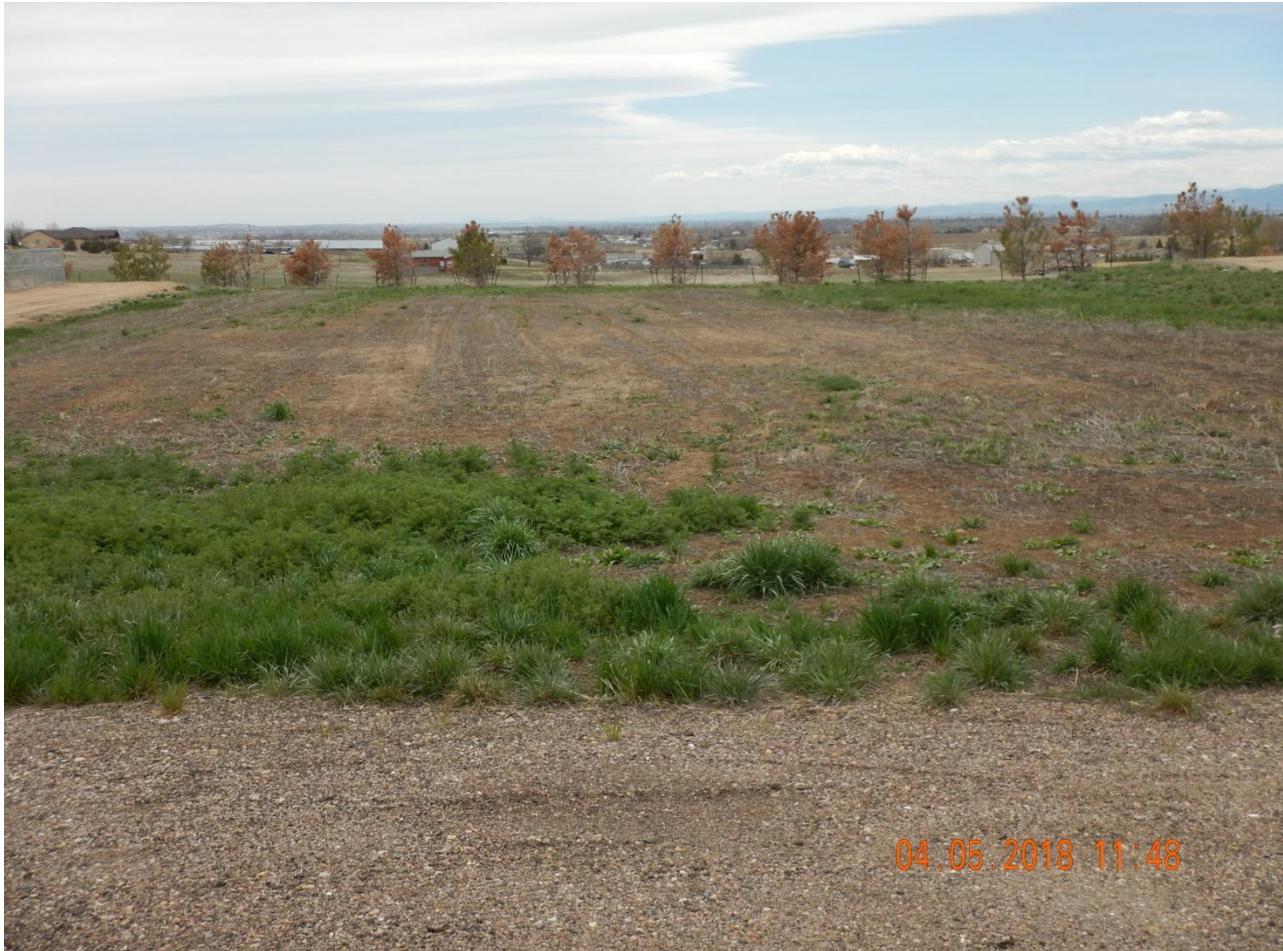
Photo 13. Photo taken from the central location on April 5, 2018, facing South. See comments under Photo 9.

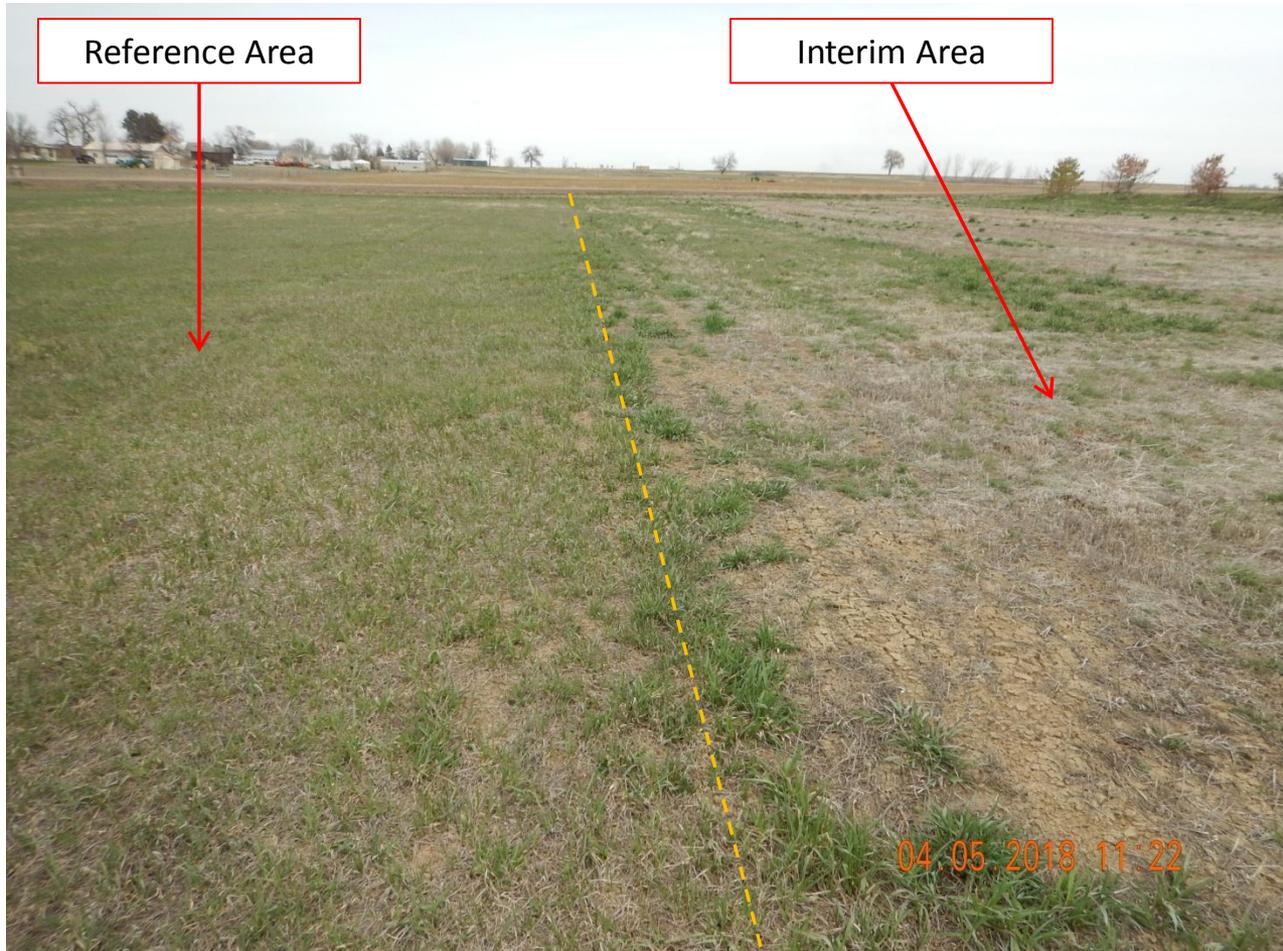
Photo 14. Reference photo taken from the western location on April 5, 2018, facing North. Photo illustrates that interim areas are not reflective of reference area vegetation.
