Construction and Stormwater Inspection

April 5, 2018

Operator: CAPTIVA ENERGY PARTNERS LLC- #10658

Inspection Photos
Location Name: STILLROVEN FARM /PAD
Location ID: 452112

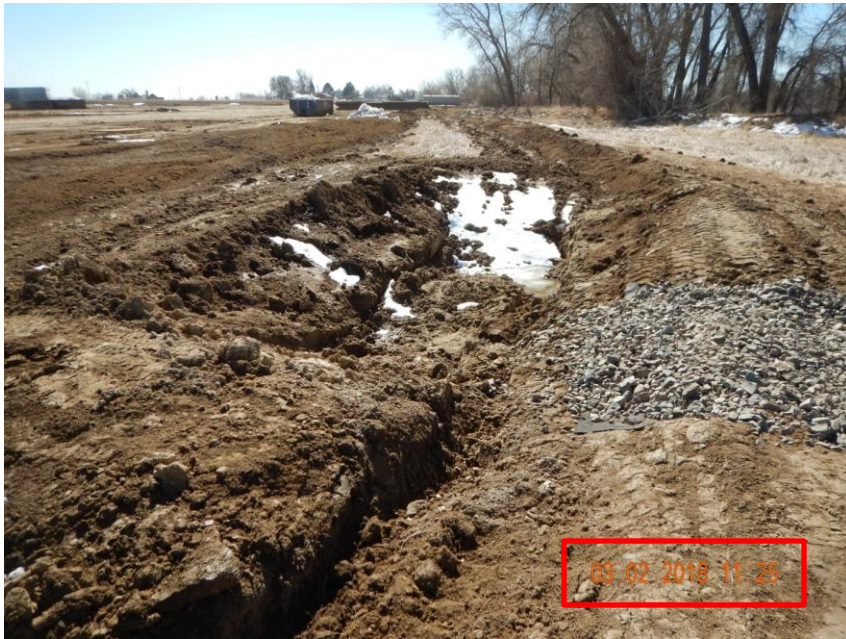
Photo 1. Photo taken from the northwestern well location on March 2, 2018, facing South. Operator has not installed the sediment trap in accordance with good engineering practices per Rule 1002.f.(2). Sediment trap side slopes are not stabilized, left unconsolidated. Sediment traps should not mix with ground water.

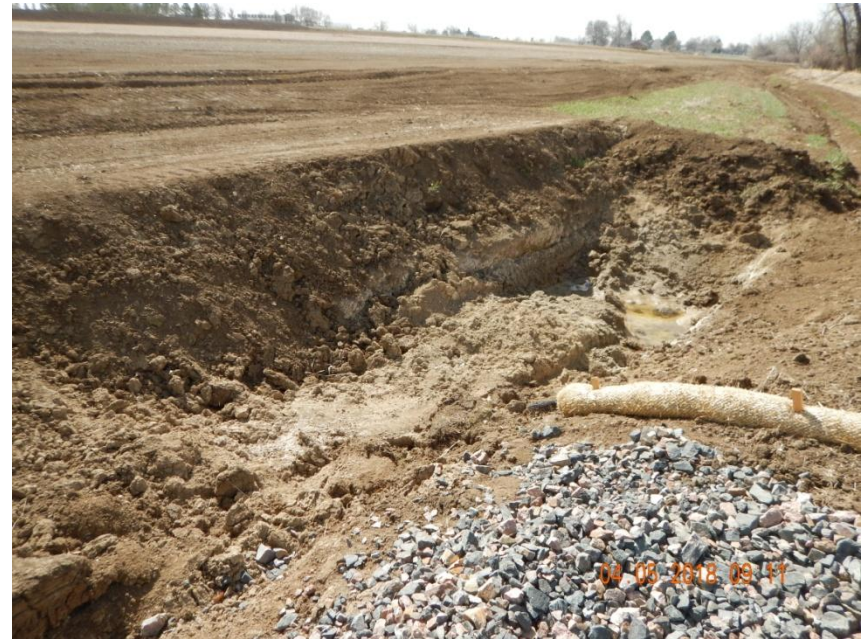
Photo 2. Photo taken from the northwestern well location on April 5, 2018, facing South. Appears the Operator built embankment berms and installed straw wattles, but did not stabilize the side slopes. Operator has encountered ground water which should not occur when installing a sediment trap.

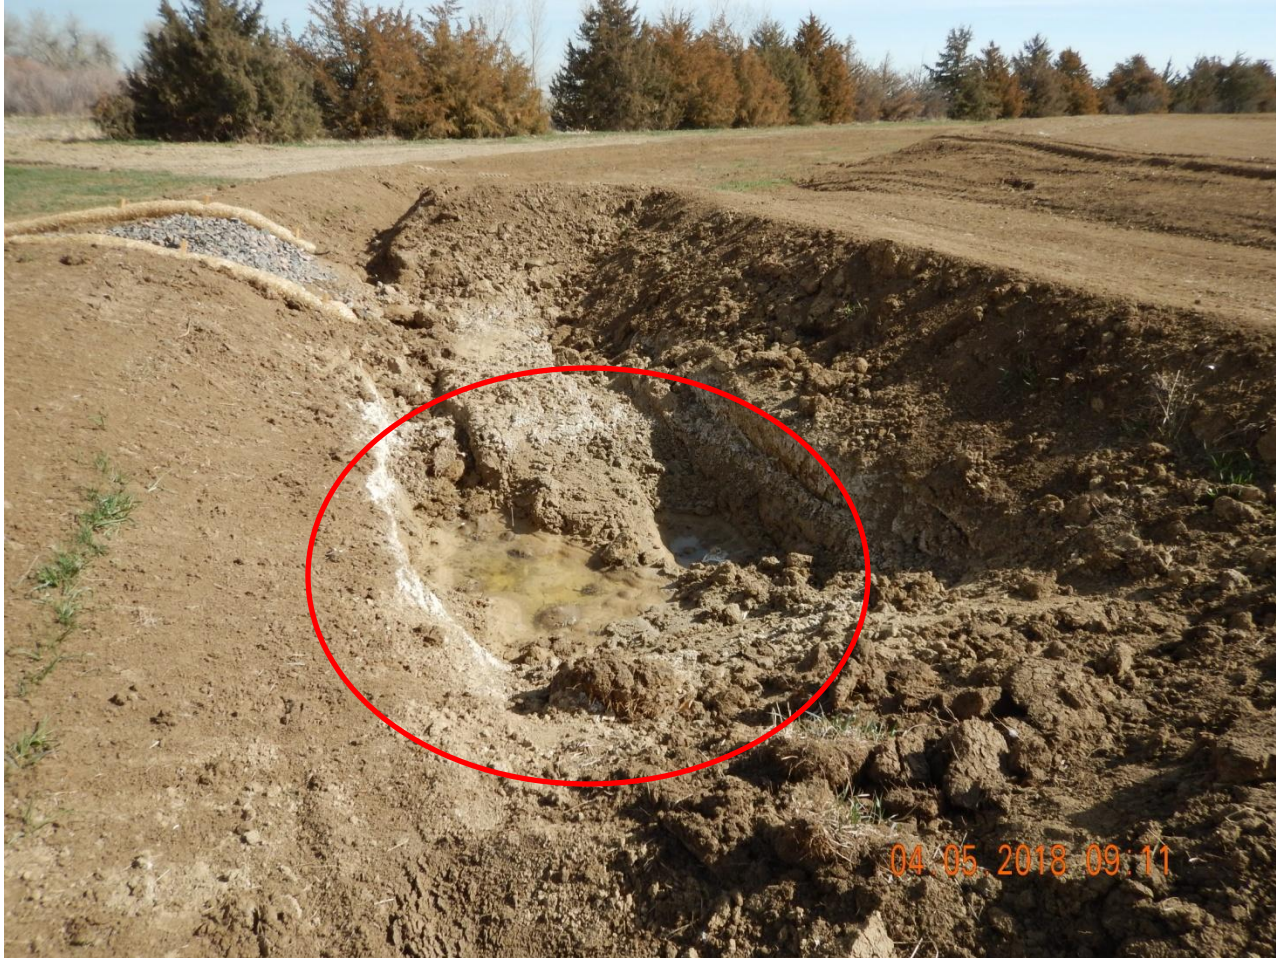
Photo 3. Photo taken from the northwestern well location on April 5, 2018, facing North. Photo illustrates unconsolidated side slopes and Operator has encountered ground water which should not occur when installing a sediment trap.

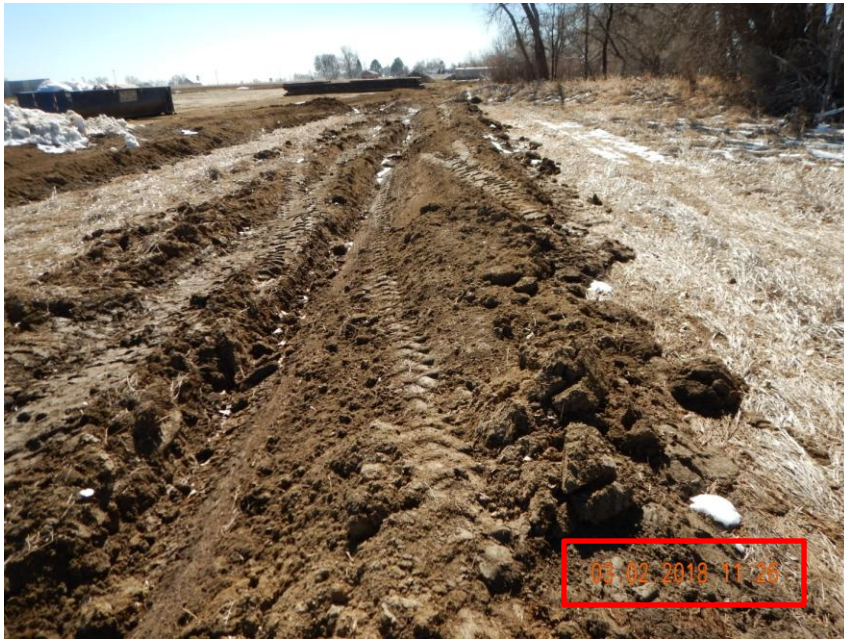
Photo 4. Photo taken from the western well location on March 2, 2018, facing South. The berm BMP along the western location has not been properly stabilized. An unconsolidated berm BMP is not a proper functioning BMP, as the unconsolidated material becomes a source of potential pollution itself. Perimeter of the well location is approximately 60 feet from the adjacent reservoir.

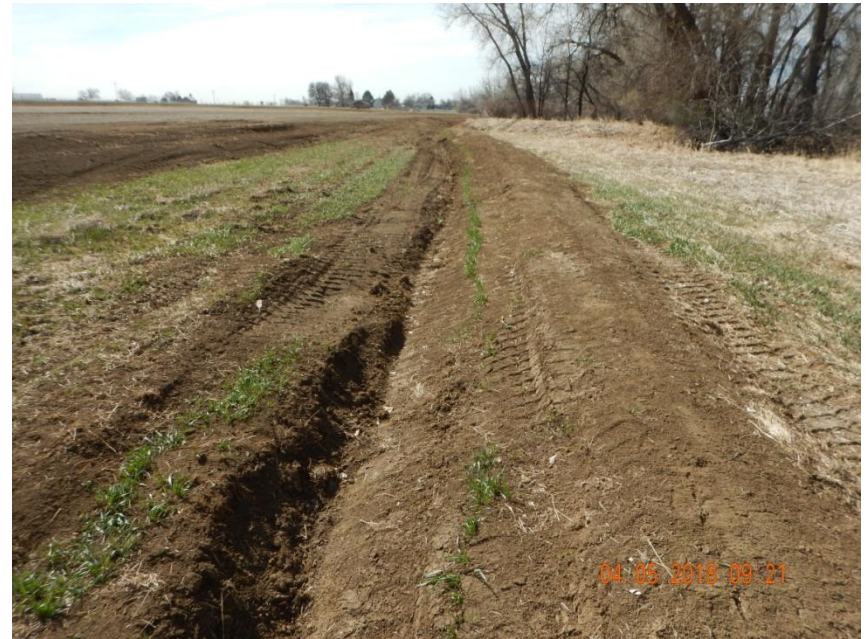
Photo 5. Photo taken from the western well location on April 5, 2018, facing South. Appears the Operator has properly stabilized the western berm BMP.

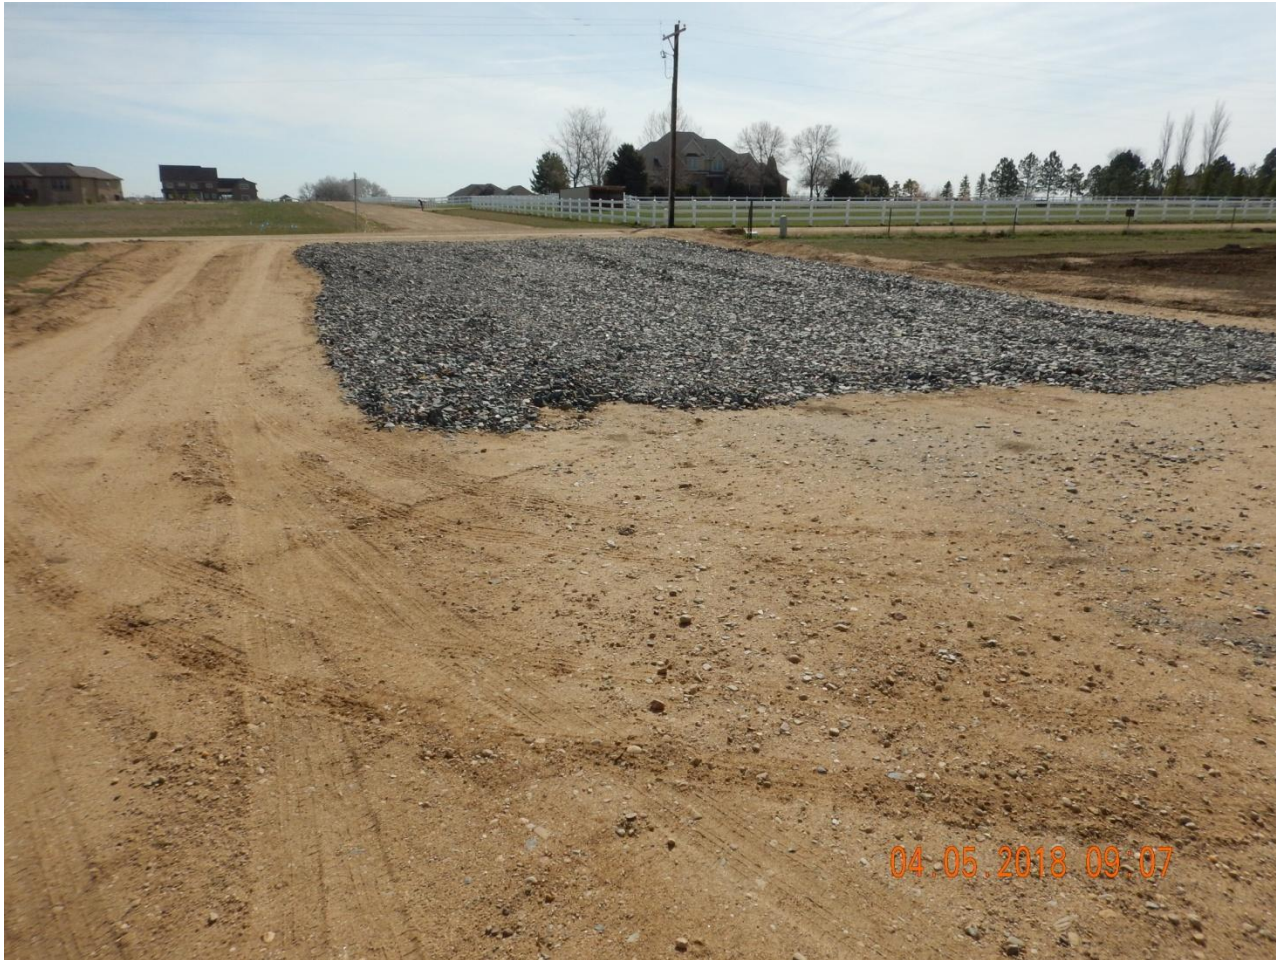
Photo 6. Photo taken from the entrance of the location on April 5, 2018, facing East. Appears the Operator has installed a tracking pad device along a portion of the location entrance. Appears there is a path along the tracking pad device with no BMPs.
