# Inspection Photos

04/10/2018

Operator: BEREN CORPORATION - 7800

Inspection Doc. Number: 682503220

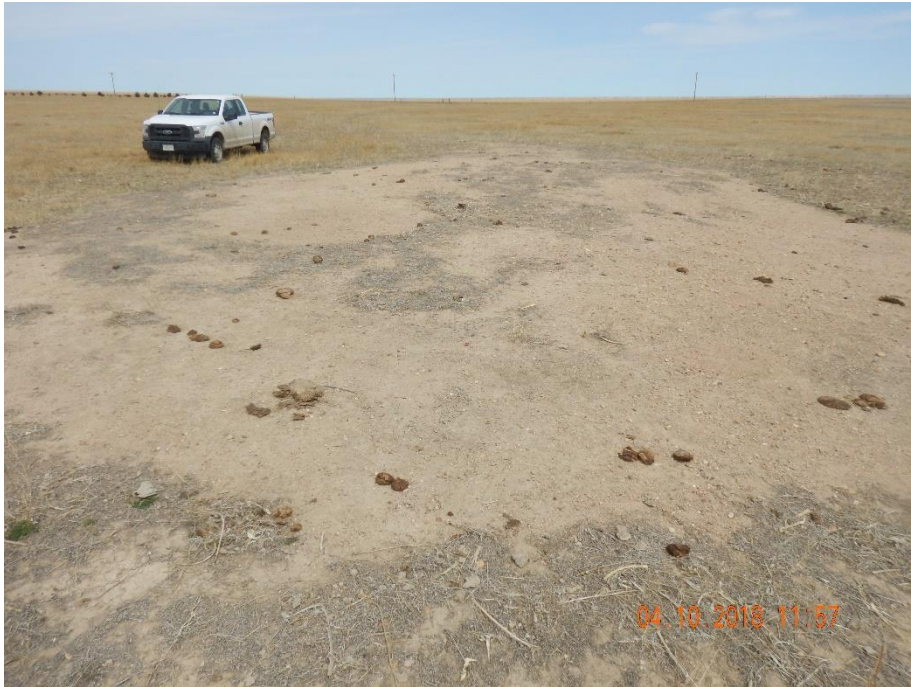
**Photo 1:** Photo taken from the well location, facing north. Photo shows well location remains predominantly bare and exposed soil. This location does not meet COGCC reclamation requirements and standards.

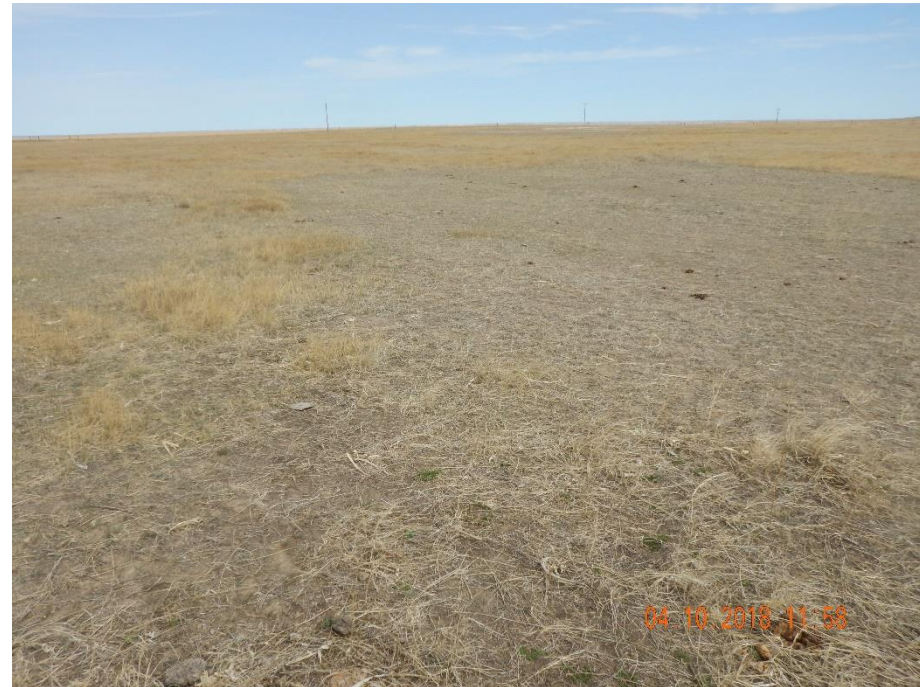
**Photo 2:** Photo taken from the well location, facing northeast. Photo shows areas where there appears to have been additional disturbance. Vegetation here appears to be stunted and/or undesirable species.

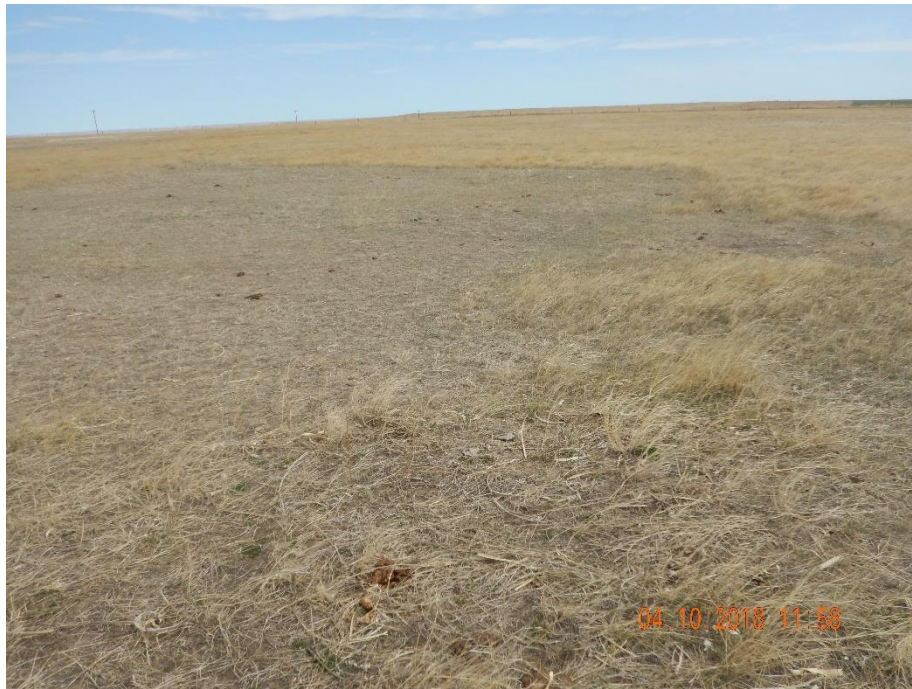
**Photo 3:** Photo taken from the well location, facing east. Photo shows areas where there appears to have been additional disturbance. Vegetation here appears to be stunted and/or undesirable species.

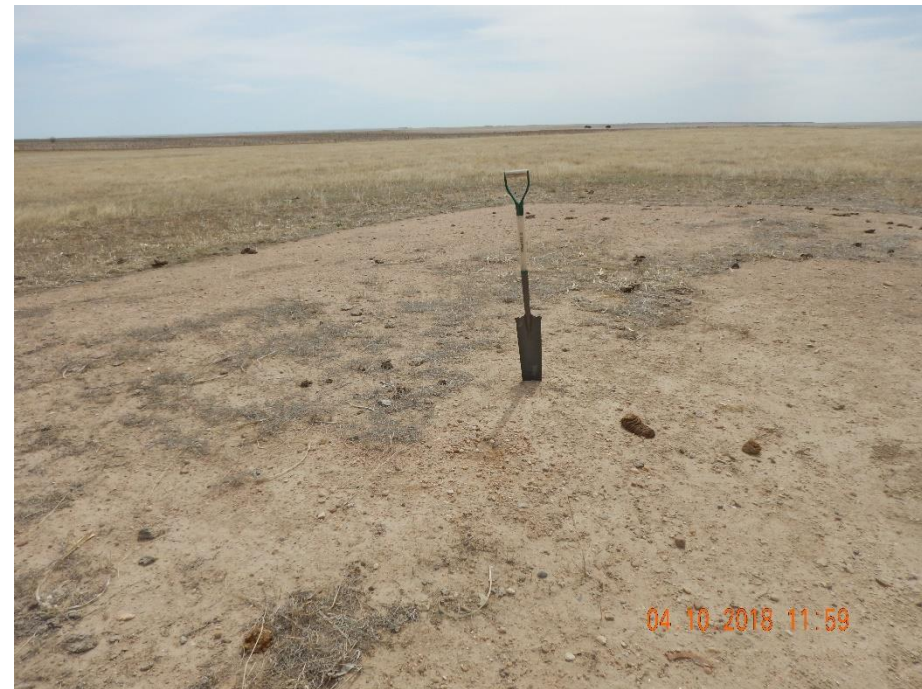
**Photo 4:** Photo taken from the well location, facing north. Photo shows inspector tested the location for compaction concerns; inspector was only able to penetrate the first few inches of the disturbance area. It does not appear as though compaction alleviation has been conducted in accordance to 1004.a

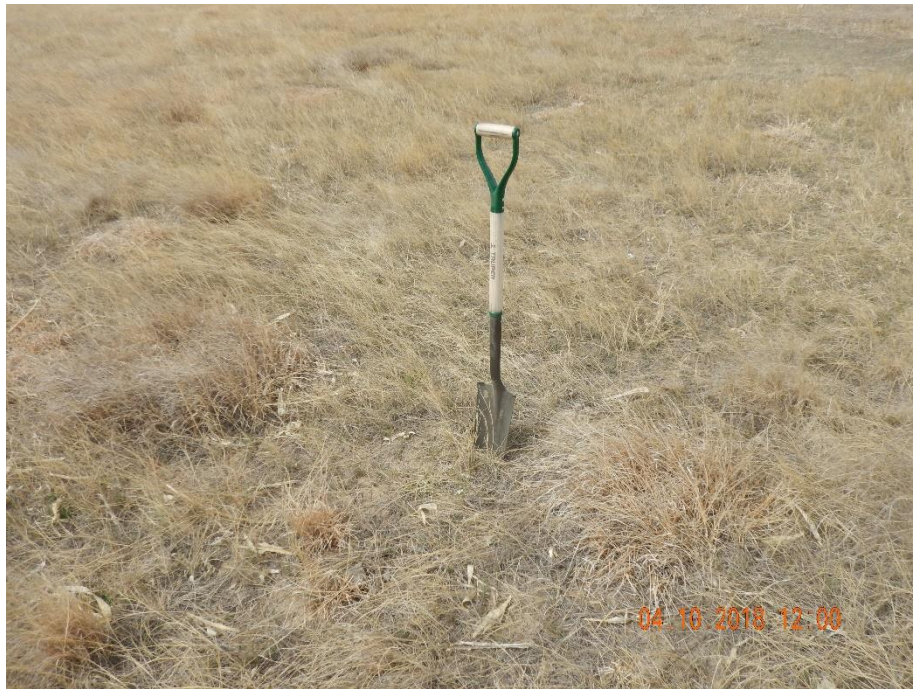
**Photo 5:** Photo taken from the adjacent reference area. Photo shows inspector tested the reference area compare/contrast to the disturbance for compaction concerns. Photo shows inspector was able to penetrate the top 8 inches of soil with relative ease.

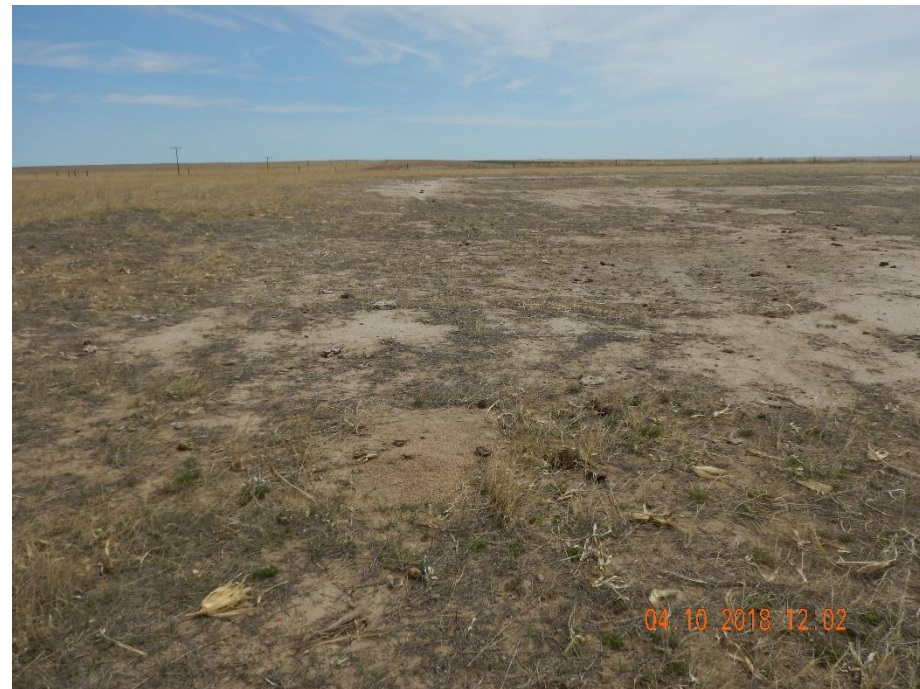
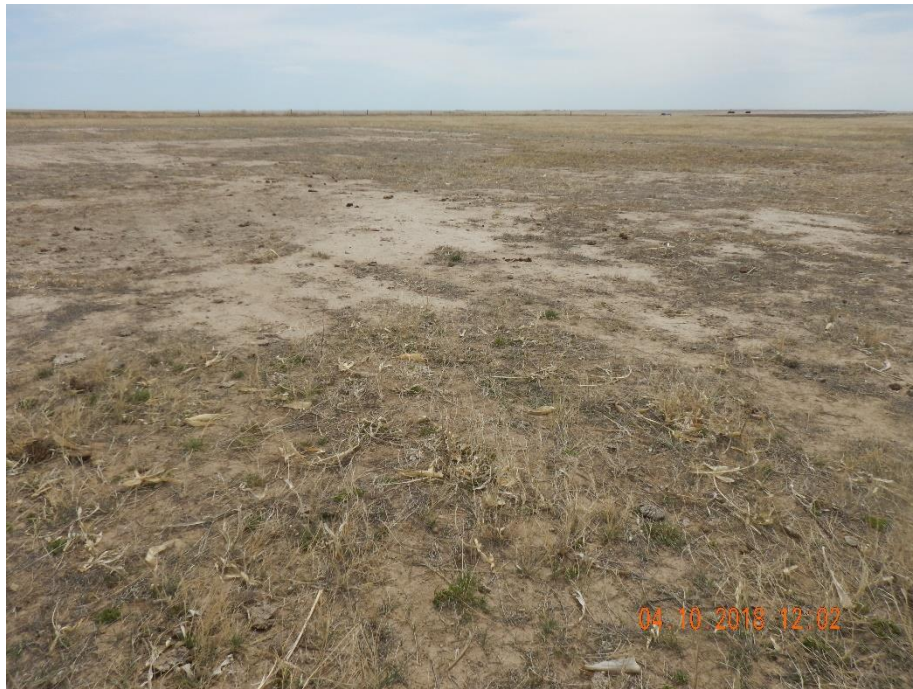
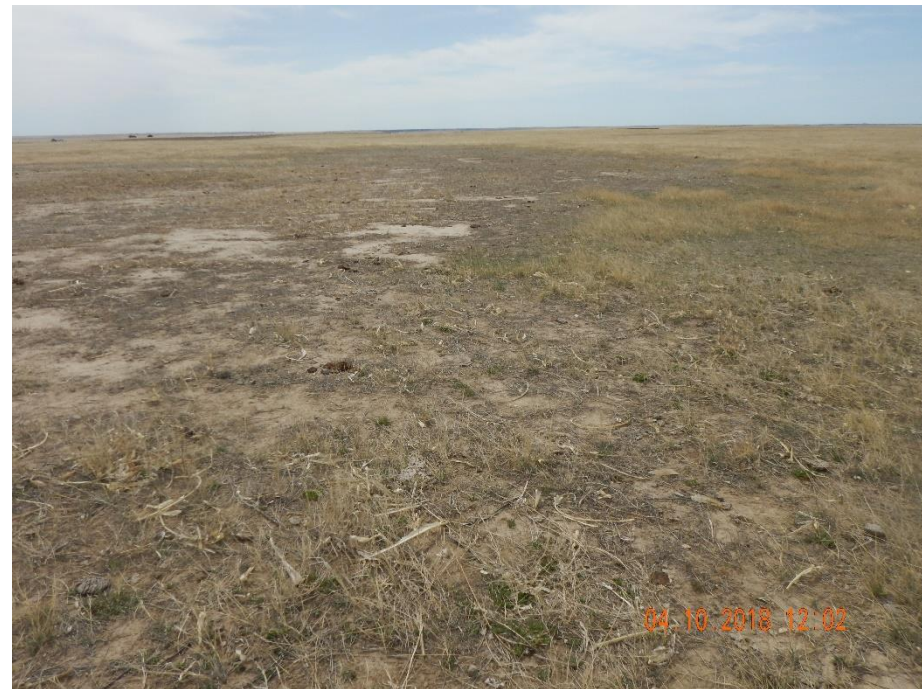
**Photo 6:** Photo taken from the northwest corner of the former pit locations, facing east. Photos 6-8 provide an overview of the pit locations from east to south. Photos show pit locations do not meet 1004.a reclamation requirements and standards. Area of the pits remains predominantly undesirable weedy plant species, or bare and exposed soil.

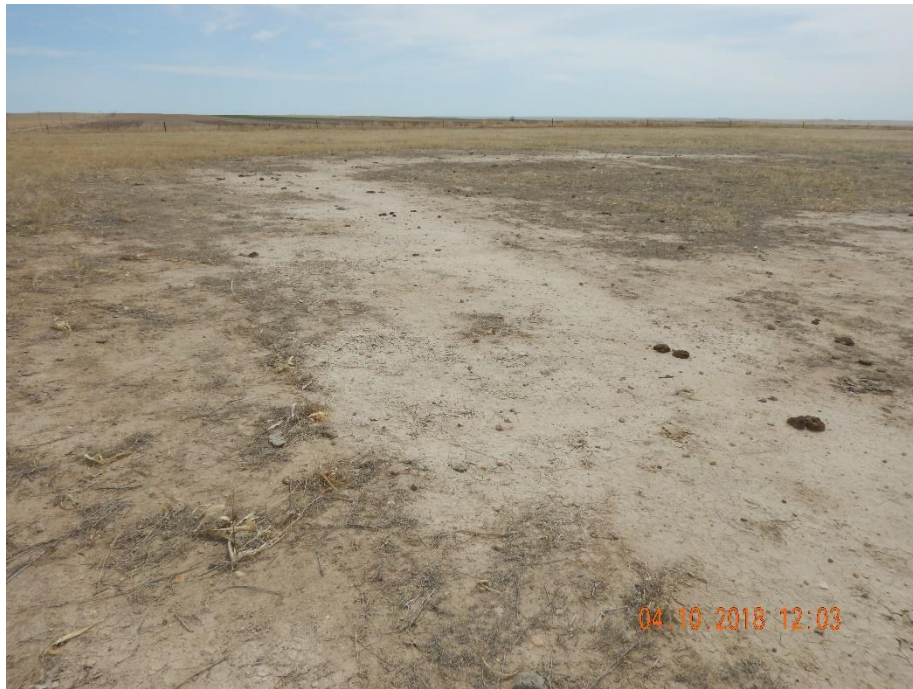
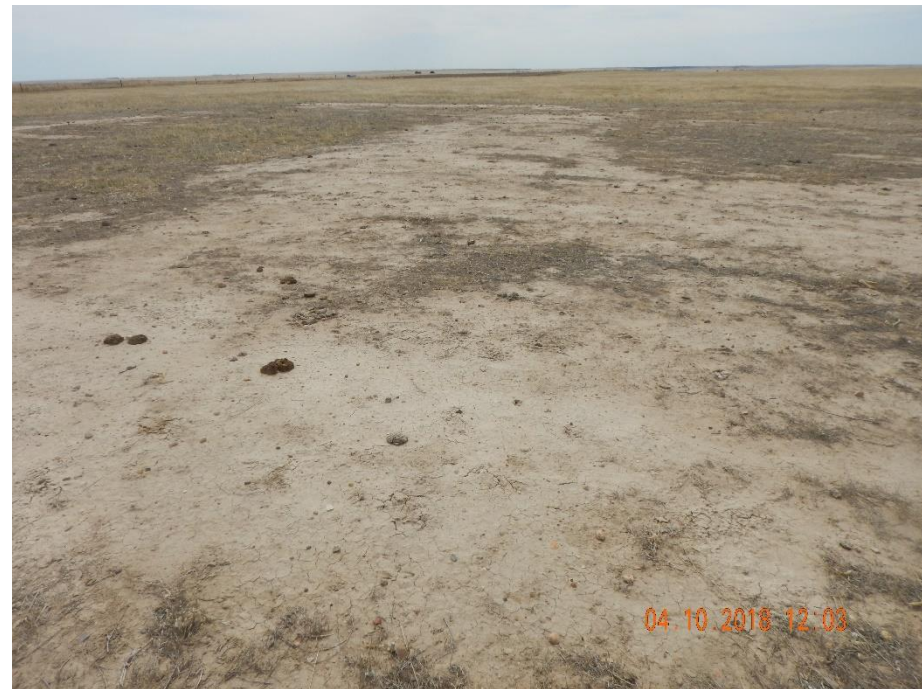
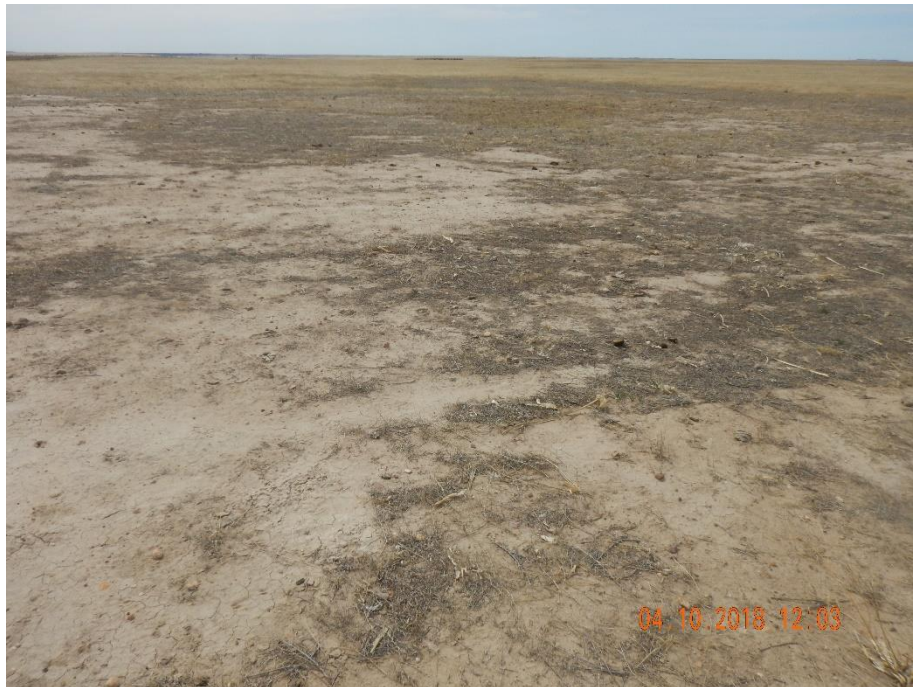
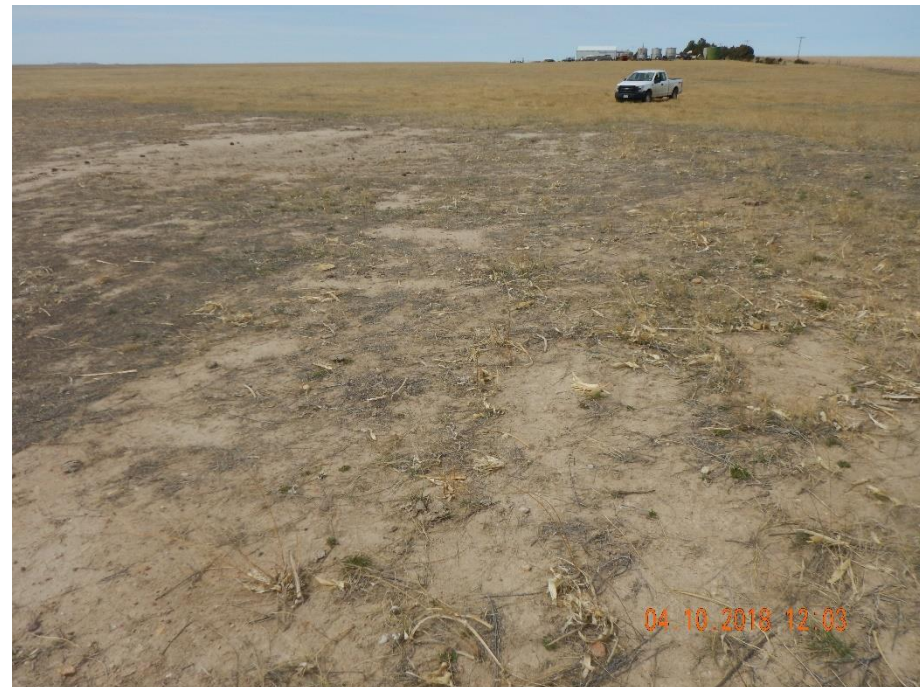
**Photo 9:** Photo taken from the northern end of the former pit locations, facing east. Photos 9-12 provide an overview of the pit locations from east to south to west. Photos show pit locations do not meet 1004.a reclamation requirements and standards. Area of the pits remains predominantly undesirable weedy plant species, or bare and exposed soil.

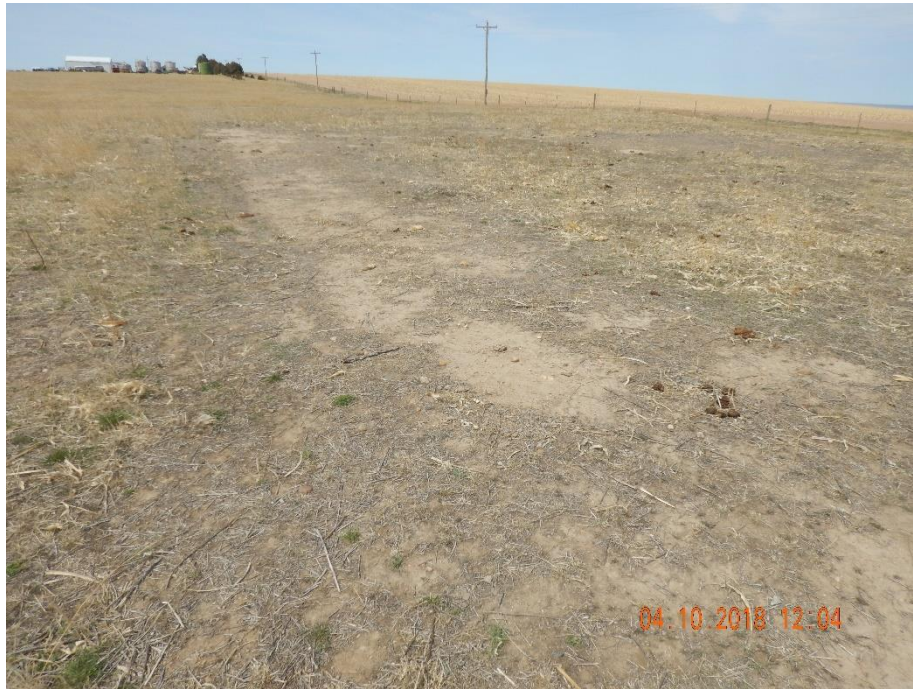
**Photo 13:** Photo taken from the southeast end of the former tank battery location, facing west. Photos shows facility location does not meet 1004.a reclamation requirements and standards. Area of the facility remains predominantly undesirable weedy plant species, or bare and exposed soil.

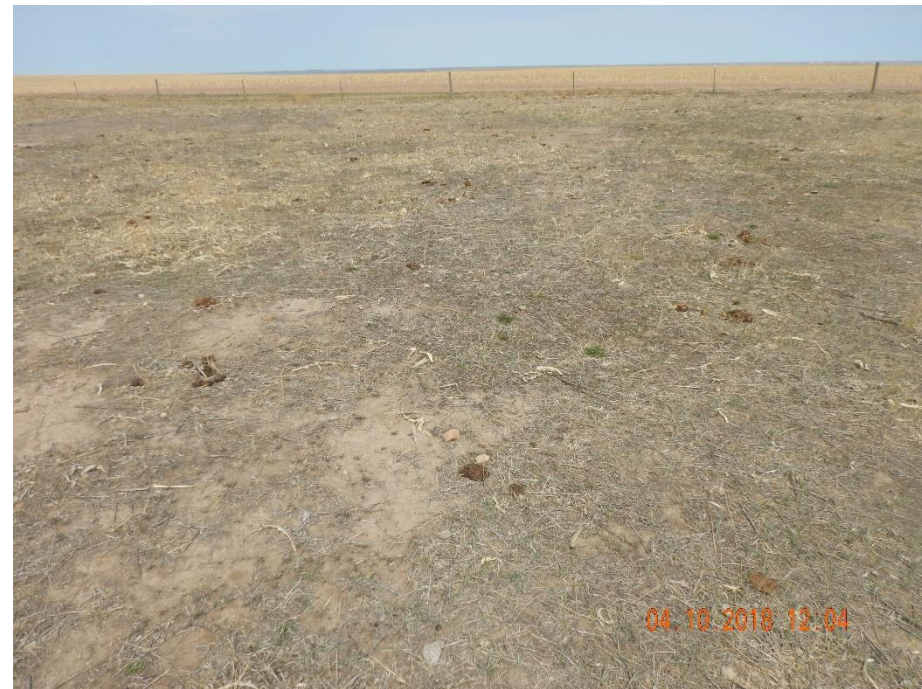
**Photo 14:** Photo taken from the southeast end of the former tank battery location, facing north. Photos shows facility location does not meet 1004.a reclamation requirements and standards. Area of the facility remains predominantly undesirable weedy plant species, or bare and exposed soil.

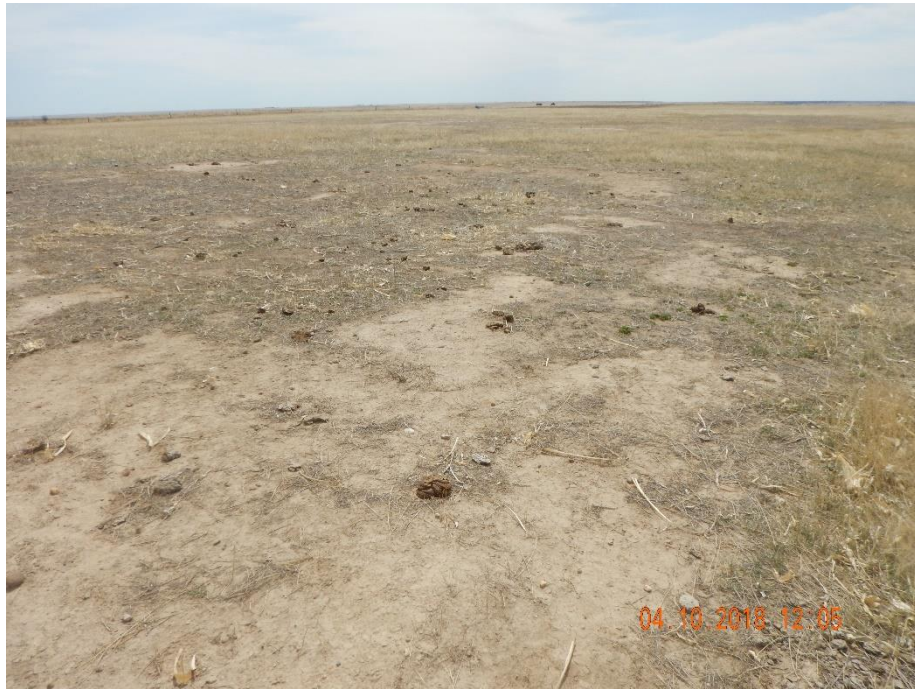
**Photo 15:** Photo taken from the northwest end of the former tank battery location, facing south. Photos shows facility location does not meet 1004.a reclamation requirements and standards. Area of the facility remains predominantly undesirable weedy plant species, or bare and exposed soil.

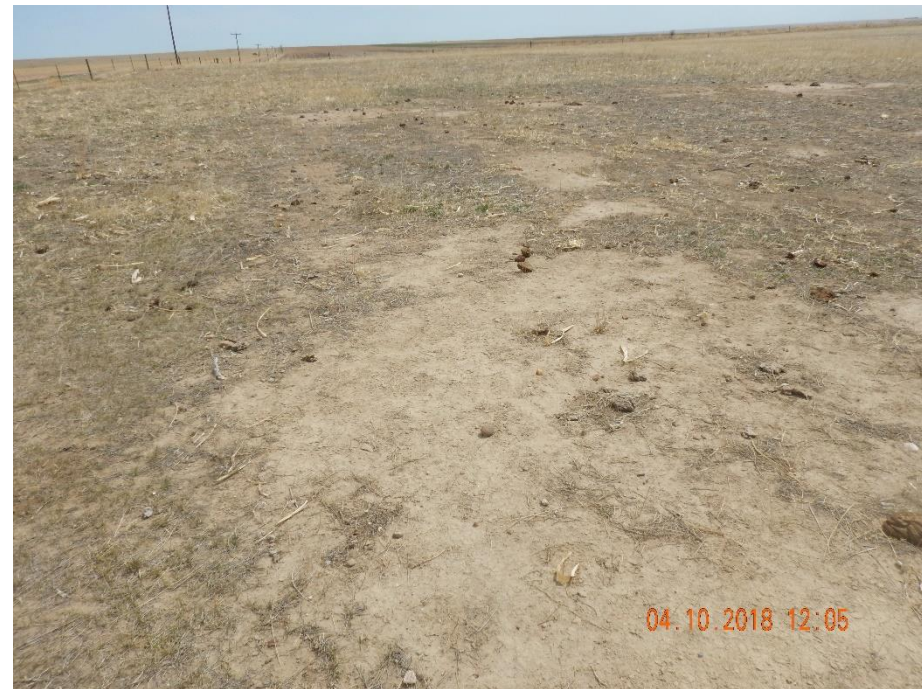
**Photo 16:** Photo taken from the northwest end of the former tank battery location, facing east. Photos shows facility location does not meet 1004.a reclamation requirements and standards. Area of the facility remains predominantly undesirable weedy plant species, or bare and exposed soil.

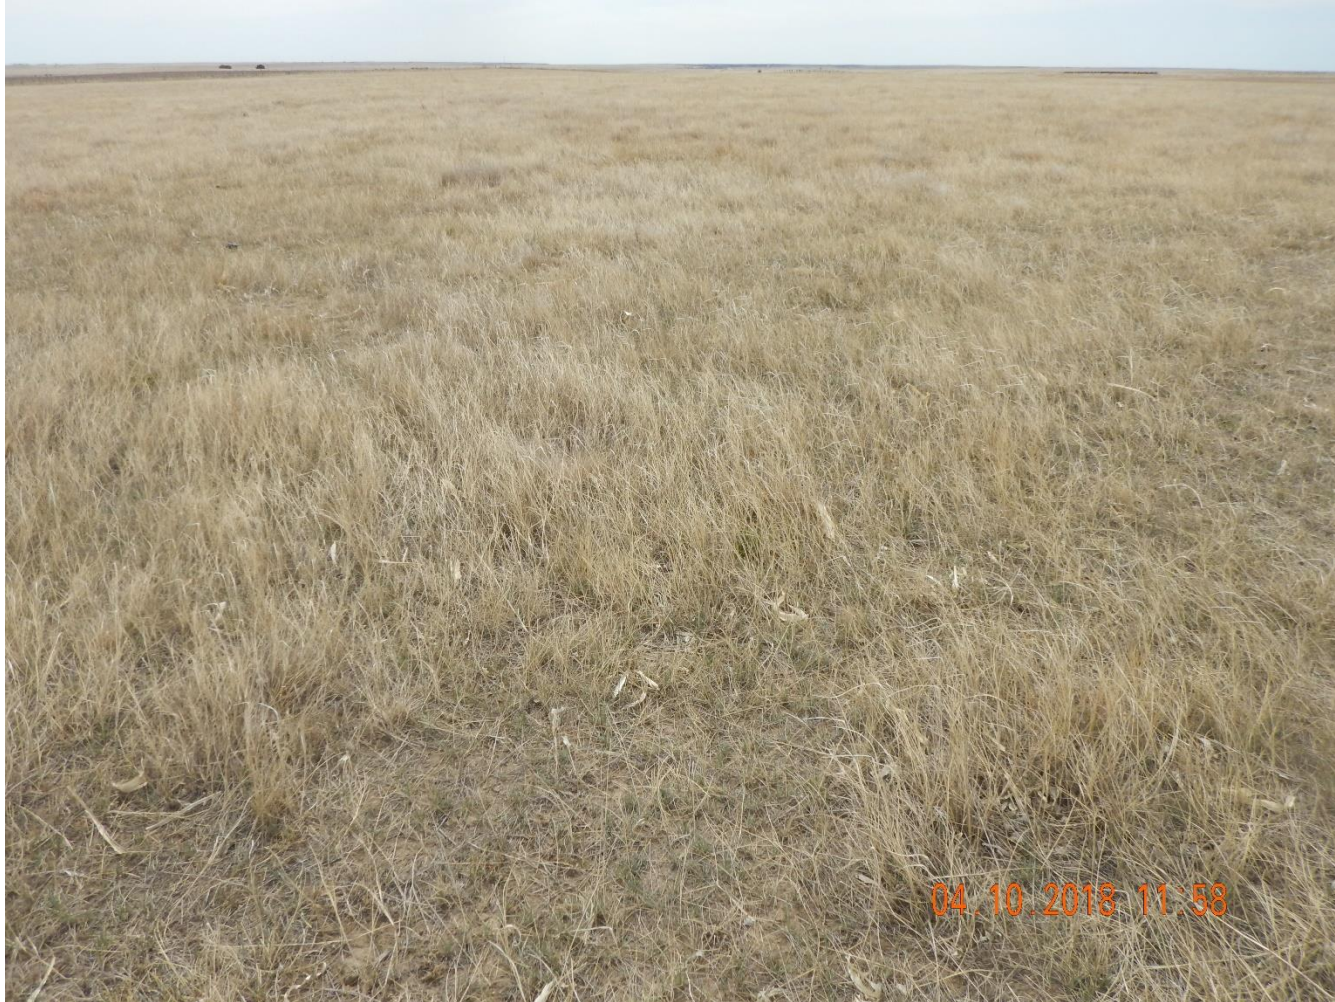
**Photo 17:** Photo taken from the adjacent reference area. Photo shows vegetation. Vegetation seen here predominantly various wheatgrass species, blue and sideoats grama, sand dropseed, etc...

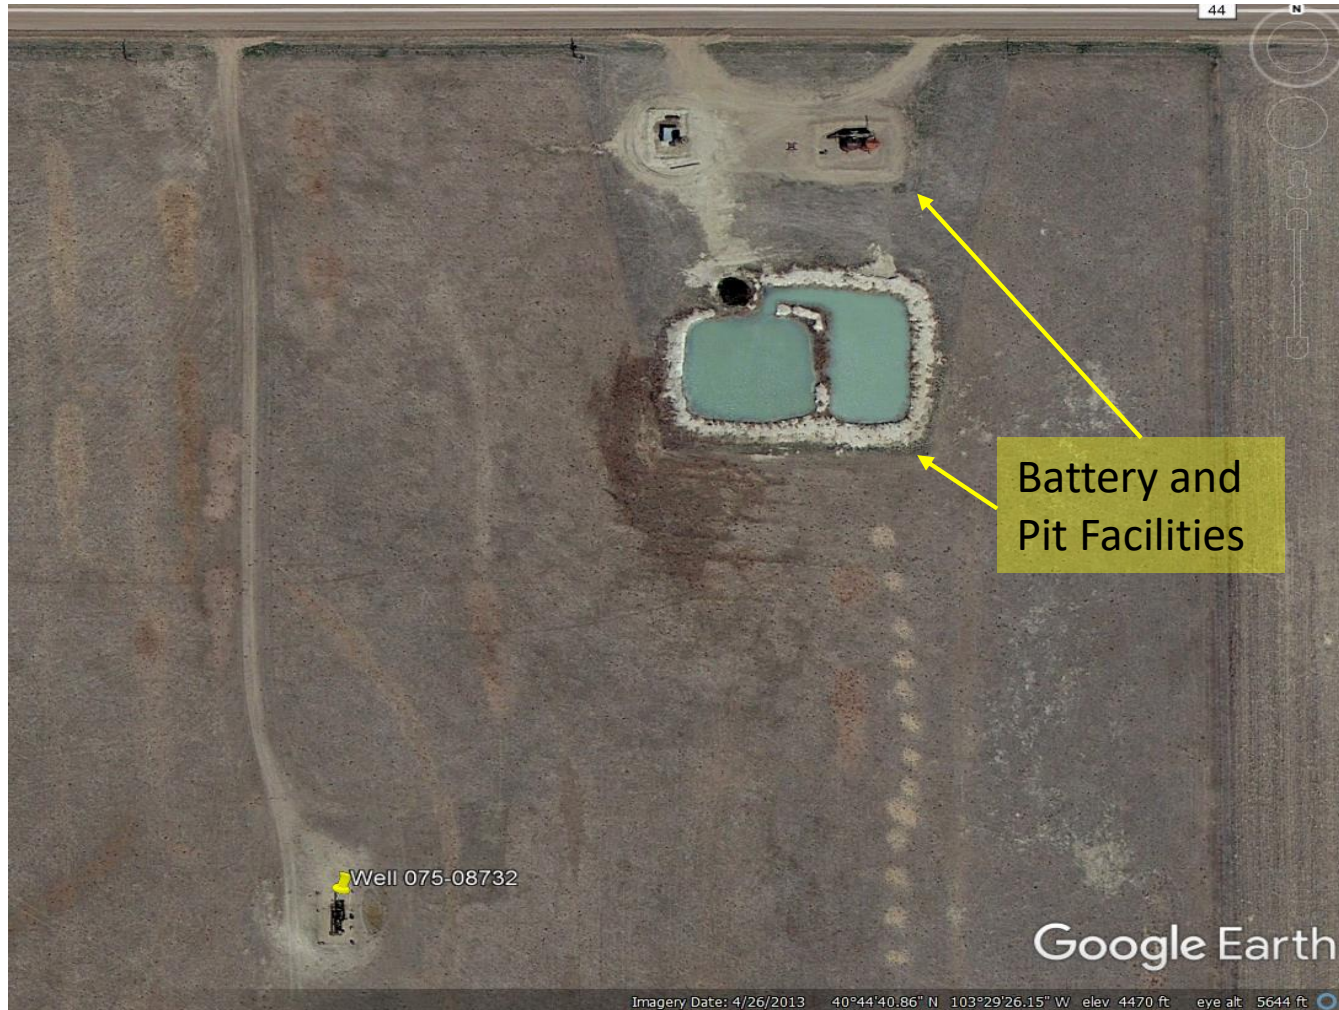
**Photo 18:** 4/26/2013 aerial imagery. 6(s) doc. #400691858 shows well was PA'd 8/29/2014. Photo shows areas of the well, battery and pit facilities prior to plugging and abandonment of the location.

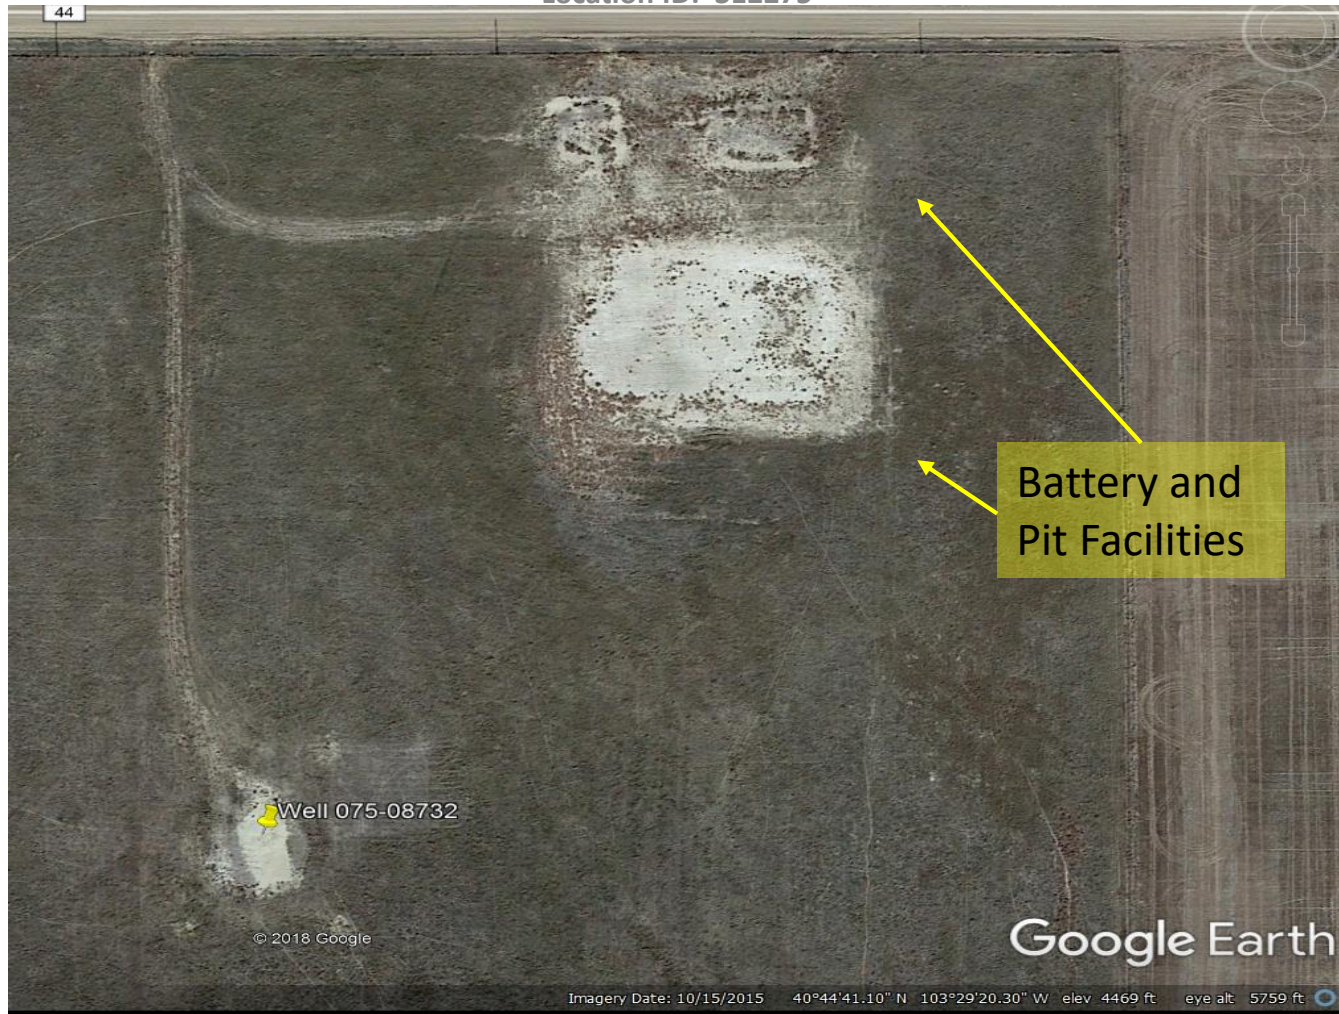
**Photo 19:** Most current available aerial imagery (10/15/2015). Photo shows areas of the well, battery and pit facilities after plugging and abandonment of the location. Photo also shows large areas of the location that appear to be predominantly bare and exposed soil.
