Inspection Photos
Location Name: CVR Pad 5-63-32
Location ID: 432011

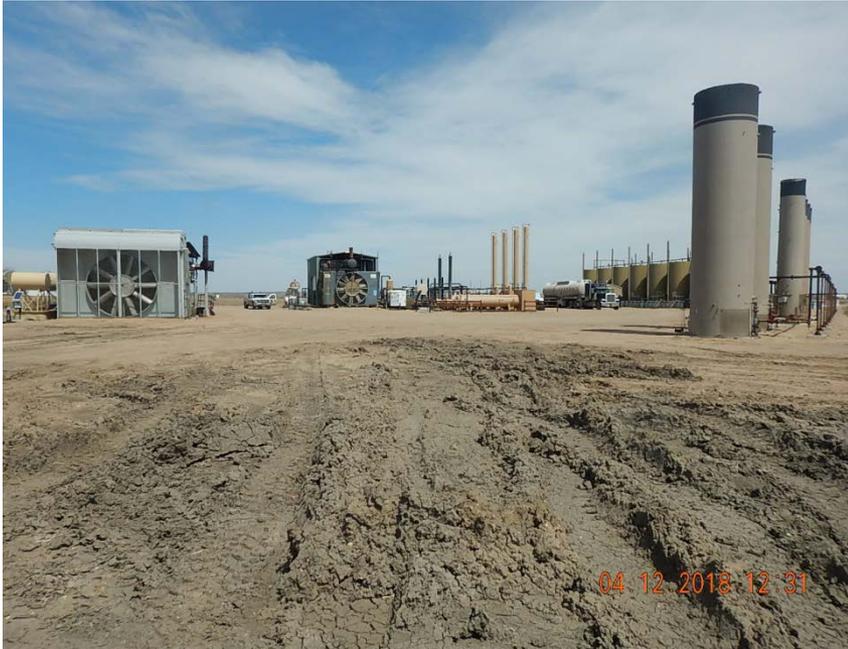
Photo 1: Location, looking NE

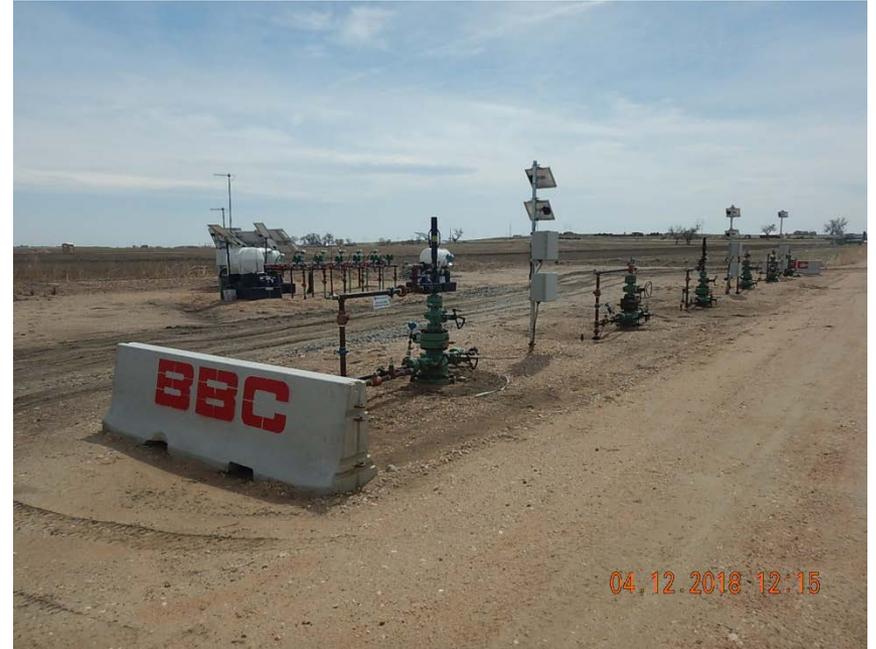
Photo 2: Wellheads, looking SW

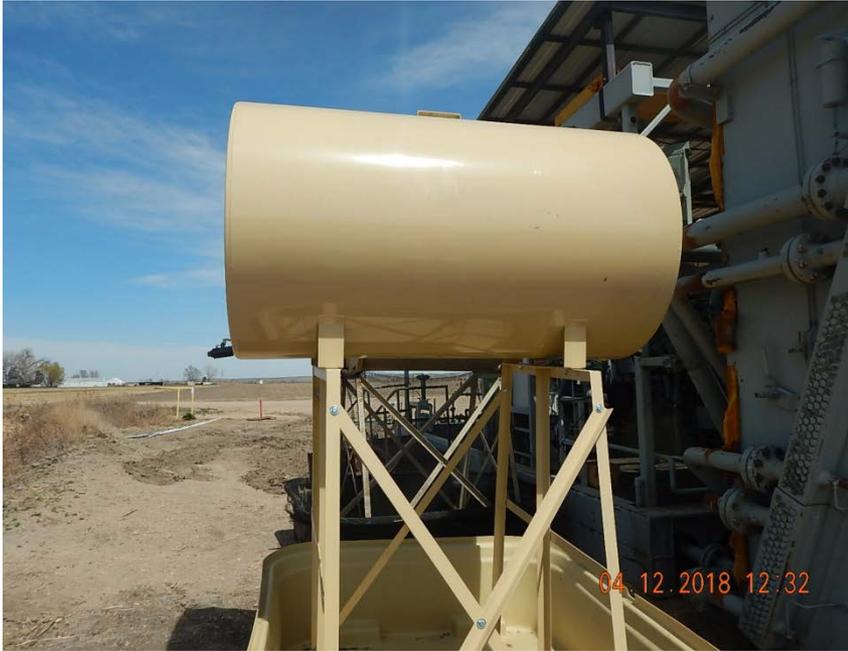
Photo 3: Unlabeled tank

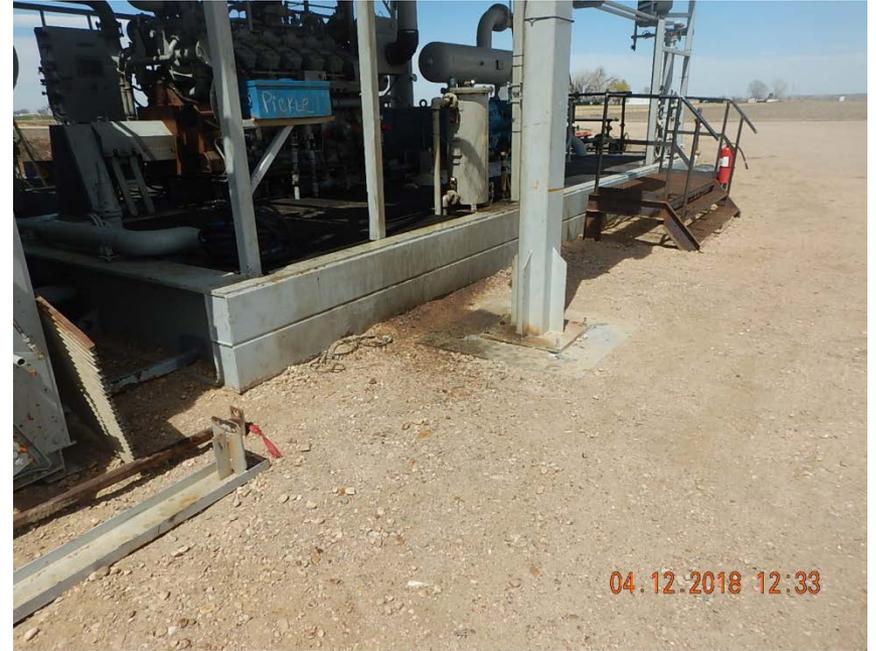
Photo 4: Stained soil at compressor

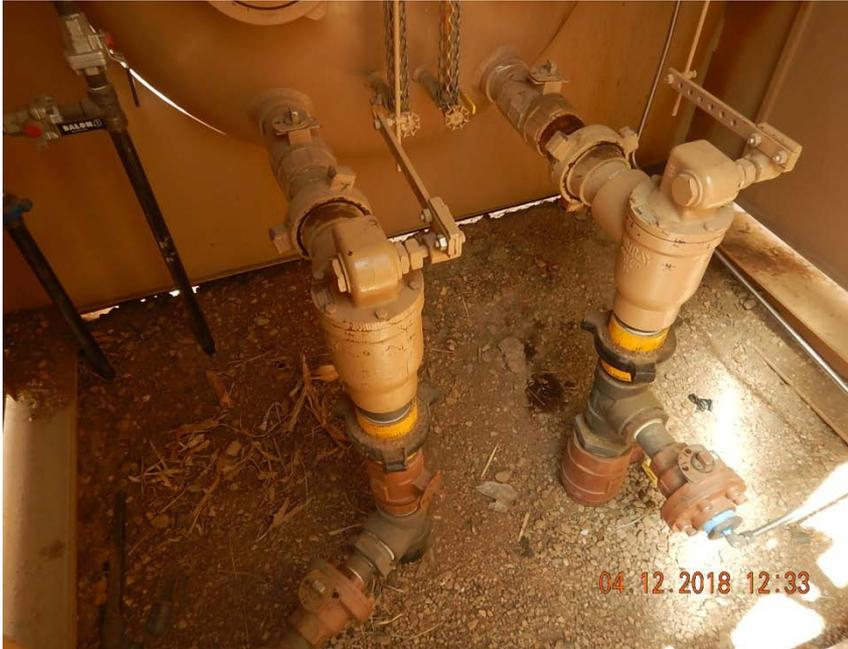
Photo 5: Stained soil in separator house.

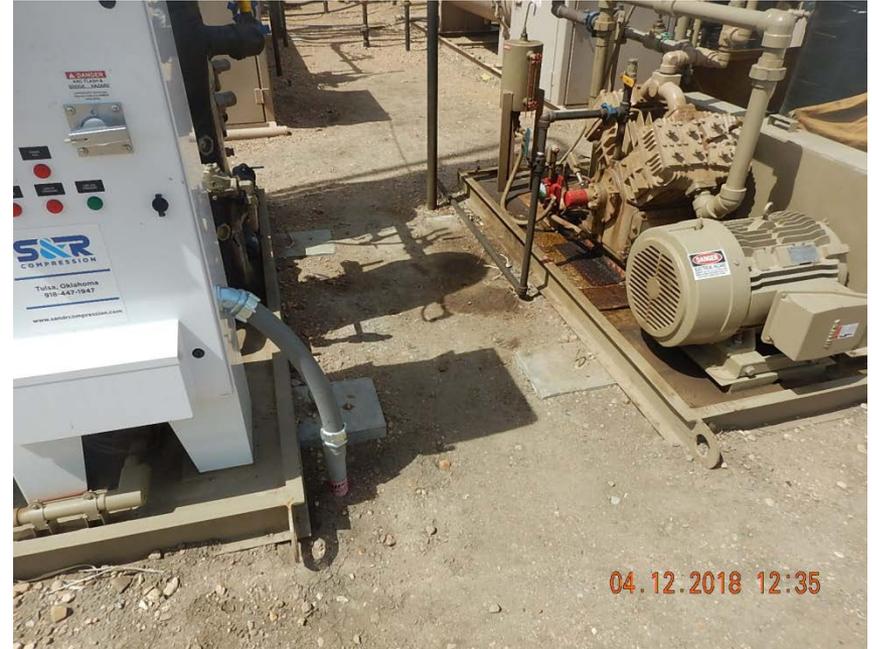
Photo 6: Stained soil at VRUs.

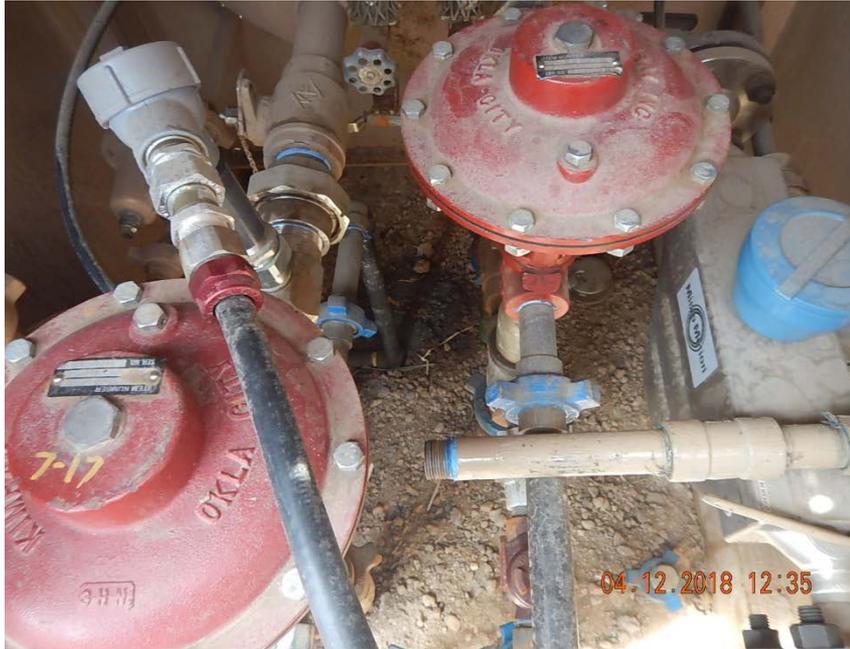
Photo 7: Stained soil in separator house

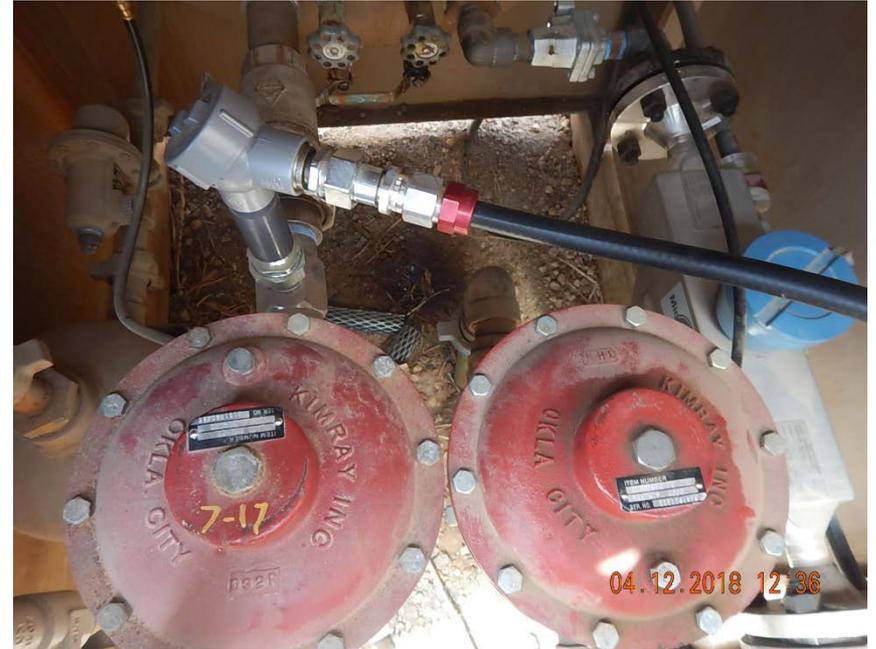
Photo 8: Stained soil in separator house

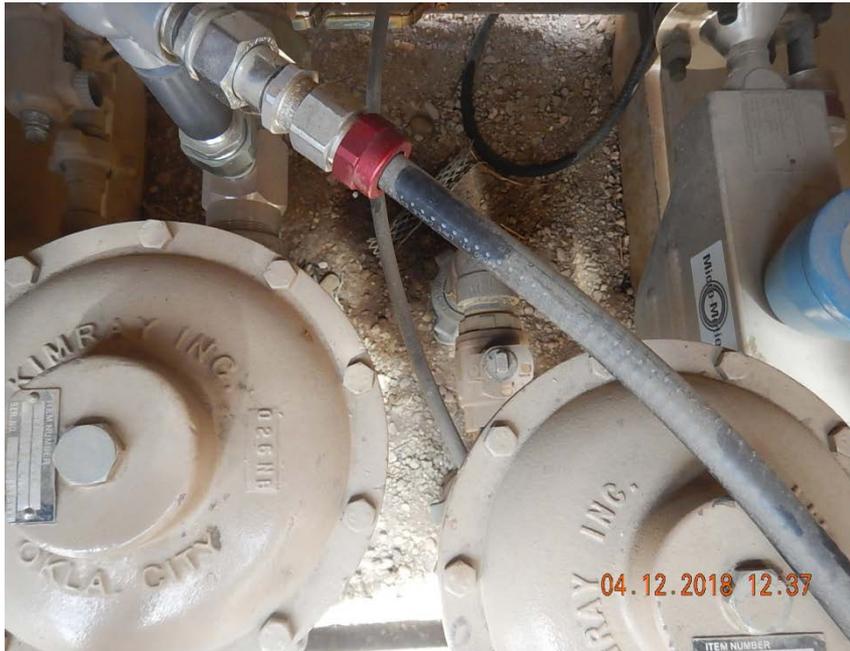
Photo 9: Stained soil in separator house

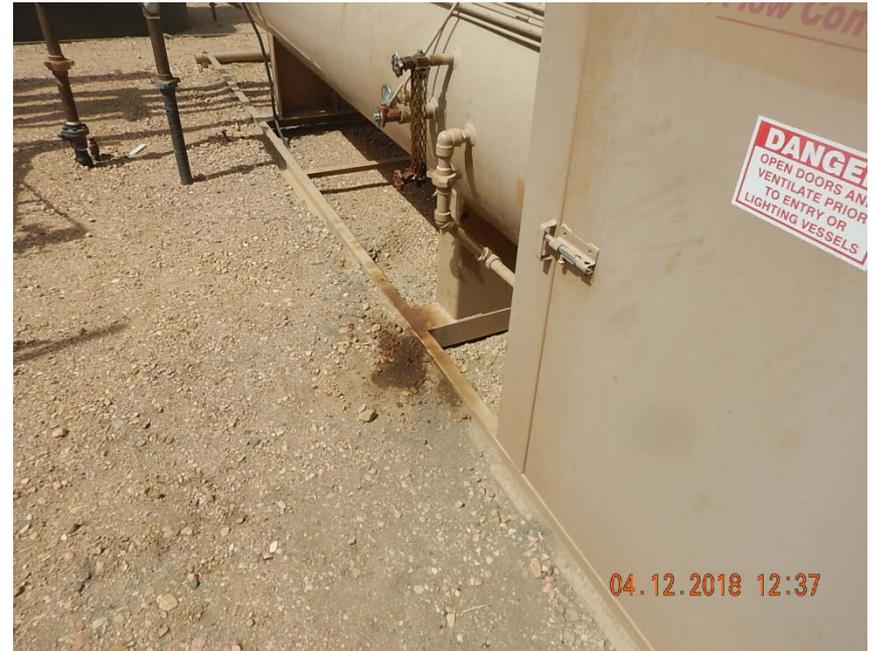
Photo 10: Stained soil near separator

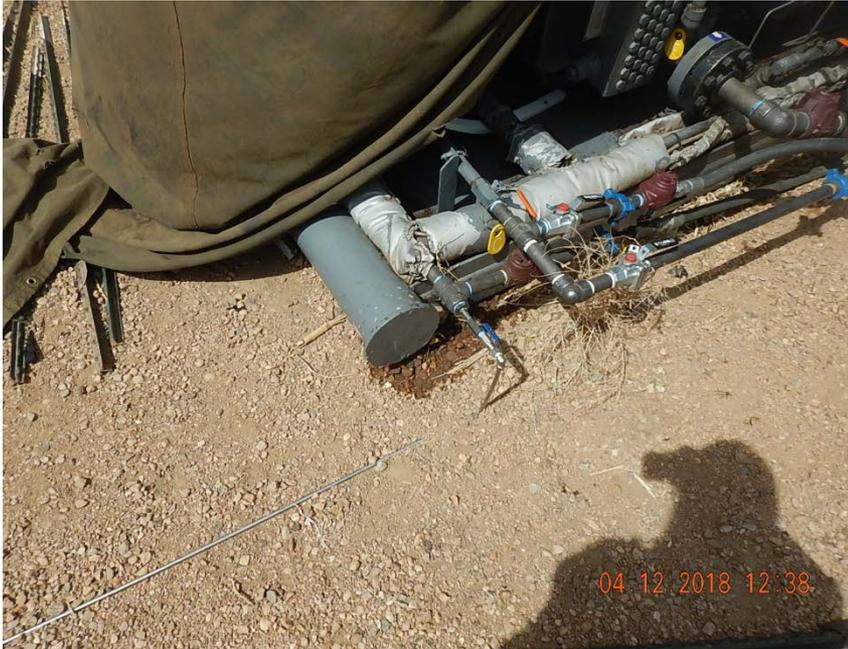
Photo 11: Stained soil at VRU.

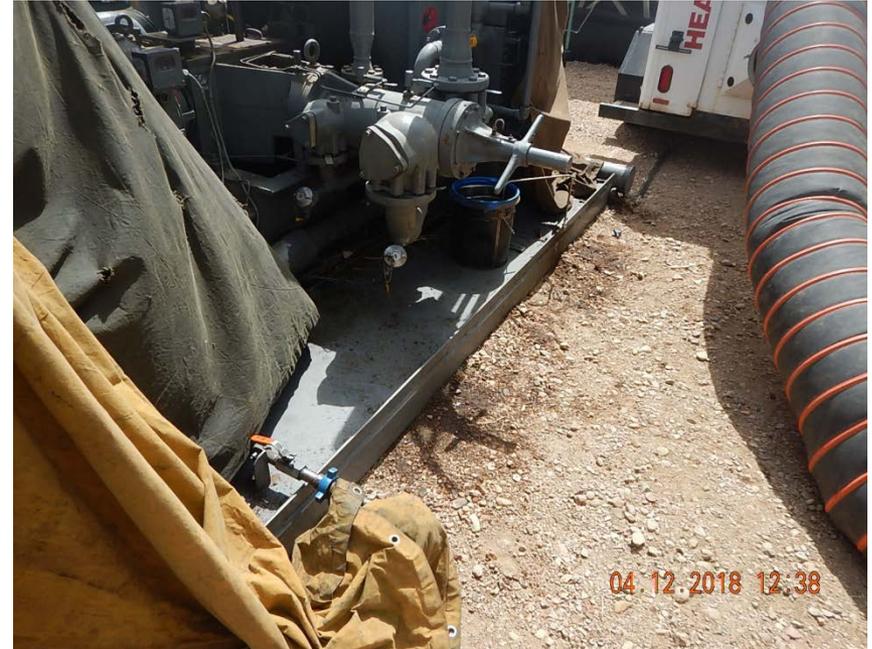
Photo 12: Stained soil at VRU.

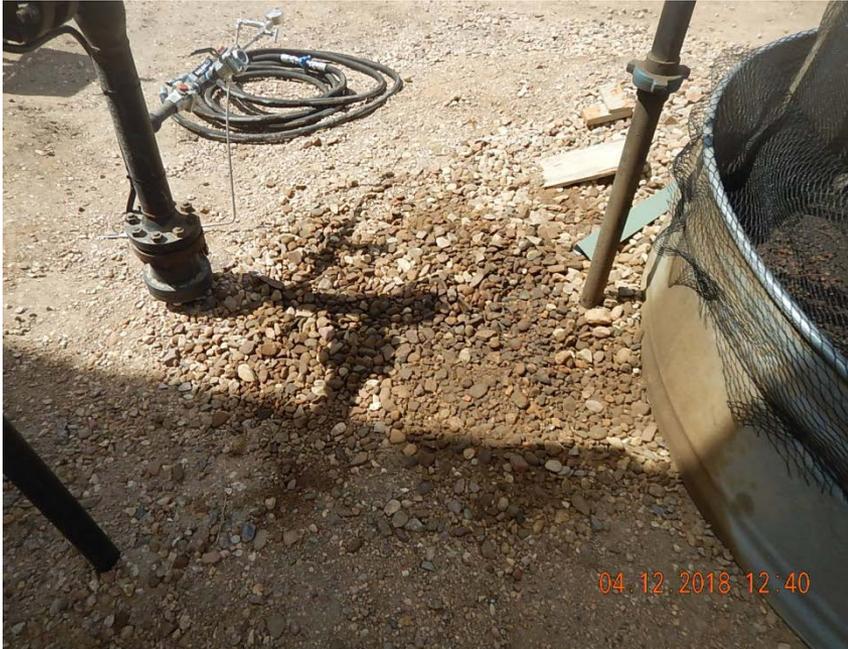
Photo 13: Stained soil at engine oil container.

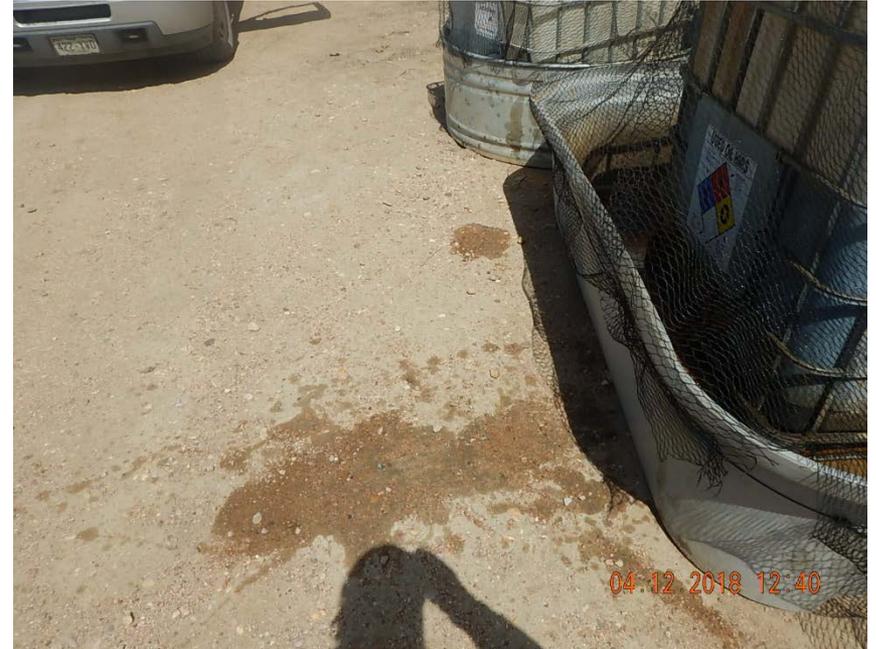
Photo 14: Stained soil at used engine oil container.

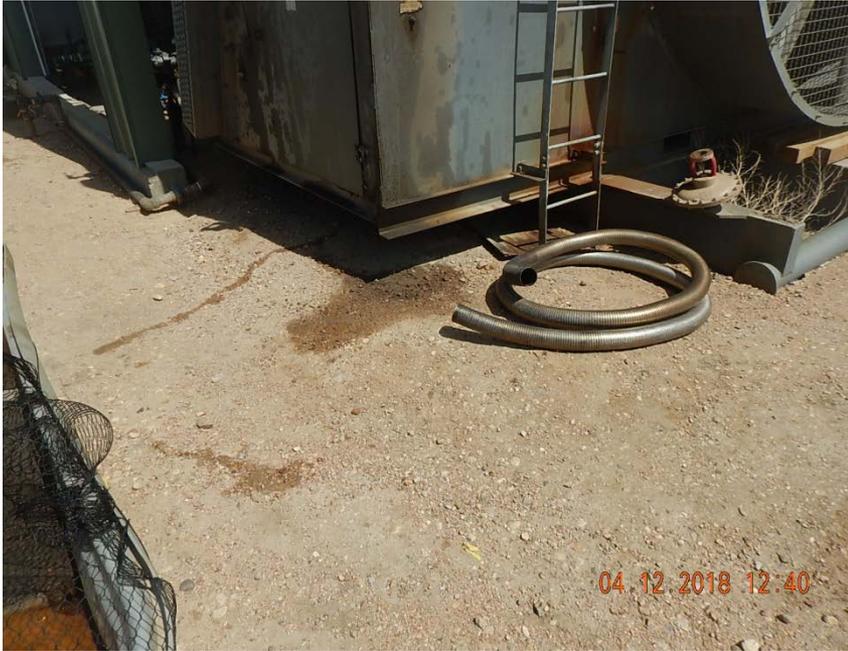
Photo 15: Stained soil at compressor.

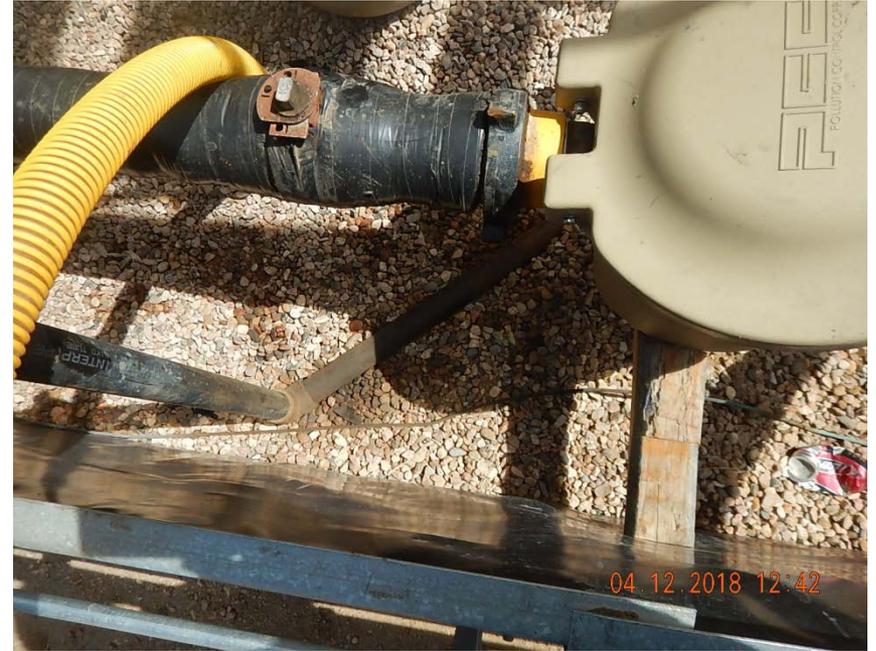
Photo 16: Stained soil at loadout.

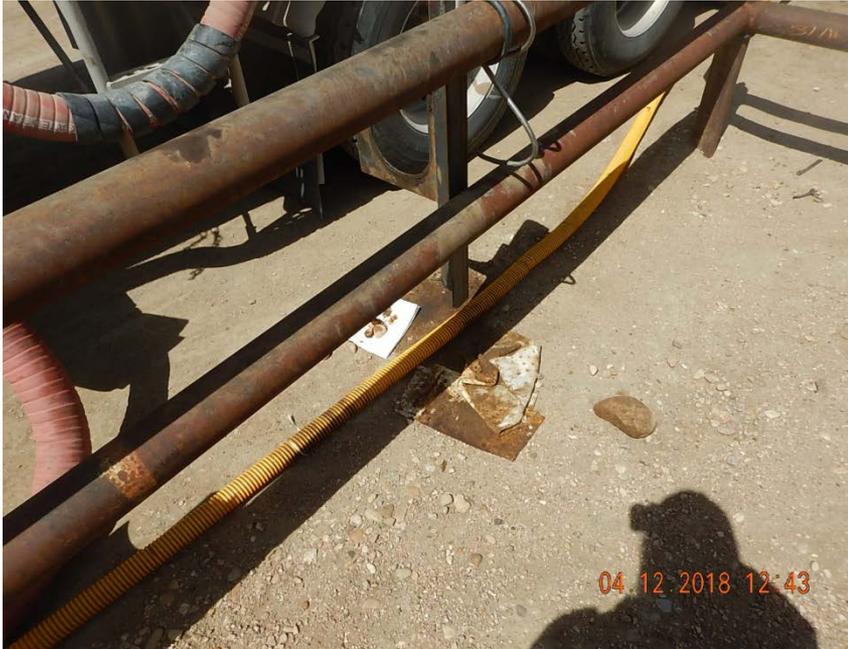
Photo 17: Stained soil near LACT.

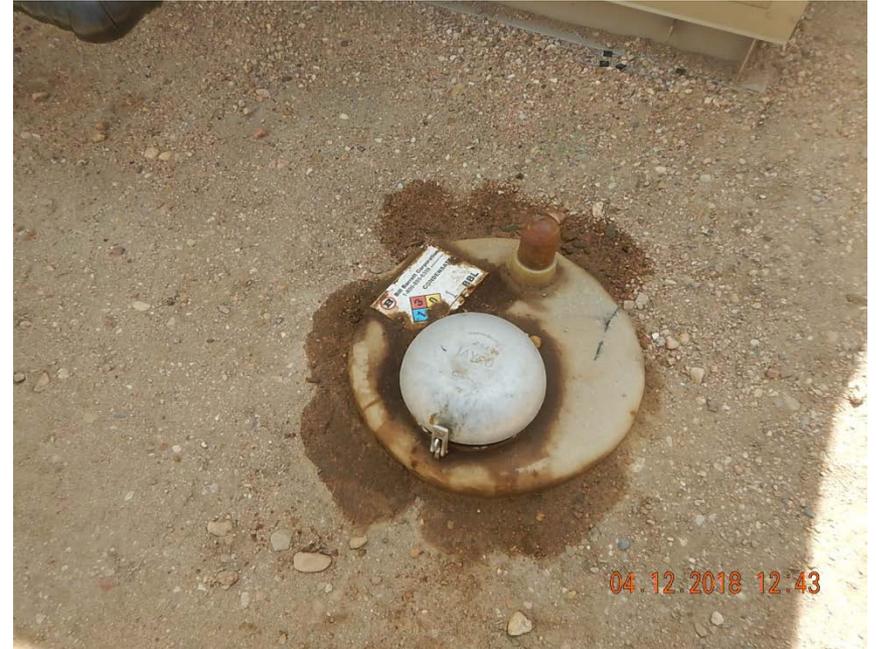
Photo 18: Stained soil at container at LACT.
