Inspection Photos

04/10/2018

Location ID: 390528

Inspection Doc. Number: 682503218
Logan County, CO

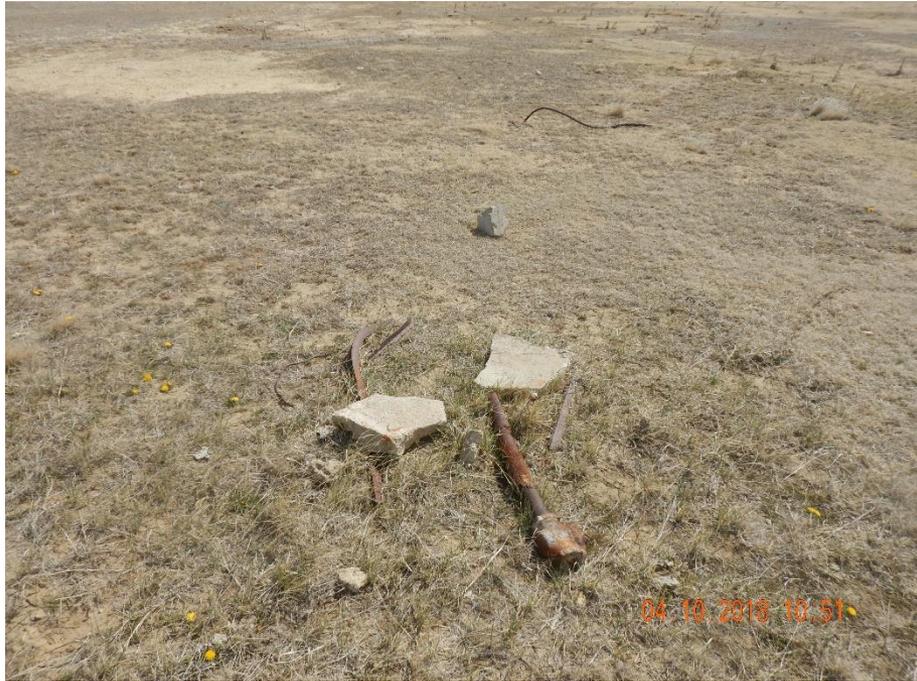
Photo 1: Photo taken from the well location, the southwest end of the disturbance area, facing east. Photo shows various debris (concrete, pipe, metal, cable) still remains on location.

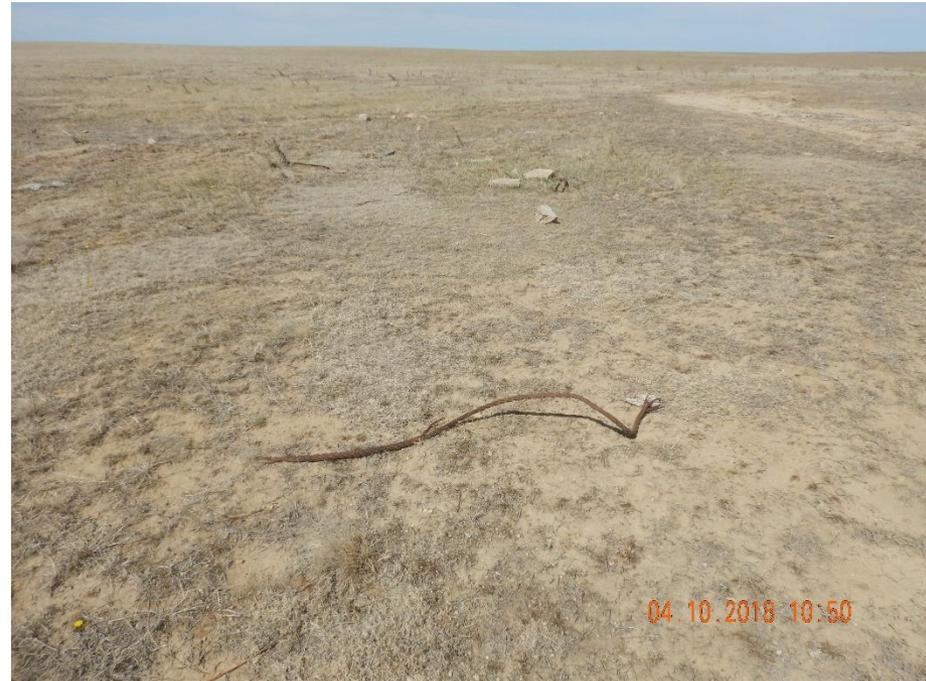
Photo 2: Photo taken from the well location, the southwest end of the disturbance area, facing west. Photo shows various debris (concrete, pipe, metal, cable) still remains on location.

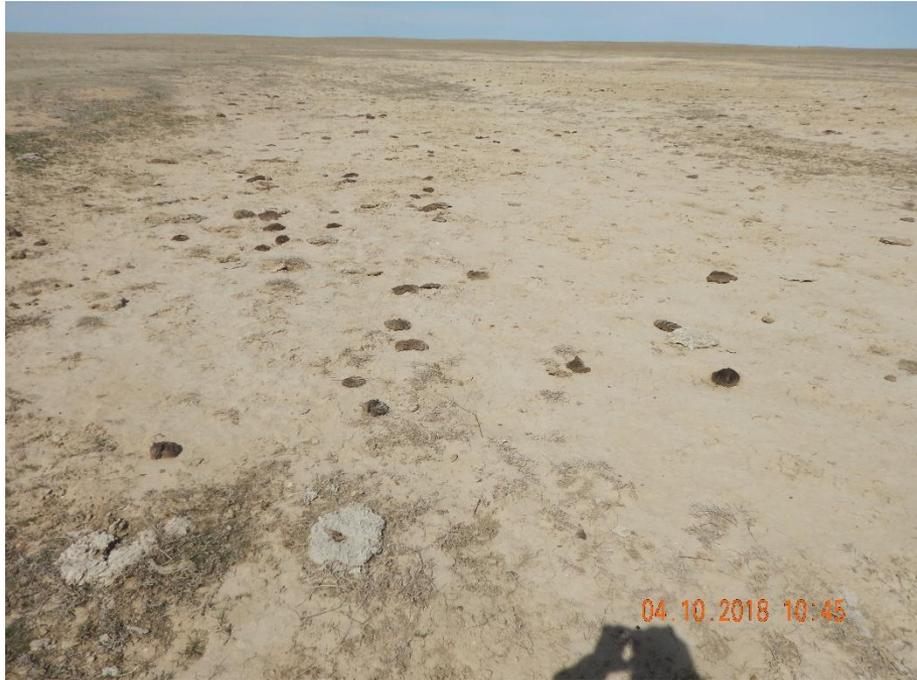
Photo 3: Photo taken from the southeast end of the disturbance area, facing west. Previous inspections documented that reclamation does not appear to be progressing and required operator to perform additional reclamation activities by 3/31/2018. Photos show no additional reclamation or remediation activities appear to have been conducted.

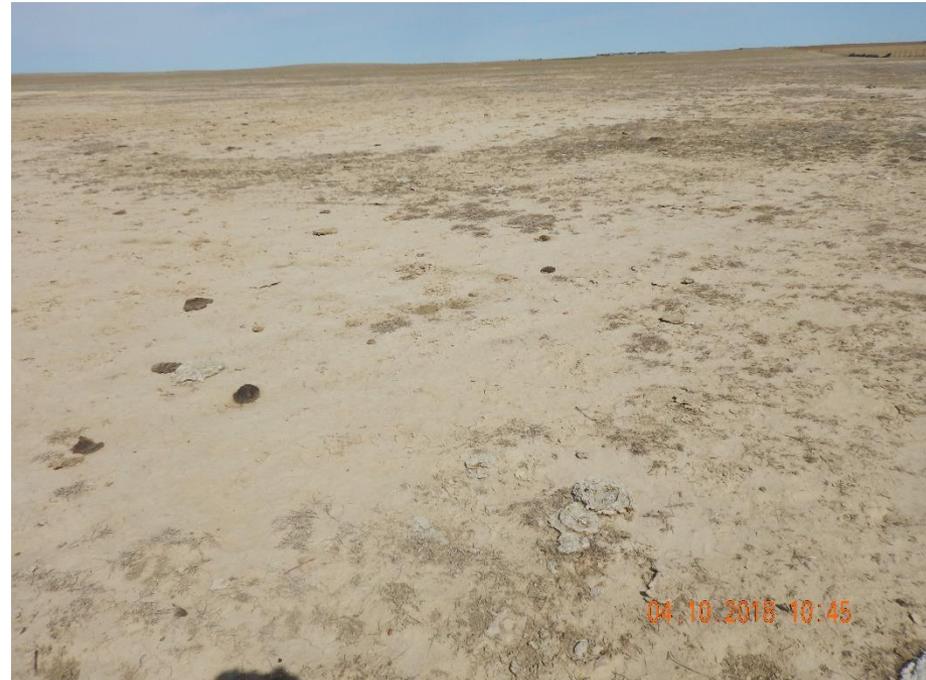
Photo 4: Photo taken from the southeast end of the disturbance area, facing north. See comments under photo 3.

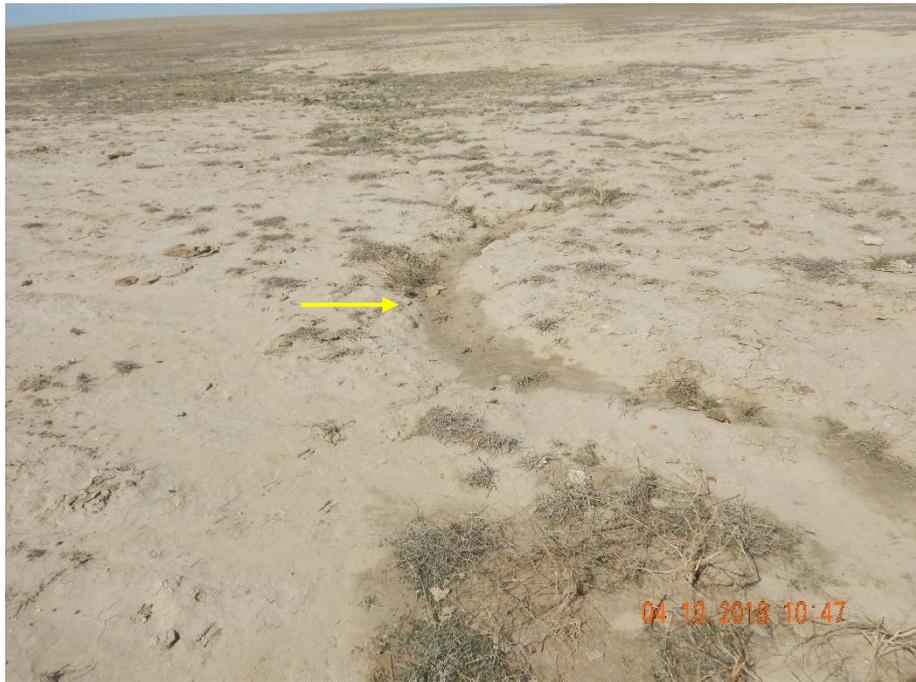
Photo 5: Photo taken from the southern end of the disturbance area. Photo shows stormwater erosion is beginning to once more degrade the location. Active stormwater monitoring and management does not appear to be ongoing. Location does not appear to be sufficiently stabilized to prevent erosion degradation.

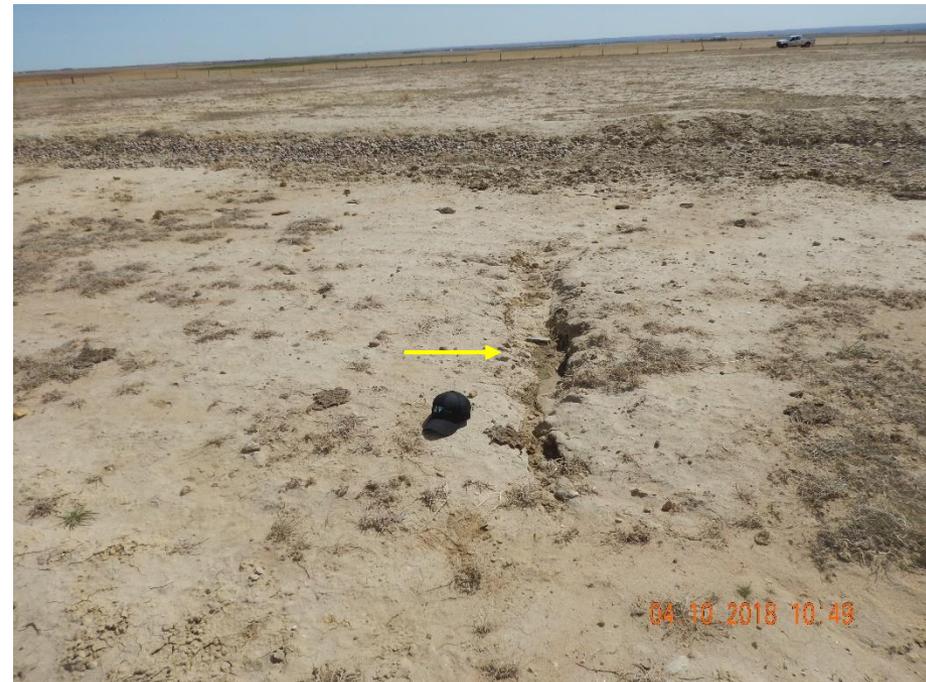
Photo 6: Photo taken from the southern end of the disturbance area, near the berm. Photo shows stormwater erosion is beginning to once more degrade the location. Active stormwater monitoring and management does not appear to be ongoing. Location does not appear to be sufficiently stabilized to prevent erosion degradation. Black ball cap for reference.

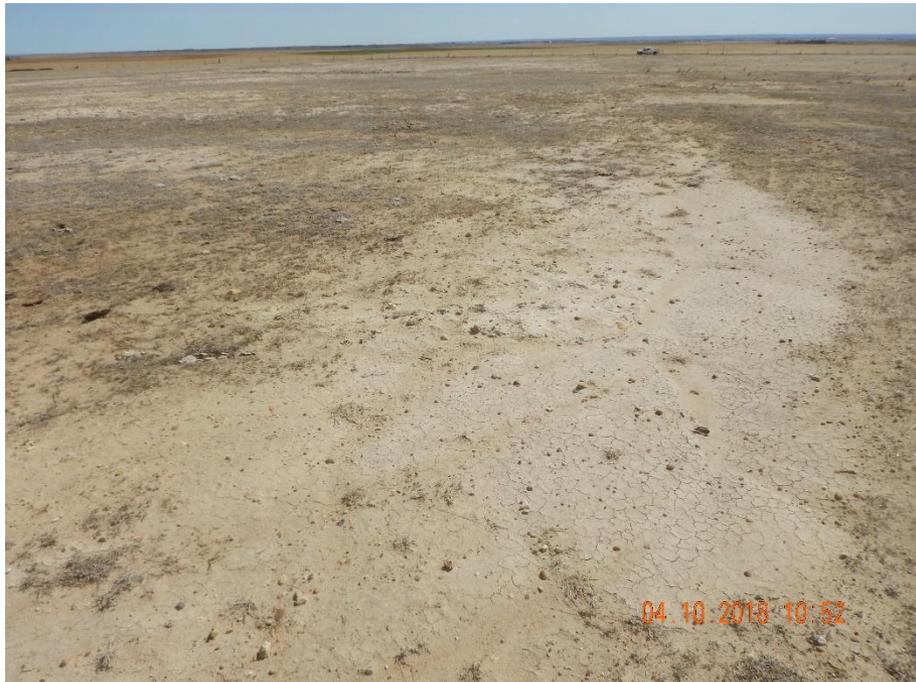
Photo 7: Photo taken from the southwest end of the disturbance area, facing east. See comments under photo 3.

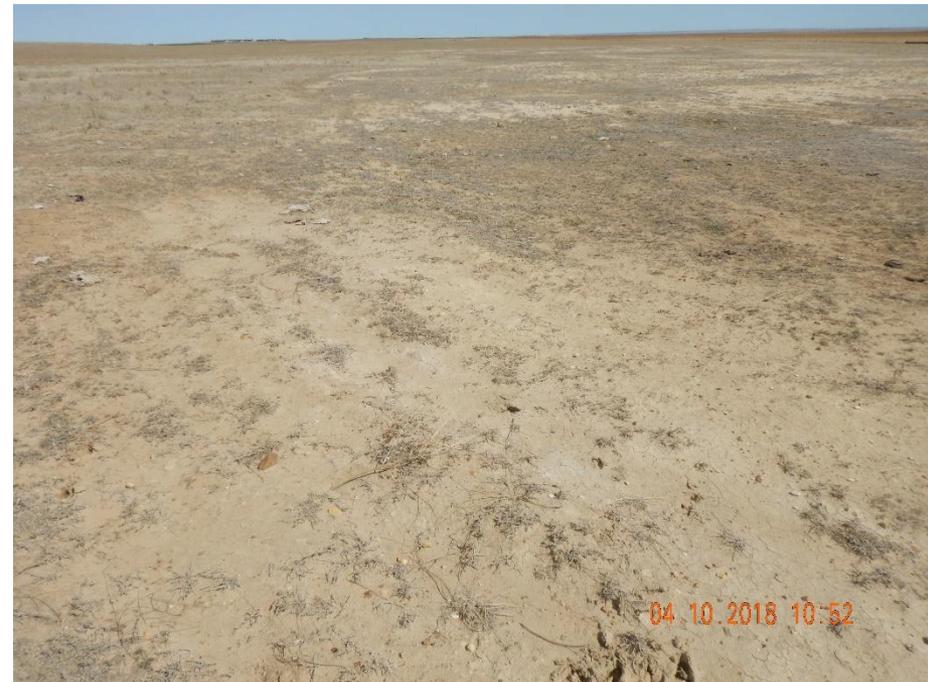
Photo 8: Photo taken from the southwest end of the disturbance area, facing north. See comments under photo 3.

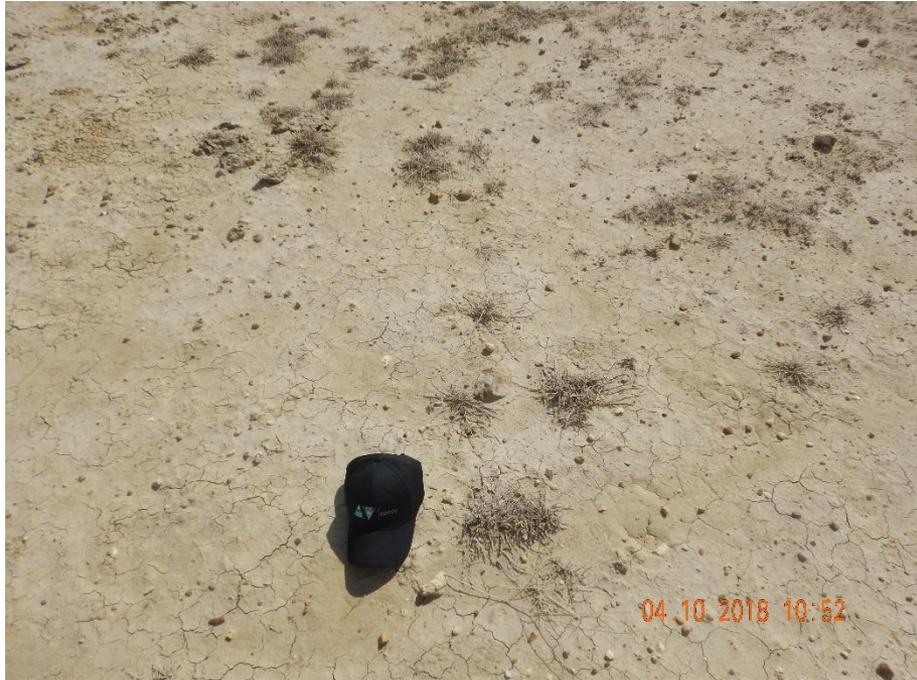
Photo 9: Photo taken from the southwest end of the disturbance area. Previous inspections documented that reclamation does not appear to be progressing and required operator to perform additional reclamation activities by 3/31/2018. Photos show no additional reclamation or remediation activities appear to have been conducted. Black ball cap for reference.

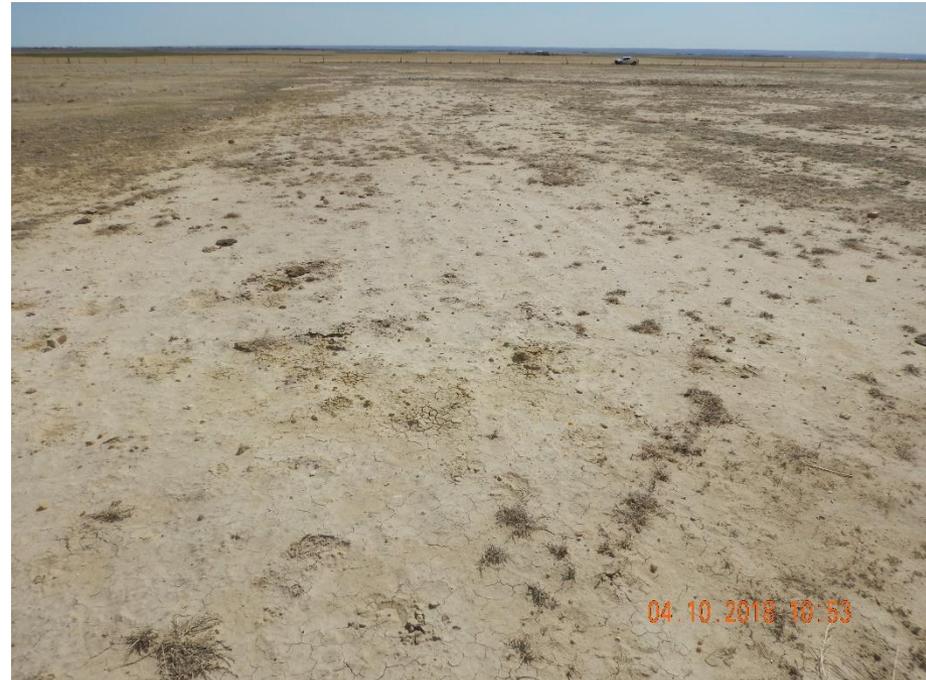
Photo 10: Photo taken from the southern area of disturbance, facing east. Previous inspections documented that reclamation does not appear to be progressing and required operator to perform additional reclamation activities by 3/31/2018. Photos show no additional reclamation or remediation activities appear to have been conducted.

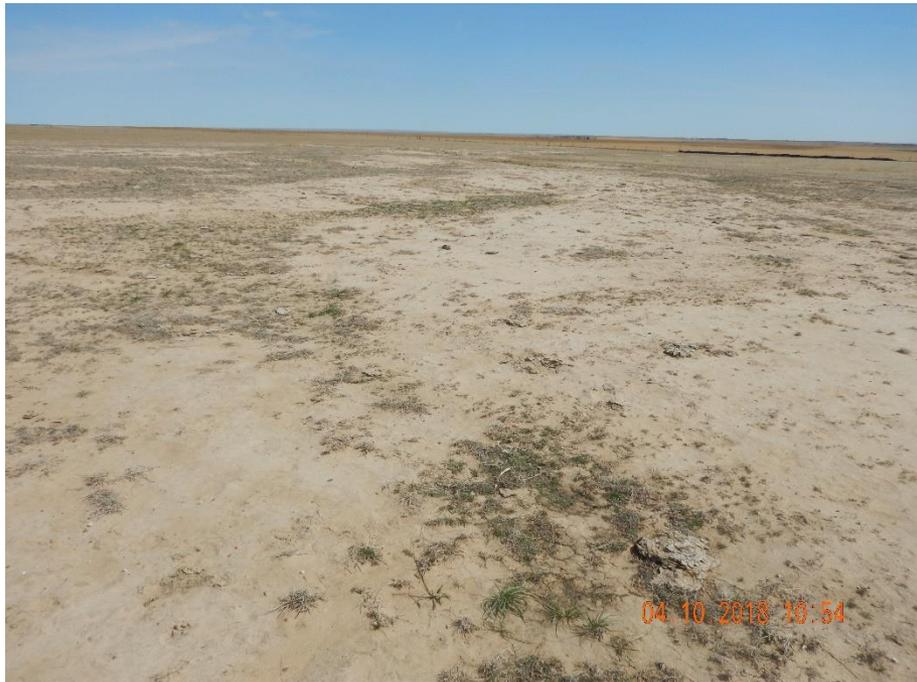
Photo 11: Photo taken from the northern area of disturbance, facing east. Previous inspections documented that reclamation does not appear to be progressing and required operator to perform additional reclamation activities by 3/31/2018. Photos show no additional reclamation or remediation activities appear to have been conducted.

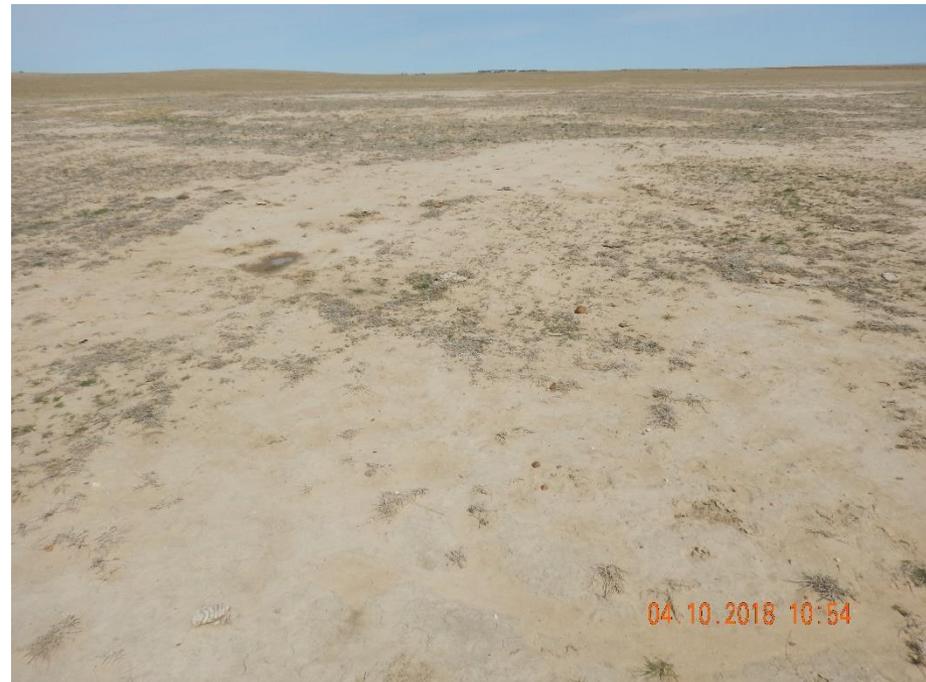
Photo 12: Photo taken from the northern area of disturbance, facing north. See comments under photo 11.

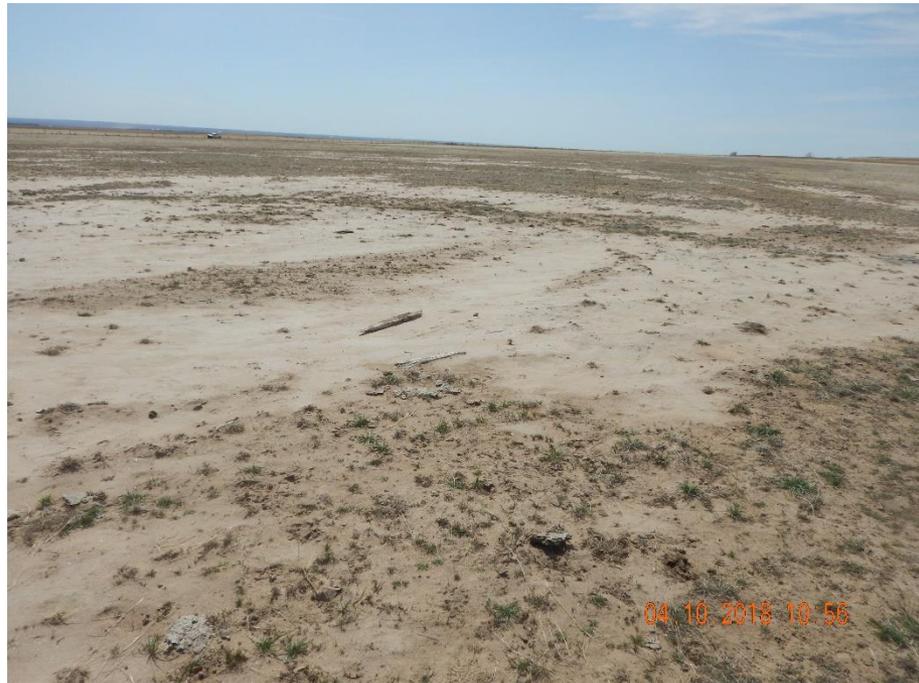
Photo 13: Photo taken from the northwest area of disturbance, facing south. See comments under photo 11.

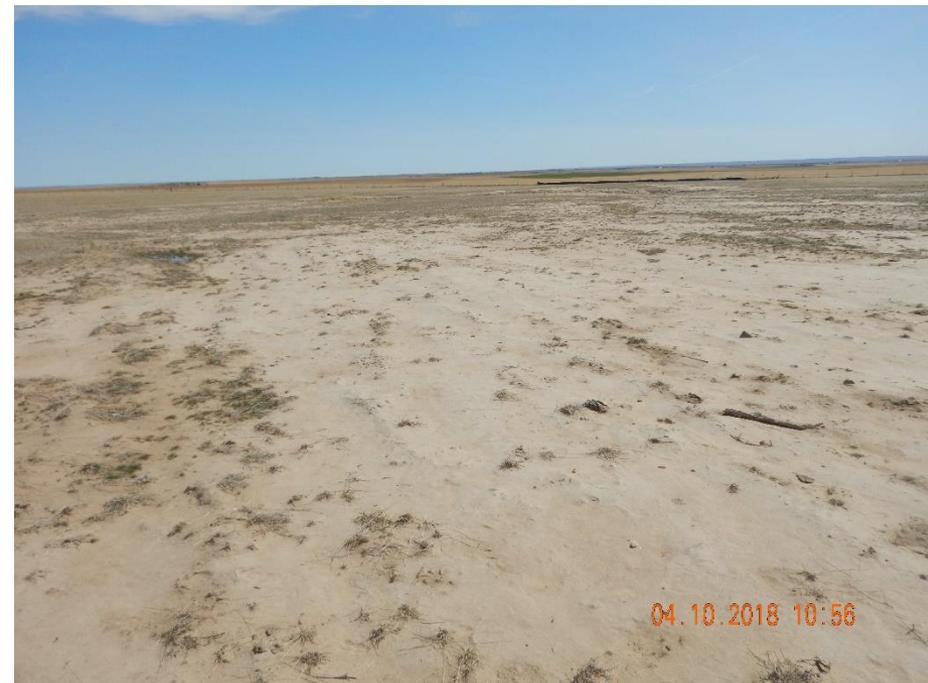
Photo 14: Photo taken from the northwest area of disturbance, facing east. See comments under photo 11.

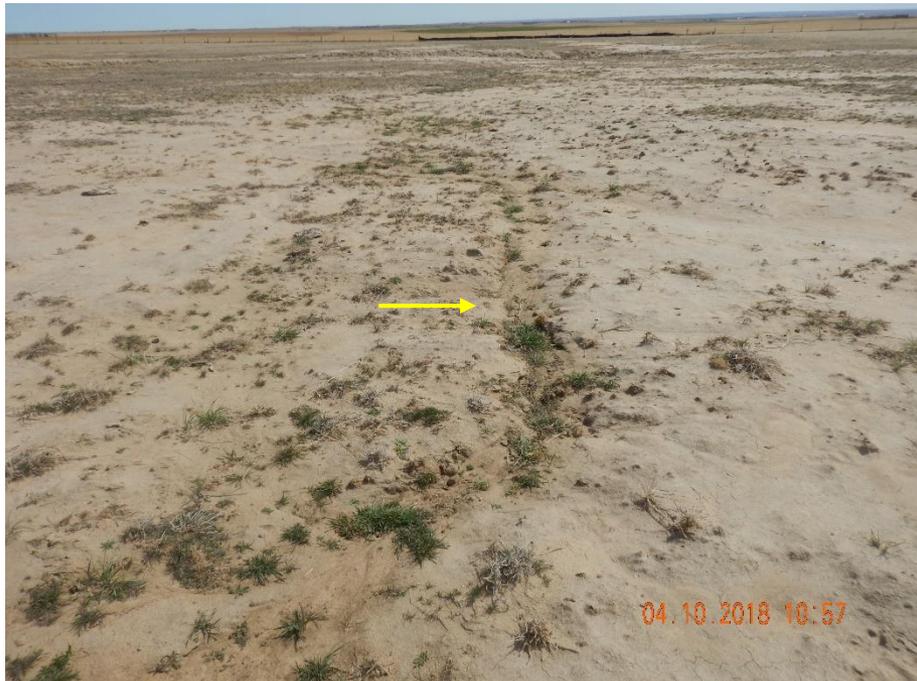
Photo 15: Photo taken from the northern end of the disturbance area, facing east. Photo shows stormwater erosion is beginning to once more degrade the location. Active stormwater monitoring and management does not appear to be ongoing. Location does not appear to be sufficiently stabilized to prevent erosion degradation.

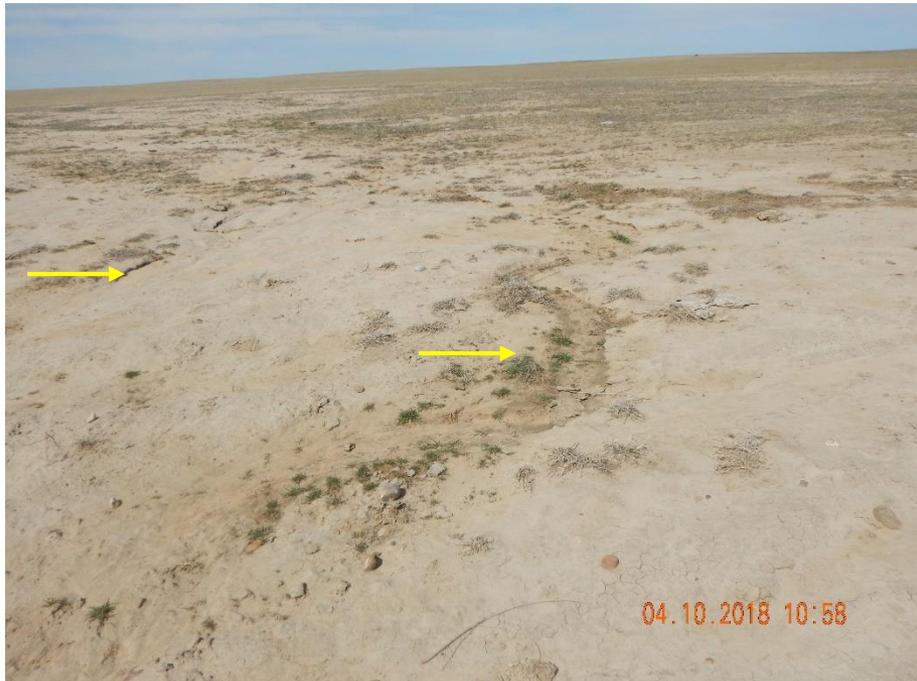
Photo 17: Photo taken from the northern end of the disturbance area, facing west. Photo shows stormwater erosion is beginning to once more degrade the location. Active stormwater monitoring and management does not appear to be ongoing. Location does not appear to be sufficiently stabilized to prevent erosion degradation.

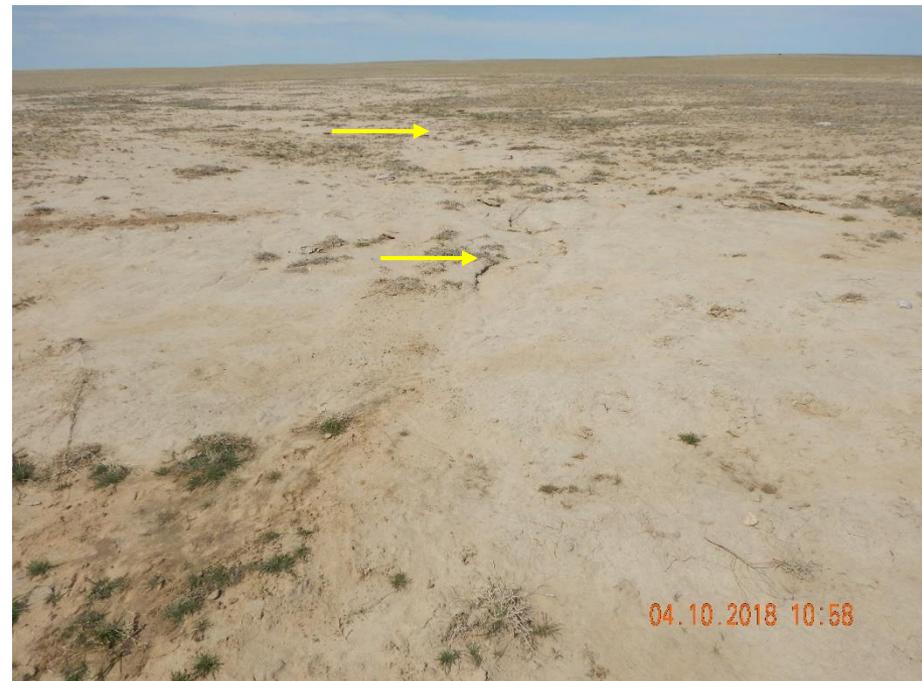
Photo 18: Photo taken from the northern end of the disturbance area, facing north. See comments under photo 17

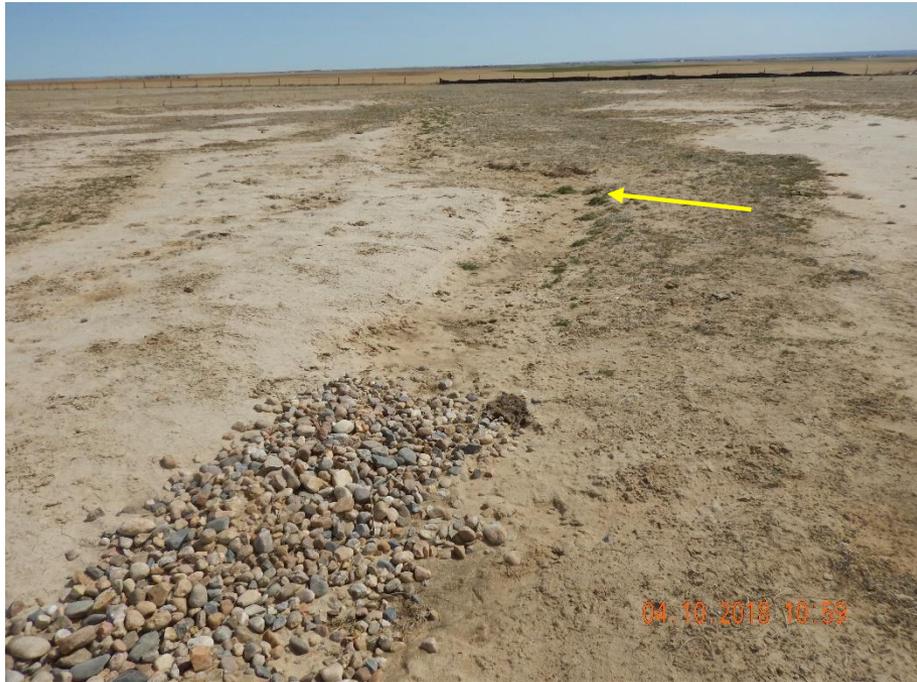
Photo 19: Photo taken from the northern end of the disturbance area, facing east. See comments under photo 17

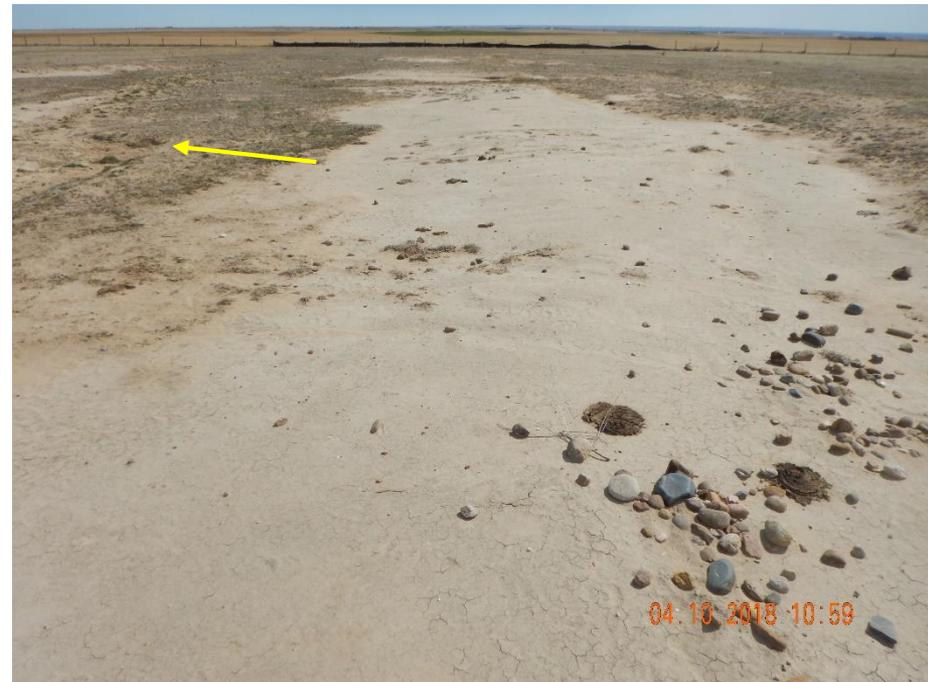
Photo 20: Photo taken from the northern end of the disturbance area, facing east. Photo shows stormwater erosion is beginning to once more degrade the location. Photos also shows no additional reclamation or remediation activities appear to have been conducted.

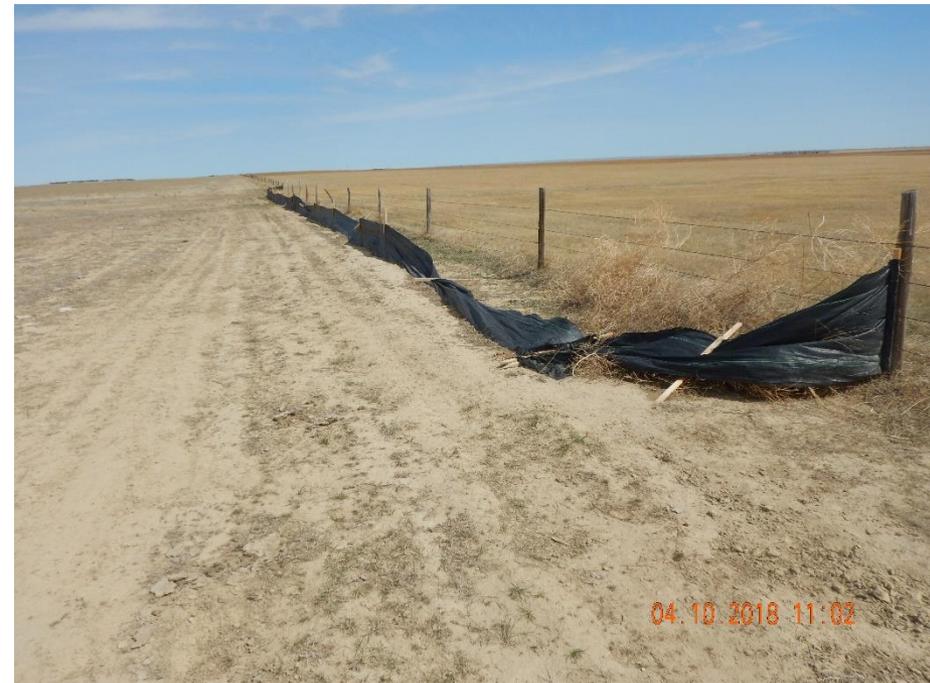
Photo 22: Photo taken from the northeast end of the disturbance area, facing north. Photo of silt fence BMP. Previous inspection documented that areas of the silt fence is already in disrepair and advised maintenance. Photo shows areas of the silt fence continues to be in disrepair.

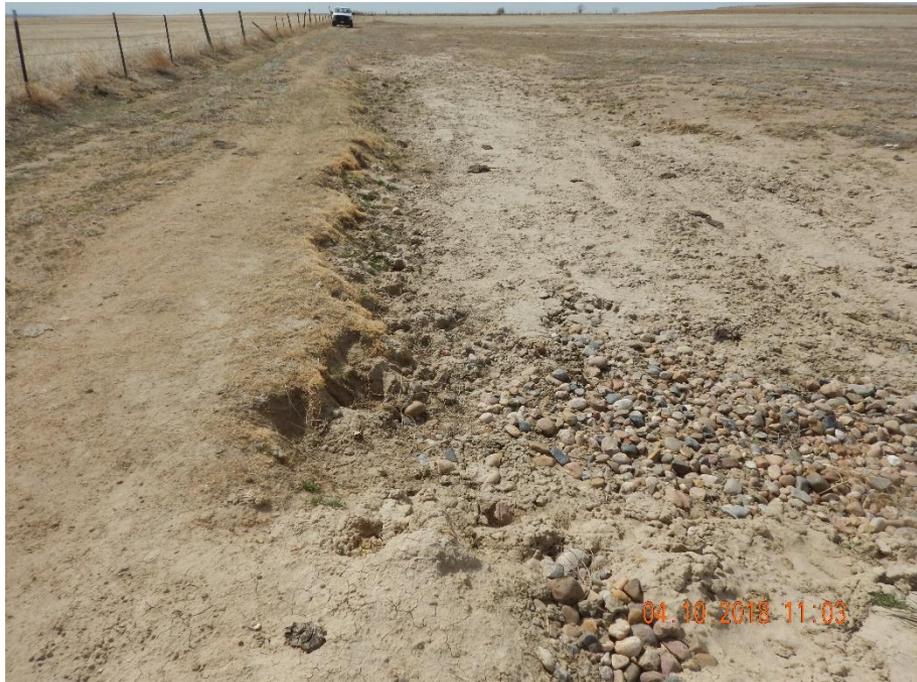
Photo 23: Photo taken from the southeastern end of the disturbance area, facing south. Photo shows stormwater erosion is beginning to once more degrade the location. Photos also shows no additional reclamation or remediation activities appear to have been conducted.

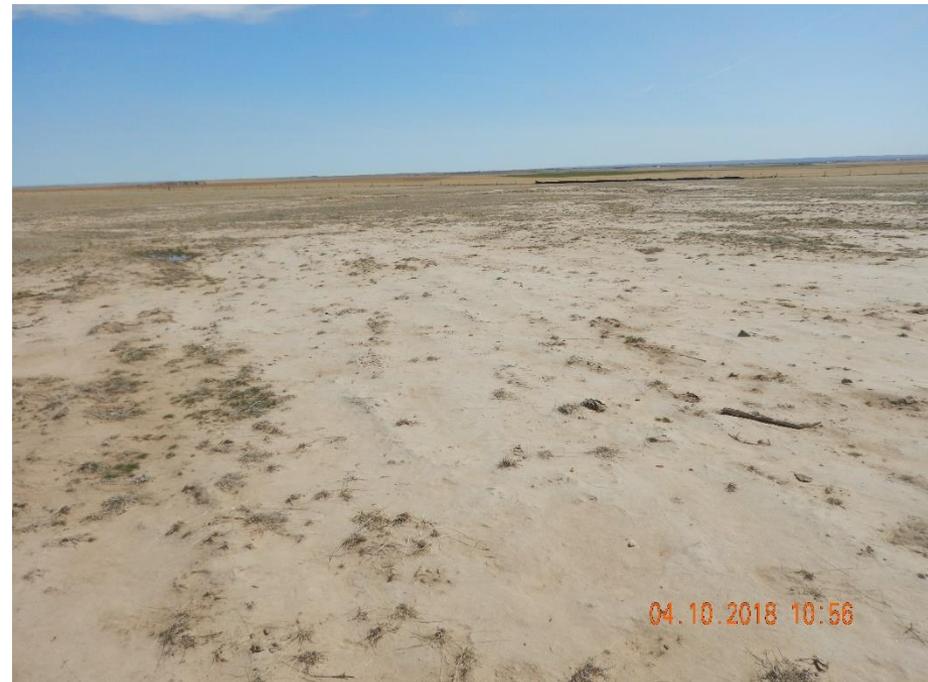
Photo 24: Photo taken from the southeastern end of the disturbance area, facing southwest. Photo shows stormwater erosion is beginning to once more degrade the location. Photos also shows no additional reclamation or remediation activities appear to have been conducted.
