Inspection Photos

Location Name: Staudinger 1-31H API: 05-123-34161

Inspection Date: 04/12/2018

COLORADO
Oil & Gas Conservation
Commission
Department of Natural Resources

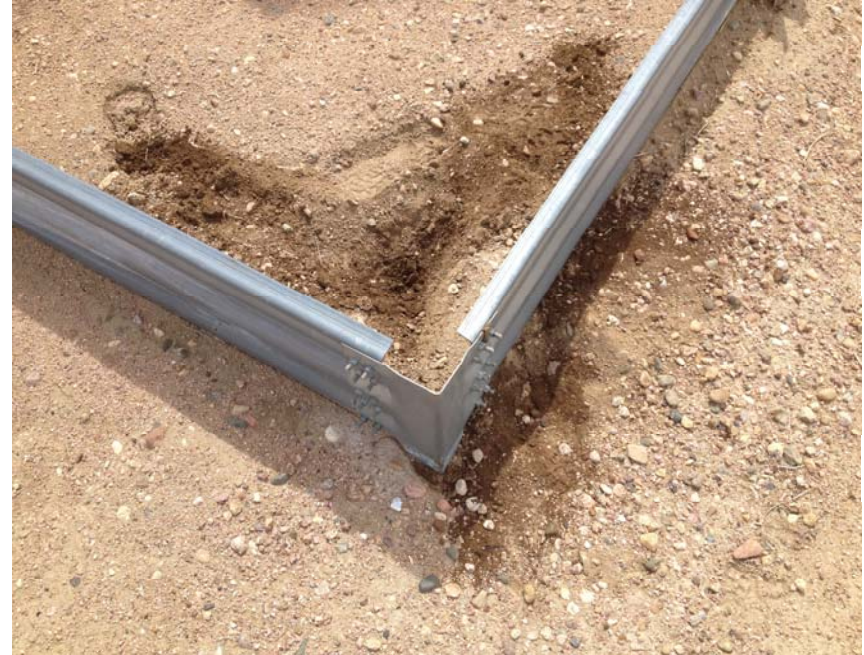
Photo 2 – Impacted soil beneath clean gravel at northwest corner of heater treater secondary containment

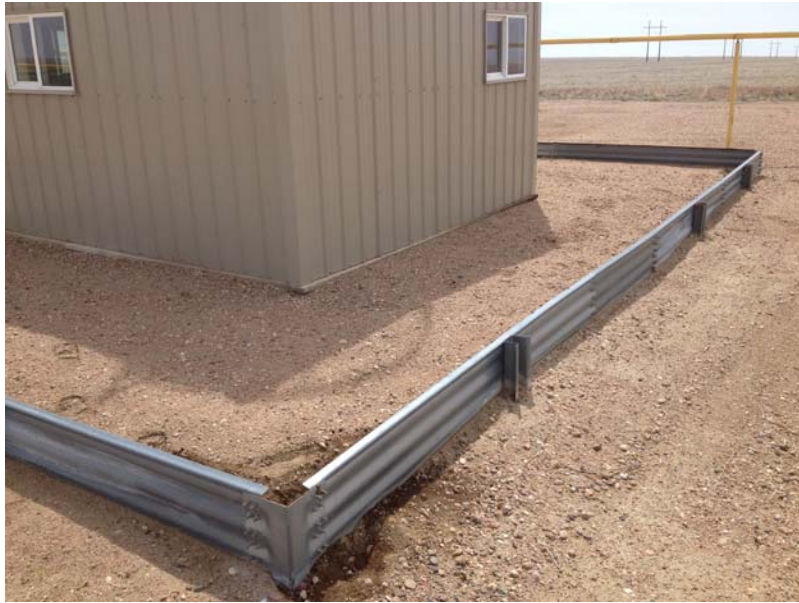
Photo 3 – Northwest corner of heater treater secondary containment. Impacted soil in foreground.

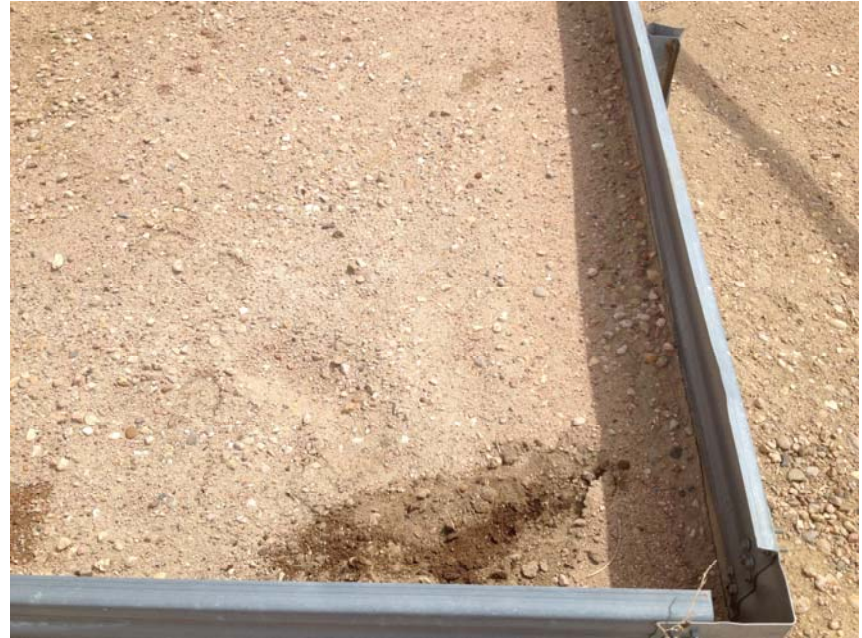
Photo 4 – Impacted soil beneath clean gravel at southwest corner heater treater secondary containment

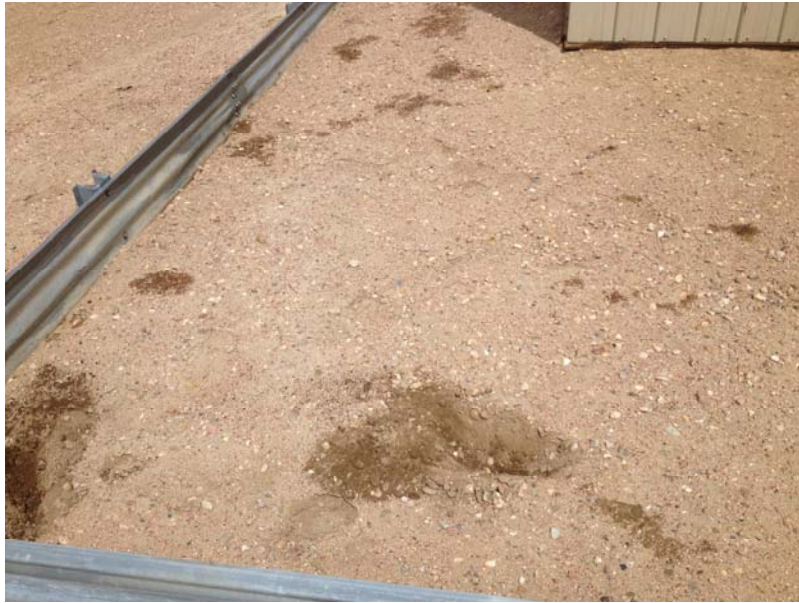
**Photo 5 – Southwest corner of heater treater containment.
Impacted soil within containment.**

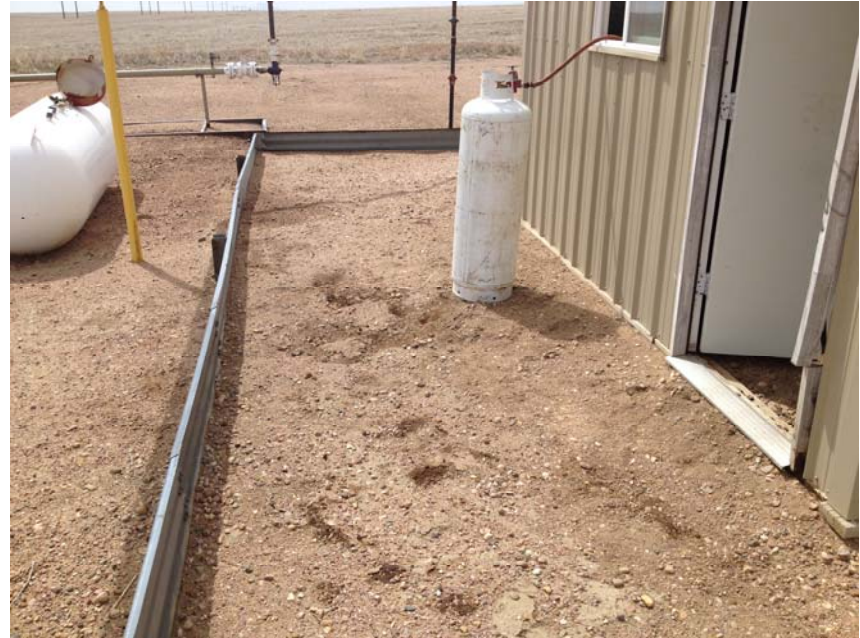
**Photo 6 – Northeast corner of heater treater containment
looking south.**

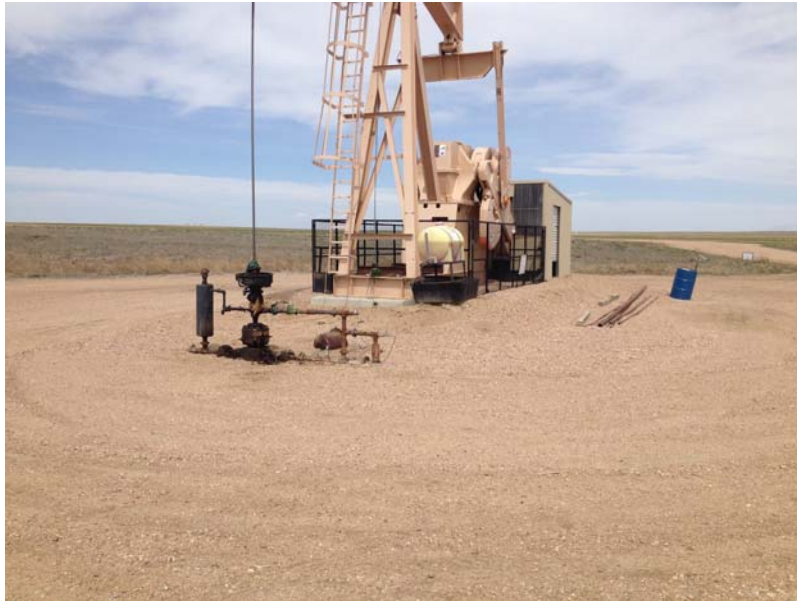
Photo 7 – Wellhead area with unused rods and lube oil drum with no secondary containment.

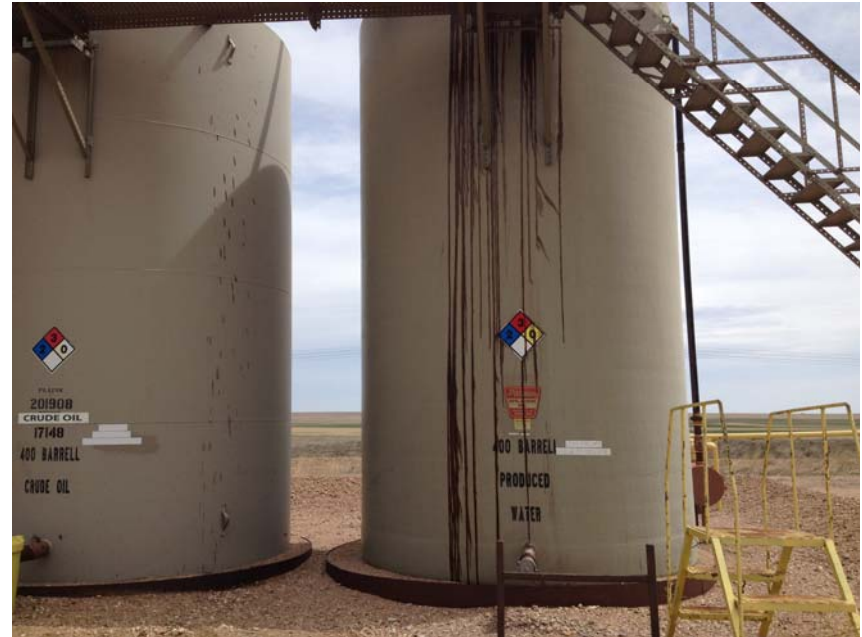
Photo 8 – produced water AST showing release from thief hatch.
