Final Reclamation and Stormwater Inspection

April 11, 2018

Operator: SRC ENERGY INC- #10311

Location ID: 333286

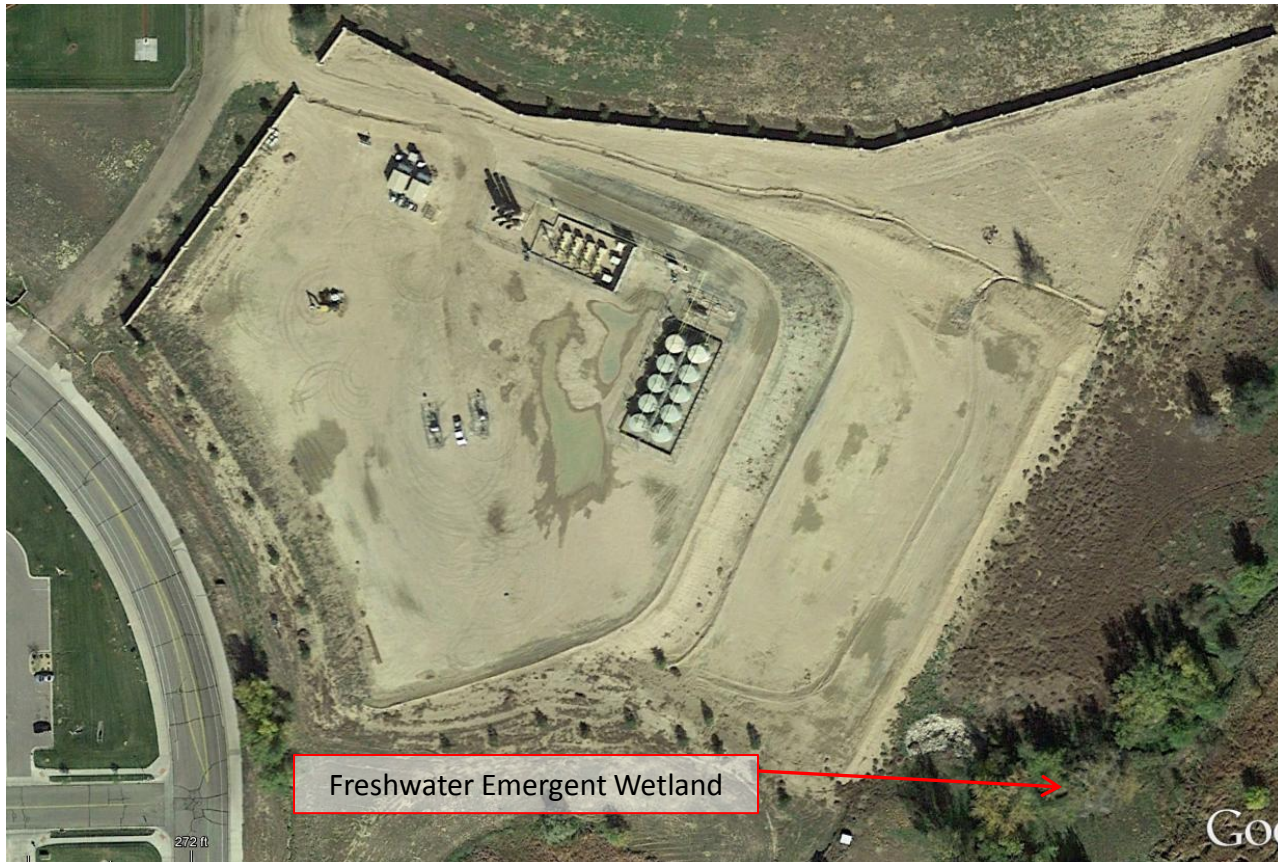
Google Earth aerial imagery taken October 14, 2017. Photo illustrates all six wells were plugged (last plugging on 1/26/2017) and equipment was removed from location. Note: A Freshwater Emergent Wetland is approximately 275' east of the location.

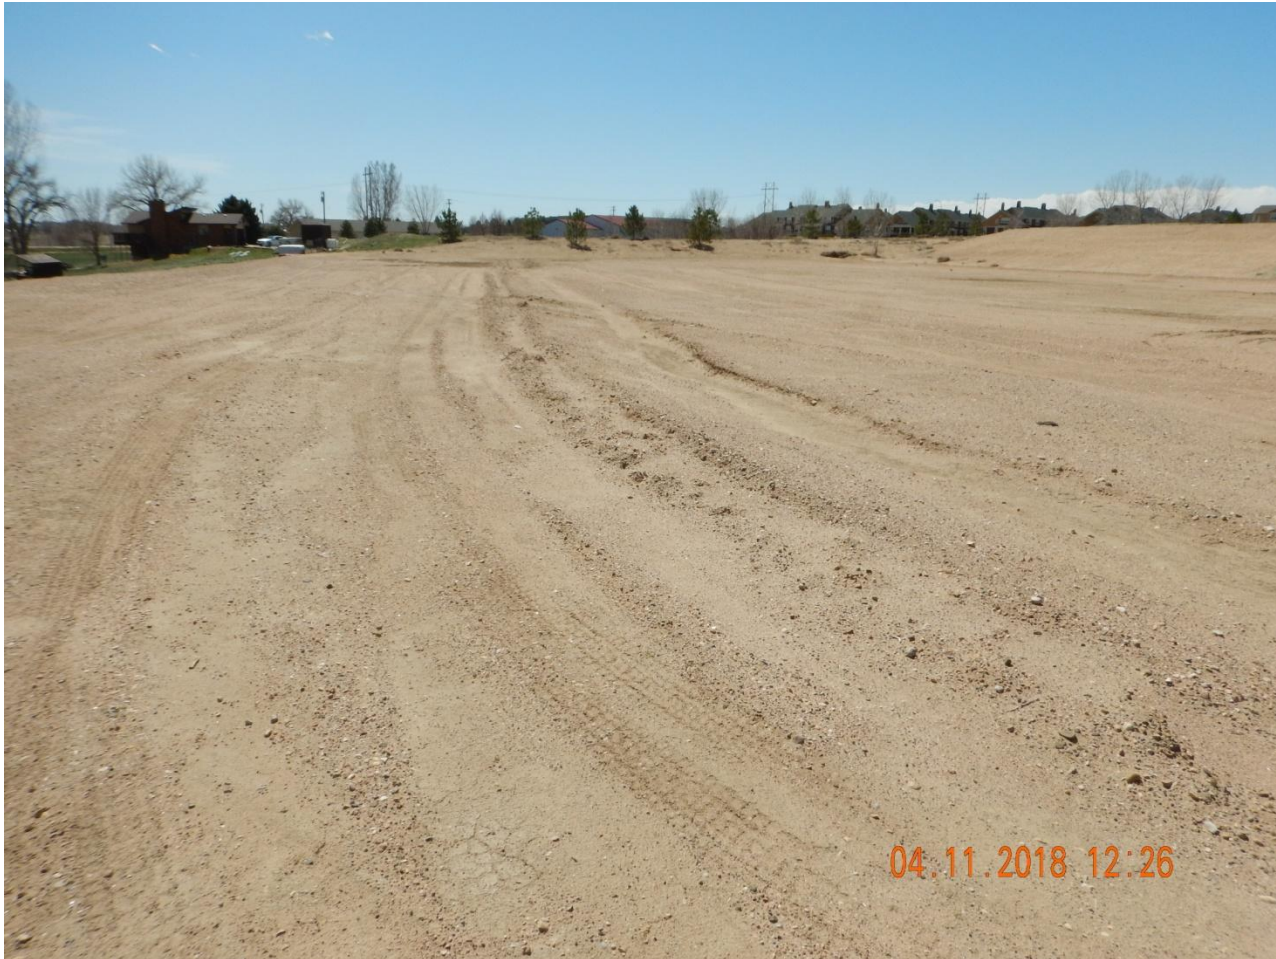
Photo 1. Photo taken from the northern location, facing South. Operator has failed to reclaim the Northridge location per Rule 1004.a. standards.

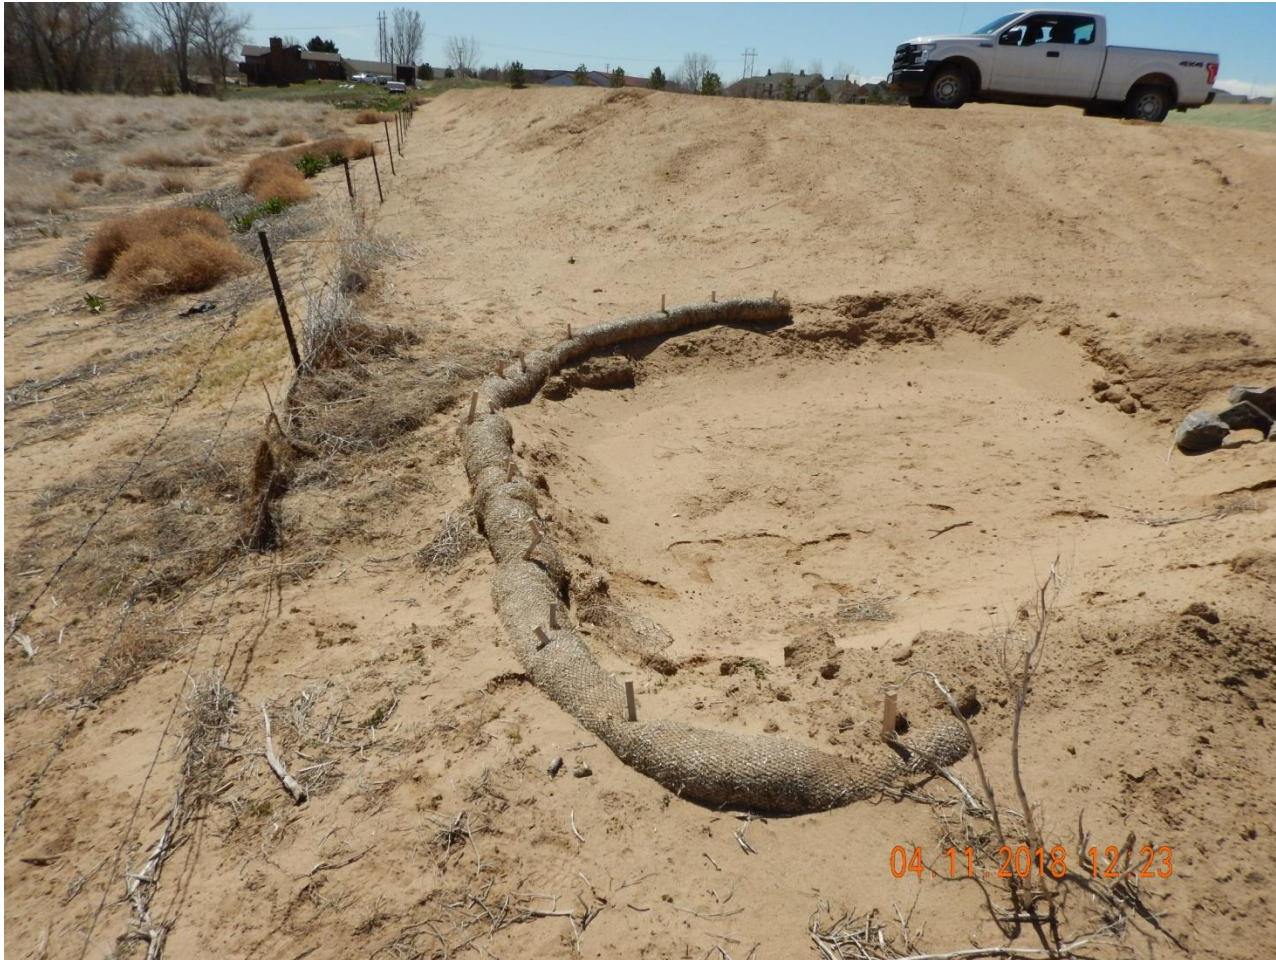
Photo 2. Photo taken from the northeastern location, facing South. Operator has failed to maintain stormwater BMPs per Rule 1002.f.(2). Photo also illustrates fill slopes of the location have not been stabilized and have eroded off location.

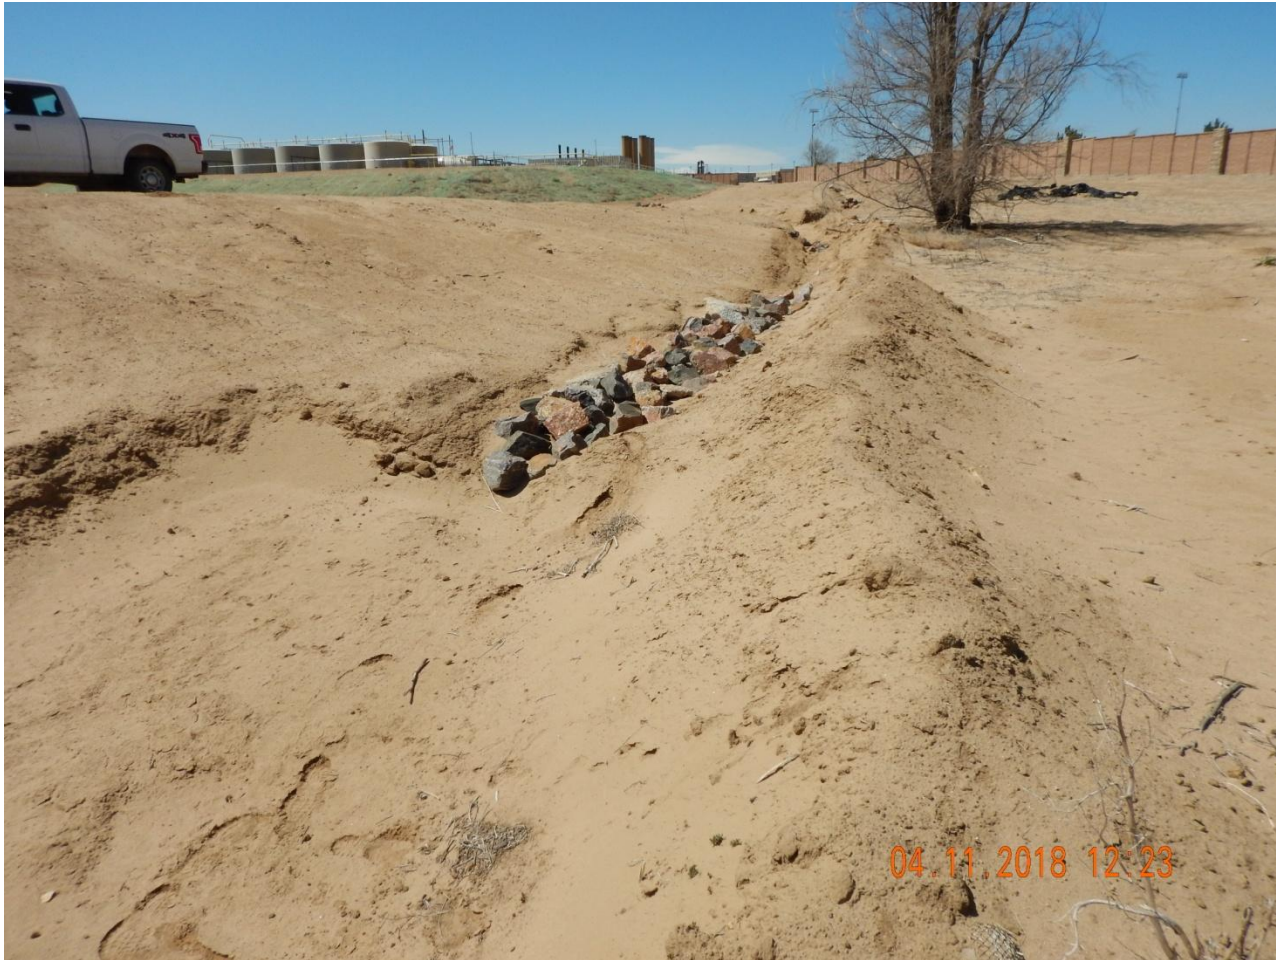
Photo 3. Photo taken from the northeastern location, facing West. Operator has failed to maintain stormwater BMPs per Rule 1002.f.(2).

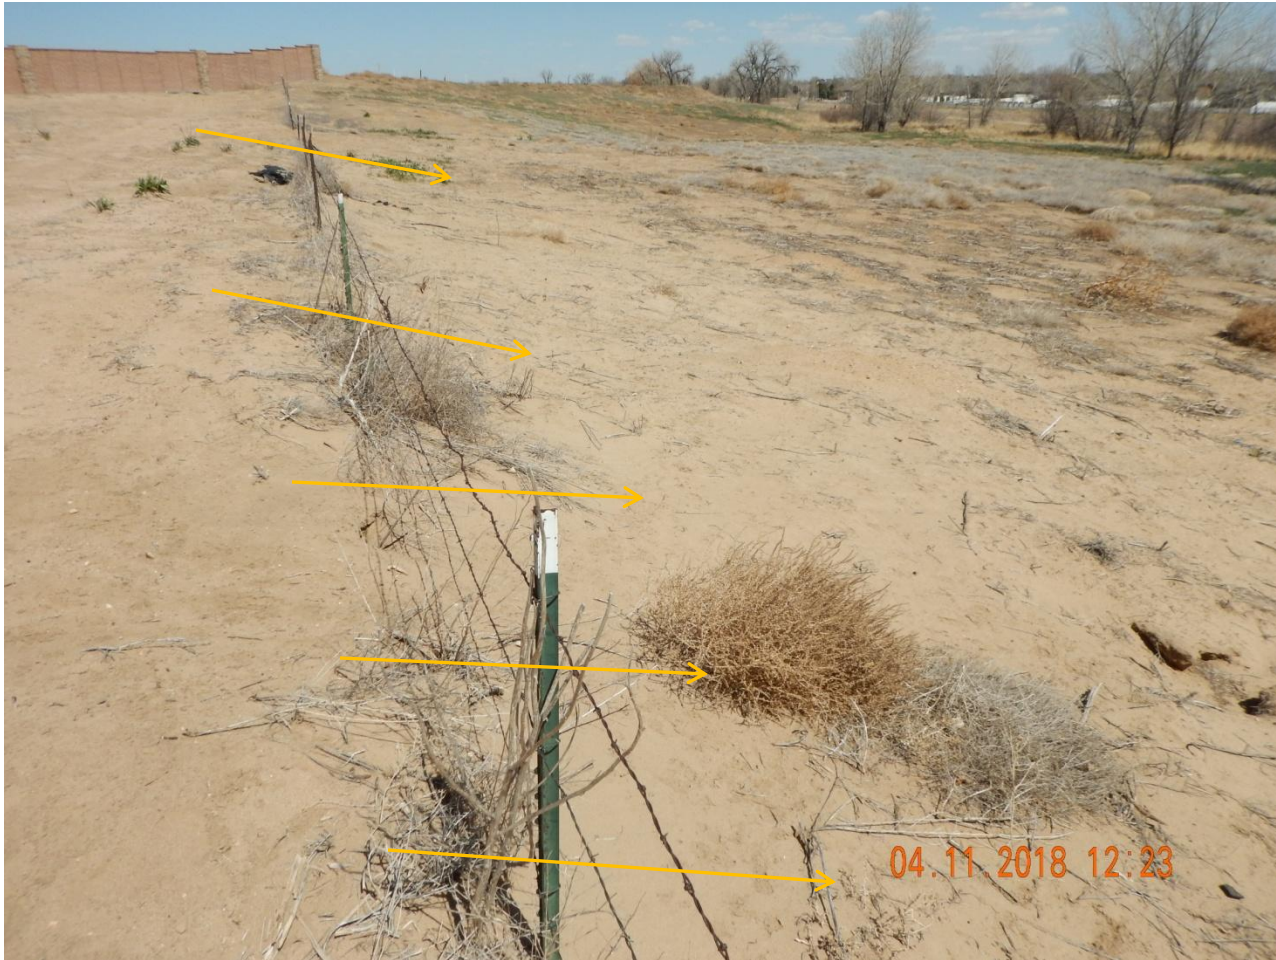
Photo 4. Photo taken from the northeastern location, facing North. The northern location has not been stabilized and no vegetation was observed throughout any portion. Appears sediment discharge from the location has eroded off location.

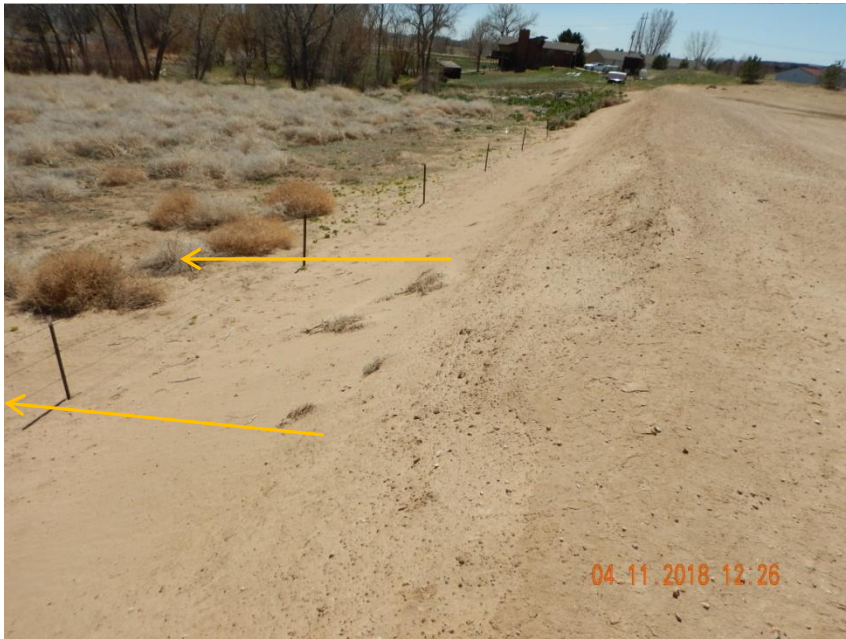
Photo 5. Photo taken from the eastern well pad location, facing South. Photo illustrates fill slopes of the location have not been stabilized and have eroded off location. Kochia and Russian thistle observed east of location which could have established from the well location or the Kelly Farm location.

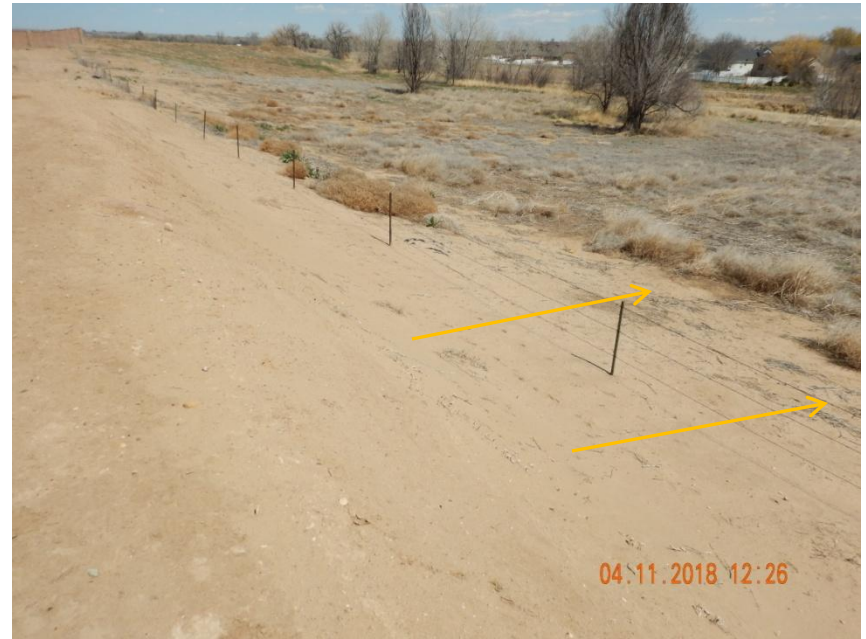
Photo 6. Photo taken from the eastern well pad location, facing North. See comments under Photo 5.

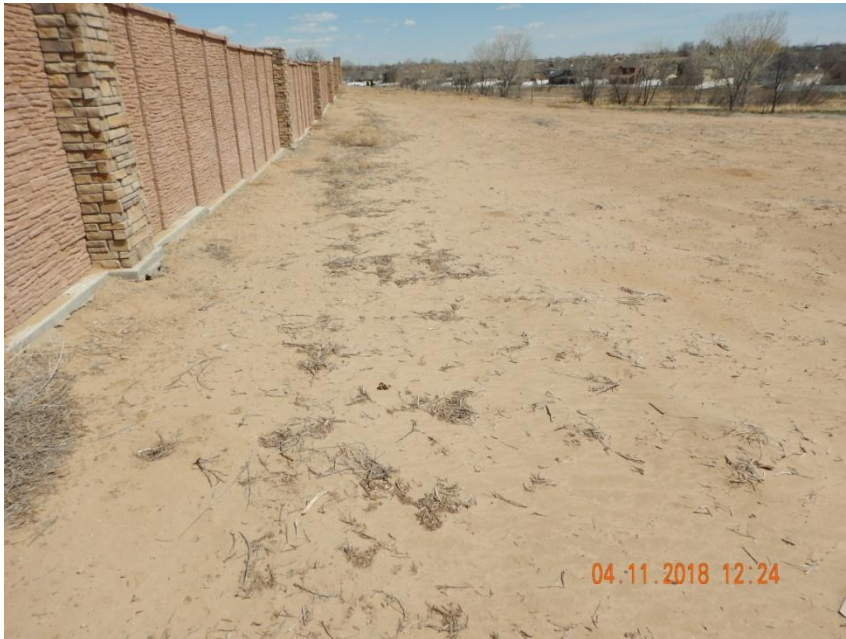
Photo 7. Photo taken from the northern location, facing East. The northern location has not been stabilized and no vegetation was observed throughout any portion.

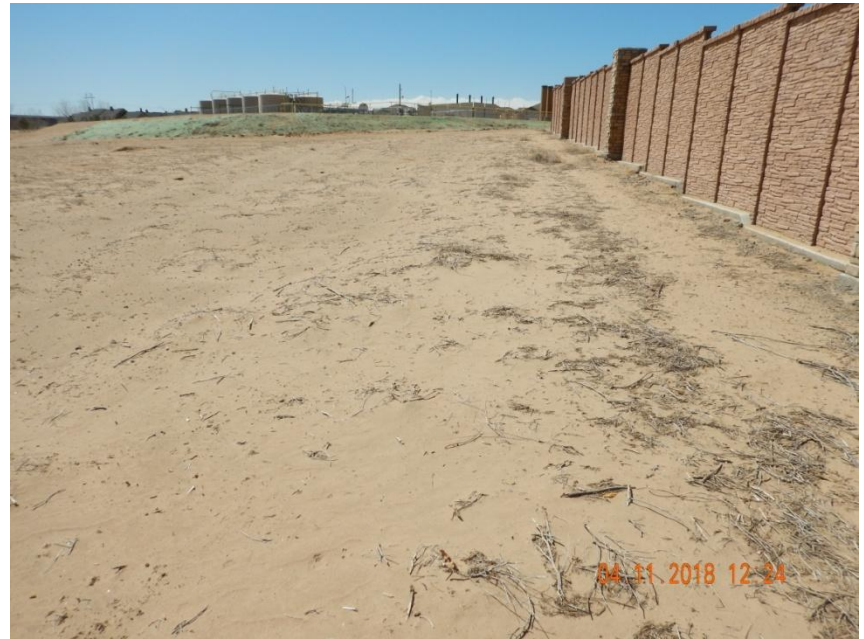
Photo 8. Photo taken from the northern location, facing West. See comments under Photo 7.

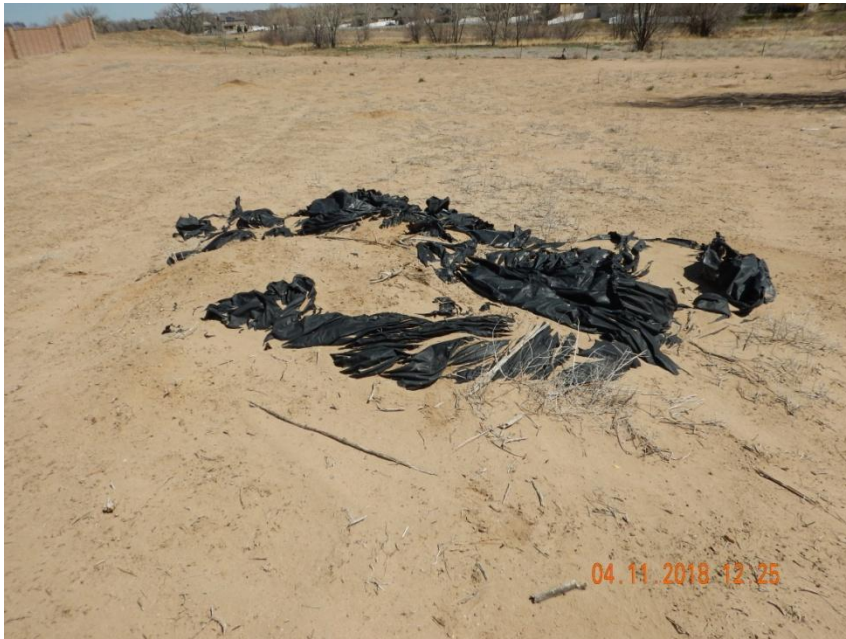
Photo 9. Photo taken from the northern location, facing East. Debris shall be removed per Rule 603.f.

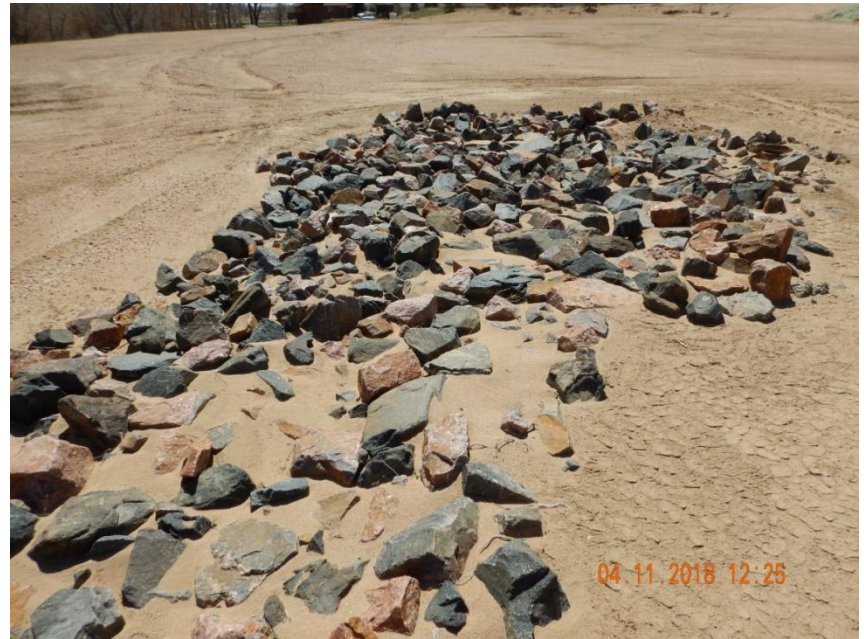
Photo 10. Photo taken from the northern well pad location, facing South. See comments under Photo 3.
