Inspection Photos

API: 05-067-06574

Operator: ENDURING RESOURCES LLC

Inspection Date: 3/21/2018

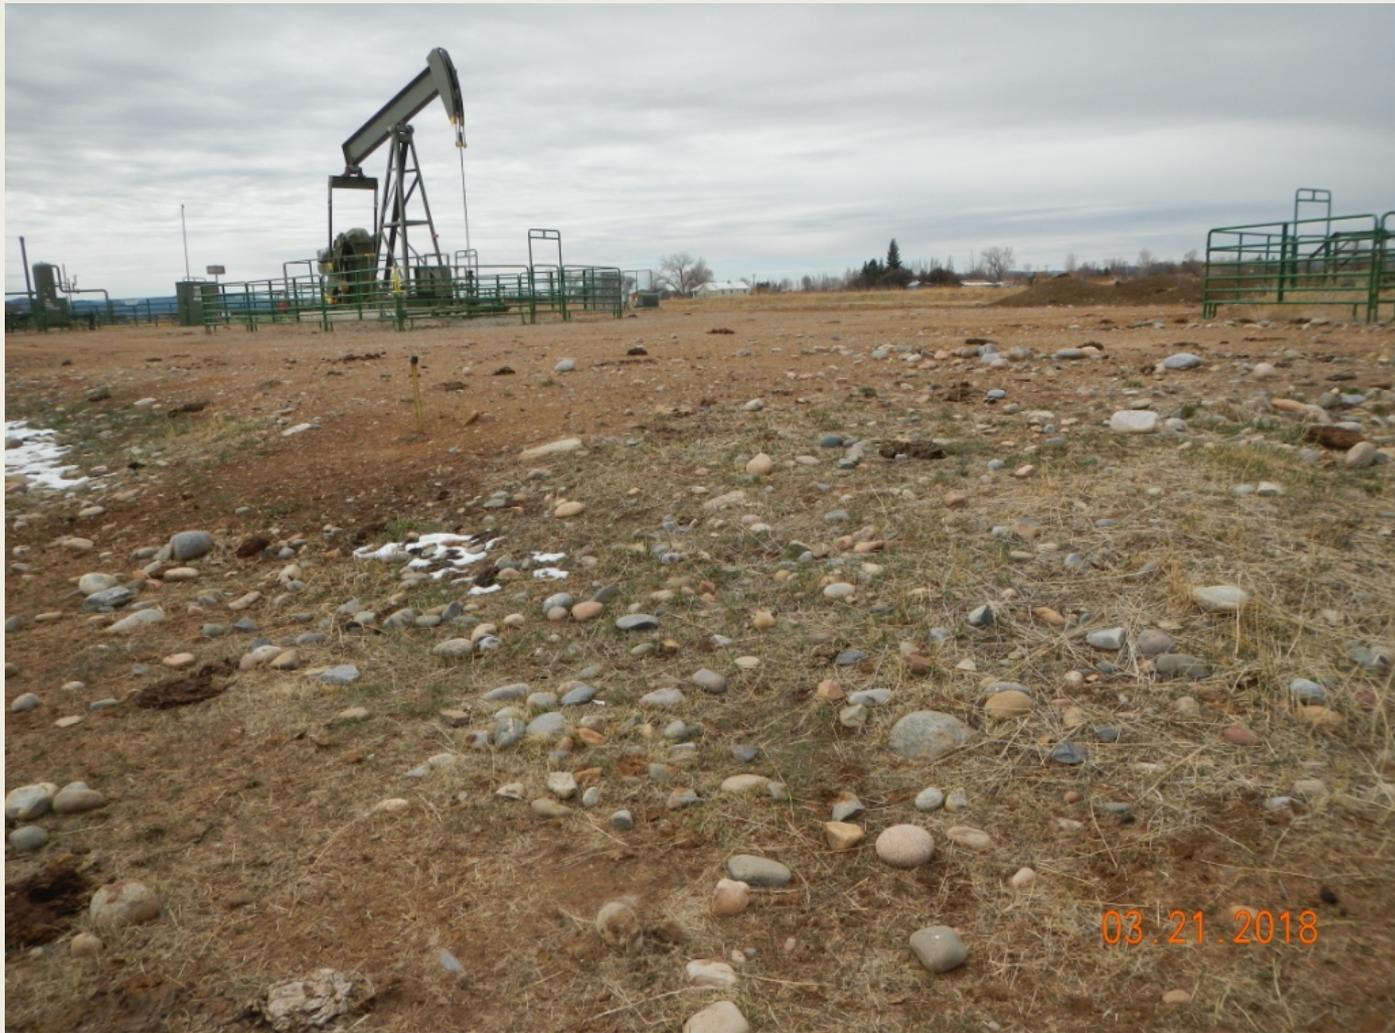
Photo 1. View of the project area from the southwestern corner facing center.

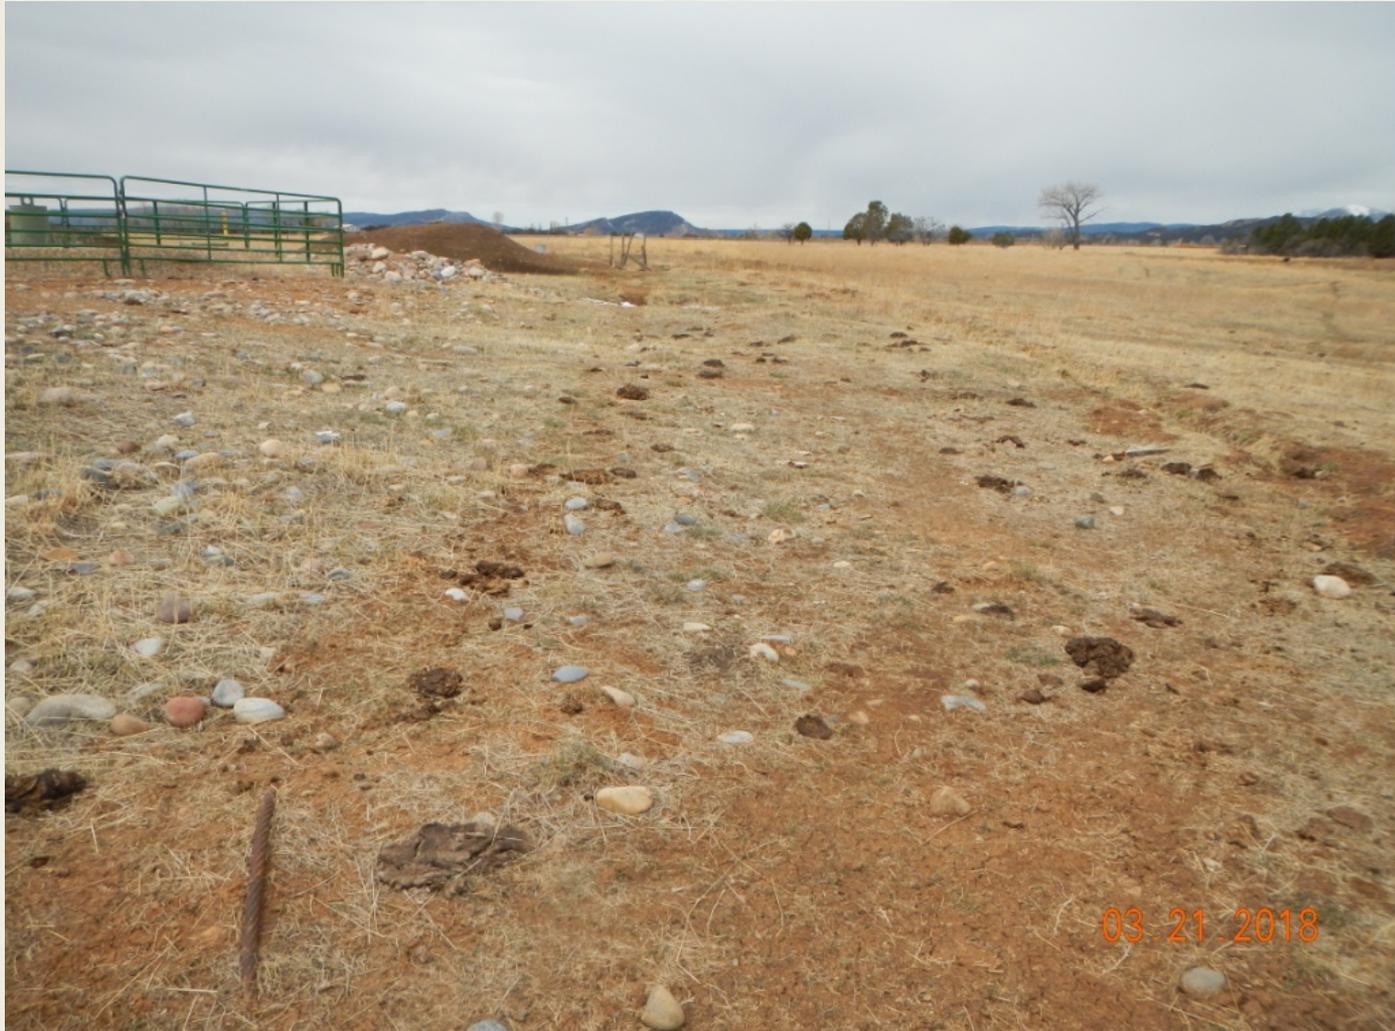
Photo 2. View of the northern portion of the project area from the northeastern corner facing westward.

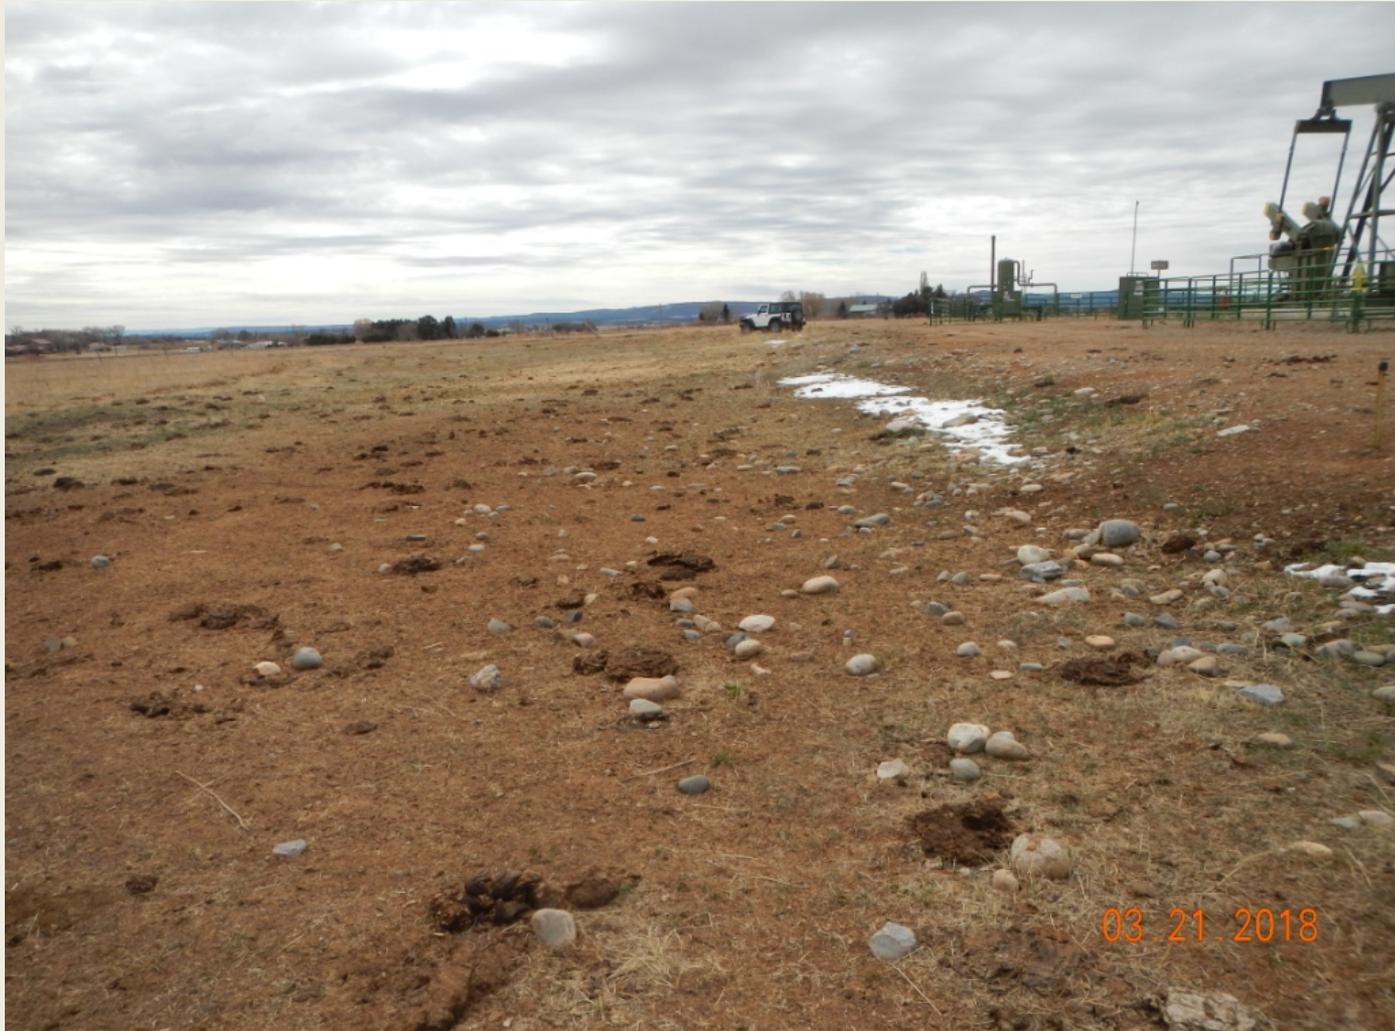
Photo 3. View of the eastern portion of the project area from the northeastern corner facing southward. Vegetation is grazed and not in identifiable condition.

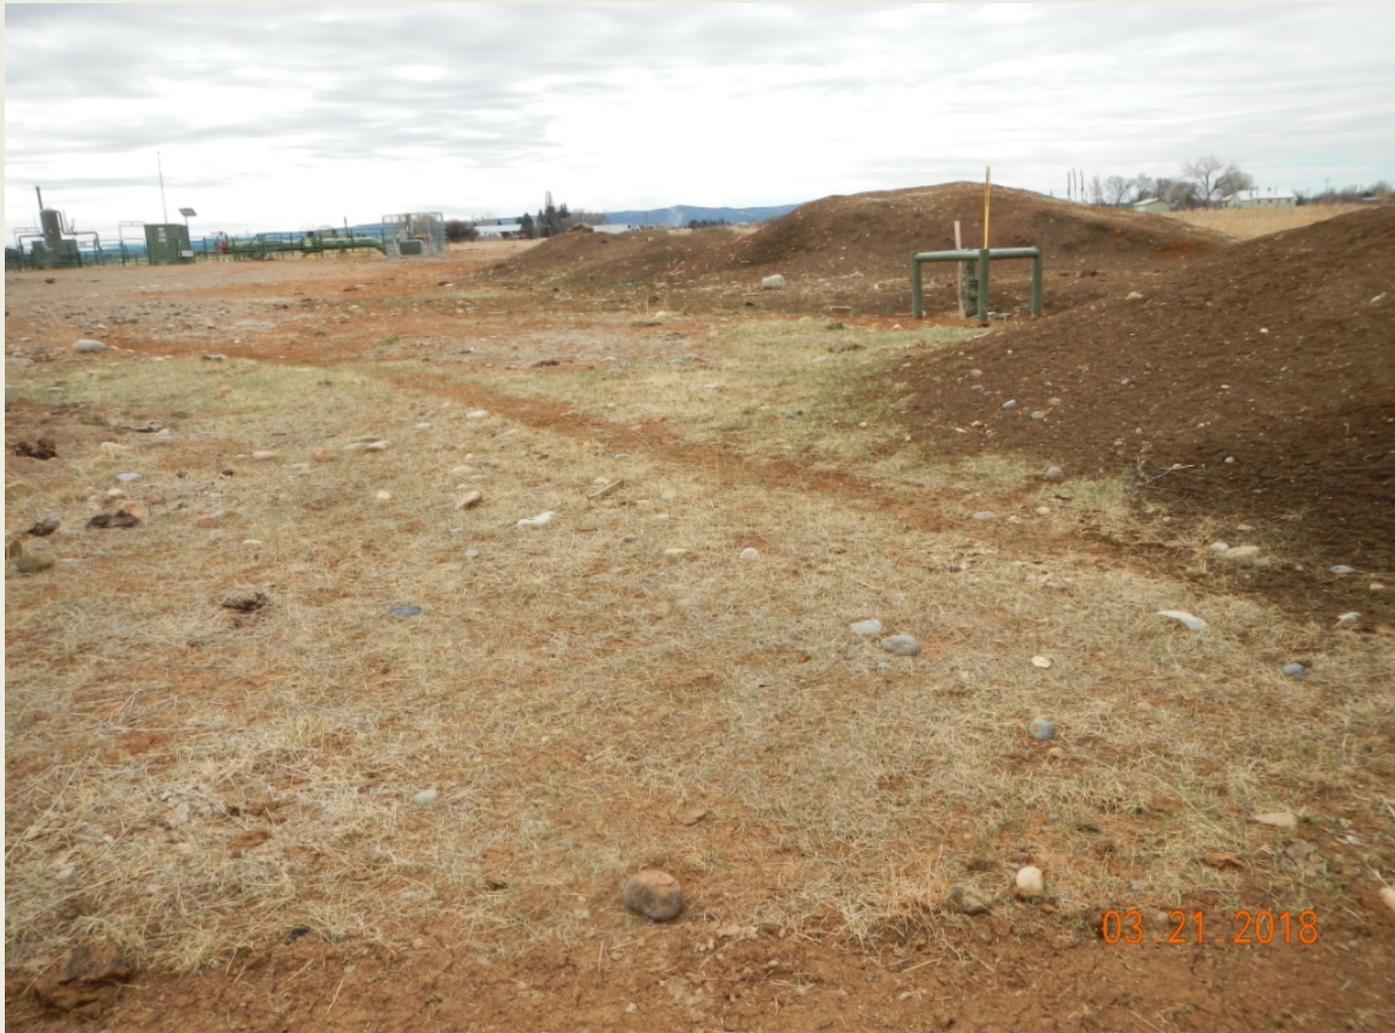
Photo 4. View of the western portion of the project area from the northwestern corner facing southward.

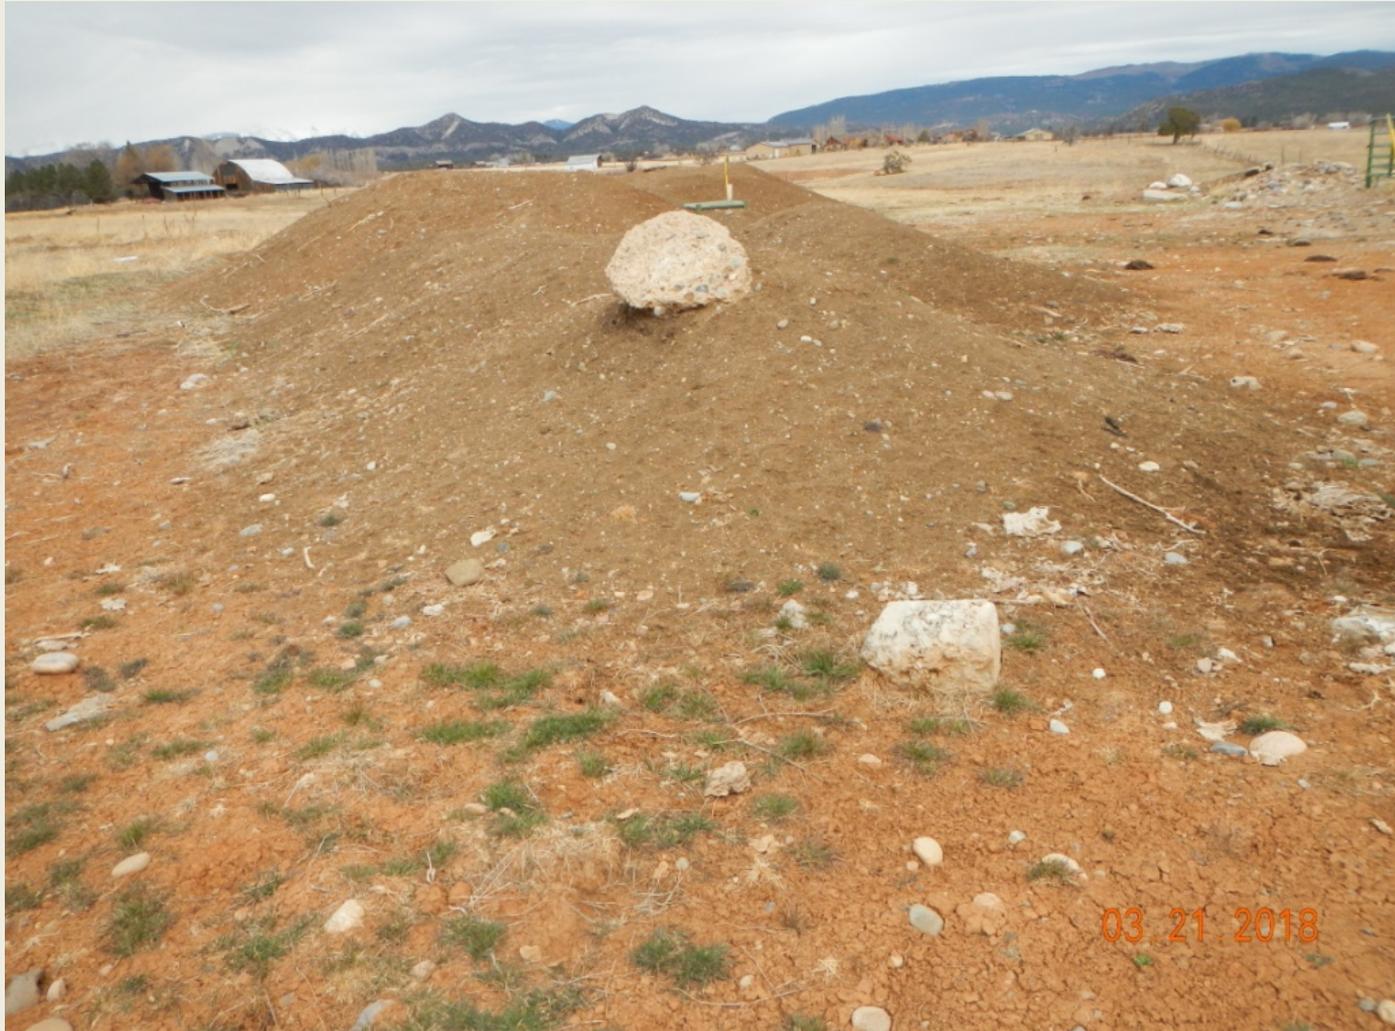
Photo 5. View of soil piles in the western project area. Cement debris, metal, and liner debris observed within the piles.

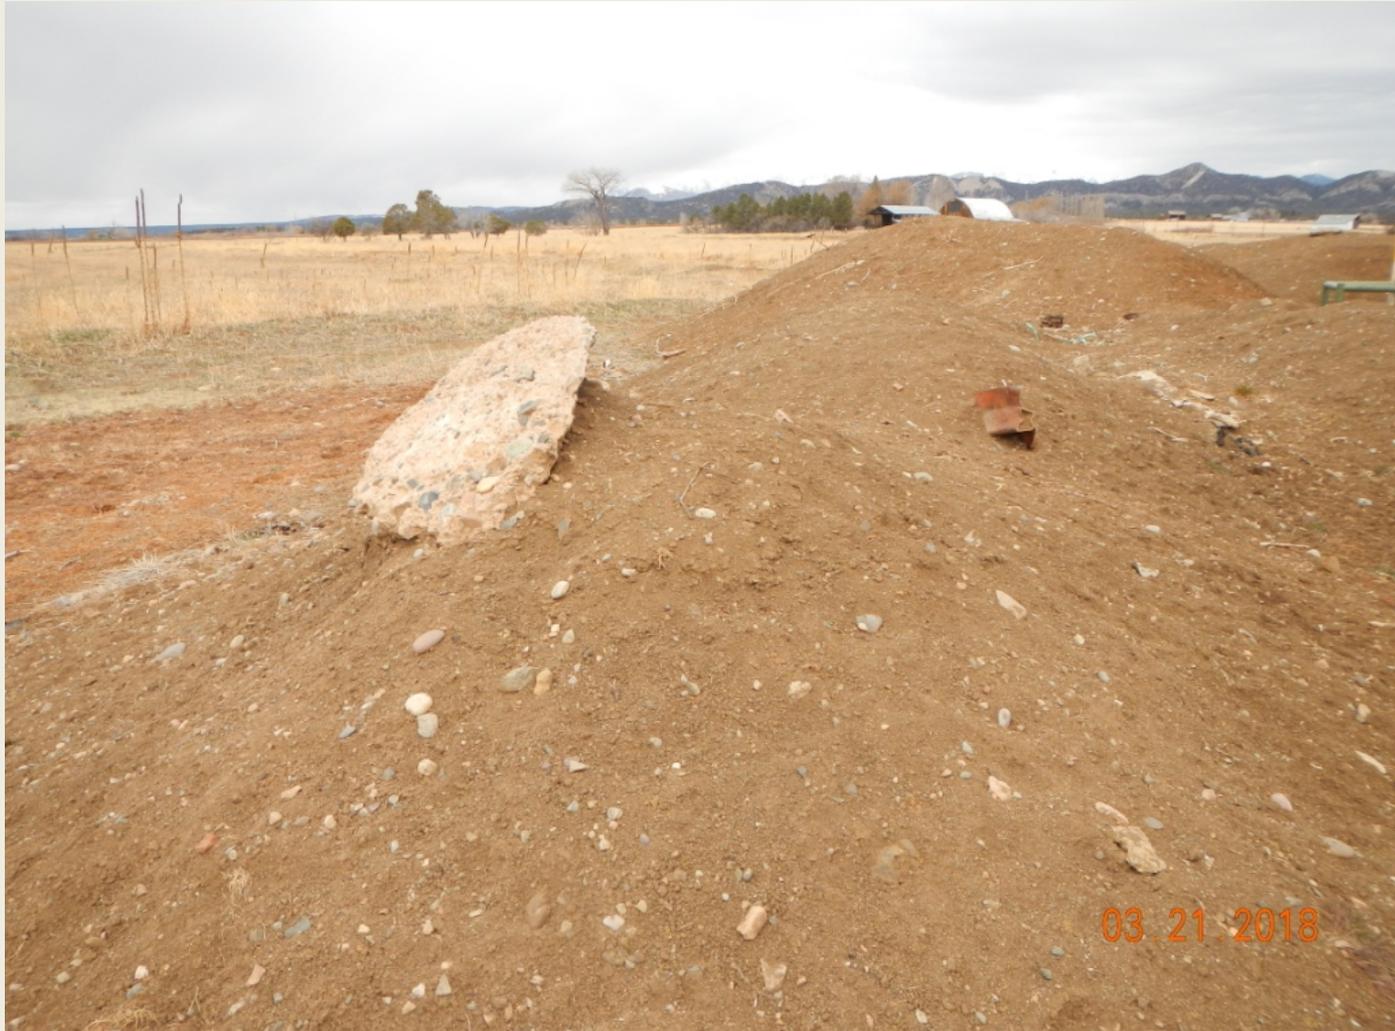
Photo 6. Closeup view of soil piles in the western project area and debris.
