Interim Reclamation and Stormwater Inspection

April 11, 2018

Operator: SRC ENERGY INC- #10311

Location ID: 434391

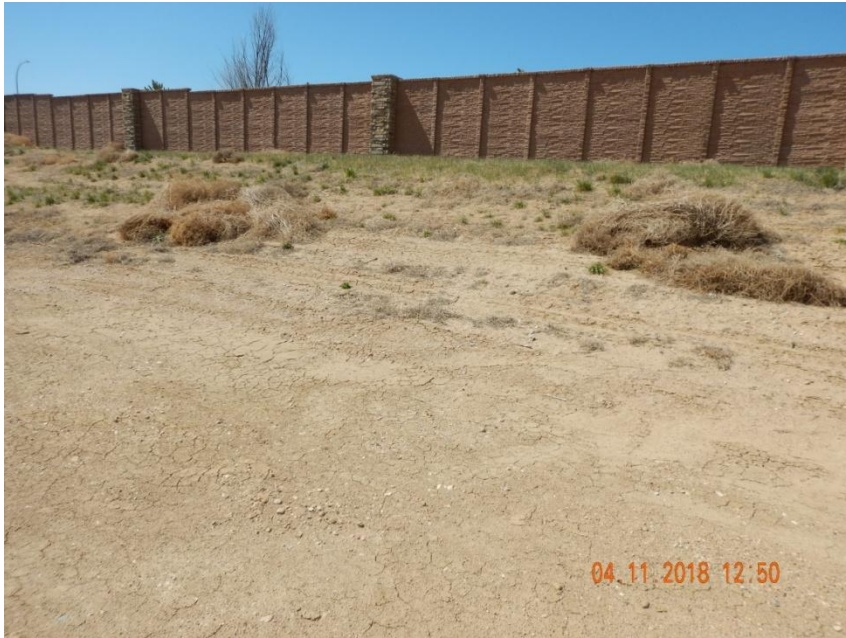
Photo 1. Photo taken from the western location, facing West. Russian thistle weed debris observed throughout portions of the location.

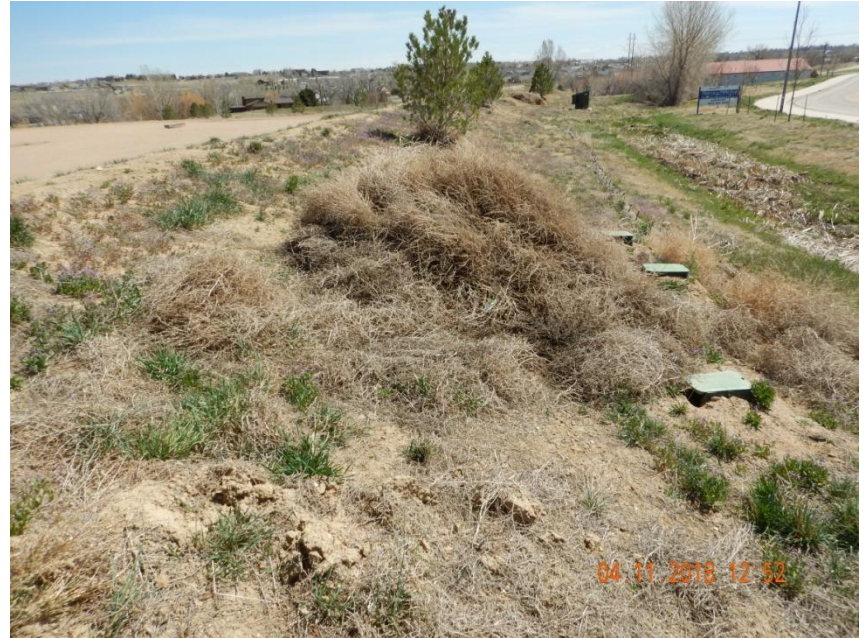
Photo 2. Photo taken from the southwest location, facing East. See comments under Photo 1. In addition, there does not appear to be sufficient perennial vegetation along the south-facing slope along the southern location.

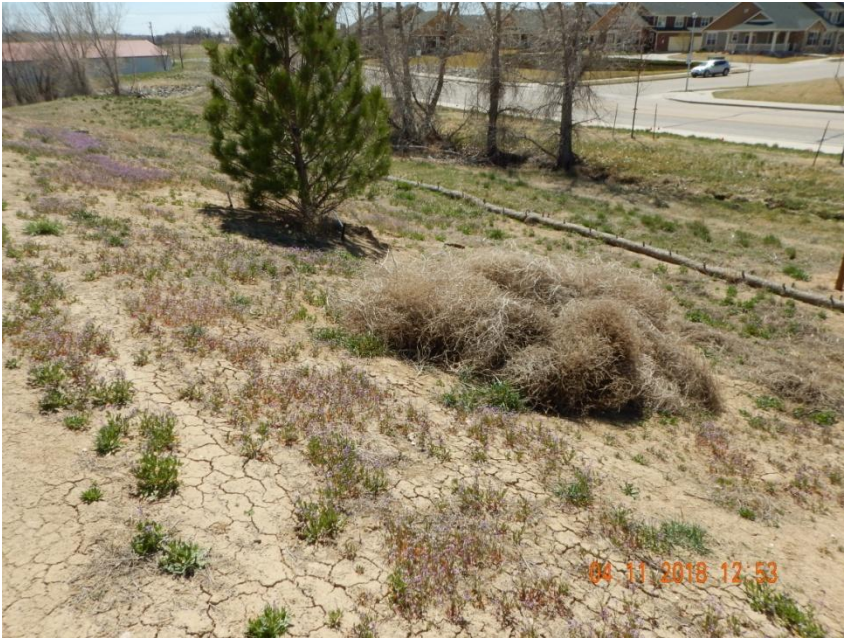
Photo 3. Photo taken from the southern location, facing Southeast. See comments under Photo 1 and 2.

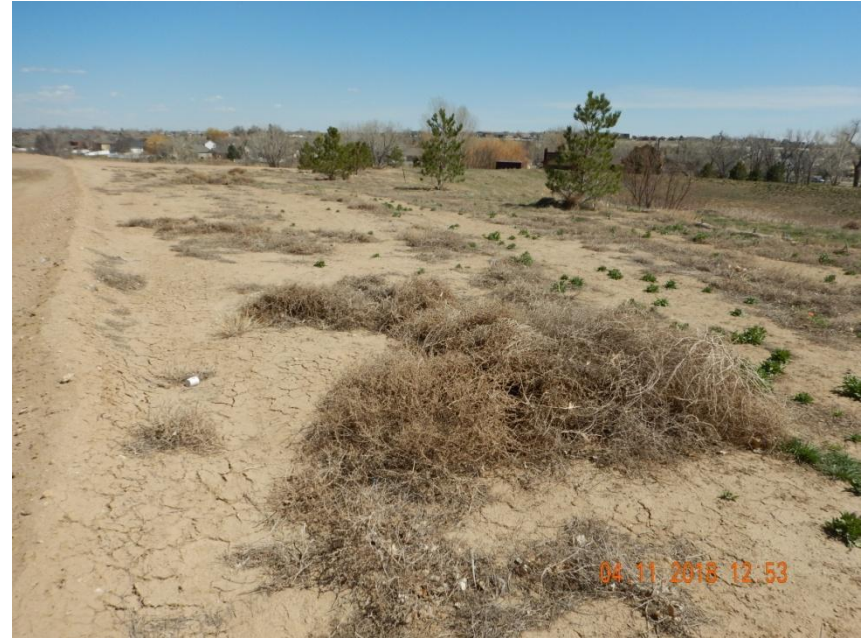
Photo 4. Photo taken from the southeast location, facing East. See comments under Photo 1. There is little to no perennial establishment along the southeast and eastern portions of the location.

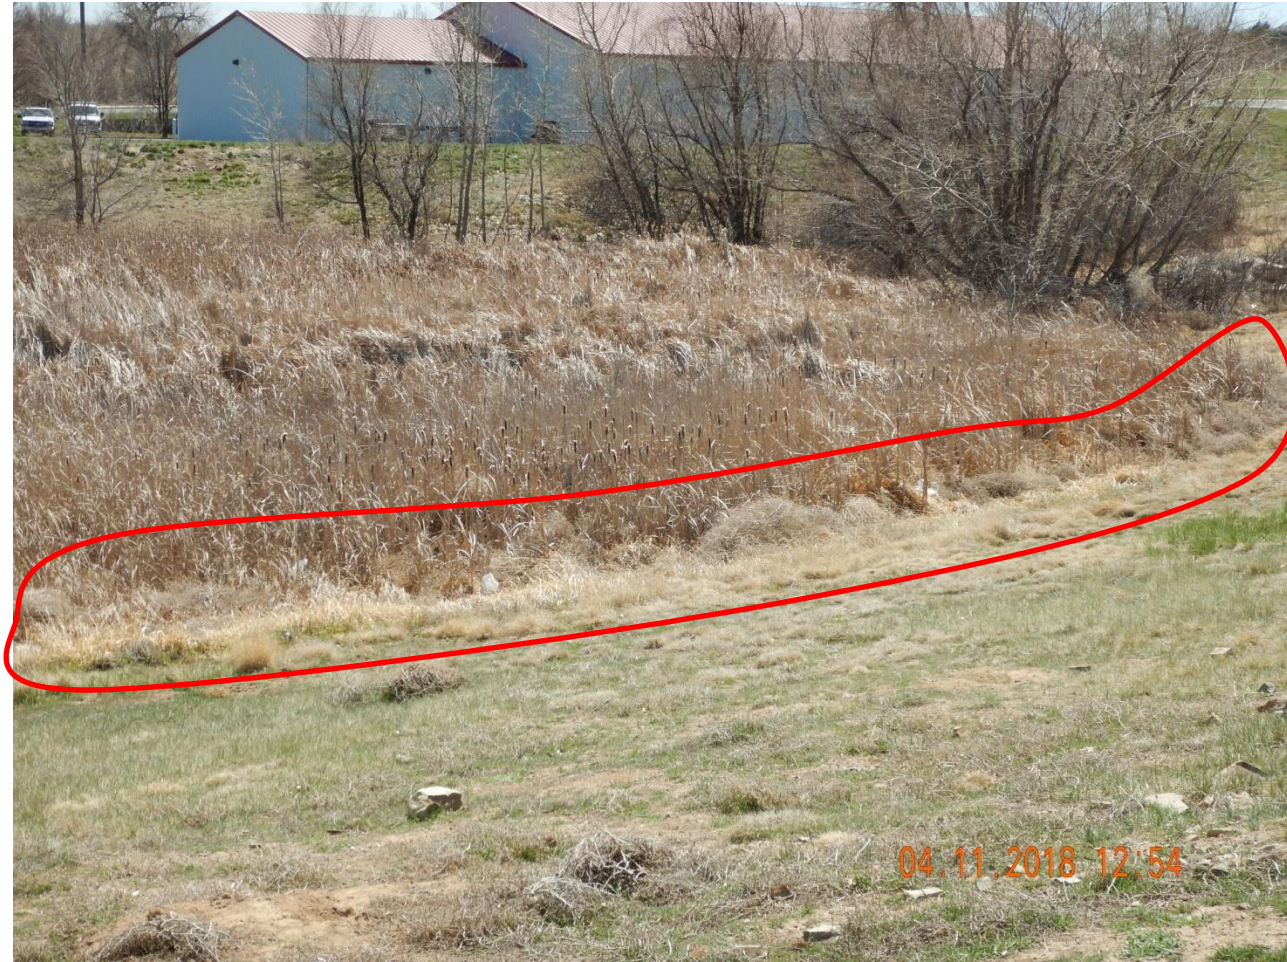
Photo 5. Photo taken from the southeastern location, facing South. Photo illustrates Russian thistle weed debris that has blown off location.

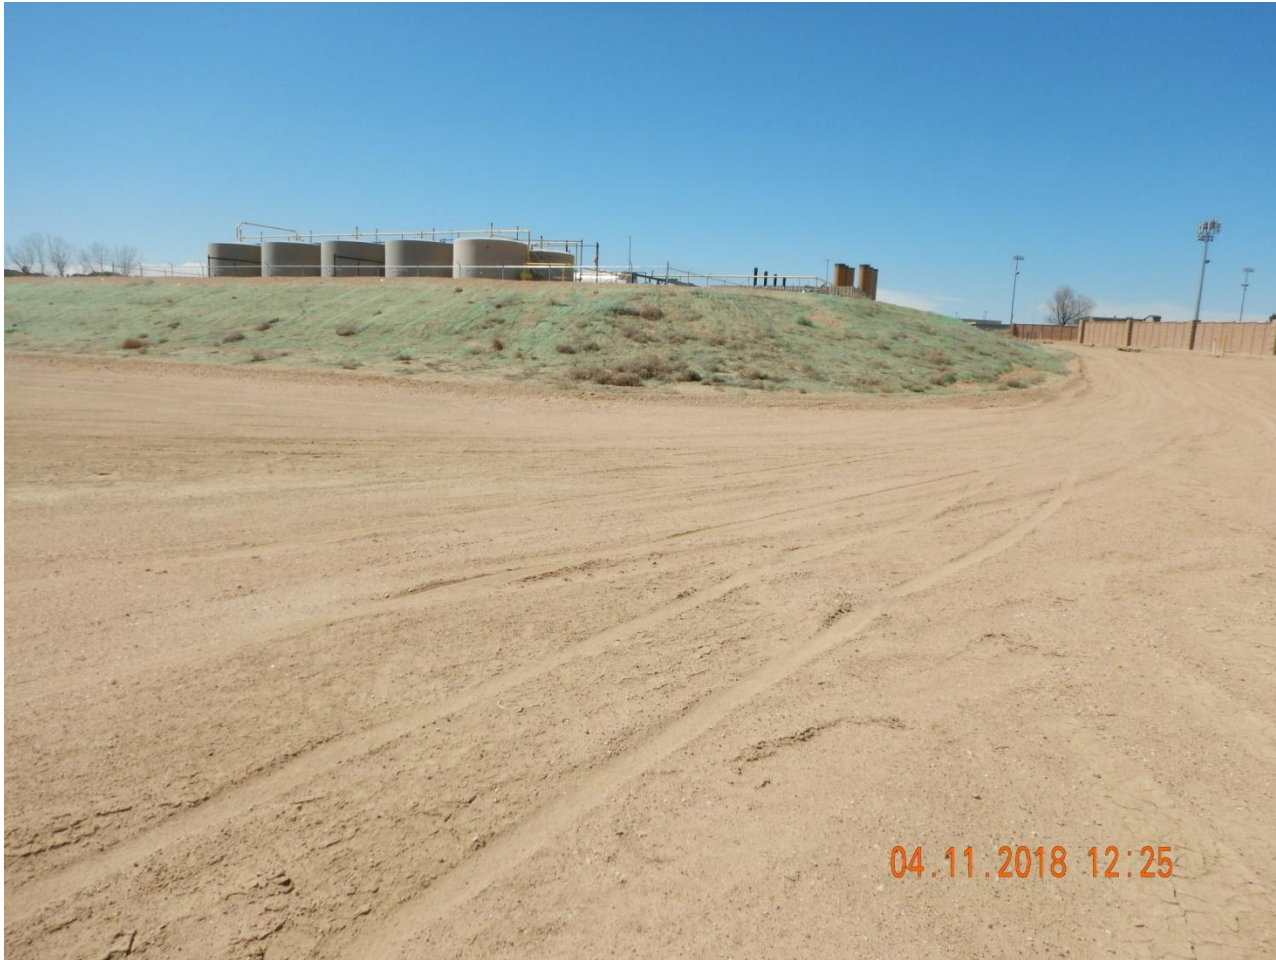
Photo 6. Photo taken east of the location, facing West. The fill north and east fill slopes have not been stabilized. Erosion blanket netting no longer in proper functioning condition.

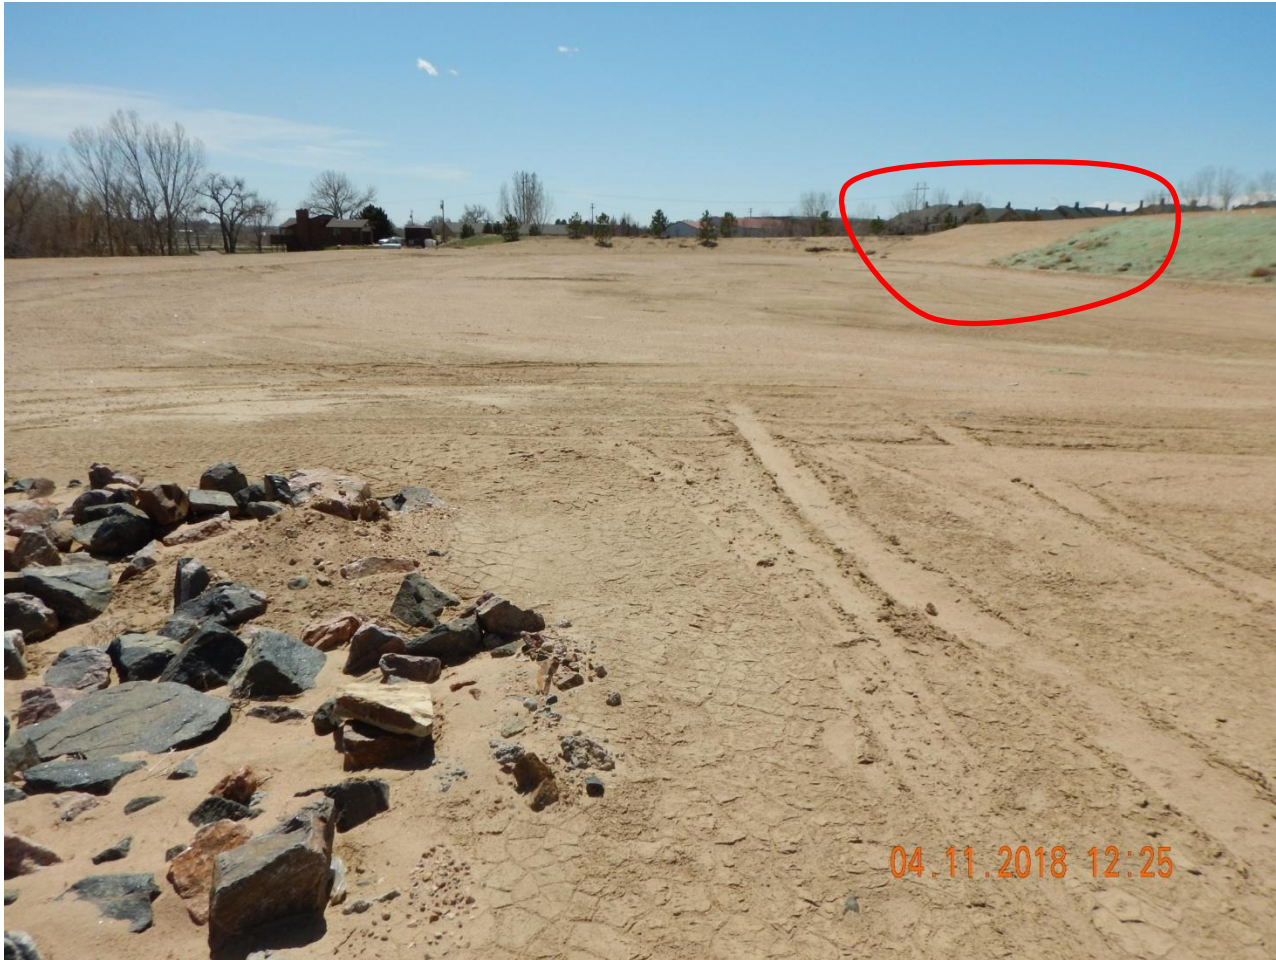
Photo 7. Photo taken east of the location, facing South. Photo illustrates the southeast fill slopes has not been stabilized.

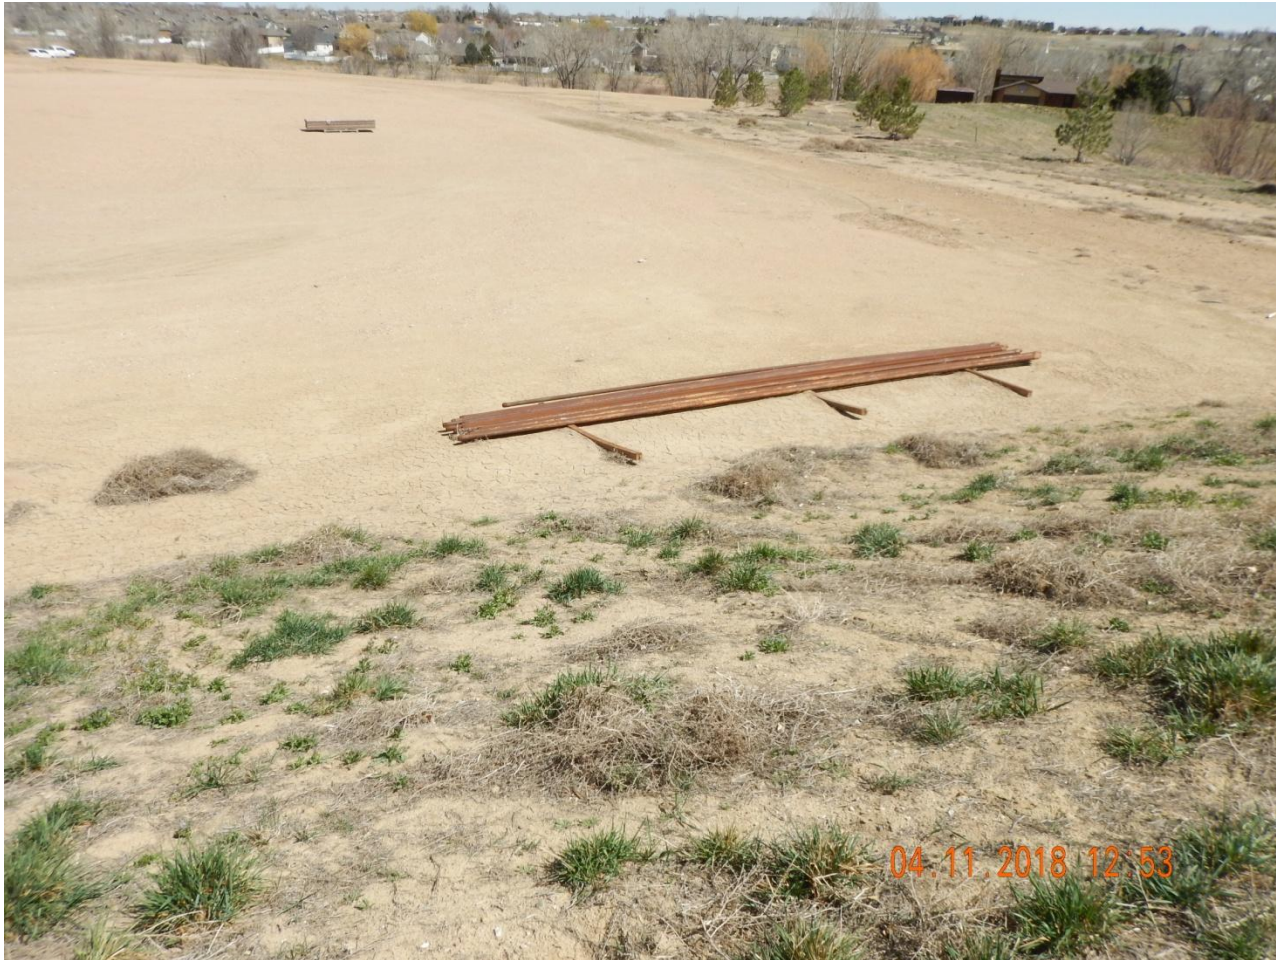
Photo 8. Photo taken from the southeast location, facing Northeast. Unused equipment needs to be removed per Rule 603.f.
