Final Reclamation Inspection

Operator: NOBLE ENERGY INC- #100322

API: 05-123-12233

Inspection Photos
Location Name: G W DOERING #1-28
API: 05-123-12233

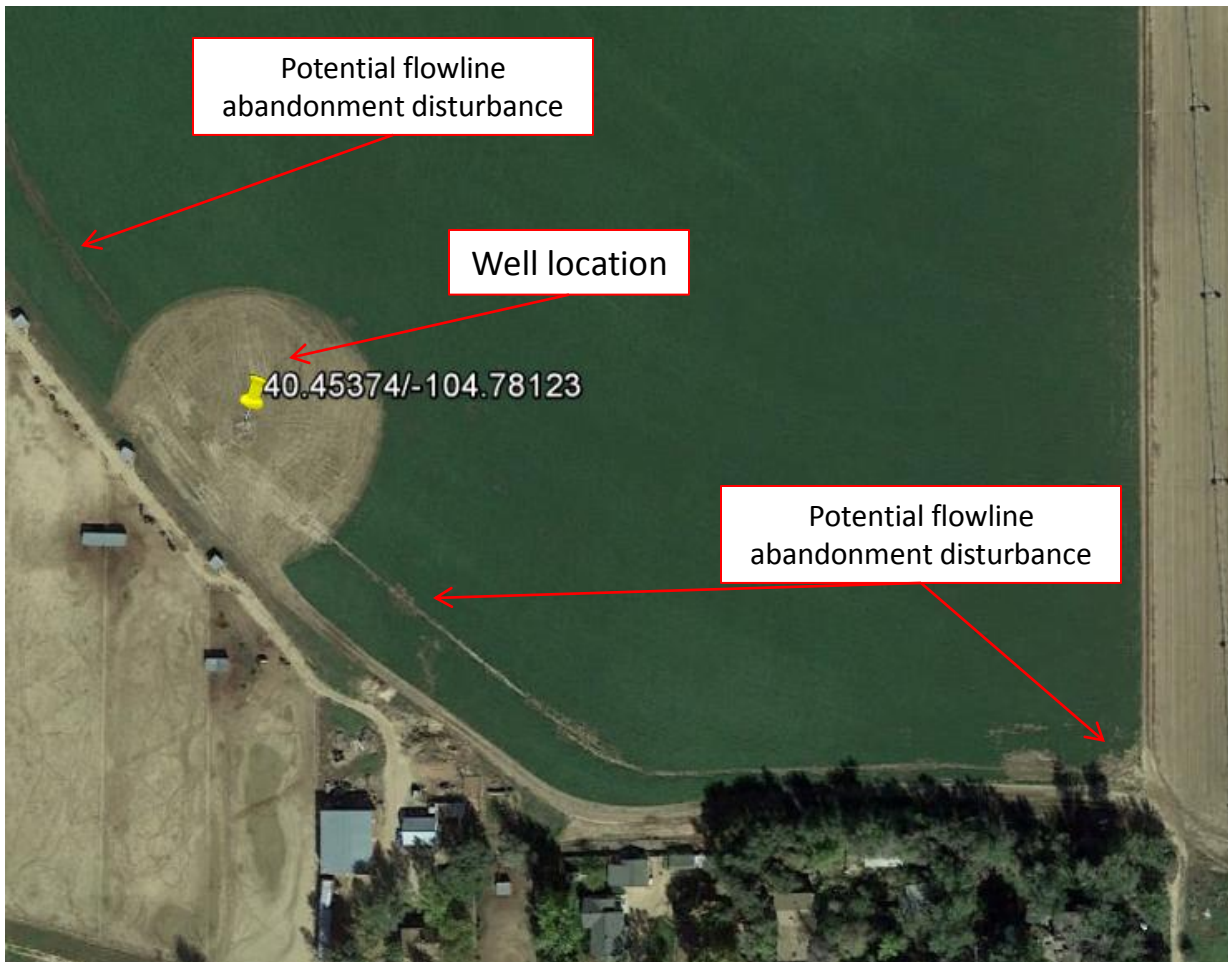
Google Earth aerial imagery taken October 14, 2017, post plugging operations. Image illustrates plugging disturbances around the well location. Also, there appears to be other disturbances that might be associated with potential flowline abandonment.

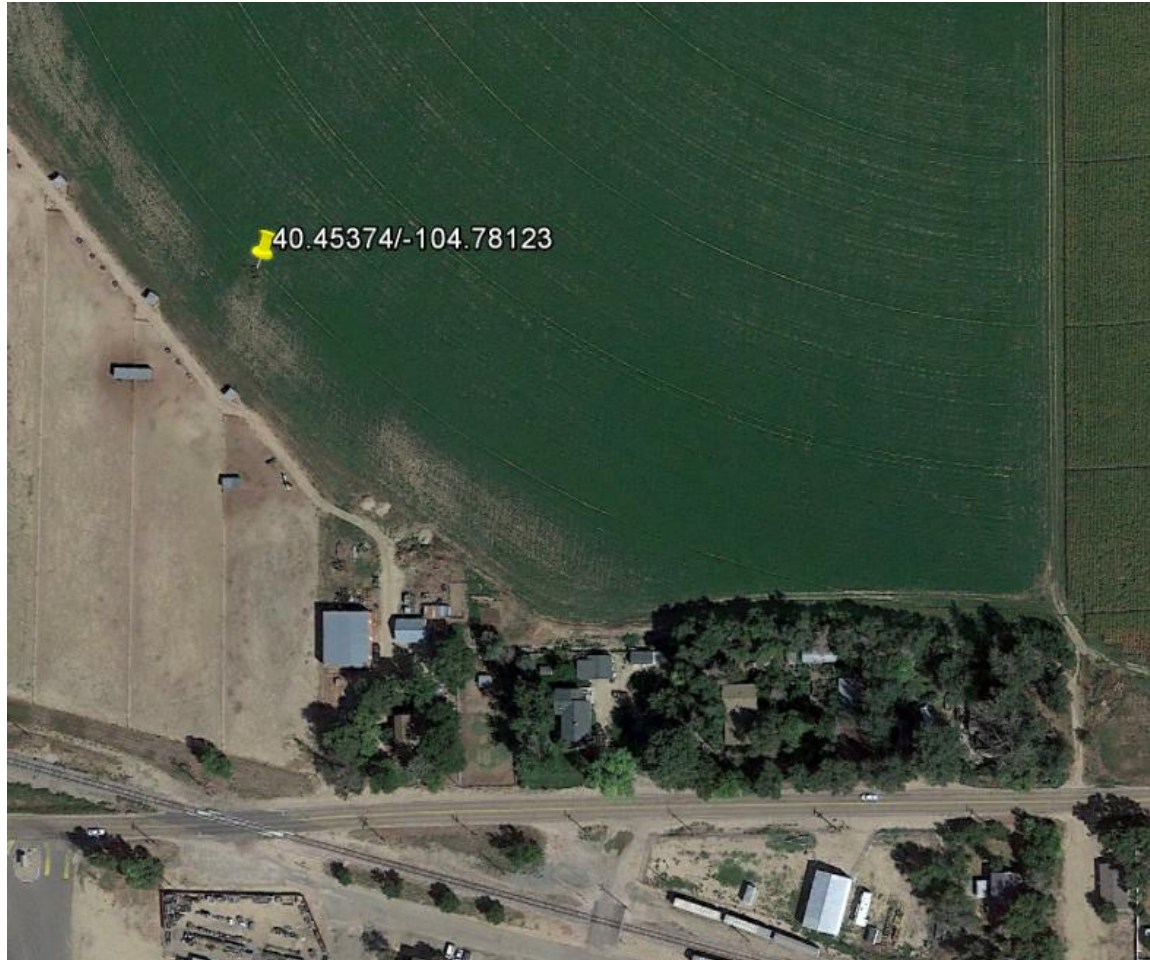
Google Earth aerial imagery taken September 7, 2017, before plugging operations.

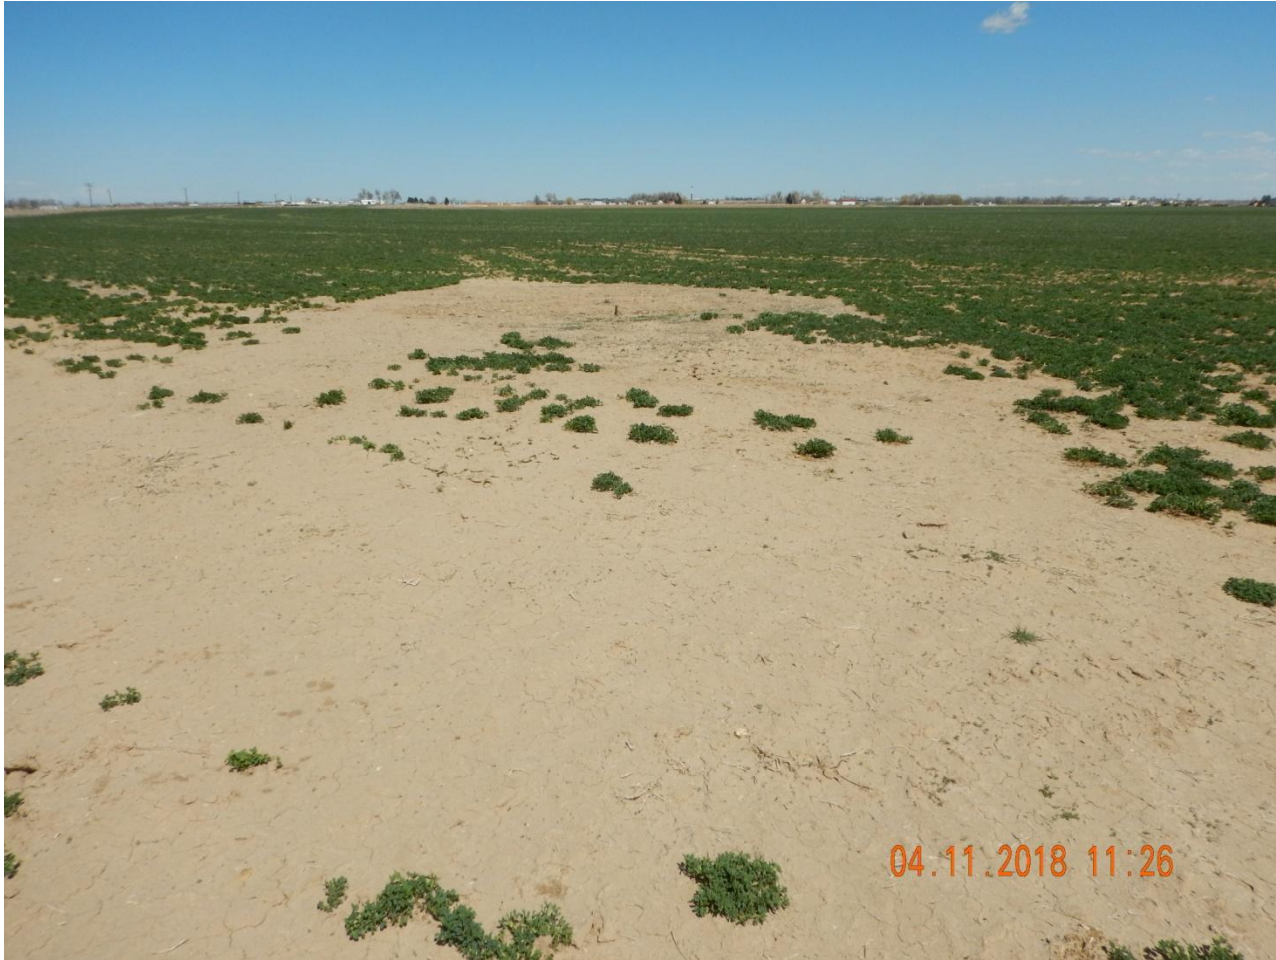
Photo 1. Photo taken from the well location, facing North. Well location is not reflective of reference crop areas (no growth throughout portions surrounding the well location).

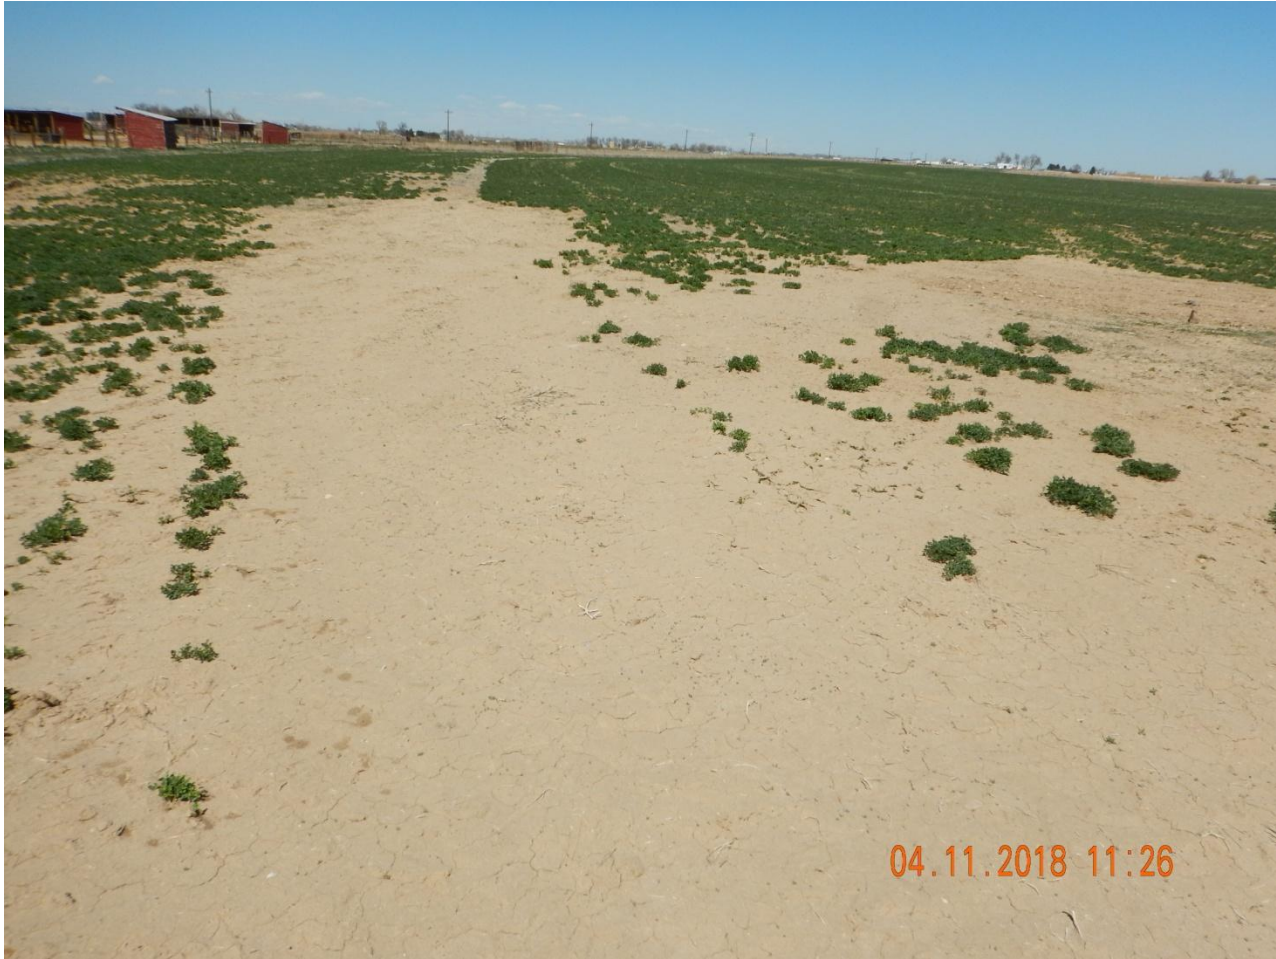
Photo 2. Photo taken from the well location, facing Northwest. There appears to be other disturbances that might be associated with potential flowline abandonment. If that is the case, then the Operator shall comply with Rule 1004 throughout all disturbance areas of the flowline abandonment.

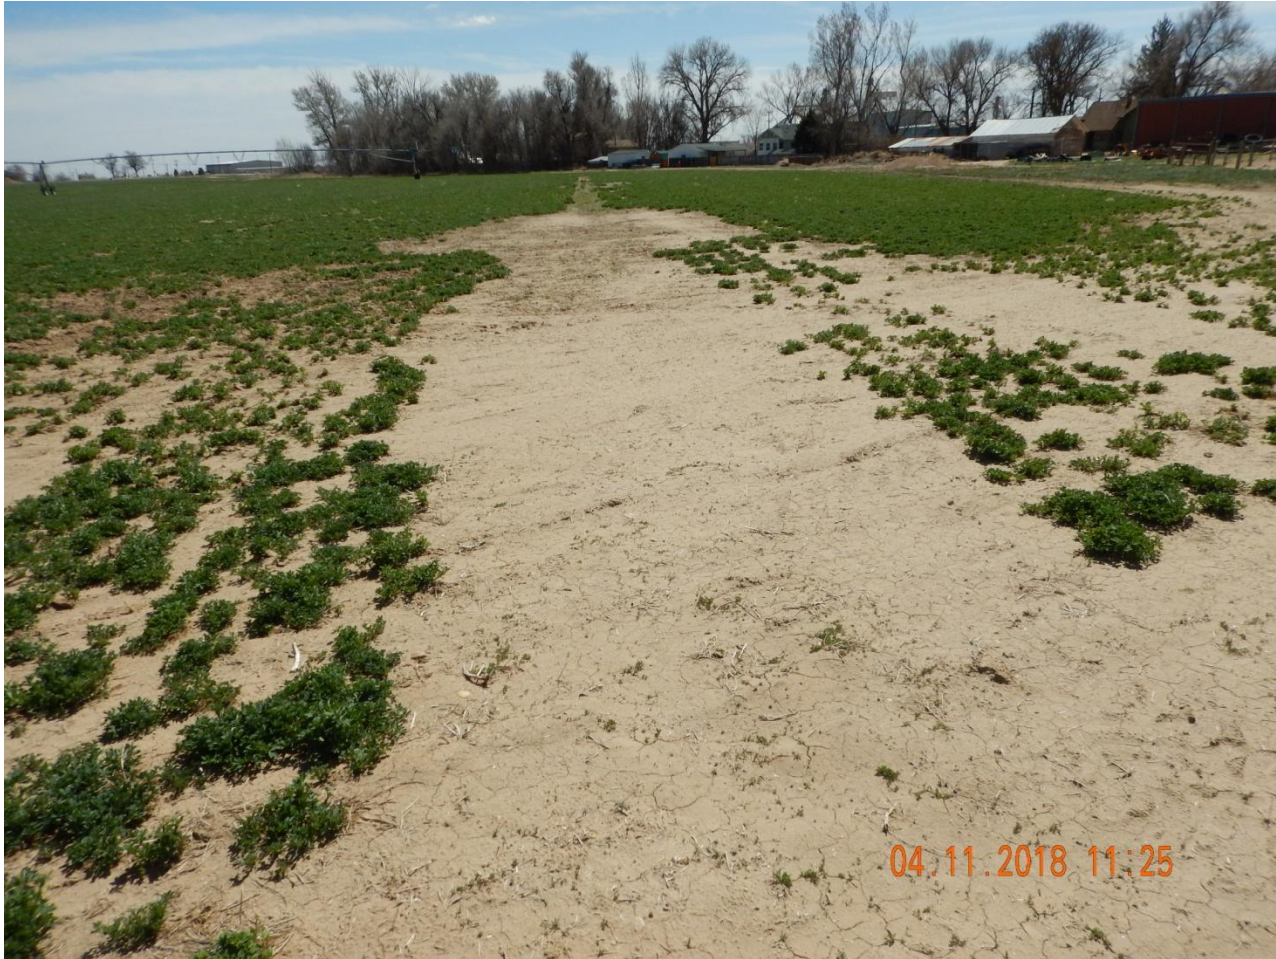
Photo 3. Photo taken from the well location, facing South. See comments under Photo 2.

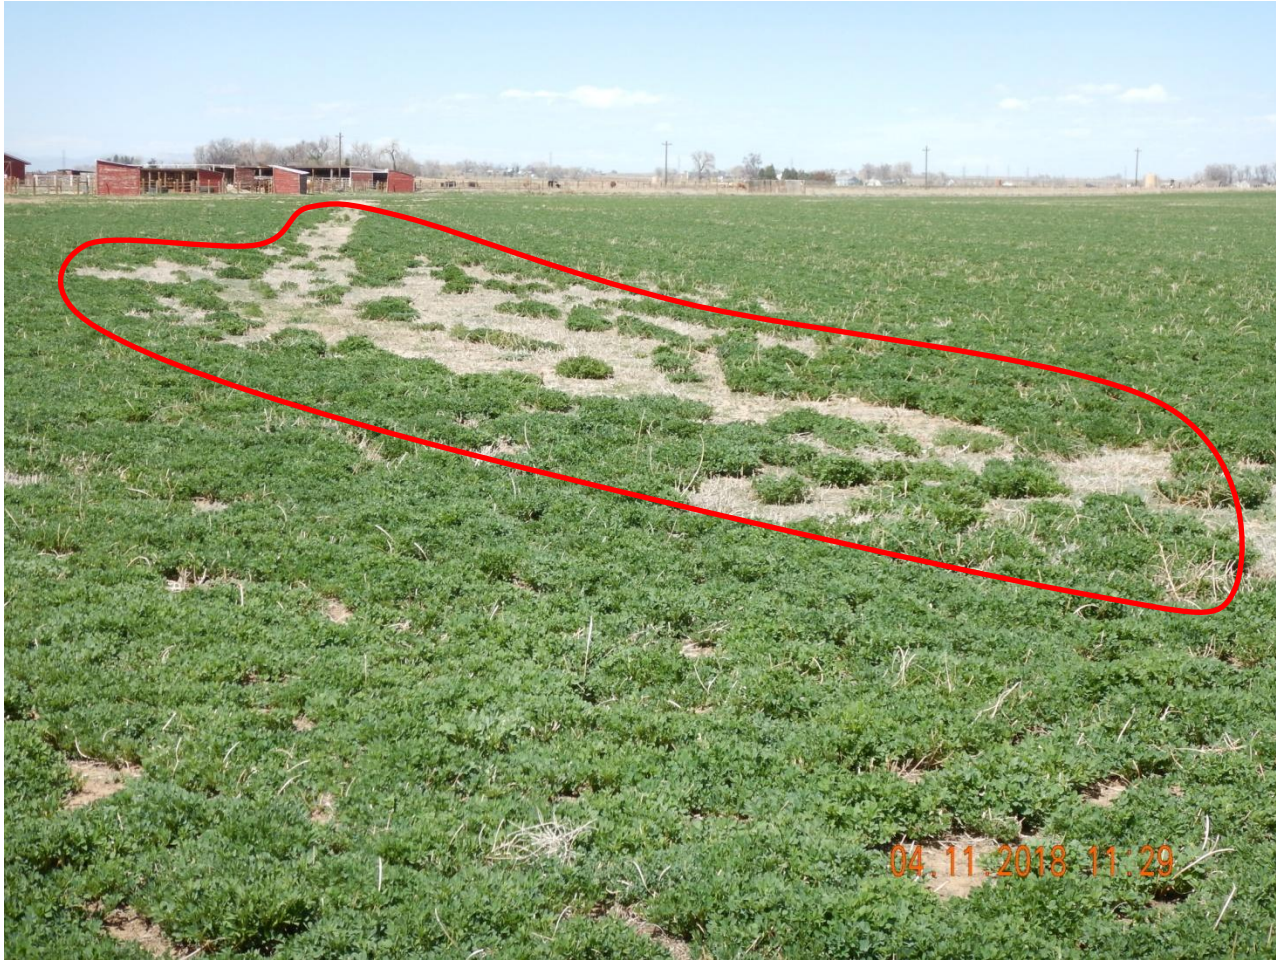
Photo 4. Photo taken east of the well location, facing West. See comments under Photo 2.

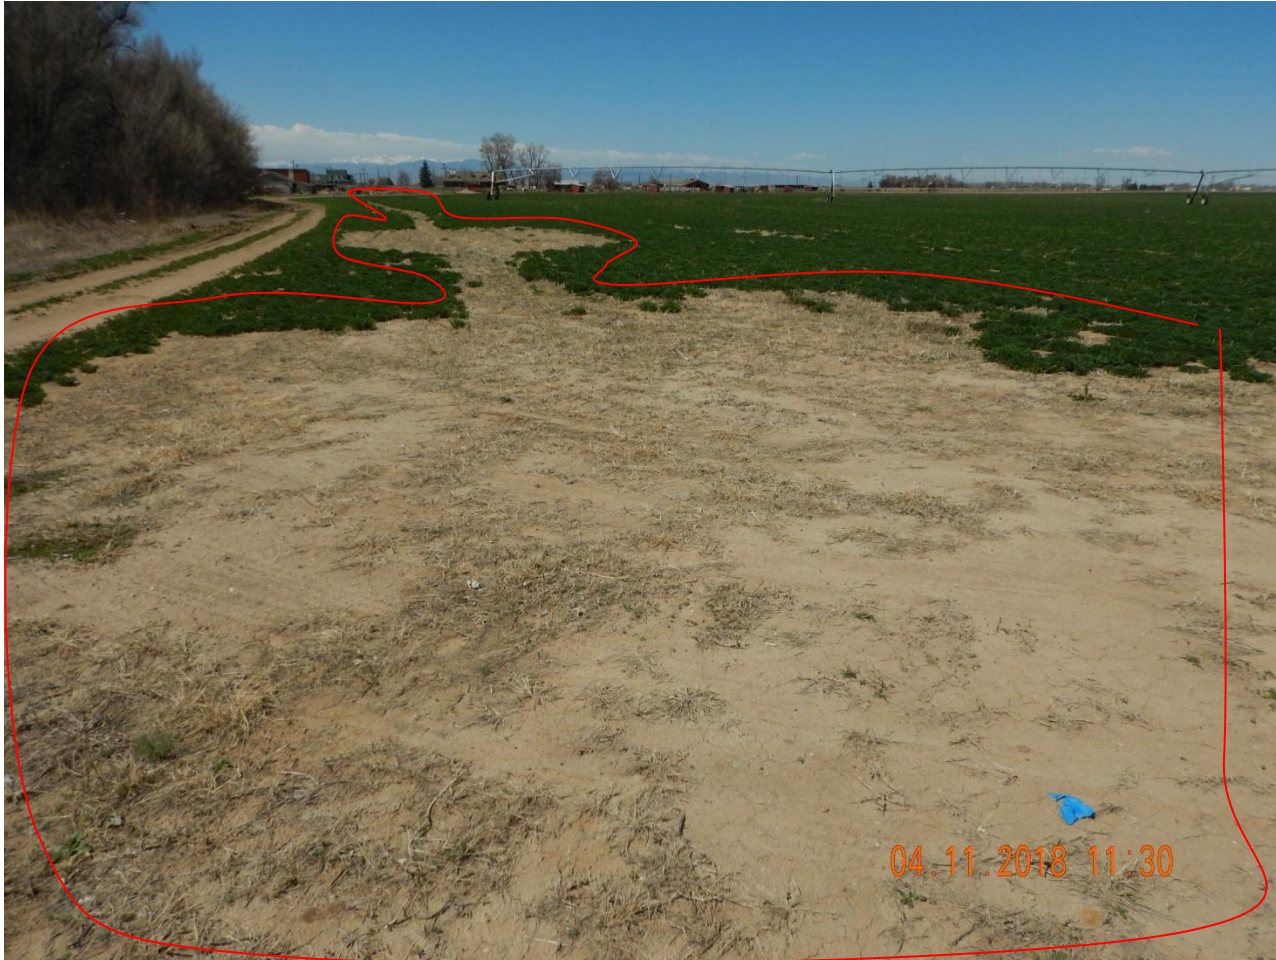
Photo 5. Photo taken east of the well location, facing West. See comments under Photo 2.
