Inspection Photos

API: 05-067-06571

Operator: BP AMERICA PRODUCTION COMPANY

Inspection Date: 3/21/2018

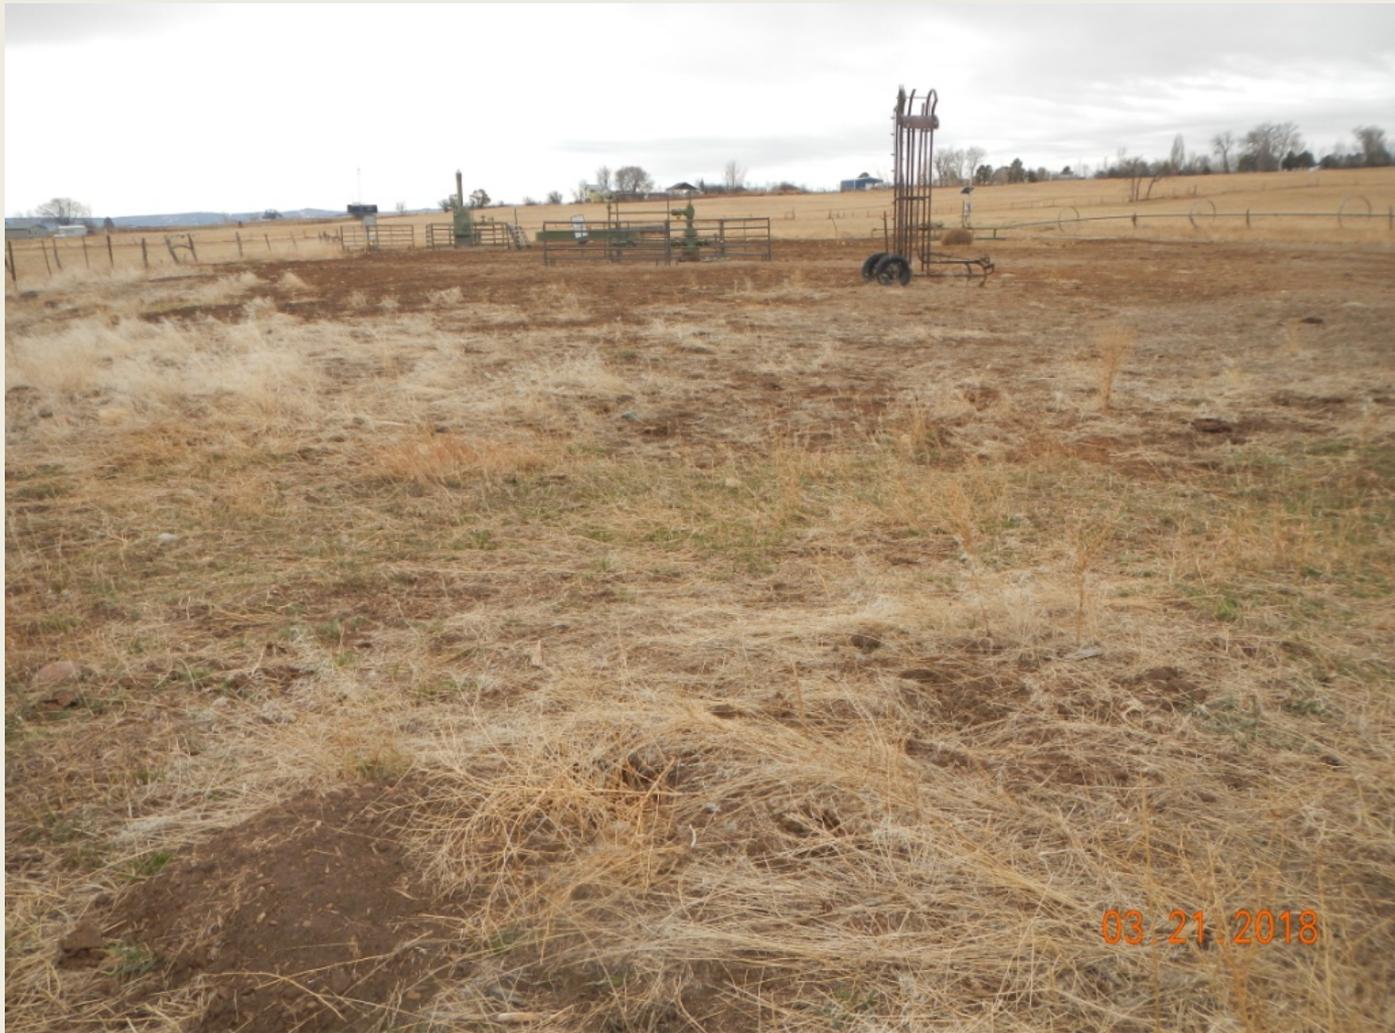
Photo 1. View of the project area from the northeastern corner facing center.

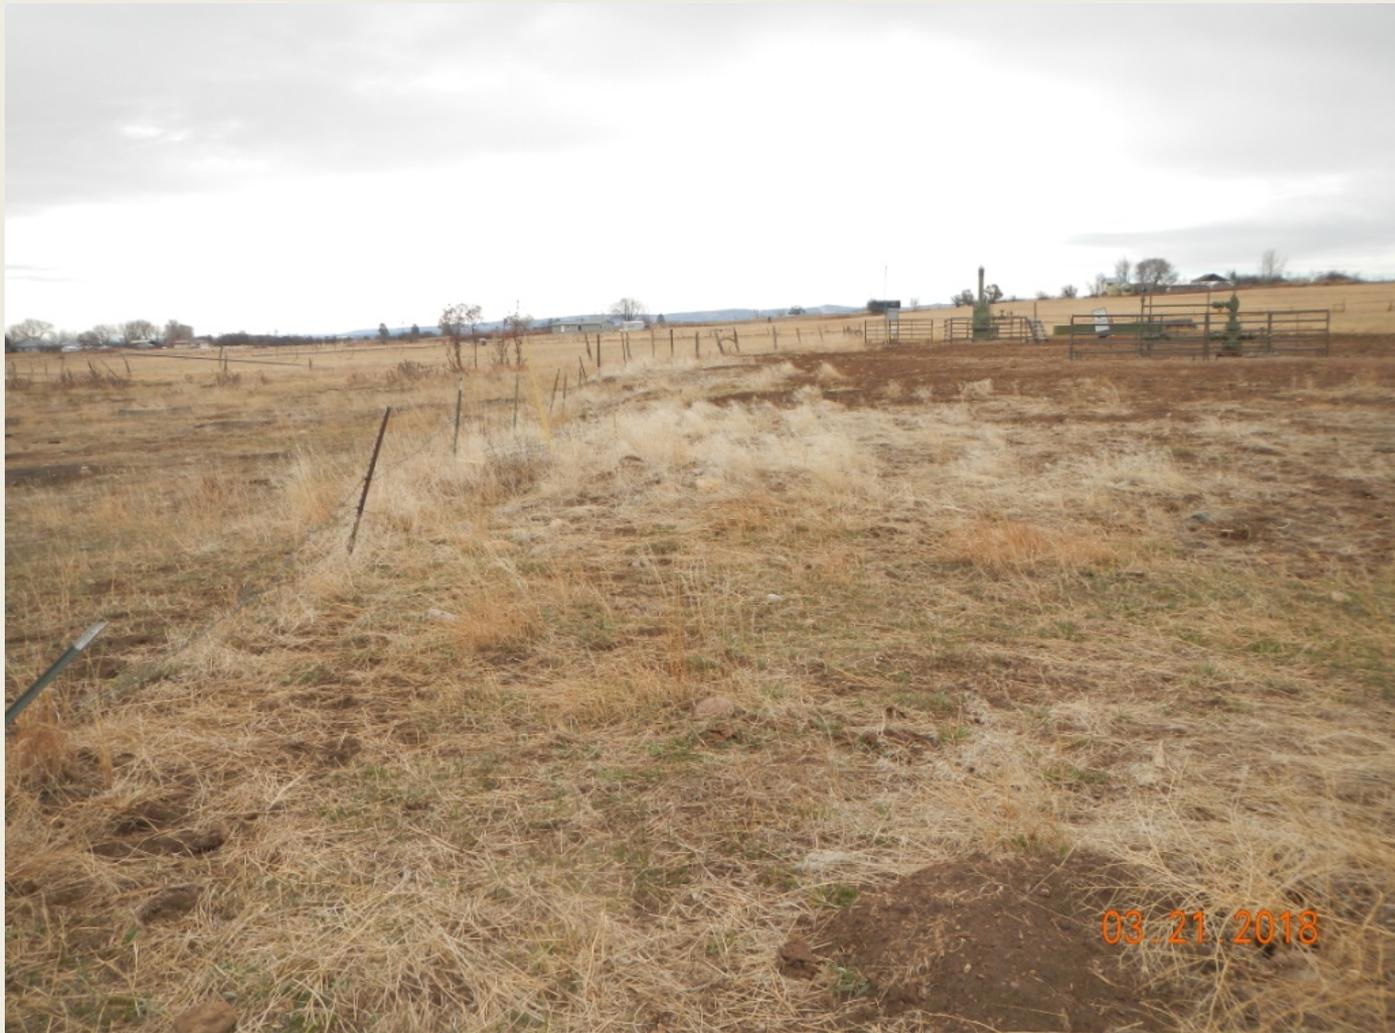
Photo 2. View of the eastern portion of the project area from the northeastern corner facing southward. Revegetation is comprised of a mix of desirable grasses such as smooth brome (*Bromus inermis*) and weeds such as yellow tumbled mustard (*Sysimbrium altissimum*).

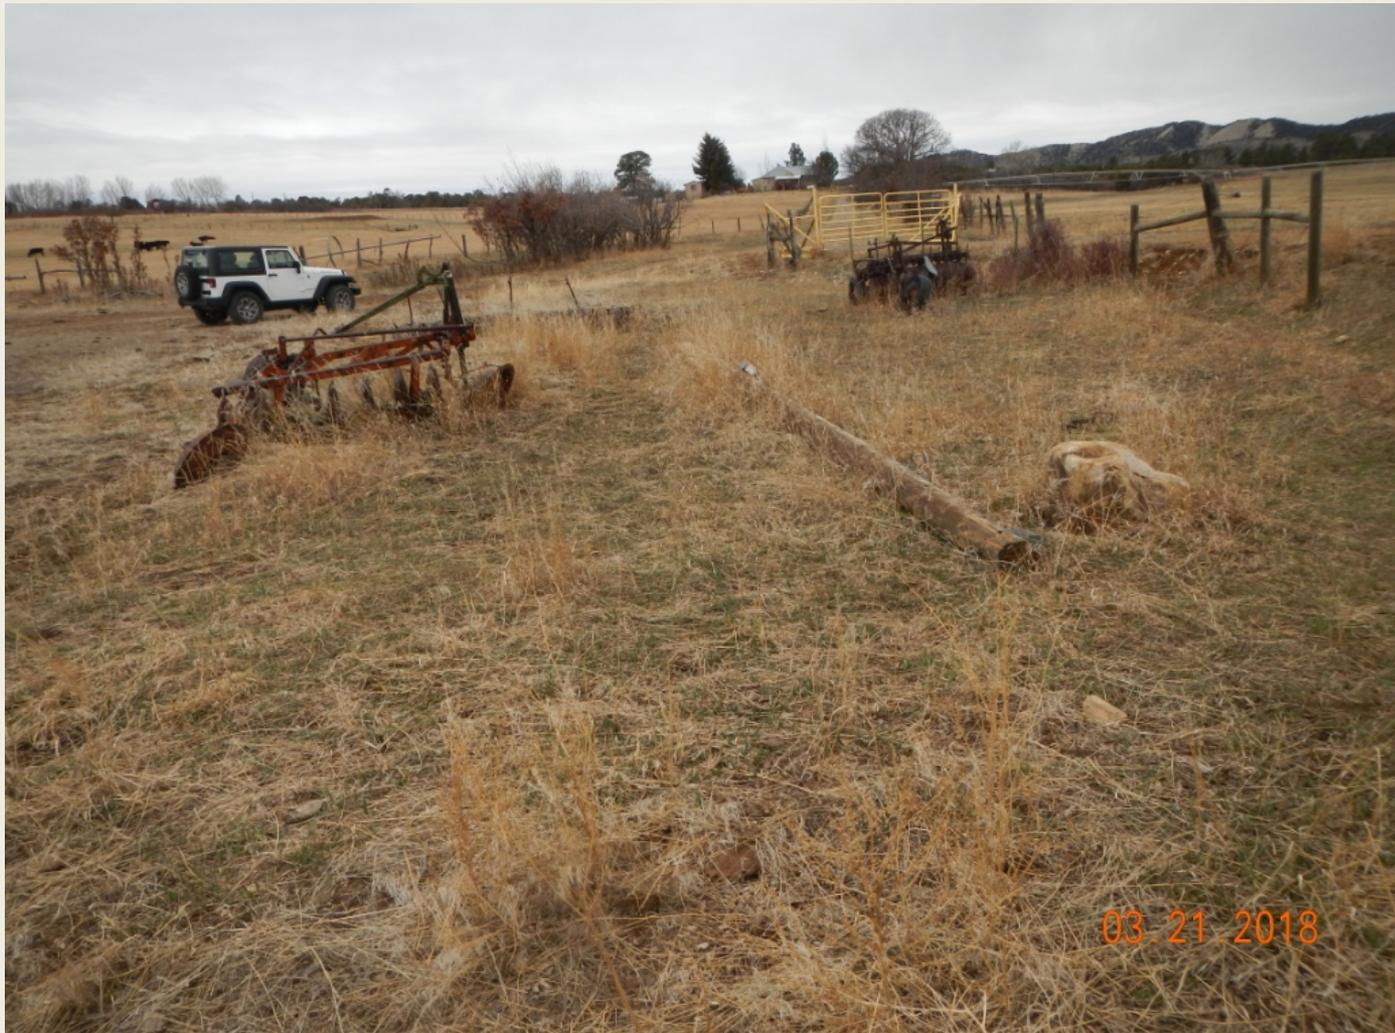
Photo 3. View of the northern portion of the interim reclamation area from the northeastern corner facing westward. What appears to be surface owner equipment is stored in the interim reclamation area.

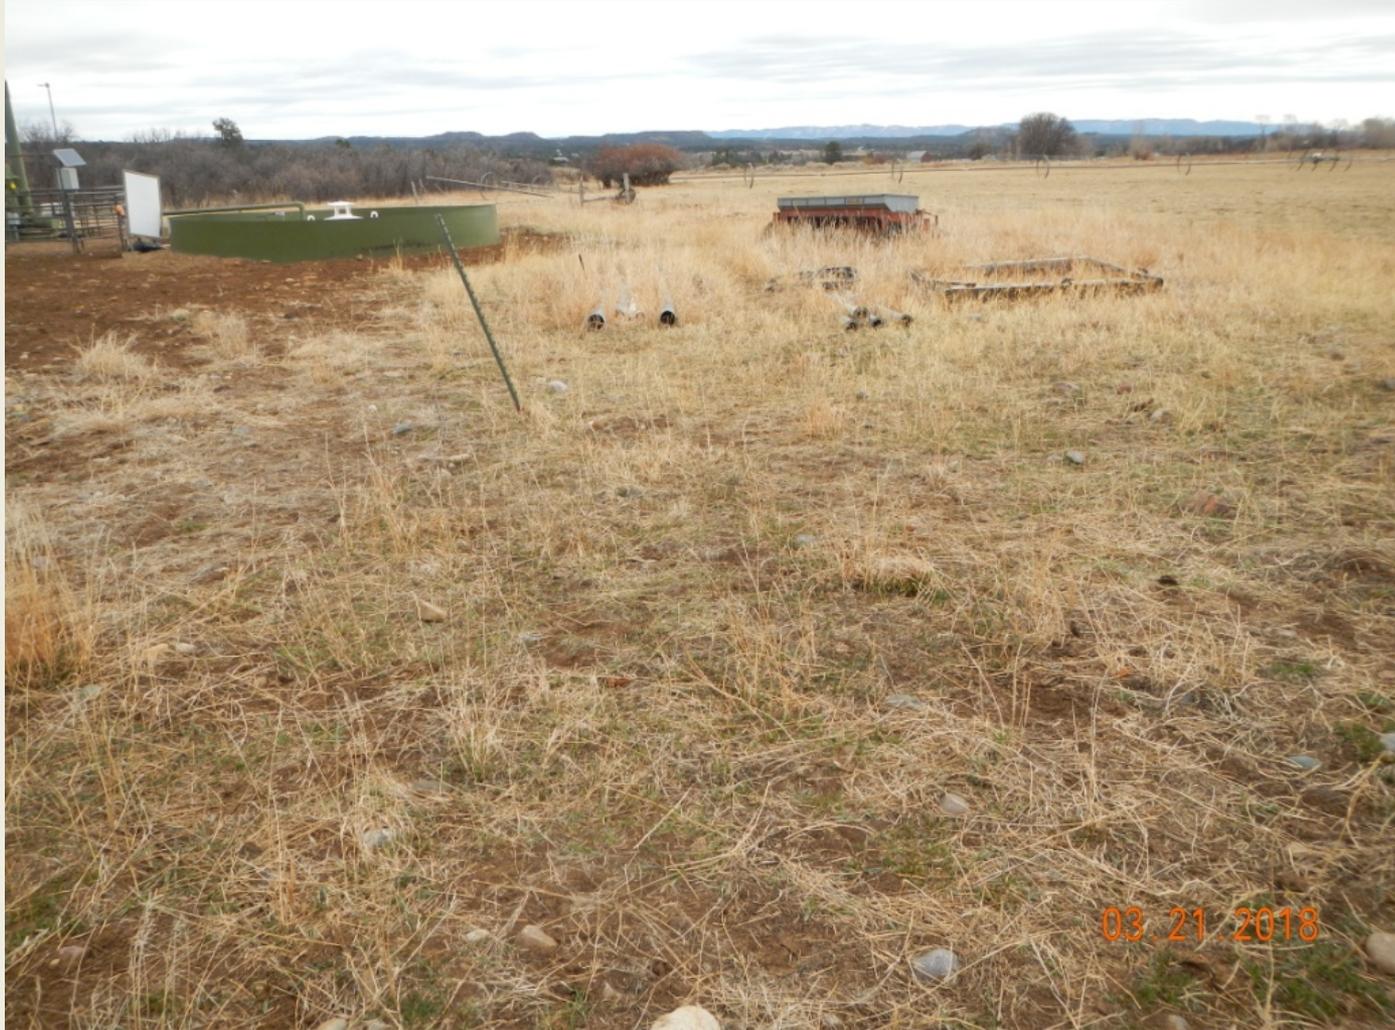
Photo 4. View of the southern portion of the project area from the southwestern corner facing eastward. Surface owner equipment is also stored in the southern portion of the interim reclamation area.

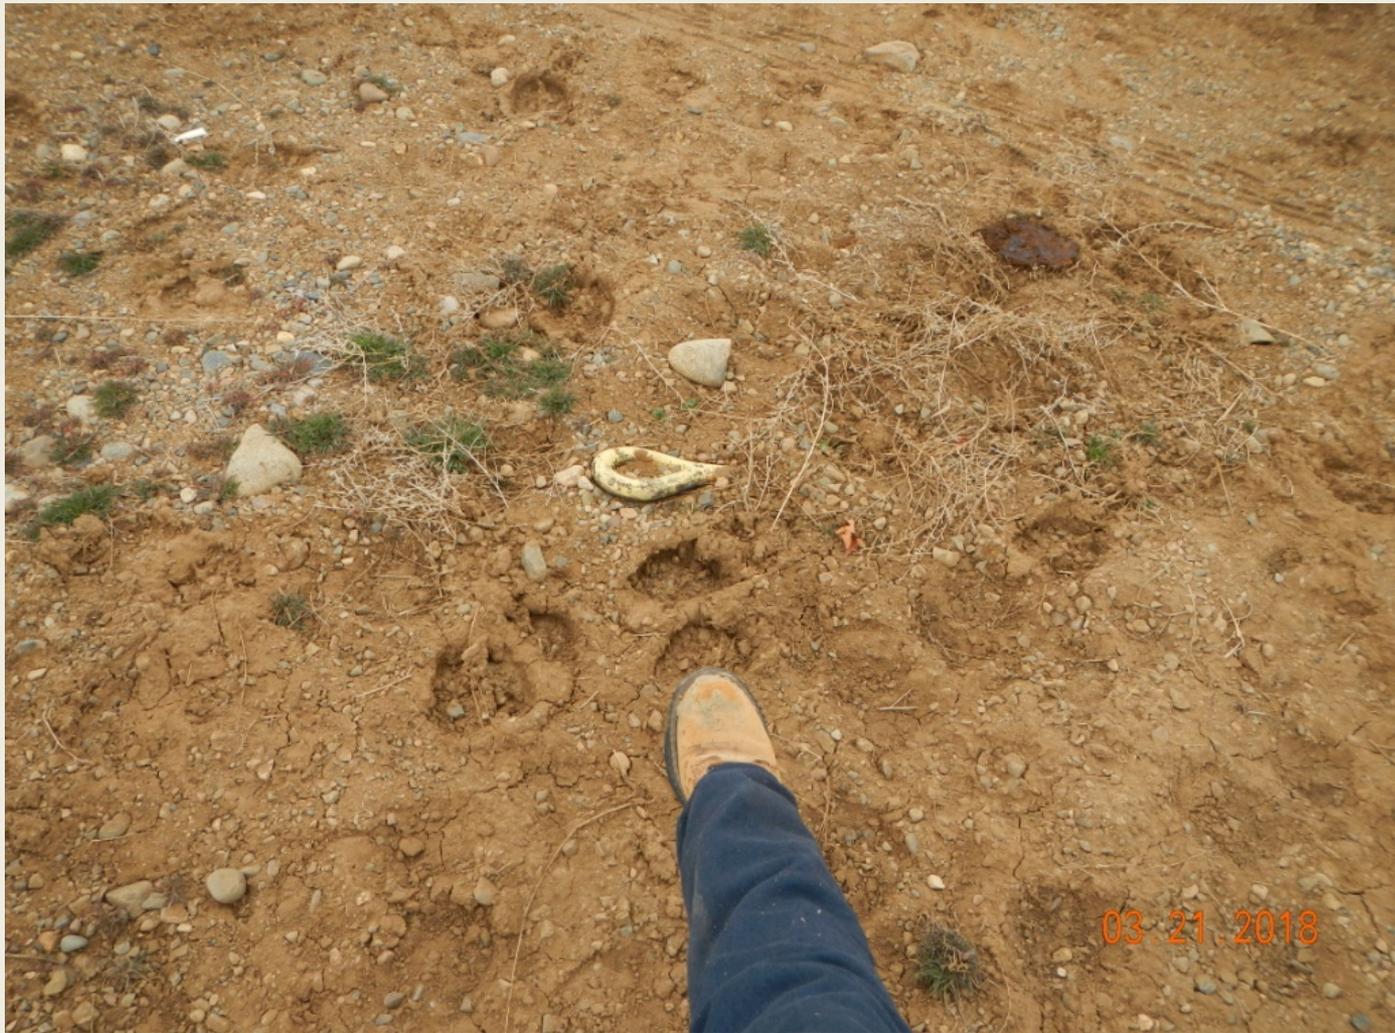
Photo 5. Rig anchor needs marker or removal.
