# Interim Reclamation and Stormwater Inspection

April 16, 2018

Operator: GADECO LLC- #10673

Location Name: Grynberg Stateline Federal /24-12-65-4 Pad

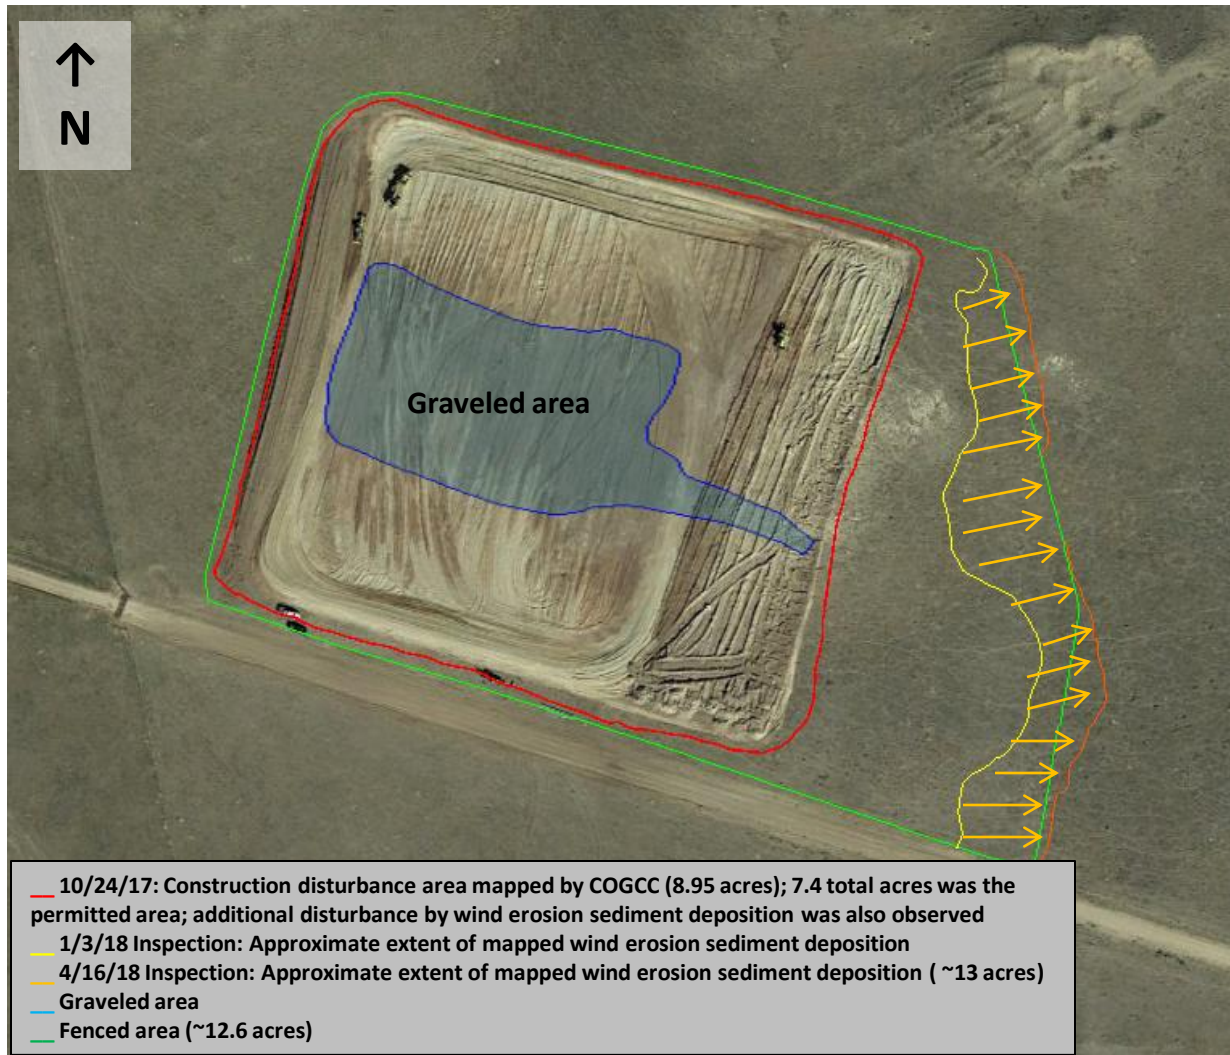
Google Earth aerial imagery taken October 14, 2017. Observations from this April 16, 2018 inspection: Wind erosion sediment deposition was observed beyond the eastern fence line ~20-40 feet; total disturbance including wind erosion sediment deposition is approximately 13.0 acres and well pad areas continue to be susceptible to wind erosion.

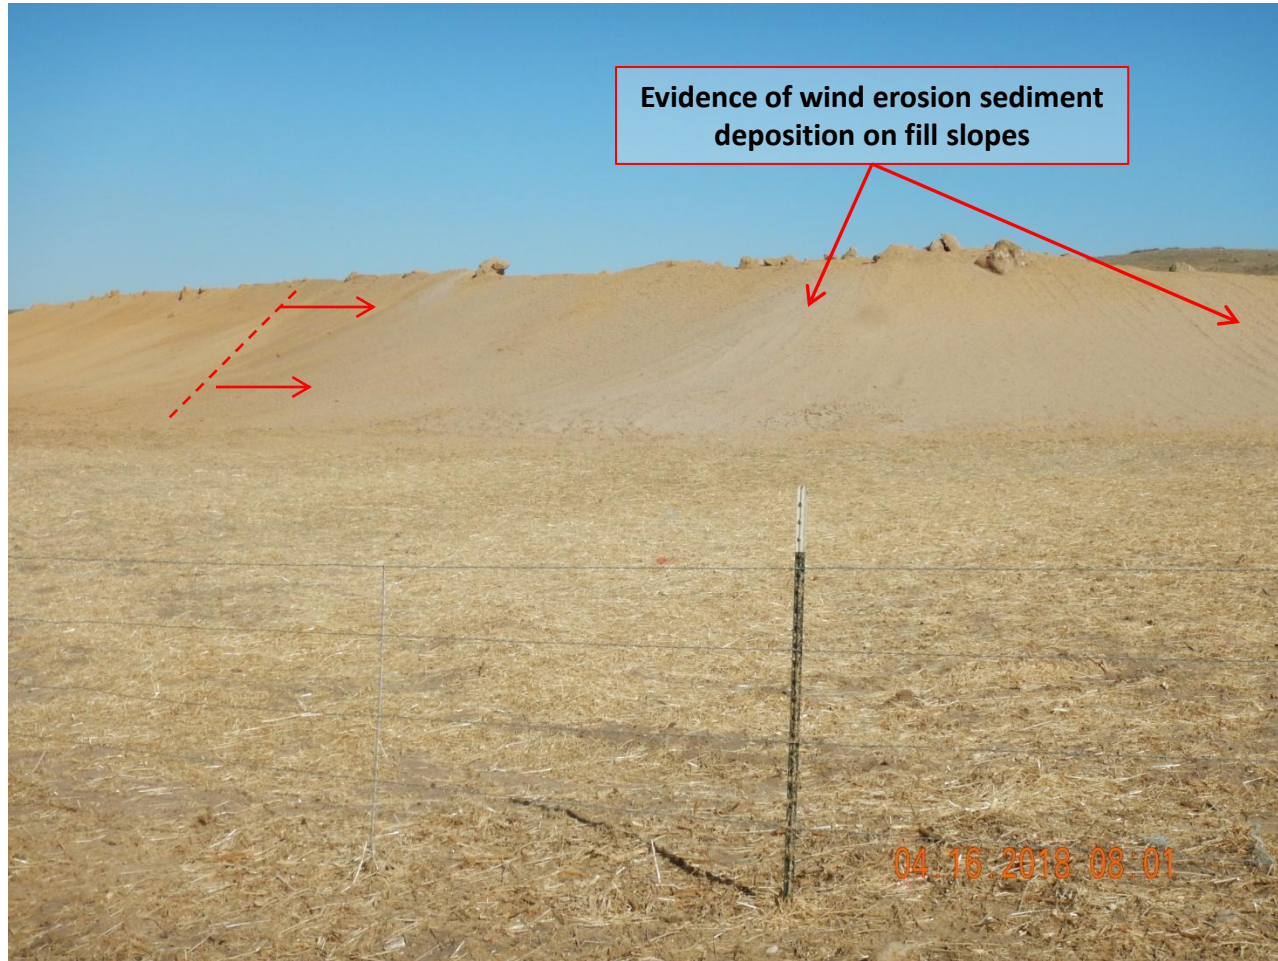
**Photo 1.** Photo taken from the southeastern perimeter of the location, facing Northwest. Photo illustrates evidence of wind erosion sediment deposition on fill slopes from unconsolidated well pad areas. The soil binding tackling agent does not appear to be applied using good engineering practices, per Rule 1002.f.(2).

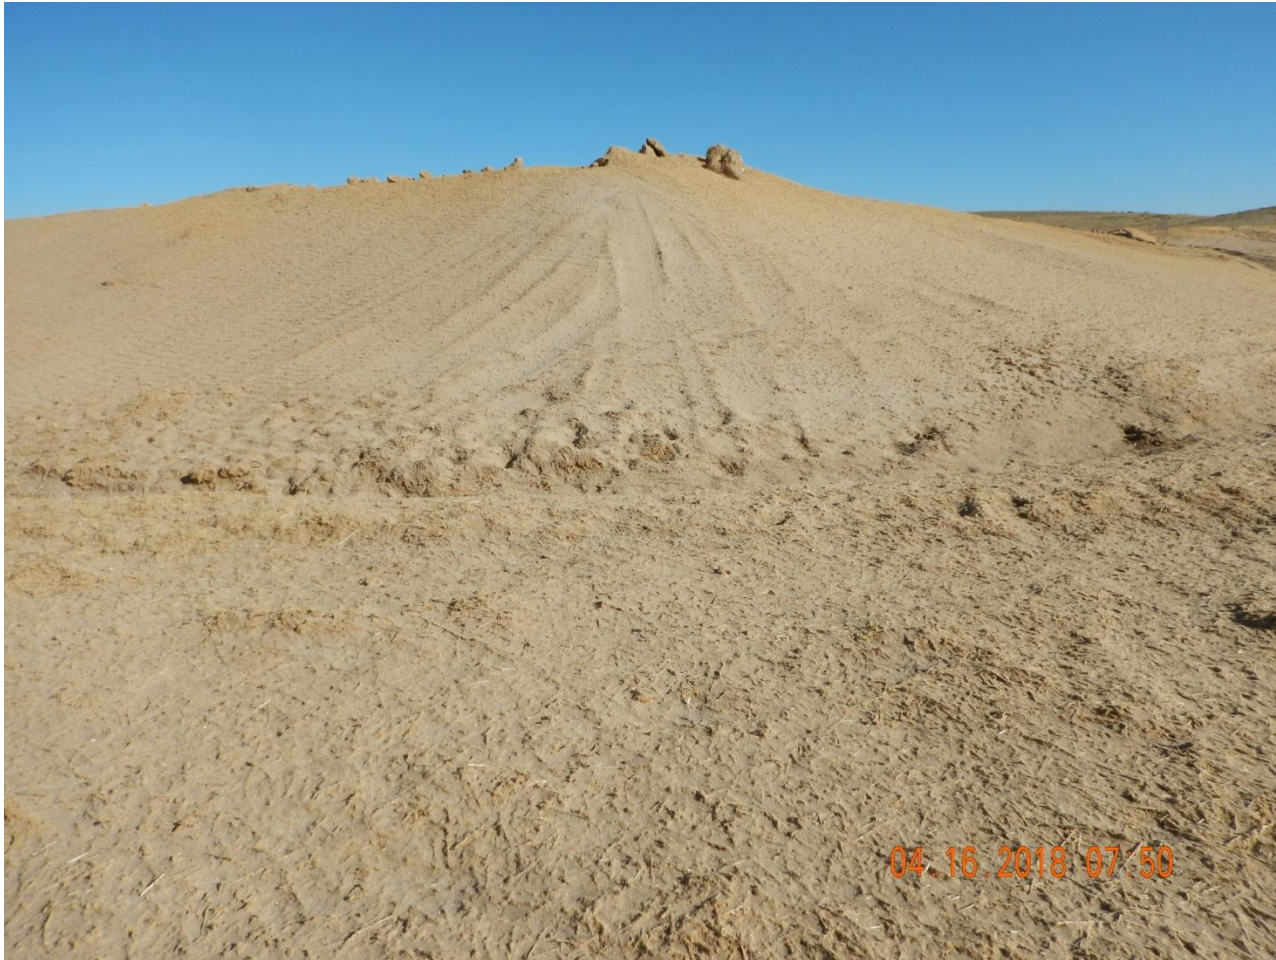
**Photo 2.** Close-up photo taken of the southeast fill slope area, facing Northwest. Photo illustrates evidence of wind erosion sediment deposition on fill slopes from unconsolidated well pad areas.

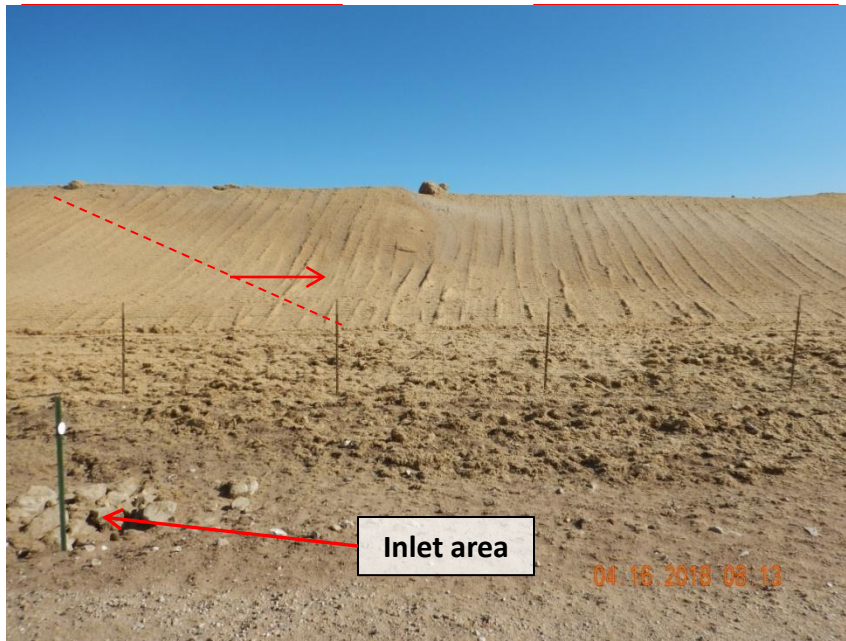
**Photo 3.** Photo taken from the southern perimeter of the location, facing North. See comments under Photo 1.

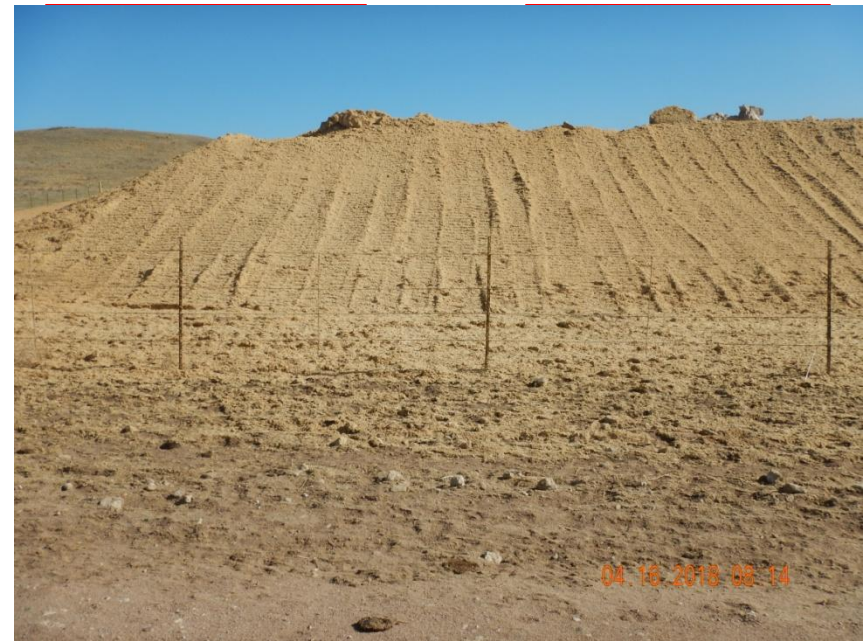
**Photo 4.** Photo taken from the southwest perimeter of the location, facing North. Photo illustrates fill slopes where there does not appear to be impacts from wind erosion sediment deposition.

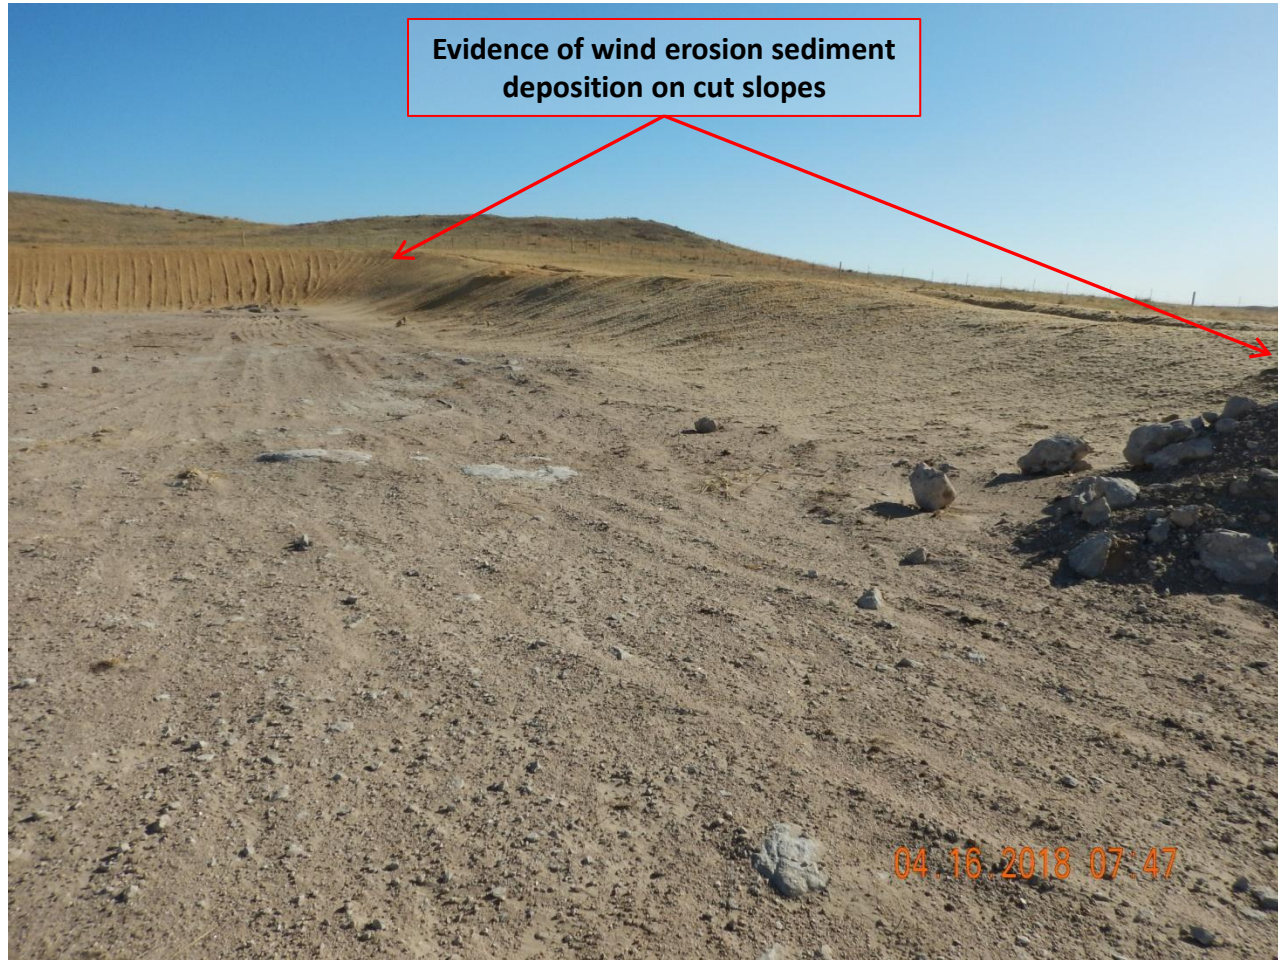
**Photo 5.** Photo taken from the access road, facing North. Photo illustrates evidence of wind erosion sediment deposition on the eastern cut slope from unconsolidated well pad areas.

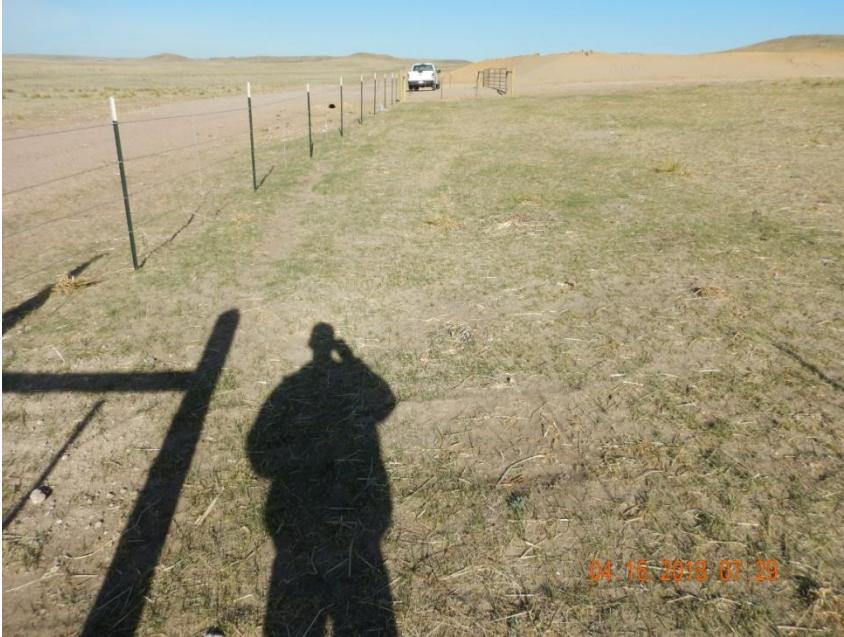
**Photo 6.** Photo taken from the southeast fence corner, facing West. According to the Operator, the area east of the access road was interseeded. Germination was occurring during this inspection. Operator shall comply with Rule 1003 standards to establish vegetation with total perennial, non-invasive uniform plant cover of at least eighty (80) percent of reference area levels. Note: COGCC parked outside, in front of the gated entrance on the 3/23/18 inspection and this inspection on 4/16/18.

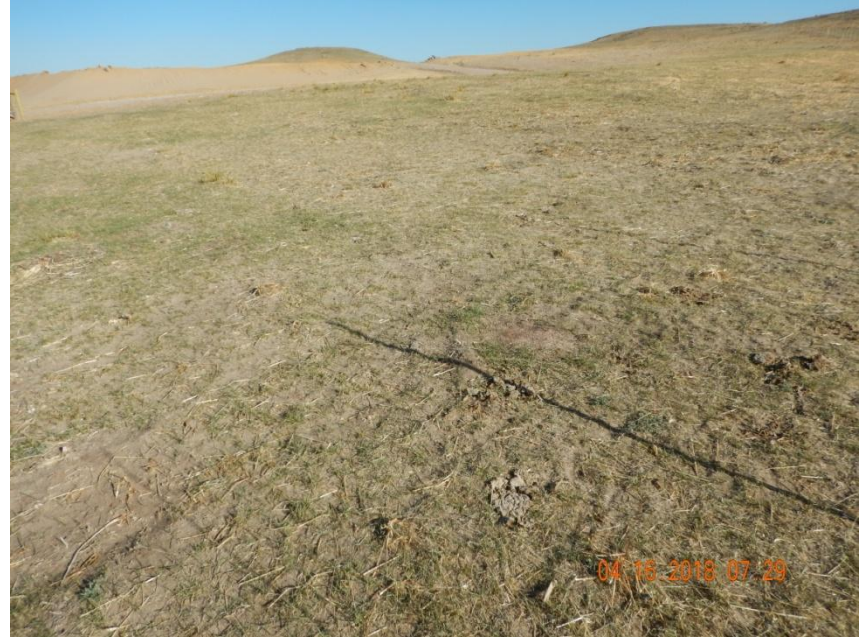
**Photo 7.** Photo taken from the southeast fence corner, facing Northwest. See comments under Photo 6.

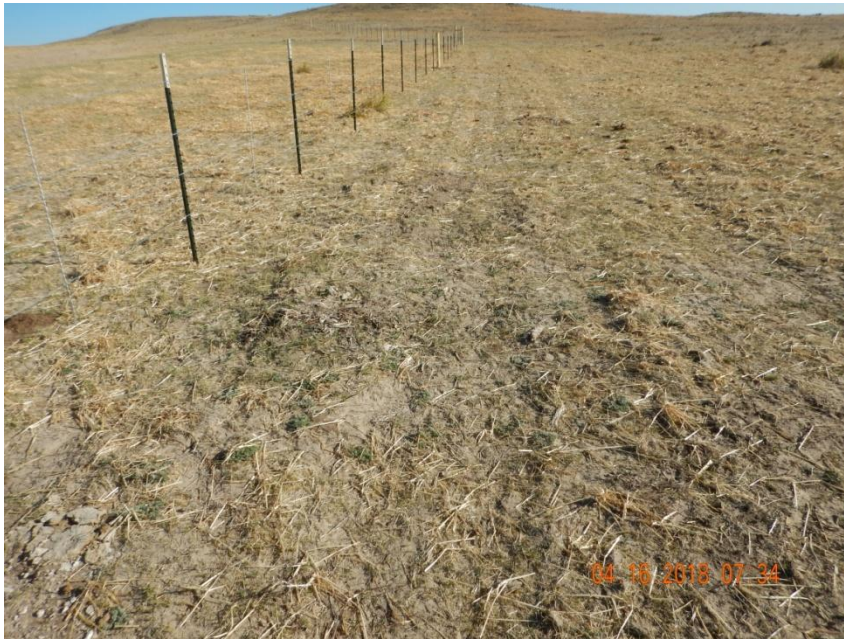
**Photo 8.** Photo taken from the southeast fence corner, facing North. See comments under Photo 6. Straw mulch did not appear to stay crimped throughout the location and has moved from the target areas, and will not function properly.

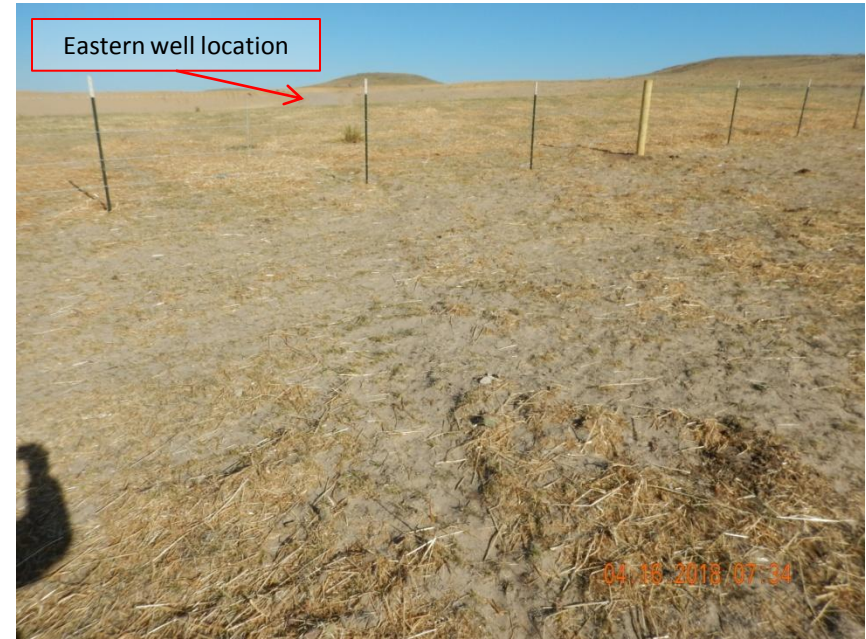
**Photo 9.** Photo taken from the eastern fence line, facing West. Photo illustrates impacts of wind erosion sediment deposition and loose straw mulch off location. Refer to the orange-line in the aerial imagery for additional reference.

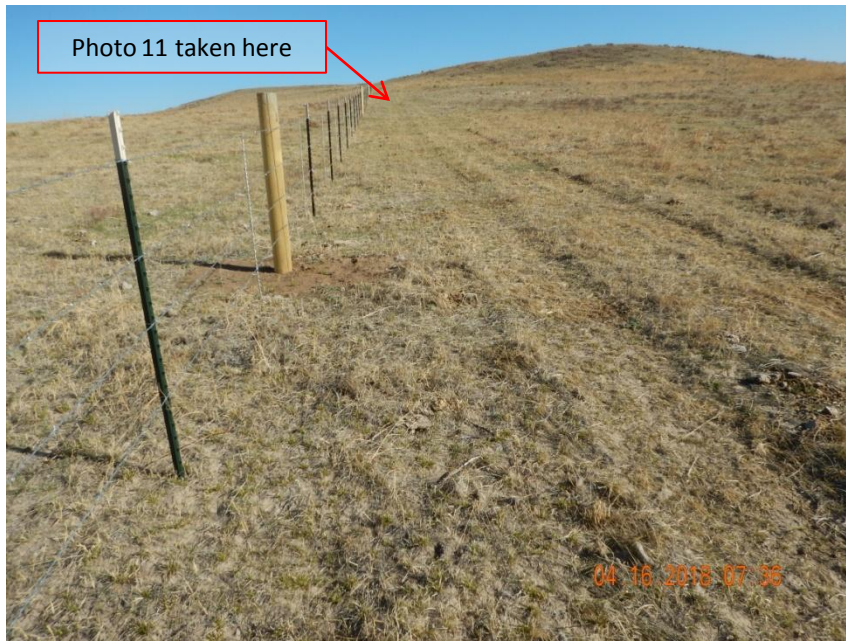
**Photo 10.** Photo taken from the eastern fence line, facing North. At the time of this inspection, the photo illustrates an area east of the fence line that does not appear to be impacted from wind erosion sediment deposition.

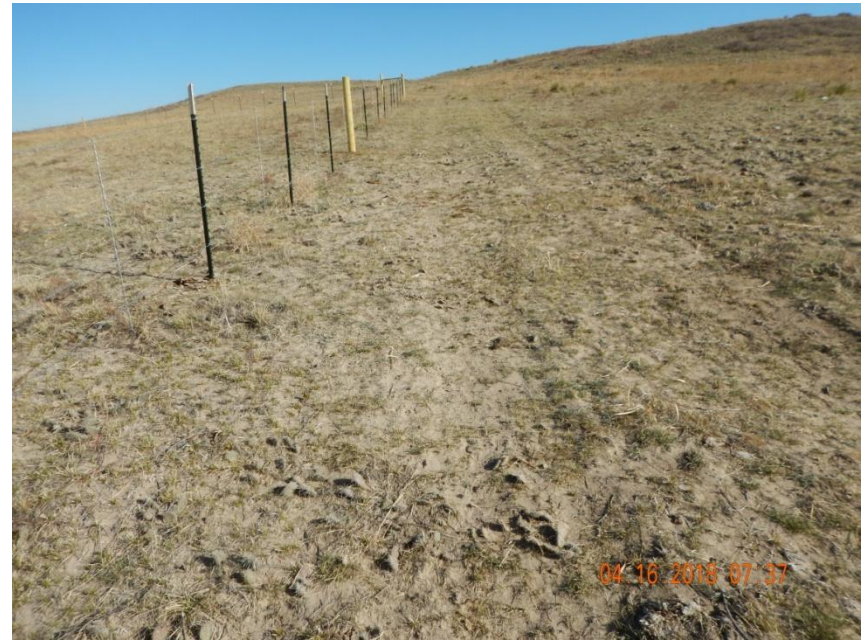
**Photo 11.** Photo taken from the northeastern fence line, facing North. Photo illustrates impacts of wind erosion sediment deposition as indicated by the light grey material on top of the vegetation/surface.

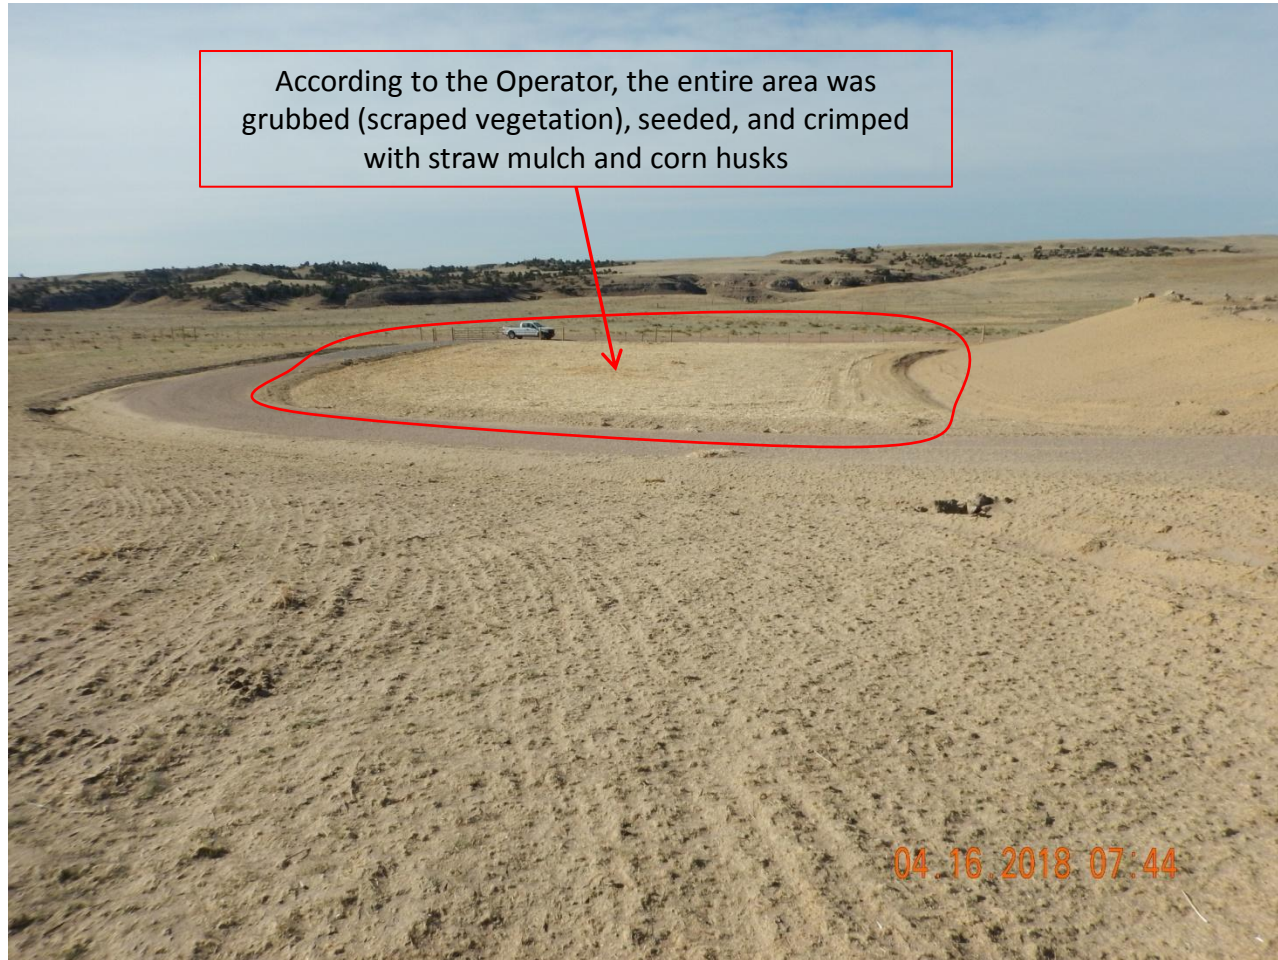
**Photo 12.** Photo taken east of the well pad perimeter, facing South. Photo illustrates impacts of wind erosion sediment deposition. Existing and seeded vegetation in the photo foreground was not apparent and is covered with soil particles from wind erosion sediment deposition. This is also apparent for the red highlighted area.
