Inspection Photos
Location Name: Hooze-Bjolin #1
Location ID: 318942

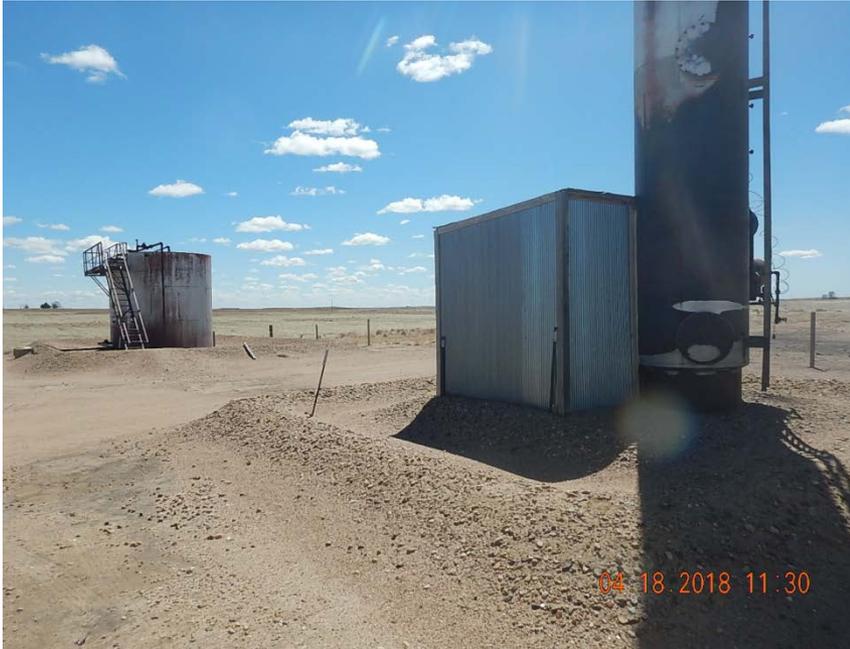
Photo 1: Location, looking SE

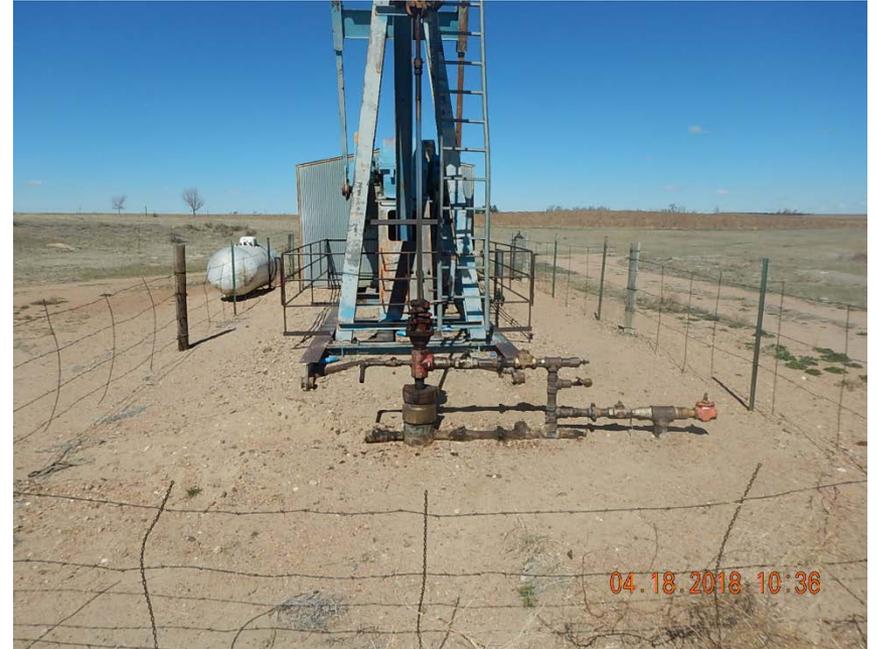
Photo 2: Wellhead, looking N

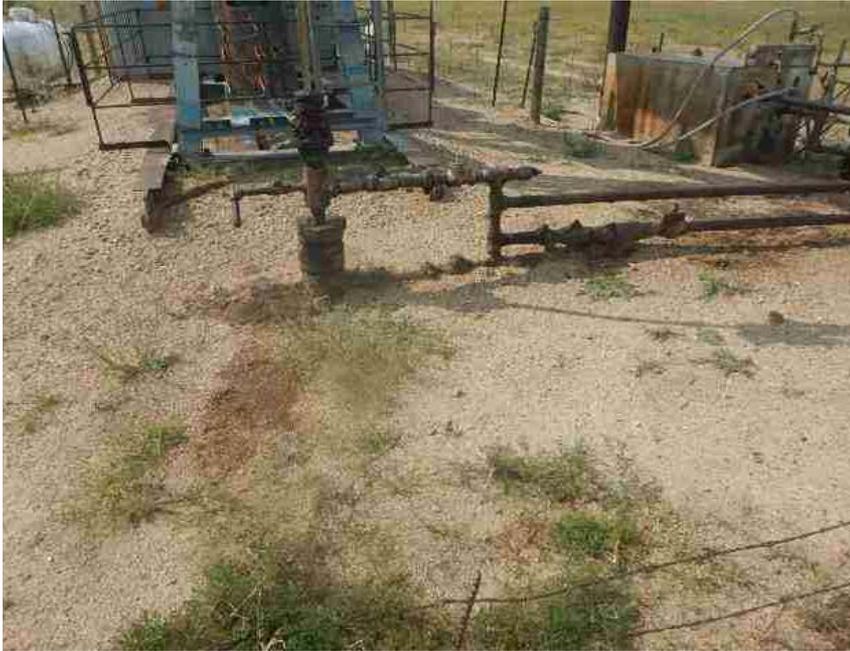
Photo from prior inspection for comparison

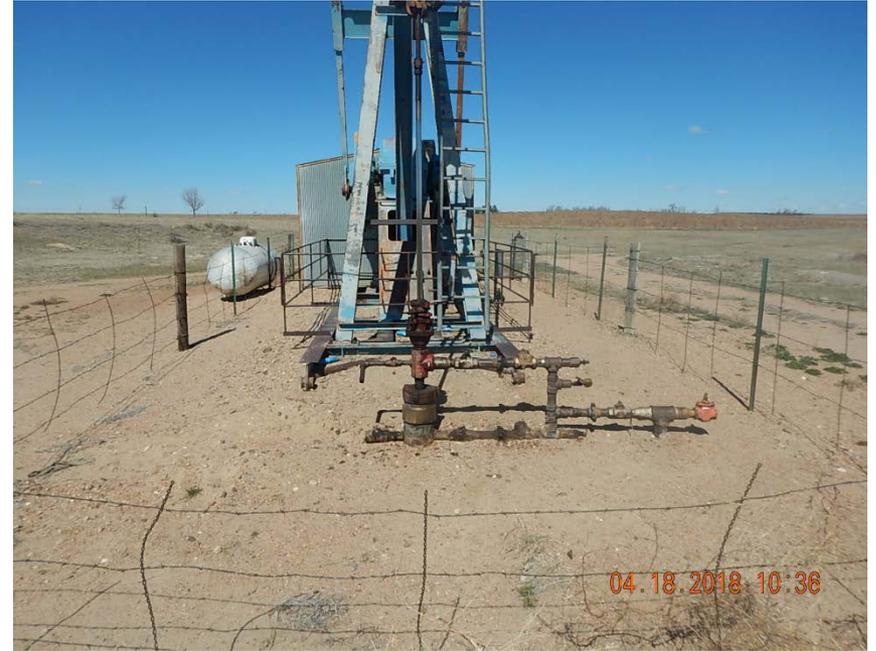
Photo 3: Stained soil removed

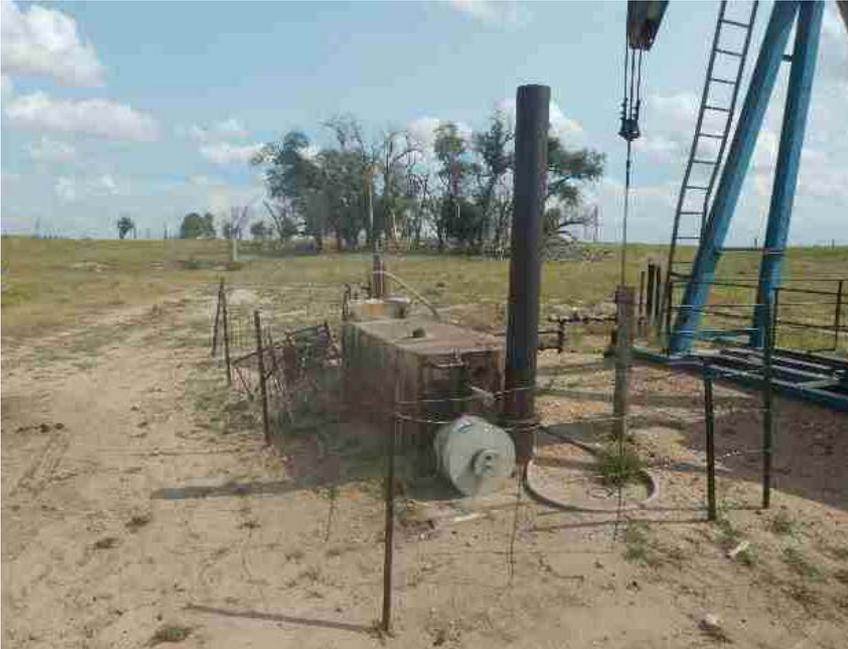
Photo from prior inspection for comparison

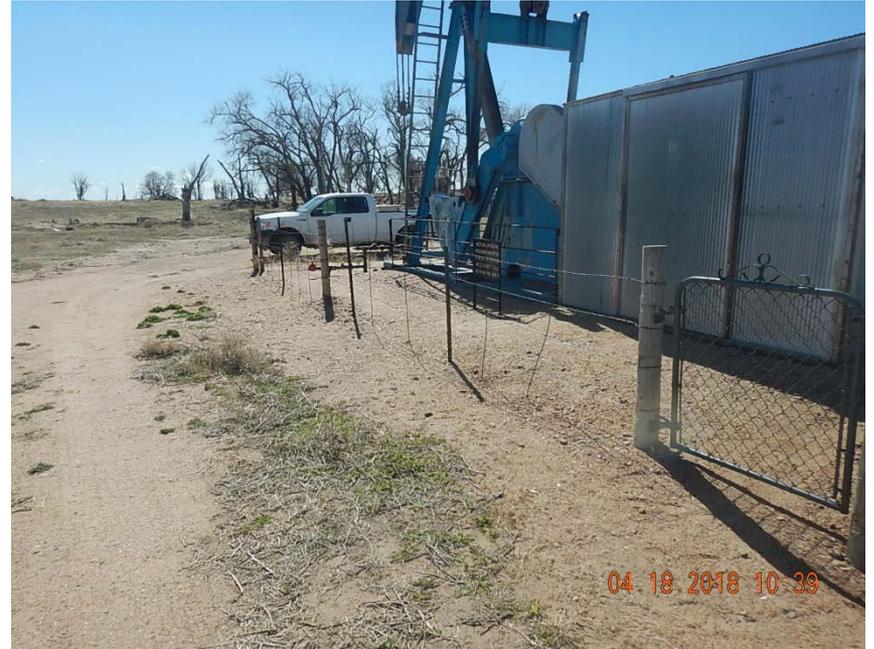
Photo 4: Treater removed

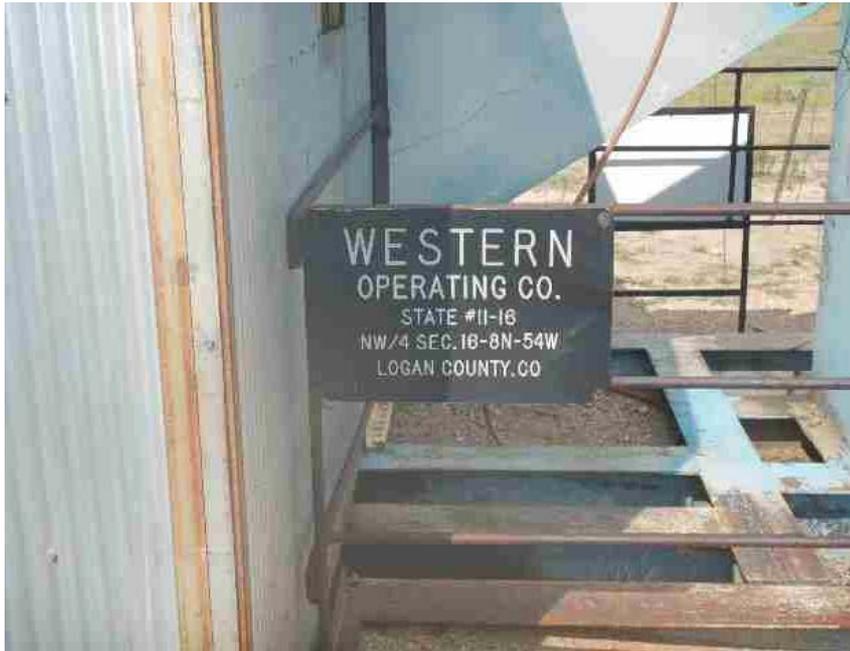
Photo from prior inspection for comparison

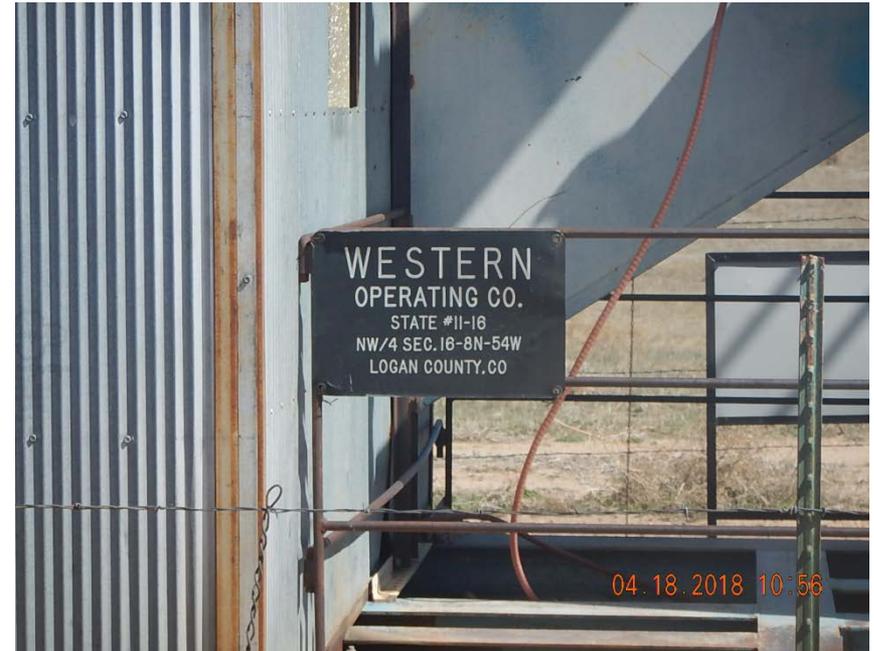
Photo 4: Incorrect sign at pump jack

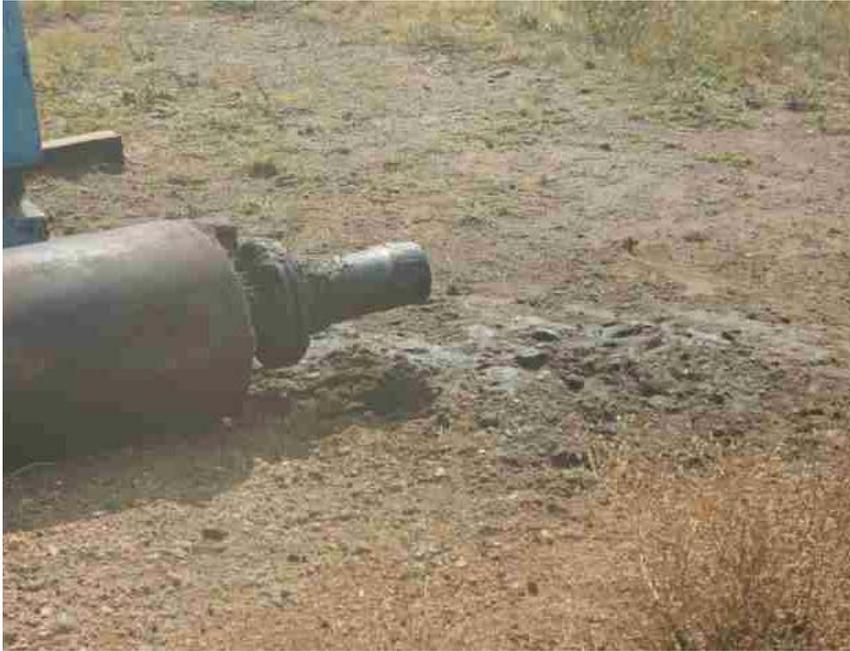
Photo from prior inspection for comparison

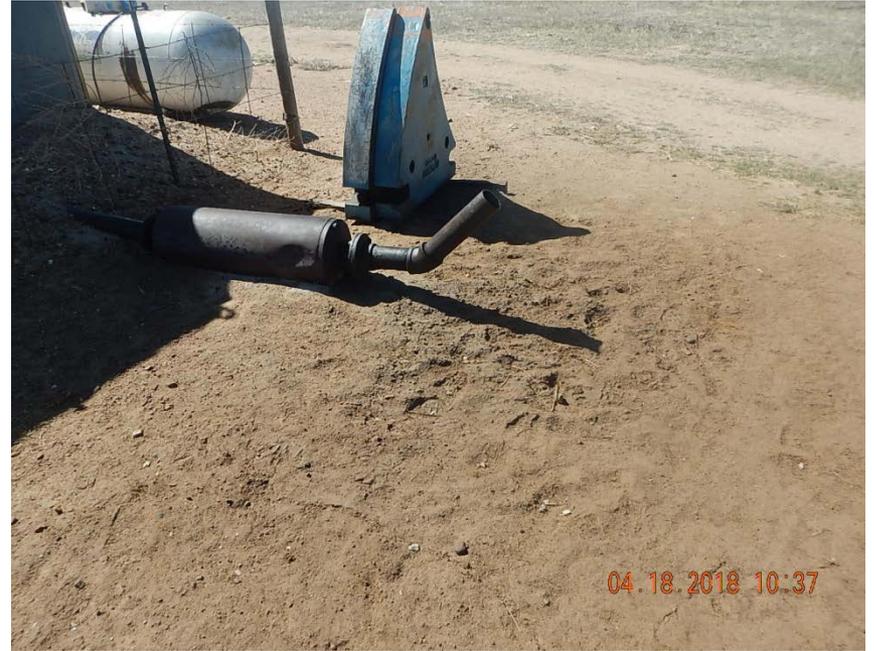
Photo 5: Stained soil remediated

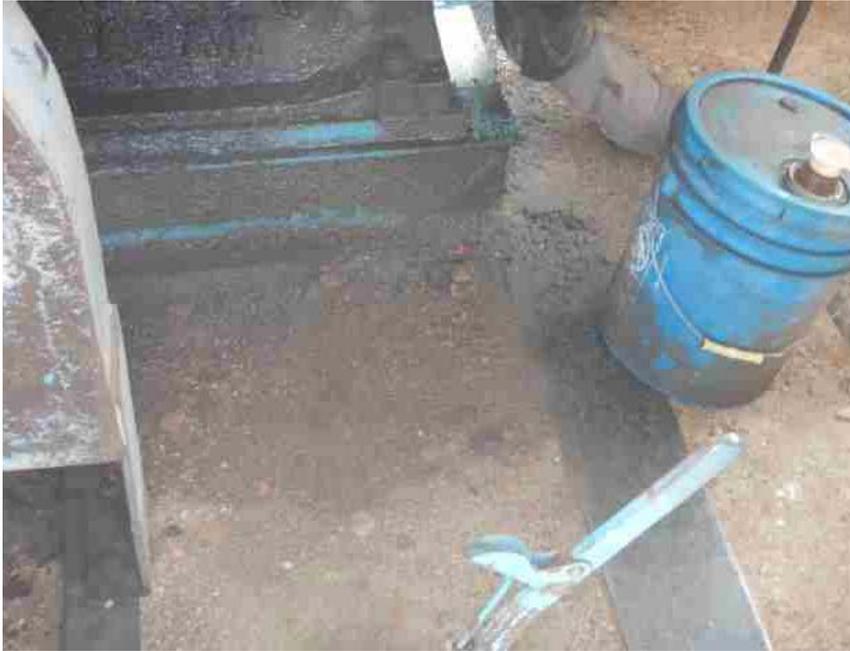
Photo from prior inspection for comparison

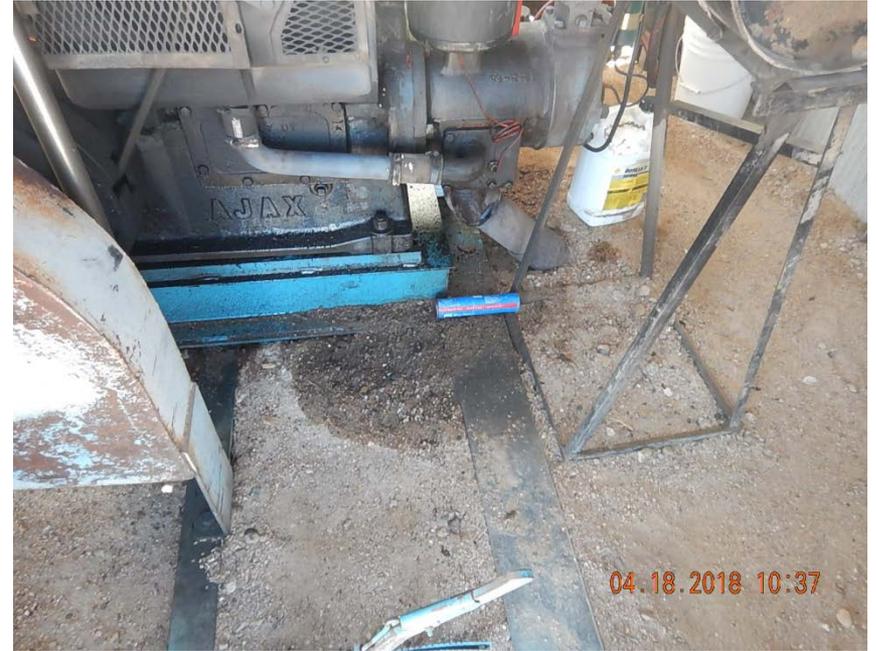
Photo 6: Stained soil at engine

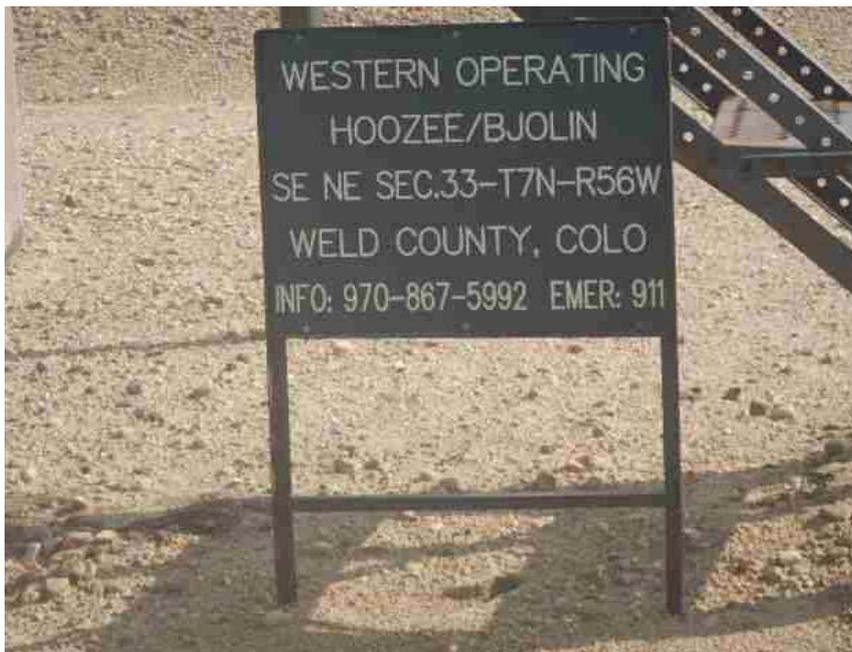
Photo from prior inspection for comparison

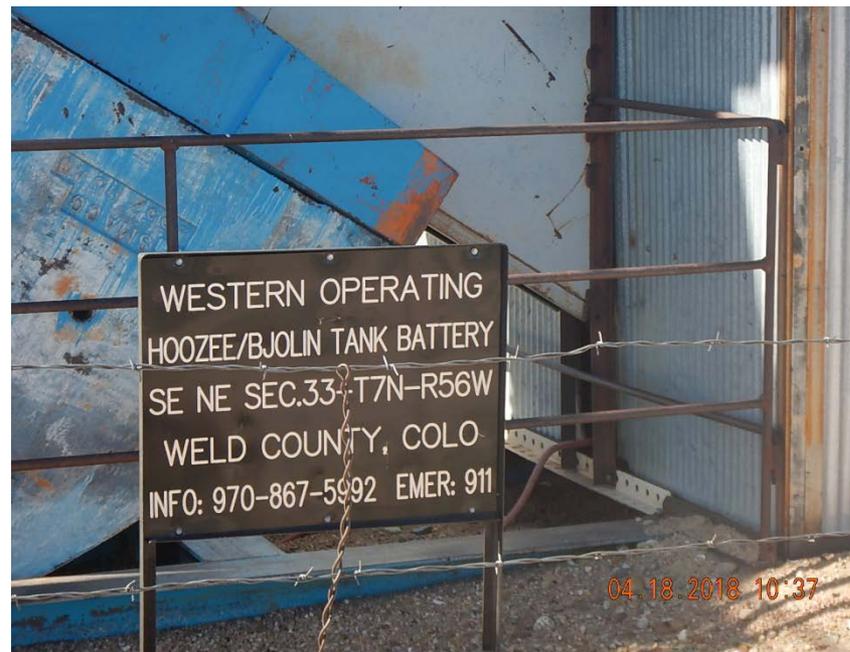
Photo 7: Emergency number did not receive response.

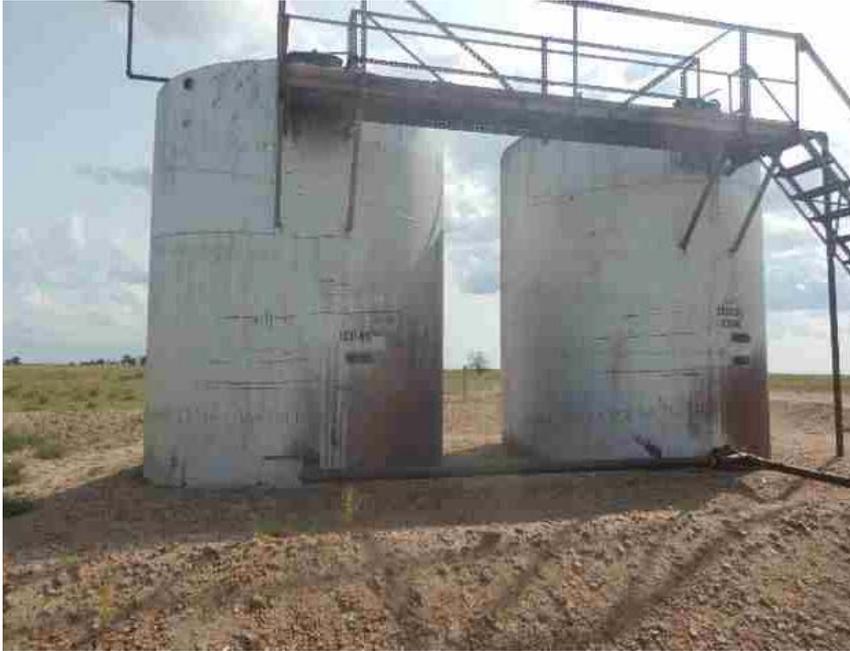
Photo from prior inspection for comparison

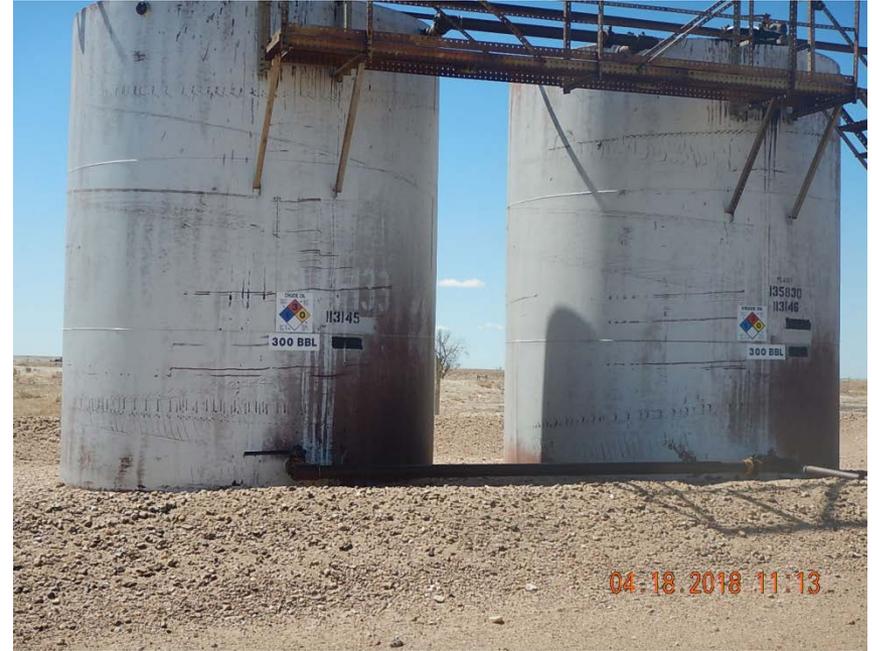
Photo 8: Production tanks labeled.

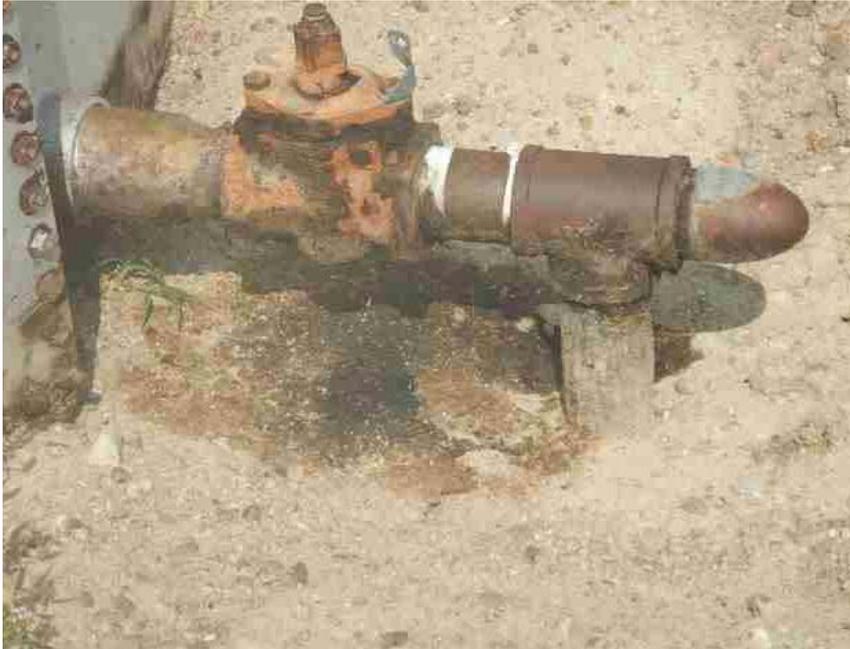
Photo from prior inspection for comparison

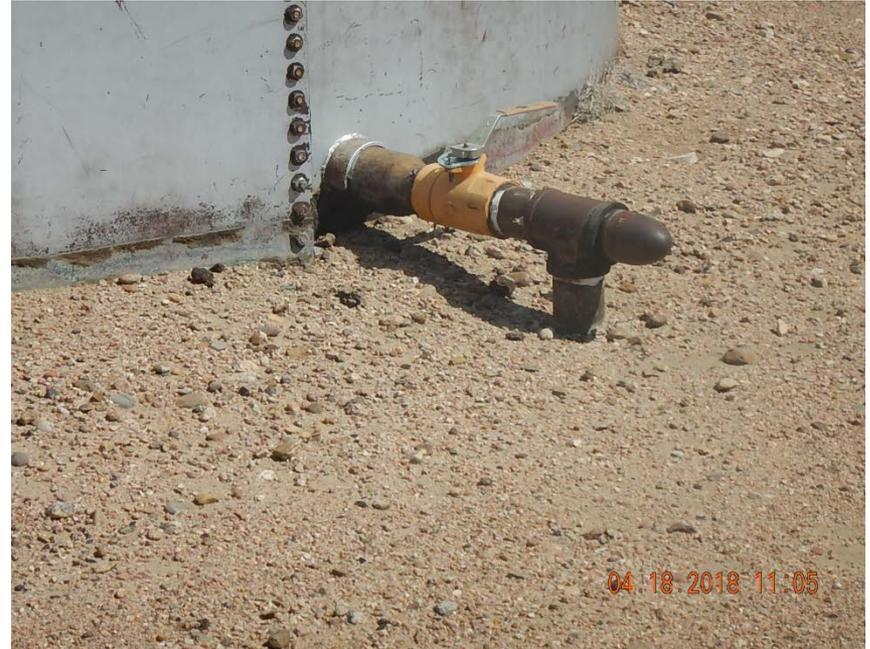
Photo 9: Stained soil removed.

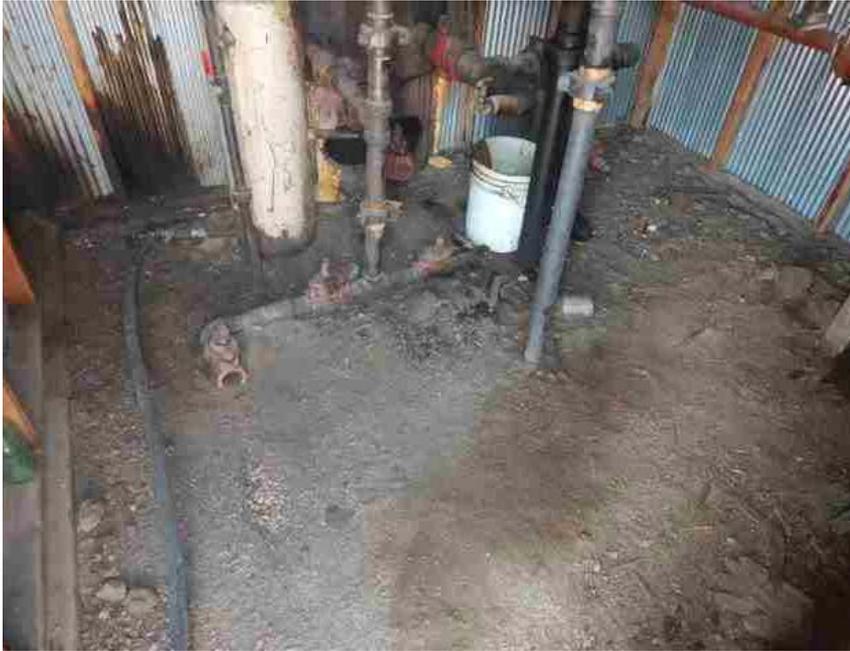
Photo from prior inspection for comparison

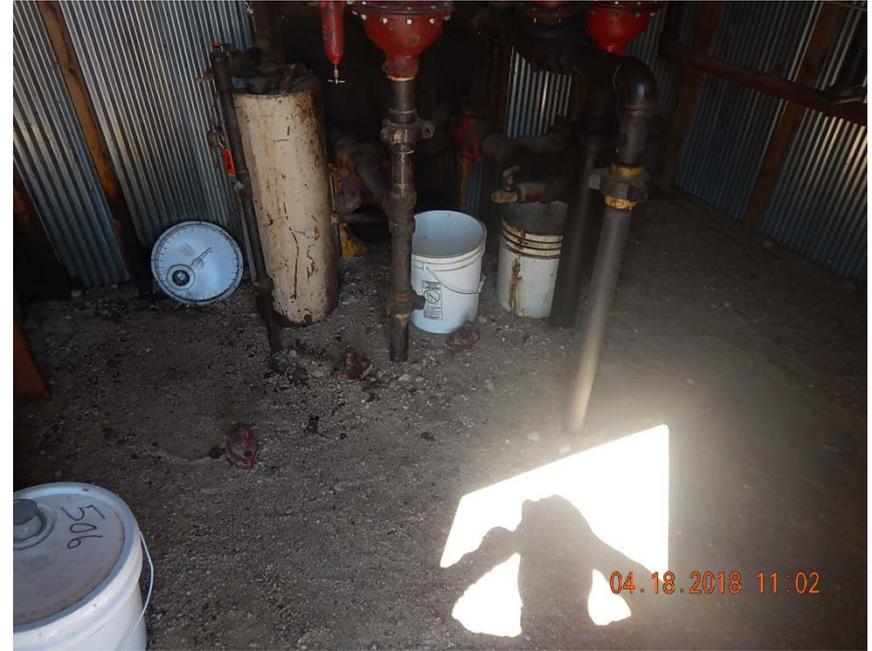
Photo 10: Stained soil removed.

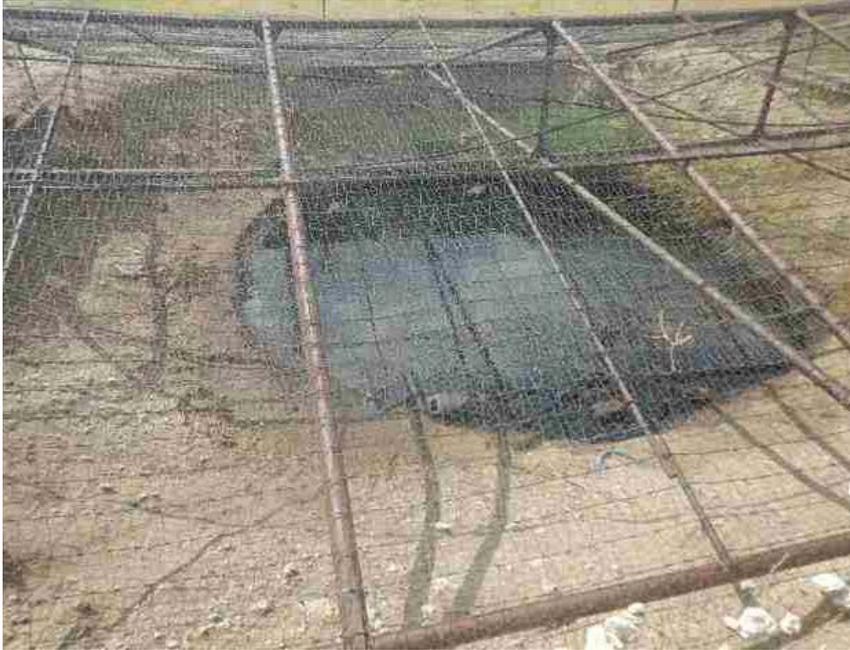
Photo from prior inspection for comparison

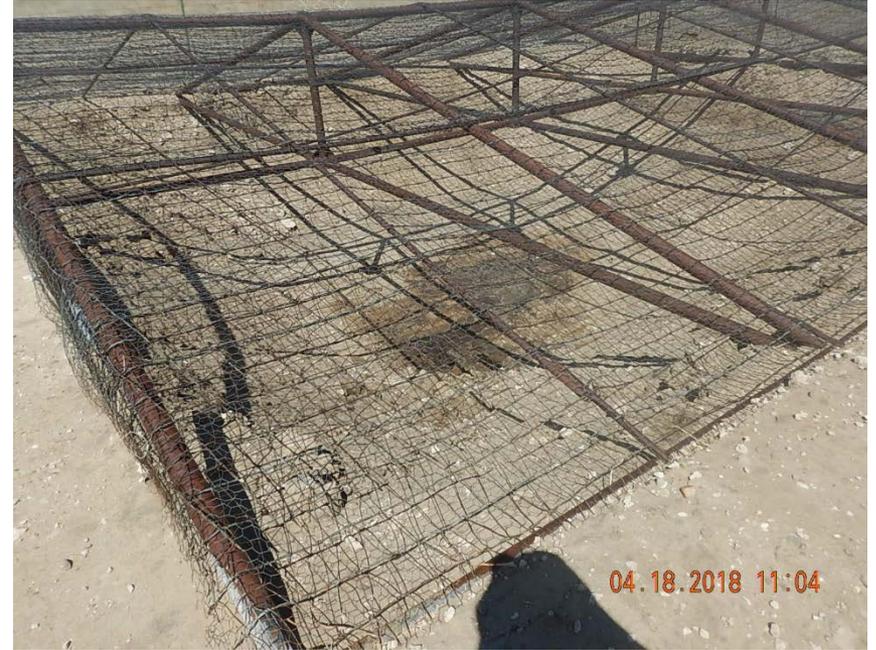
Photo 11: Oil taken off pit. Stained soil in bottom of pit.
