Inspection Photos
Location Name: Mais #1-35
Location ID: 330881

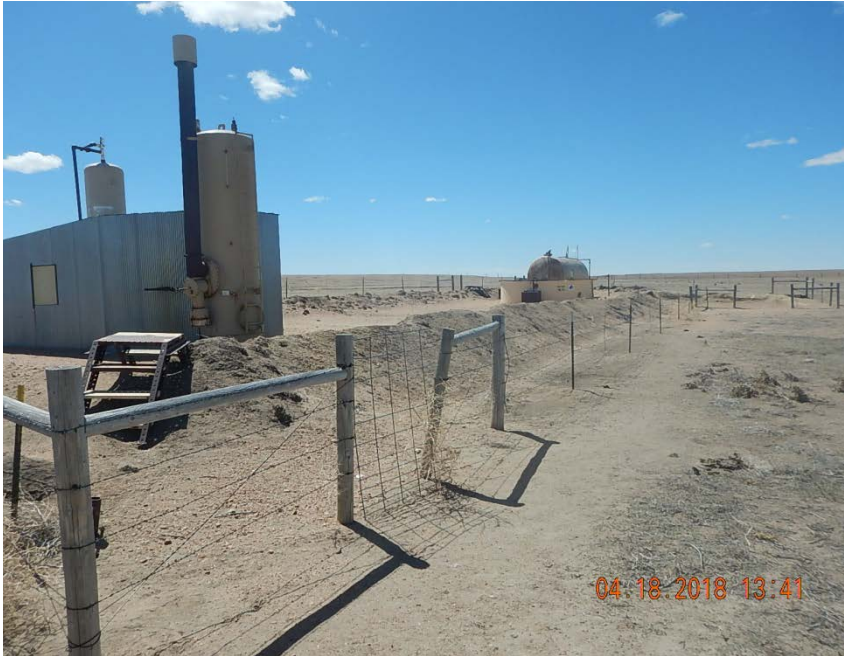
Photo 1: Location, looking SW

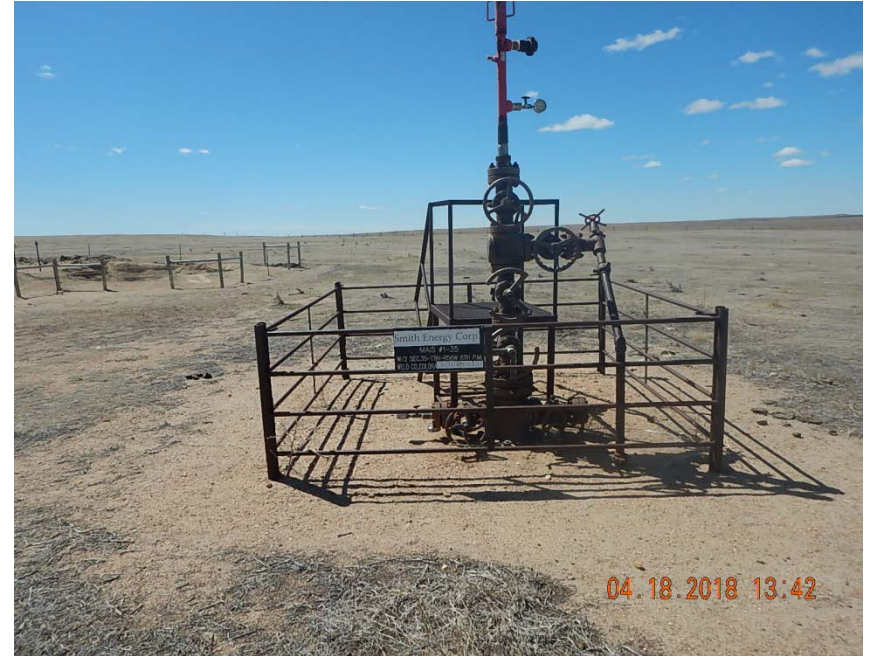
Photo 2: Wellhead, looking W

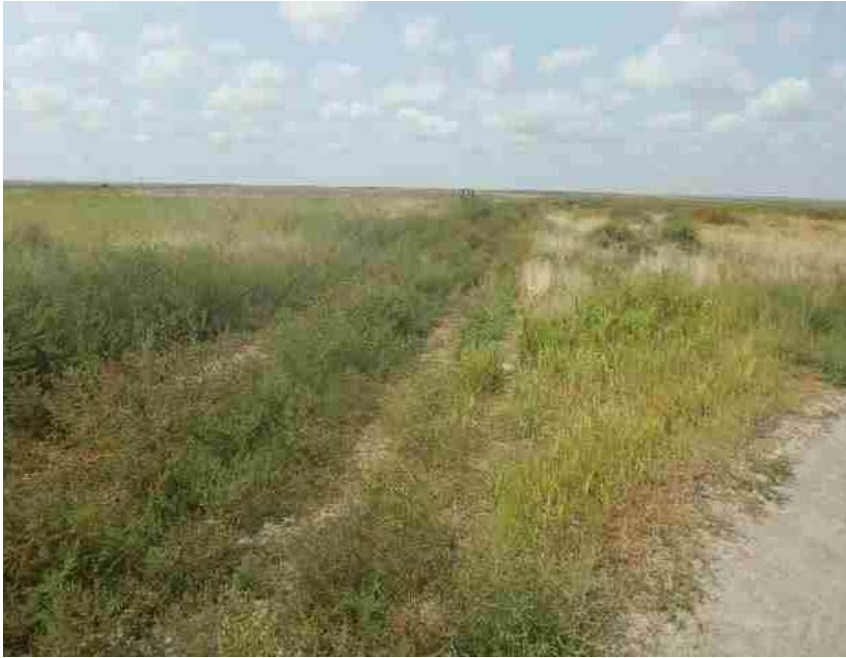
Photo from prior inspection for comparison

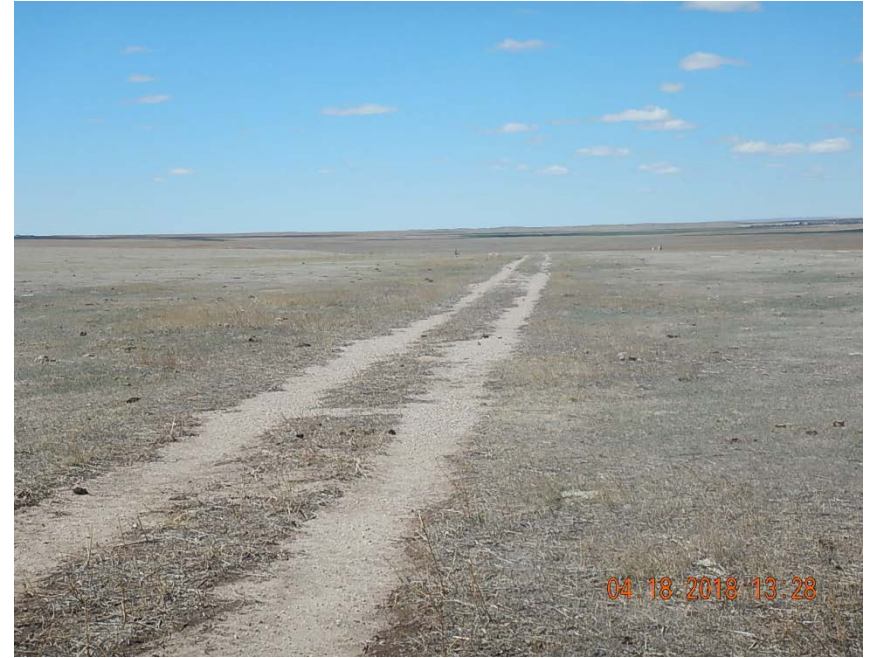
Photo 3: Weeds at lease road controlled.

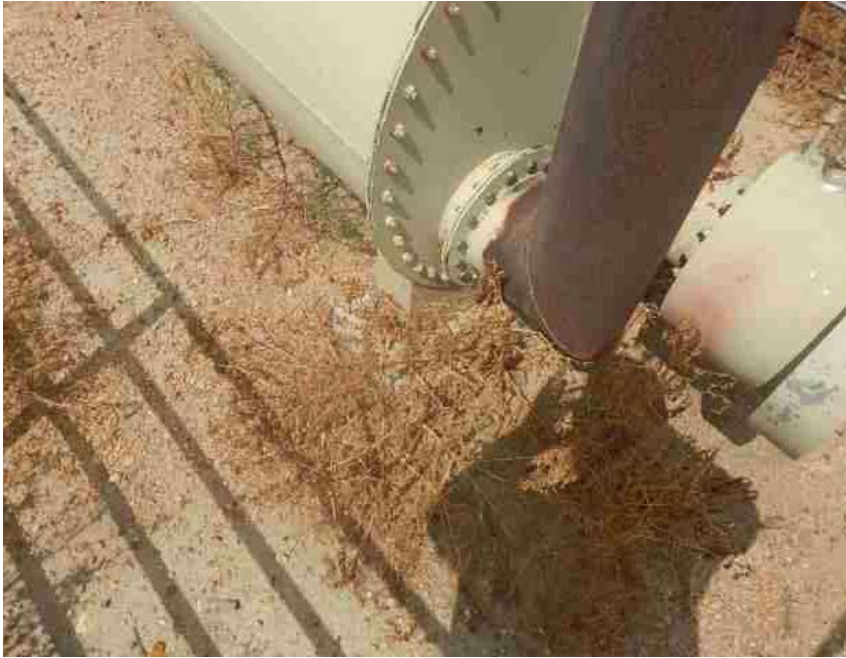
Photo from prior inspection for comparison

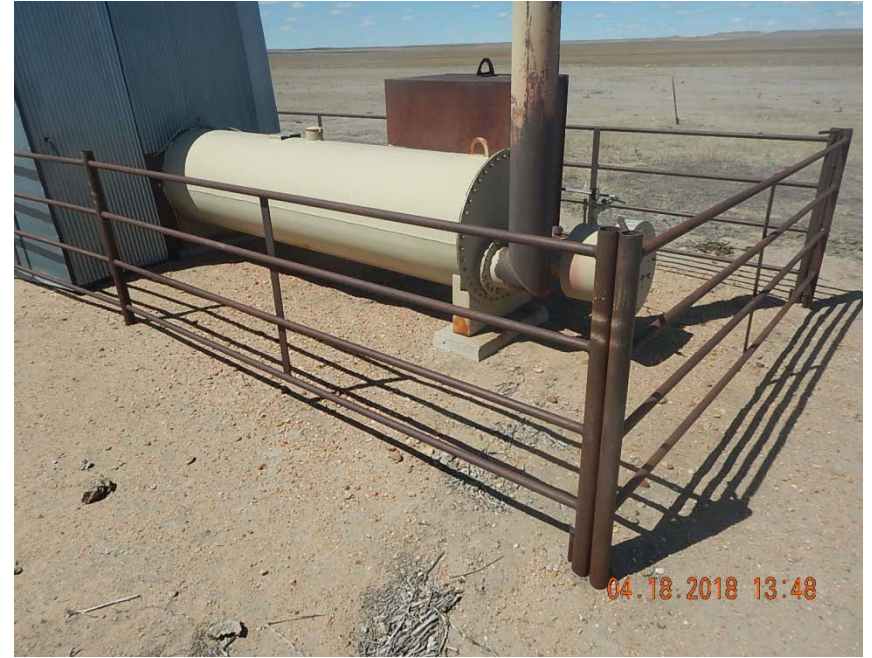
Photo 4: Weeds controlled at treater

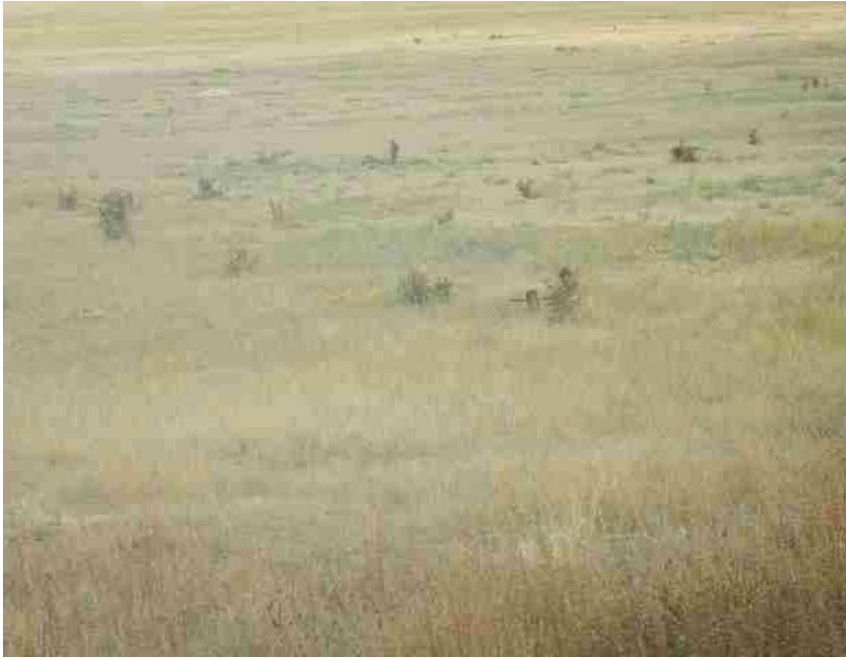
Photo from prior inspection for comparison

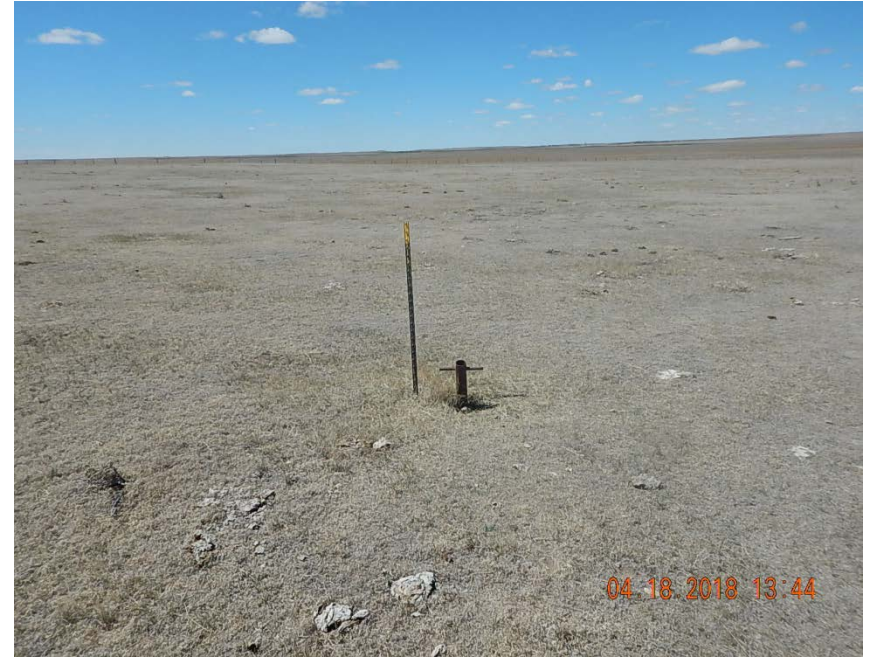
Photo 5: Deadmen marked.

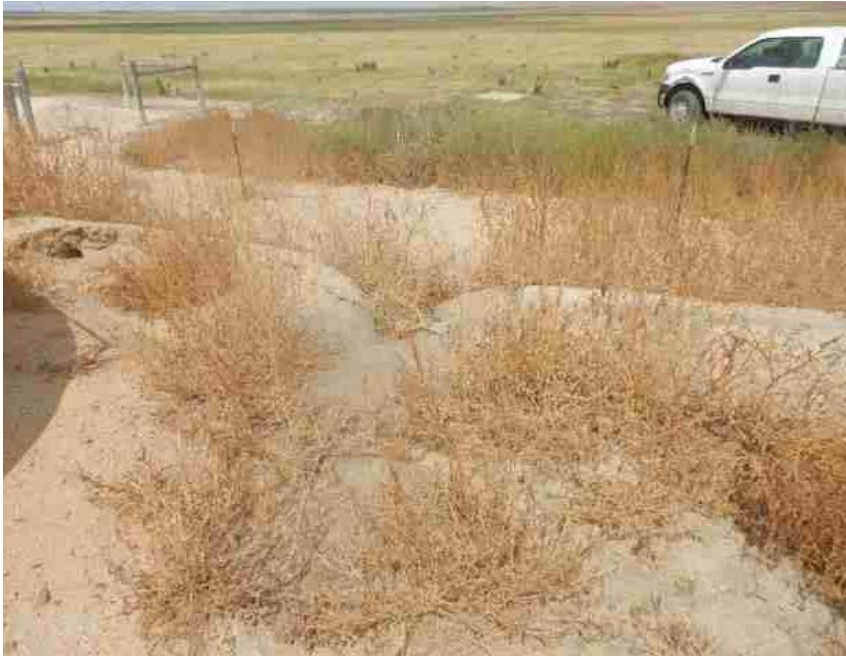
Photo from prior inspection for comparison

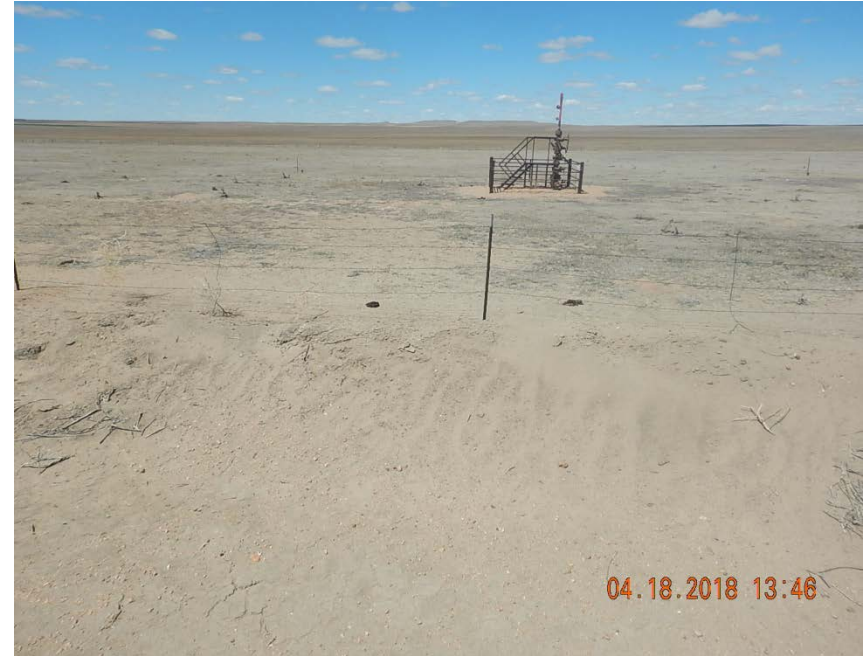
Photo 6: Stormwater erosion mitigated, weeds controlled

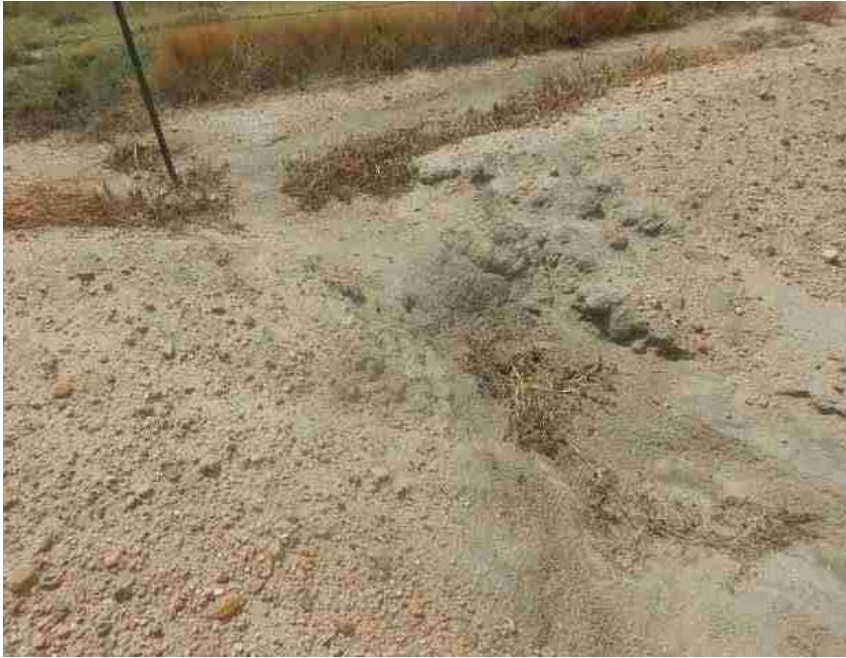
Photo from prior inspection for comparison

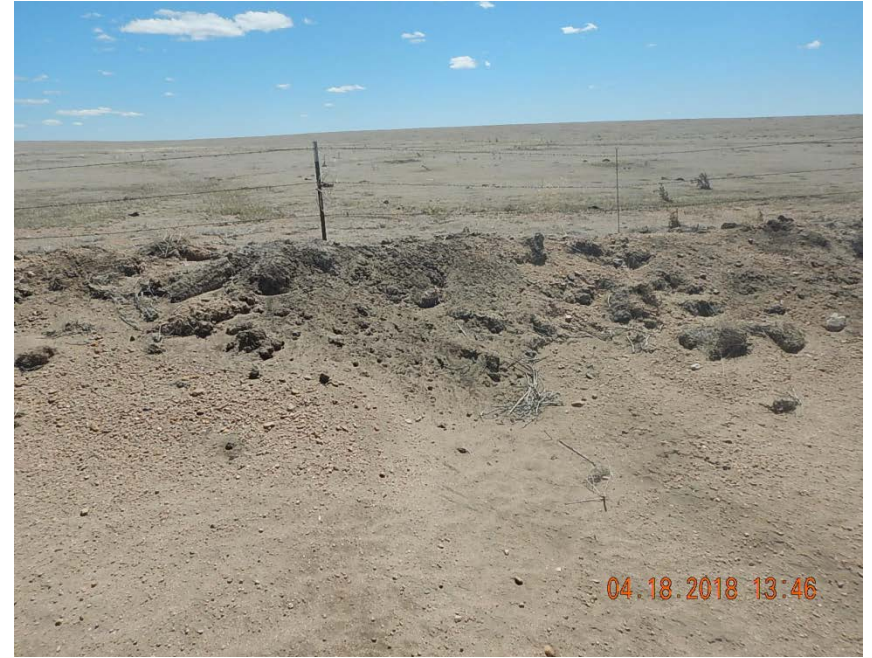
Photo 7: Stormwater erosion mitigated.

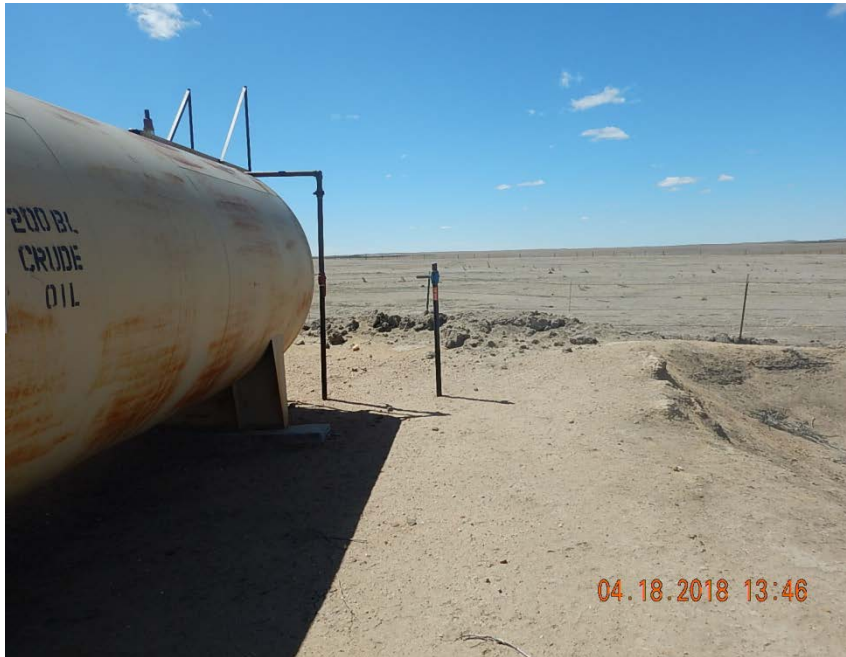
Photo 8: In use, plugged flowline riser.
