GOLDEN EAGLE MINE E-1 API # 05-071-06435 CORRECTIVE ACTIONS COMPLETED REGARDING COGCC FIR DOCUMENT # 680102752
GOLDEN EAGLE MINE E-2 API# 05-071-06436 CORRECTIVE ACTIONS COMPLETED REGARDING COGCC FIR DOCUMENT # 680102777
TIMBER CREEK - OGCC OPERATOR NUMBER 10672 – INSPECTION DATE: APRIL 05, 2018

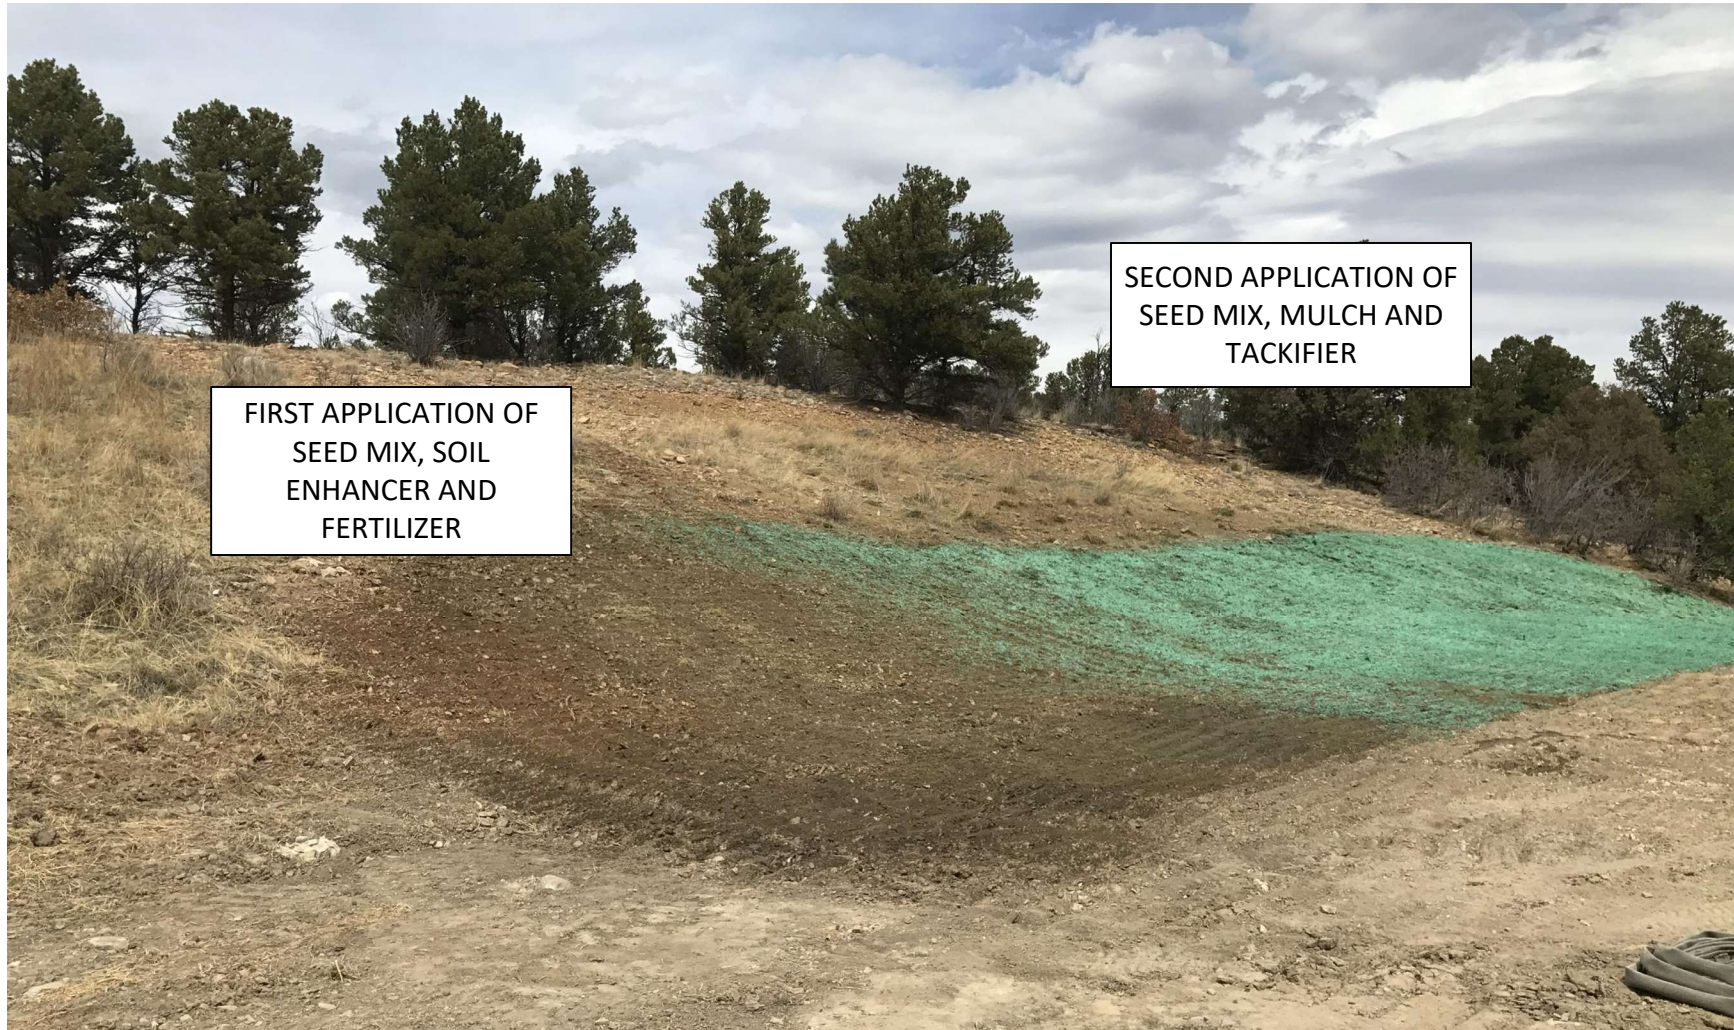
PHOTO 1: FACING THE NORTH CUT SLOPE OF WELL PAD GOLDEN EAGLE 28-13 API # 071-06435. ACCESS TO THE WEST PORTION OF THE GOLDEN EAGLE MINE E-1 AND E-2 ACCESS ROAD RECLAMATION WAS GAINED FROM THE GOLDEN EAGLE 28-13 WELL PAD. THIS DISTURBANCE WAS RECONTOURED AND RECLAIMED. THE EARTH DISTURBANCE WAS HYDRO-SEEDED WITH THE APPROVED COLORADO PARKS AND WILDLIFE (CPW) SEED MIX TO PROMOTE THE ESTABLISHMENT OF VEGETATION.

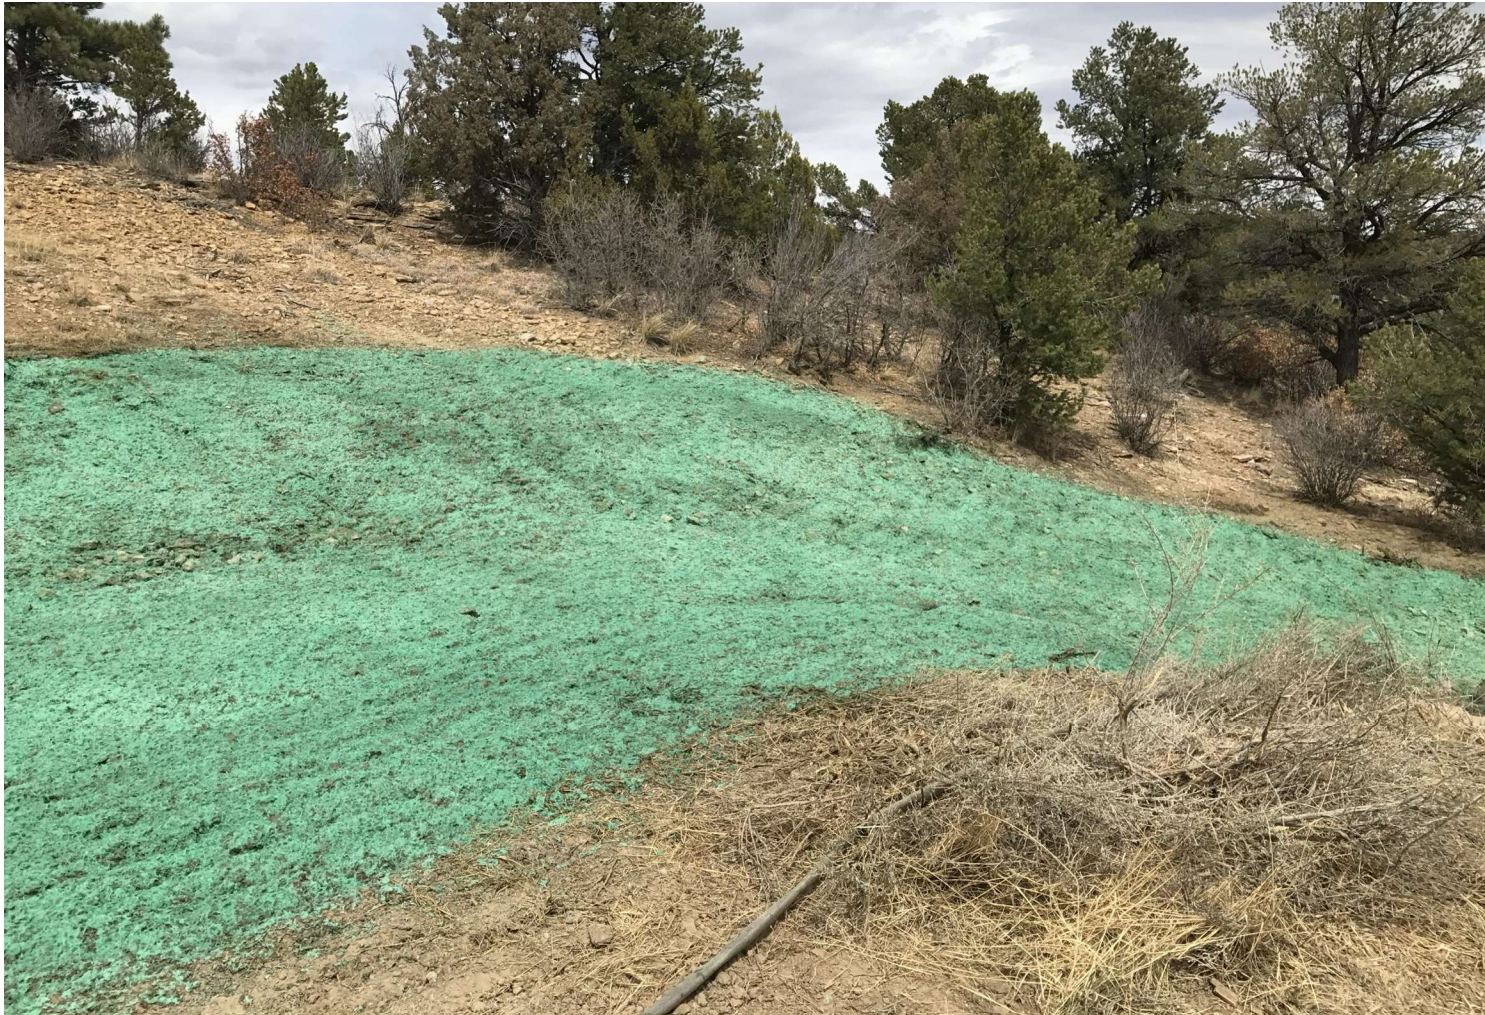
PHOTO 2 : FACING THE NORTH CUT SLOPE OF WELL PAD GOLDEN EAGLE 28-13 API # 071-06435 WERE THE CUT MEETS THE FILL SLOPE. ACCESS TO THE WEST PORTION OF THE GOLDEN EAGLE MINE E-1 AND E-2 ACCESS ROAD RECLAMATION WAS GAINED FROM THE GOLDEN EAGLE 28-13 WELL PAD. THIS DISTURBANCE WAS RECONTOURED AND RECLAIMED. THE EARTH DISTURBANCE WAS HYDRO-SEEDING WITH AN APPROVED COLORADO PARKS AND WILDLIFE (CPW) SEED MIX TO PROMOTE THE ESTABLISHMENT OF VEGETATION.

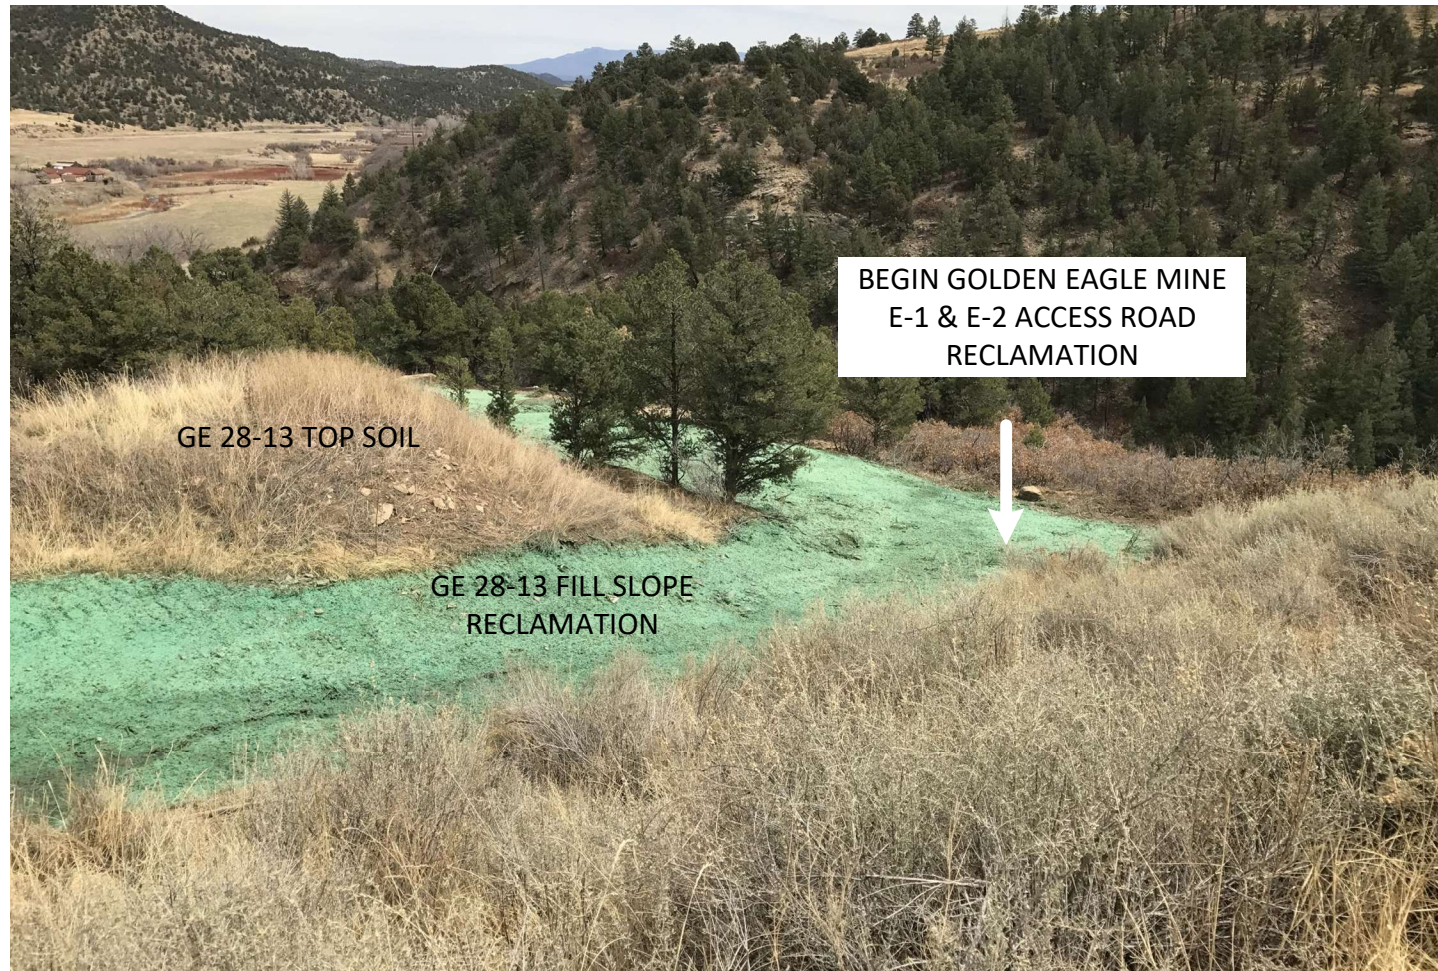
PHOTO 3 : FACING EAST TOWARD WELL PAD FILL SLOPE OF GOLDEN EAGLE 28-13 API # 071-06435. ACCESS TO THE WEST PORTION OF THE GOLDEN EAGLE MINE E-1 AND E-2 ACCESS ROAD RECLAMATION WAS GAINED FROM THE GOLDEN EAGLE 28-13 WELL PAD. THIS DISTURBANCE WAS RECONTOURED AND RECLAIMED. THE EARTH DISTURBANCE WAS HYDRO-SEEDED WITH AN APPROVED COLORADO PARKS AND WILDLIFE (CPW) SEED MIX TO PROMOTE THE ESTABLISHMENT OF VEGETATION.

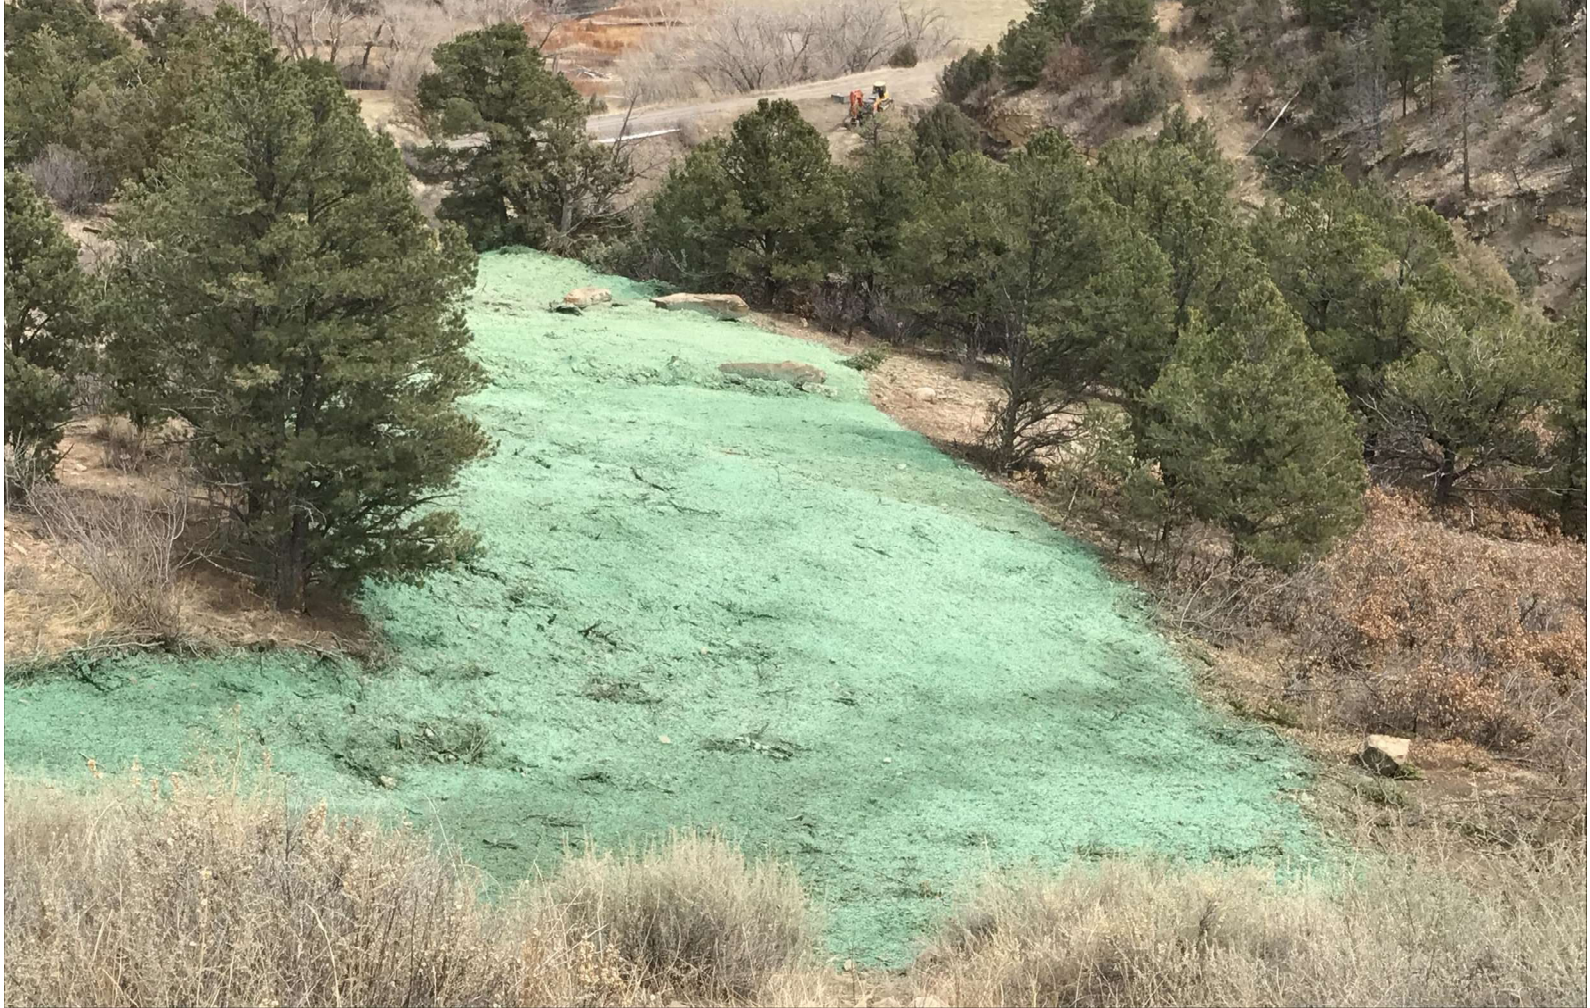
PHOTO 4 : FACING NORTHEAST TOWARD THE WEST PORTION OF THE GOLDEN EAGLE MINE E-1 AND E-2 ACCESS ROAD RECLAMATION. THE ACCESS ROAD WAS RECONTOURED TO MATCH THE SURROUNDING TERRAIN. GRADING TECHNIQUES WERE INSTALLED ON THE CONTOUR. THE EARTH DISTURBANCE WAS HYDRO-SEEDED WITH AN APPROVED COLORADO PARKS AND WILDLIFE (CPW) SEED MIX TO PROMOTE THE ESTABLISHMENT OF VEGETATION.

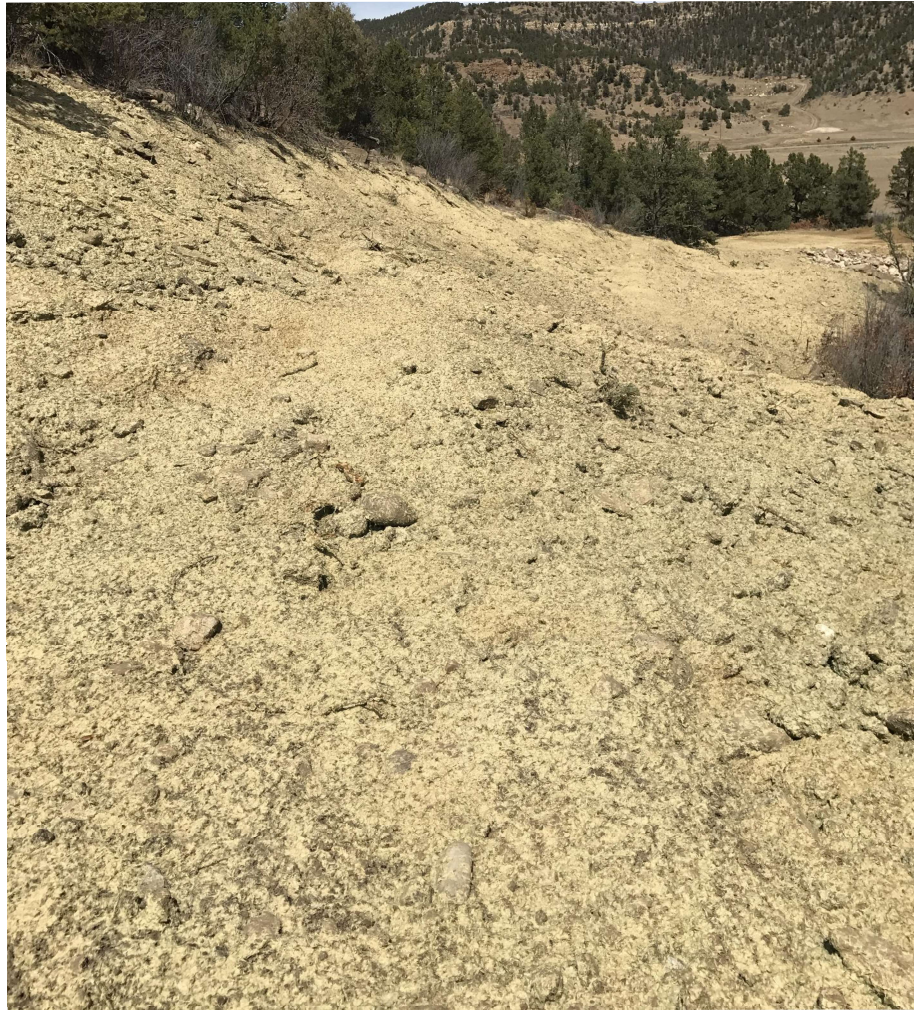
PHOTO 5 : FACING NORTH TOWARD THE WEST PORTION OF THE GOLDEN EAGLE MINE E-1 AND E-2 ACCESS ROAD RECLAMATION. THE ACCESS ROAD WAS RECONTOURED TO MATCH THE SURROUNDING TERRAIN. GRADING TECHNIQUES WERE INSTALLED ON THE CONTOUR. THE EARTH DISTURBANCE WAS HYDRO-SEEDED WITH AN APPROVED COLORADO PARKS AND WILDLIFE (CPW) SEED MIX TO PROMOTE THE ESTABLISHMENT OF VEGETATION.

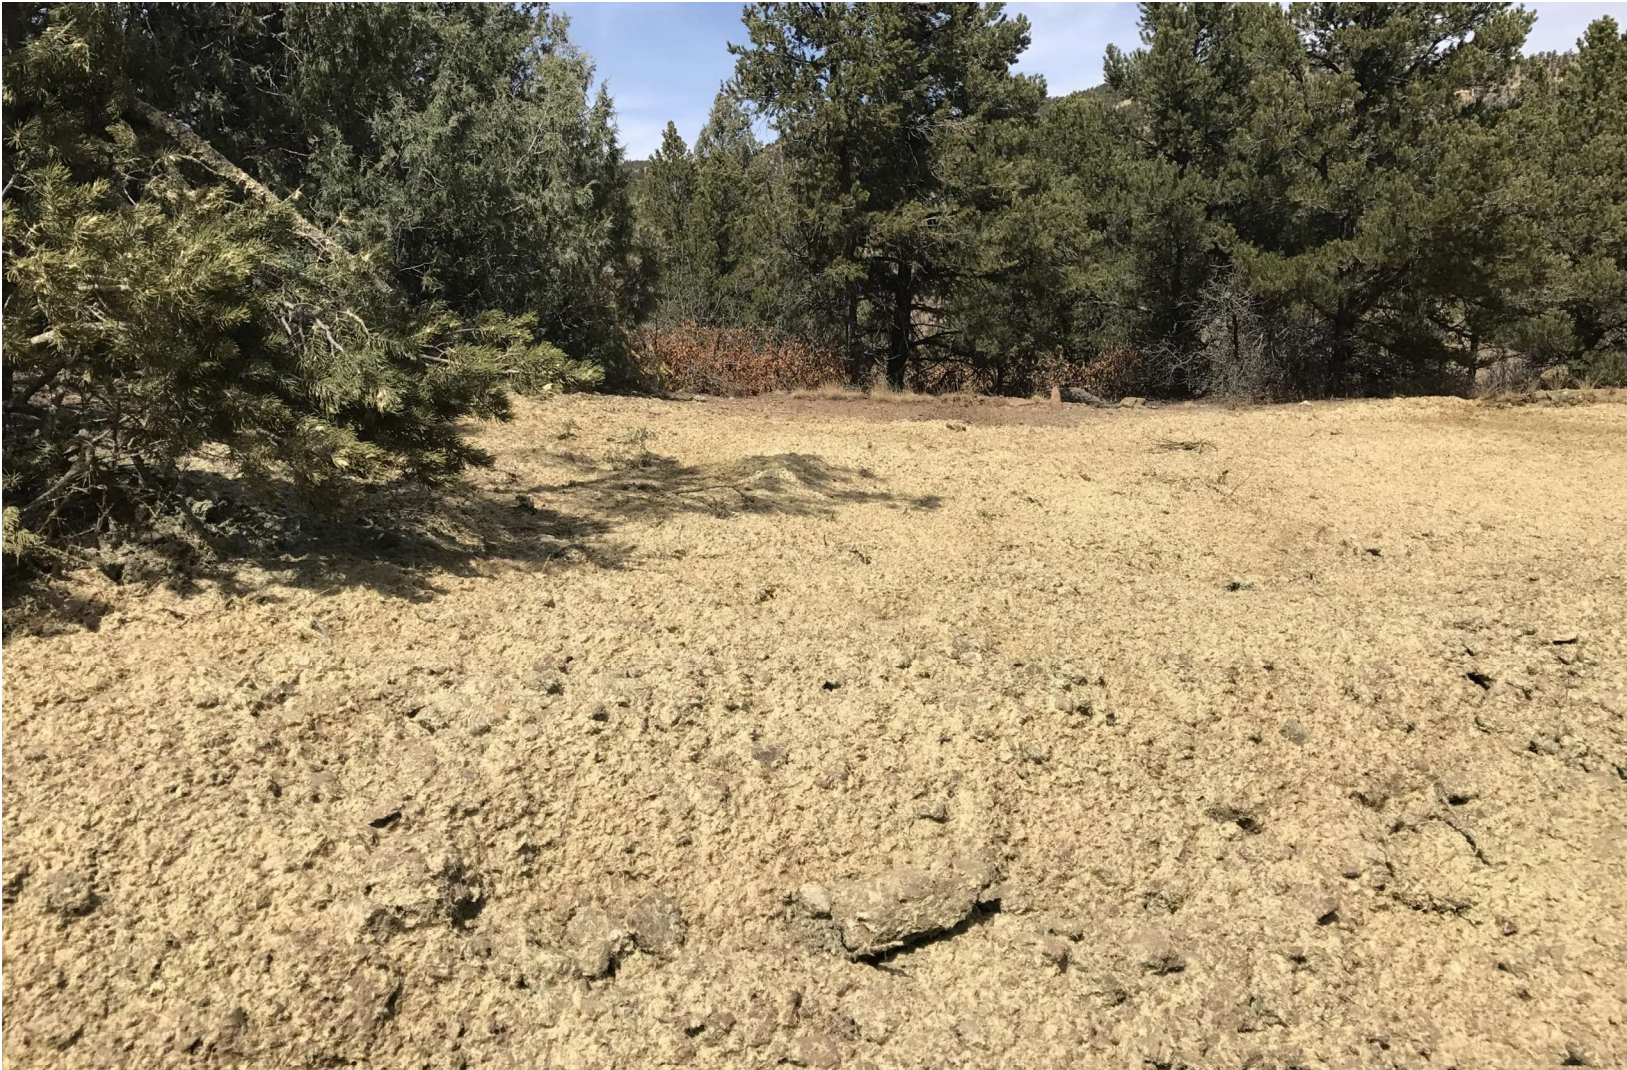
PHOTO 6 : FACING NORTH TOWARD THE WEST PORTION OF THE GOLDEN EAGLE MINE E-1 AND E-2 ACCESS ROAD RECLAMATION. THE ACCESS ROAD WAS RECONTOURED TO MATCH THE SOUROUNDING TERRAIN. GRADING TECHNIQUES WERE INSTALLED ON THE CONTOUR. THE EARTH DISTURBANCE WAS HYDRO-SEEDED WITH AN APPROVED COLORADO PARKS AND WILDLIFE (CPW) SEED MIX TO PROMOTE THE ESTABLISHMENT OF VEGETATION.

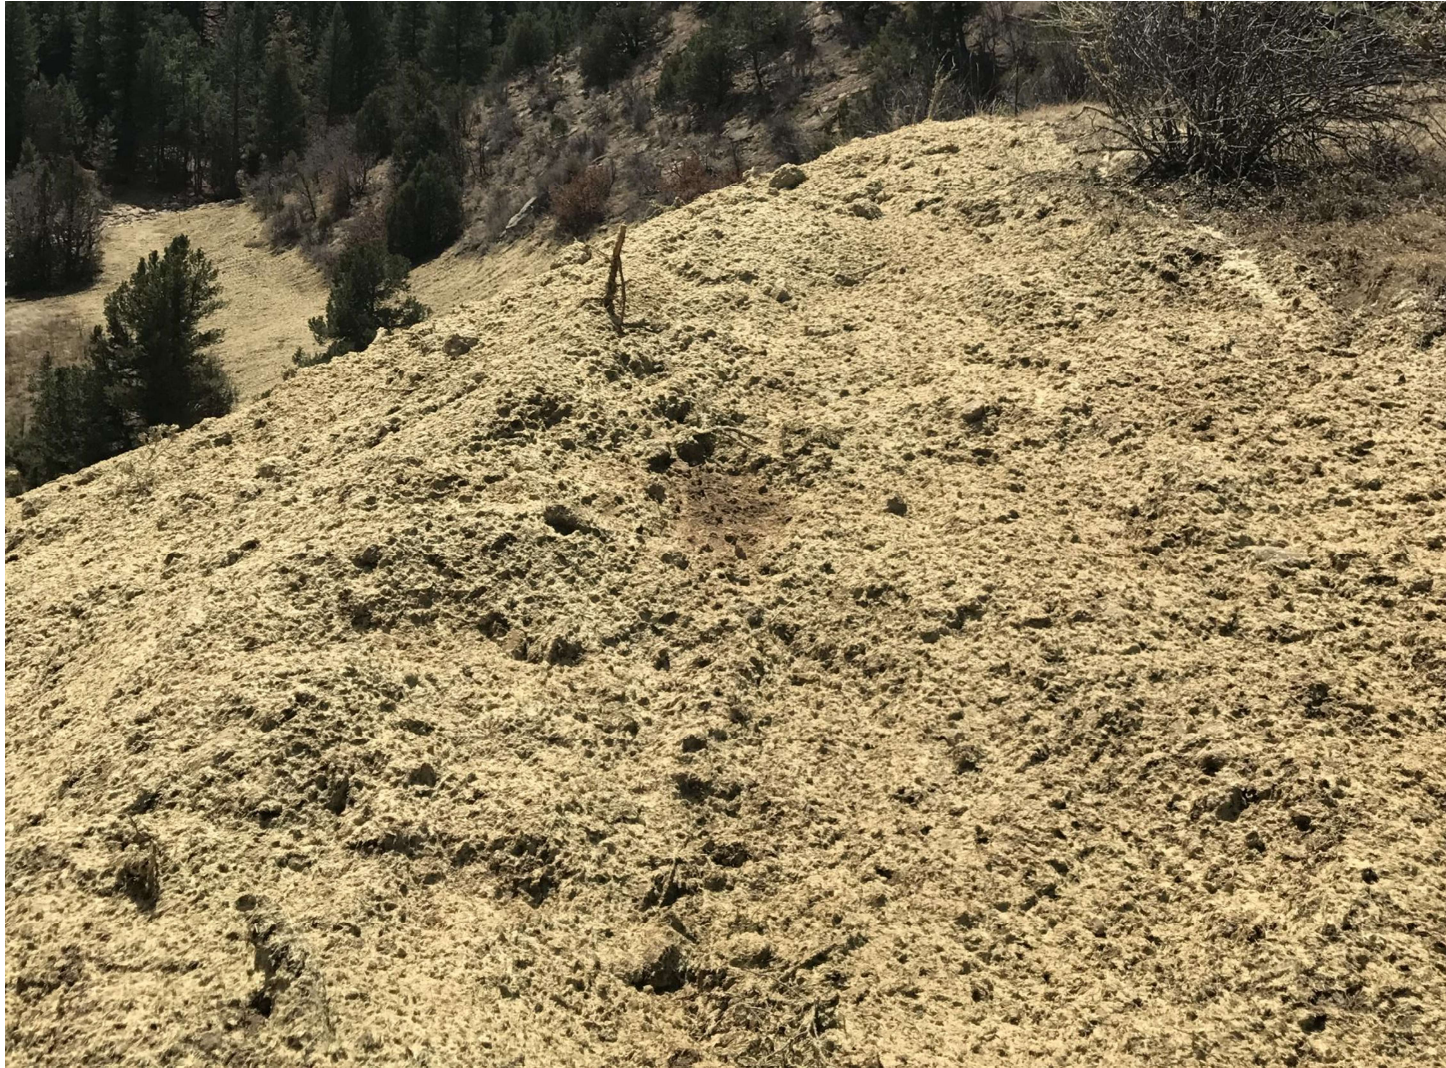
PHOTO 7: FACING SOUTH TOWARD THE WEST PORTION OF THE GOLDEN EAGLE MINE E-1 AND E-2 ACCESS ROAD RECLAMATION. THE ACCESS ROAD WAS RECONTOURED TO MATCH THE SURROUNDING TERRAIN. GRADING TECHNIQUES WERE INSTALLED ON THE CONTOUR. THE EARTH DISTURBANCE WAS HYDRO-SEEDING WITH AN APPROVED COLORADO PARKS AND WILDLIFE (CPW) SEED MIX TO PROMOTE THE ESTABLISHMENT OF VEGETATION.

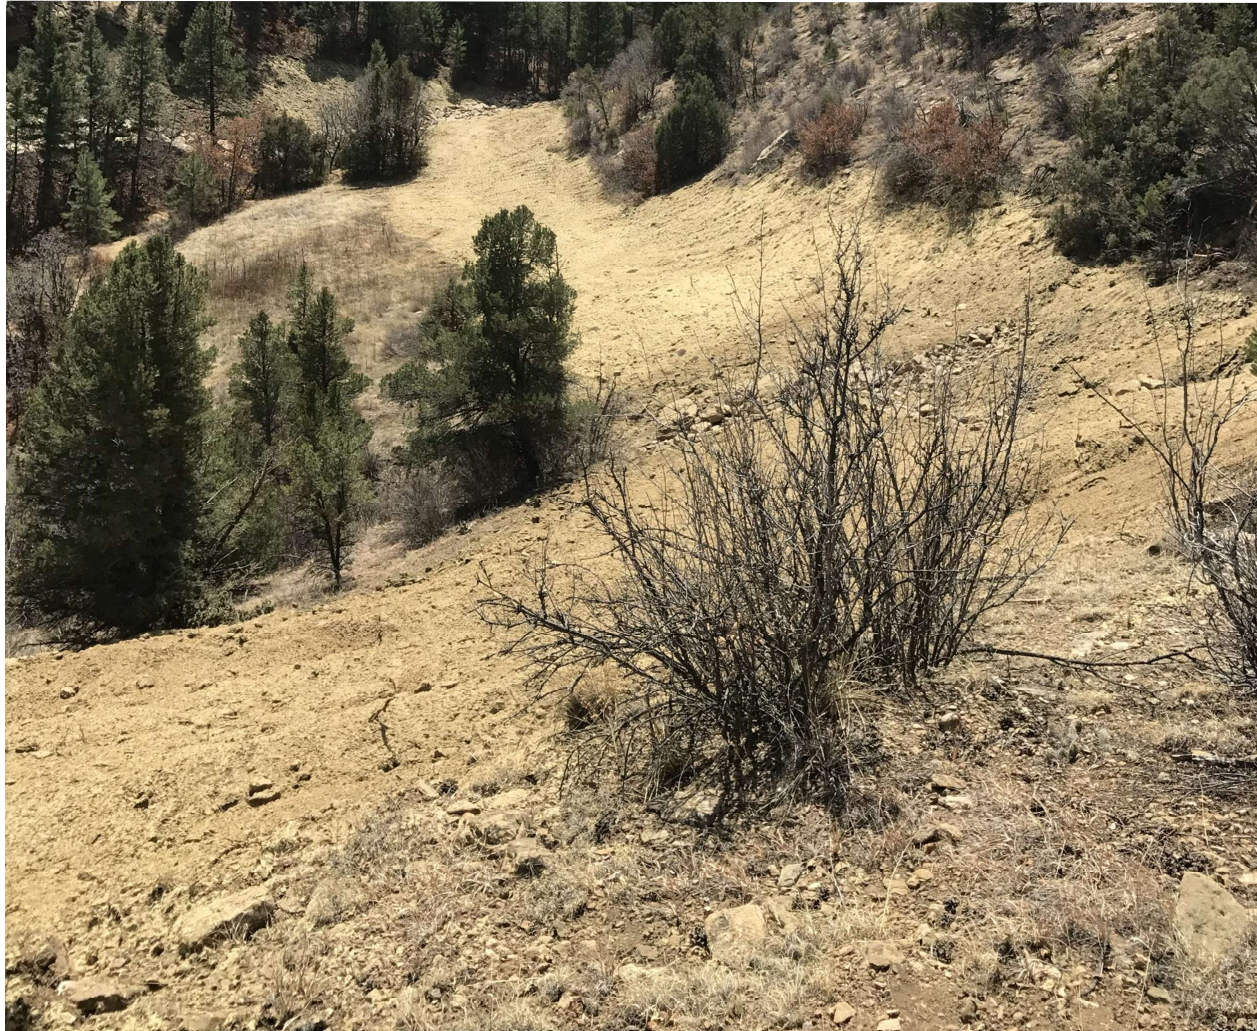
PHOTO 8: FACING SOUTH TOWARD THE WEST PORTION OF THE GOLDEN EAGLE MINE E-1 AND E-2 ACCESS ROAD RECLAMATION. THE ACCESS ROAD WAS RECONTOURED TO MATCH THE SURROUNDING TERRAIN. GRADING TECHNIQUES WERE INSTALLED ON THE CONTOUR. THE EARTH DISTURBANCE WAS HYDRO-SEEDED WITH AN APPROVED COLORADO PARKS AND WILDLIFE (CPW) SEED MIX TO PROMOTE THE ESTABLISHMENT OF VEGETATION.

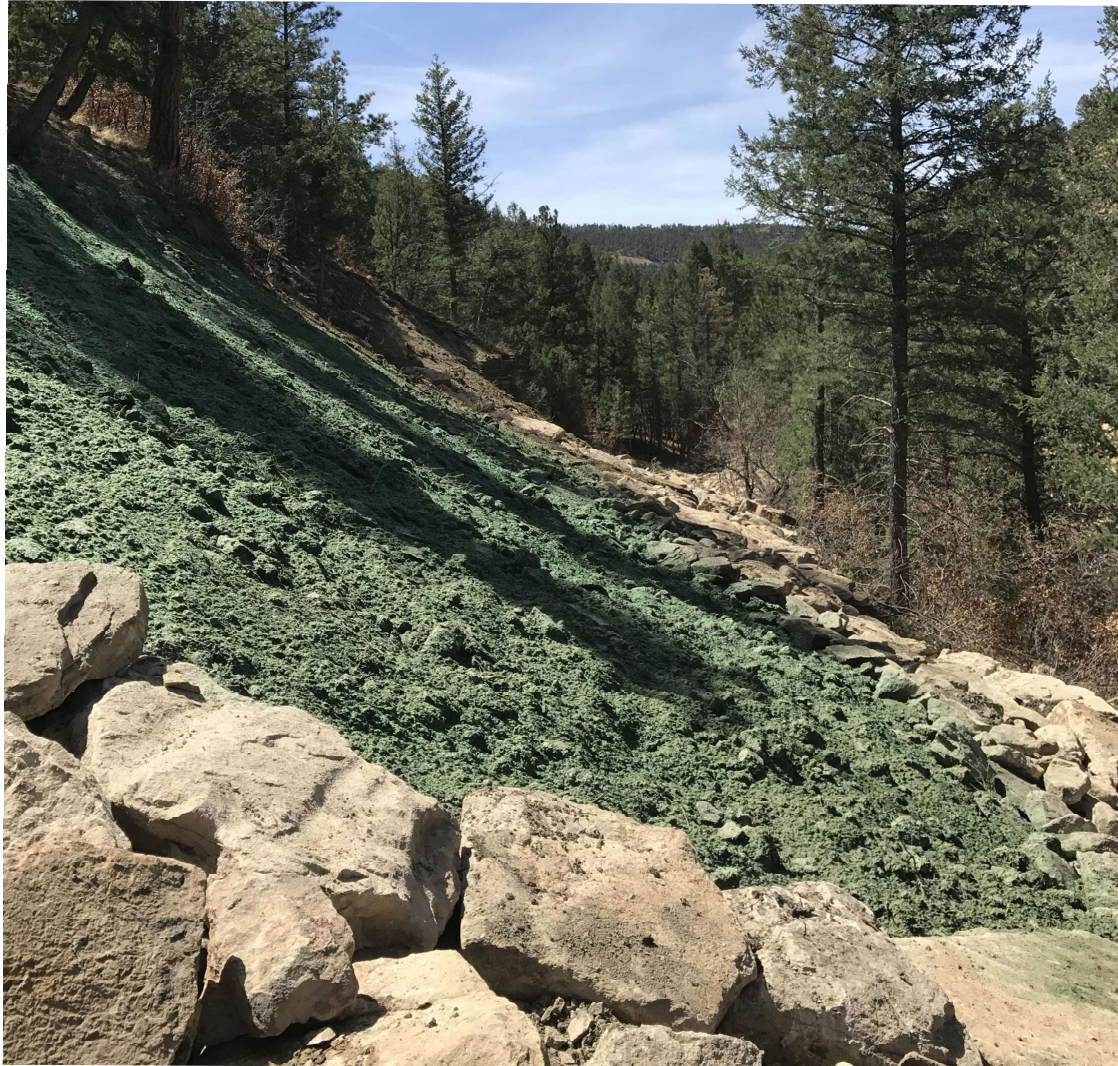
PHOTO 9: FACING SOUTHWEST TOWARD THE WELL PAD AND EAST PORTION OF THE GOLDEN EAGLE MINE E-1 AND E-2 ACCESS ROAD RECLAMATION. THE ACCESS ROAD WAS RECONTOURED TO MATCH THE SURROUNDING TERRAIN. GRADING TECHNIQUES WERE INSTALLED ON THE CONTOUR. ARMOR WAS INSTALLED TO RECEIVE RUN ON AND CONTROL EROSION. THE EARTH DISTURBANCE WAS HYDRO-SEEDED WITH AN APPROVED COLORADO PARKS AND WILDLIFE (CPW) SEED MIX TO PROMOTE THE ESTABLISHMENT OF VEGETATION.

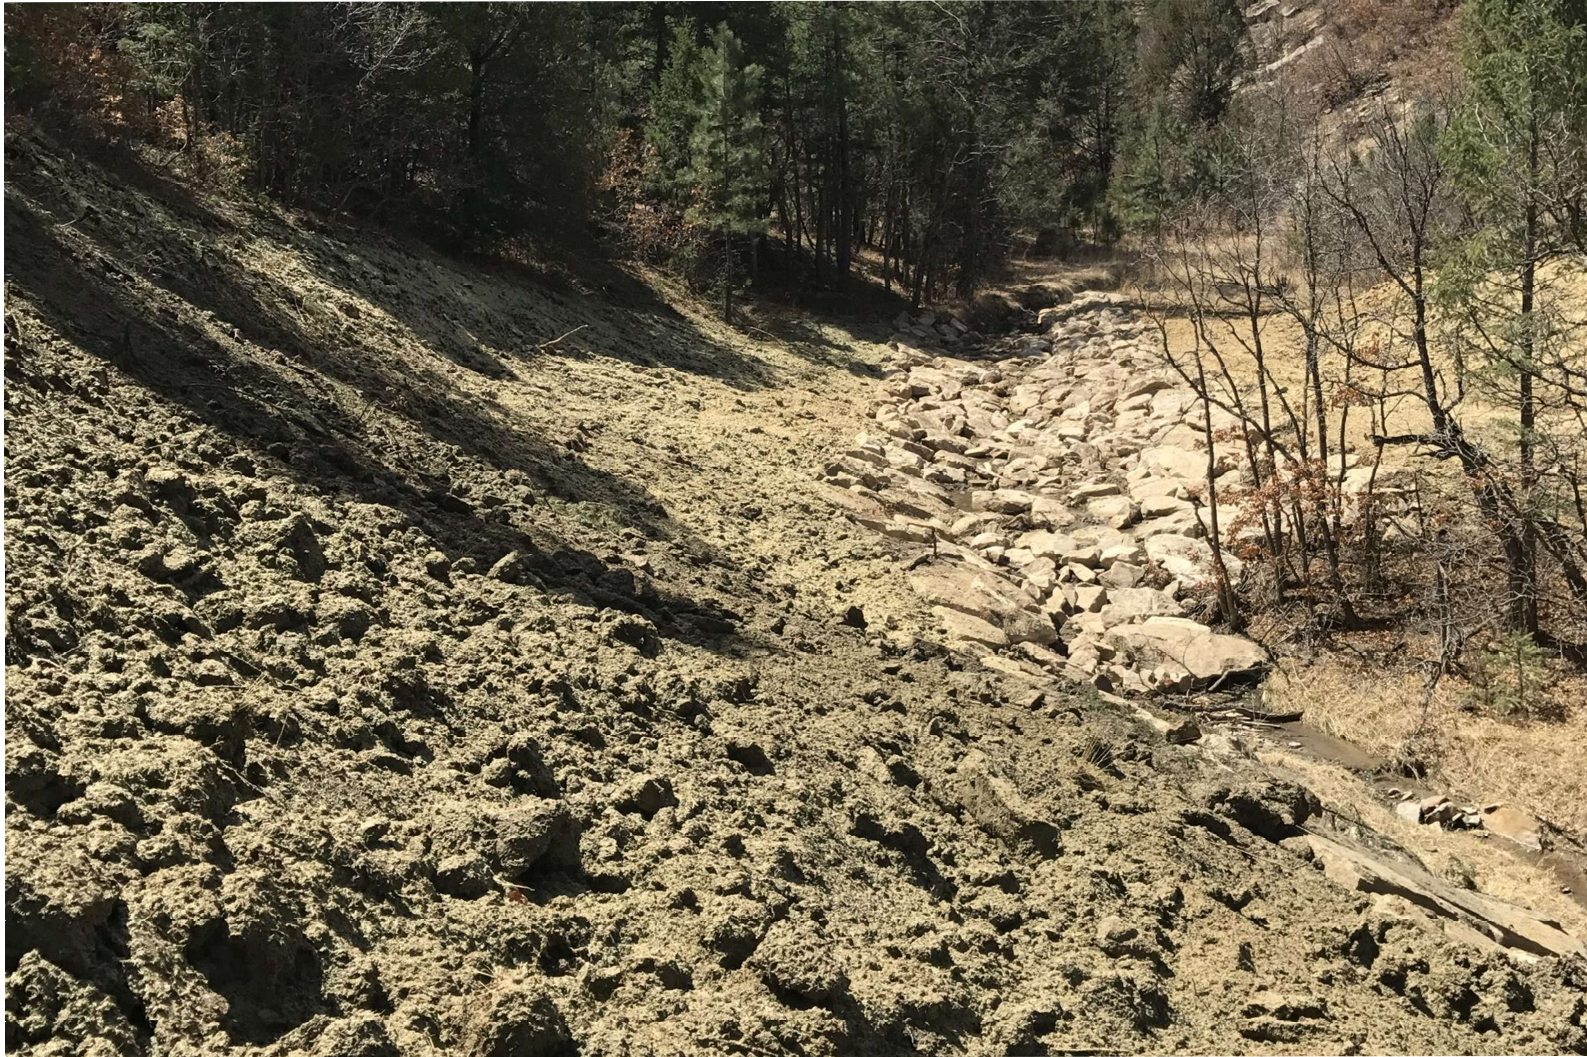
PHOTO 10: FACING THE CREEK BOTTOM OF THE GOLDEN EAGLE MINE E-1 AND E-2 ACCESS ROAD RECLAMATION. ALL PIPING, RISERS AND VALVES HAVE BEEN REMOVED. THE ACCESS ROAD WAS RECONTOURED TO MATCH THE SURROUNDING TERRAIN. GRADING TECHNIQUES WERE INSTALLED ON THE CONTOUR. ARMOR WAS INSTALLED IN THE CREEK BOTTOM FOR PERMANENT STABILIZATION. THE EARTH DISTURBANCE WAS HYDRO-SEEDED WITH AN APPROVED COLORADO PARKS AND WILDLIFE (CPW) SEED MIX TO PROMOTE THE ESTABLISHMENT OF VEGETATION.

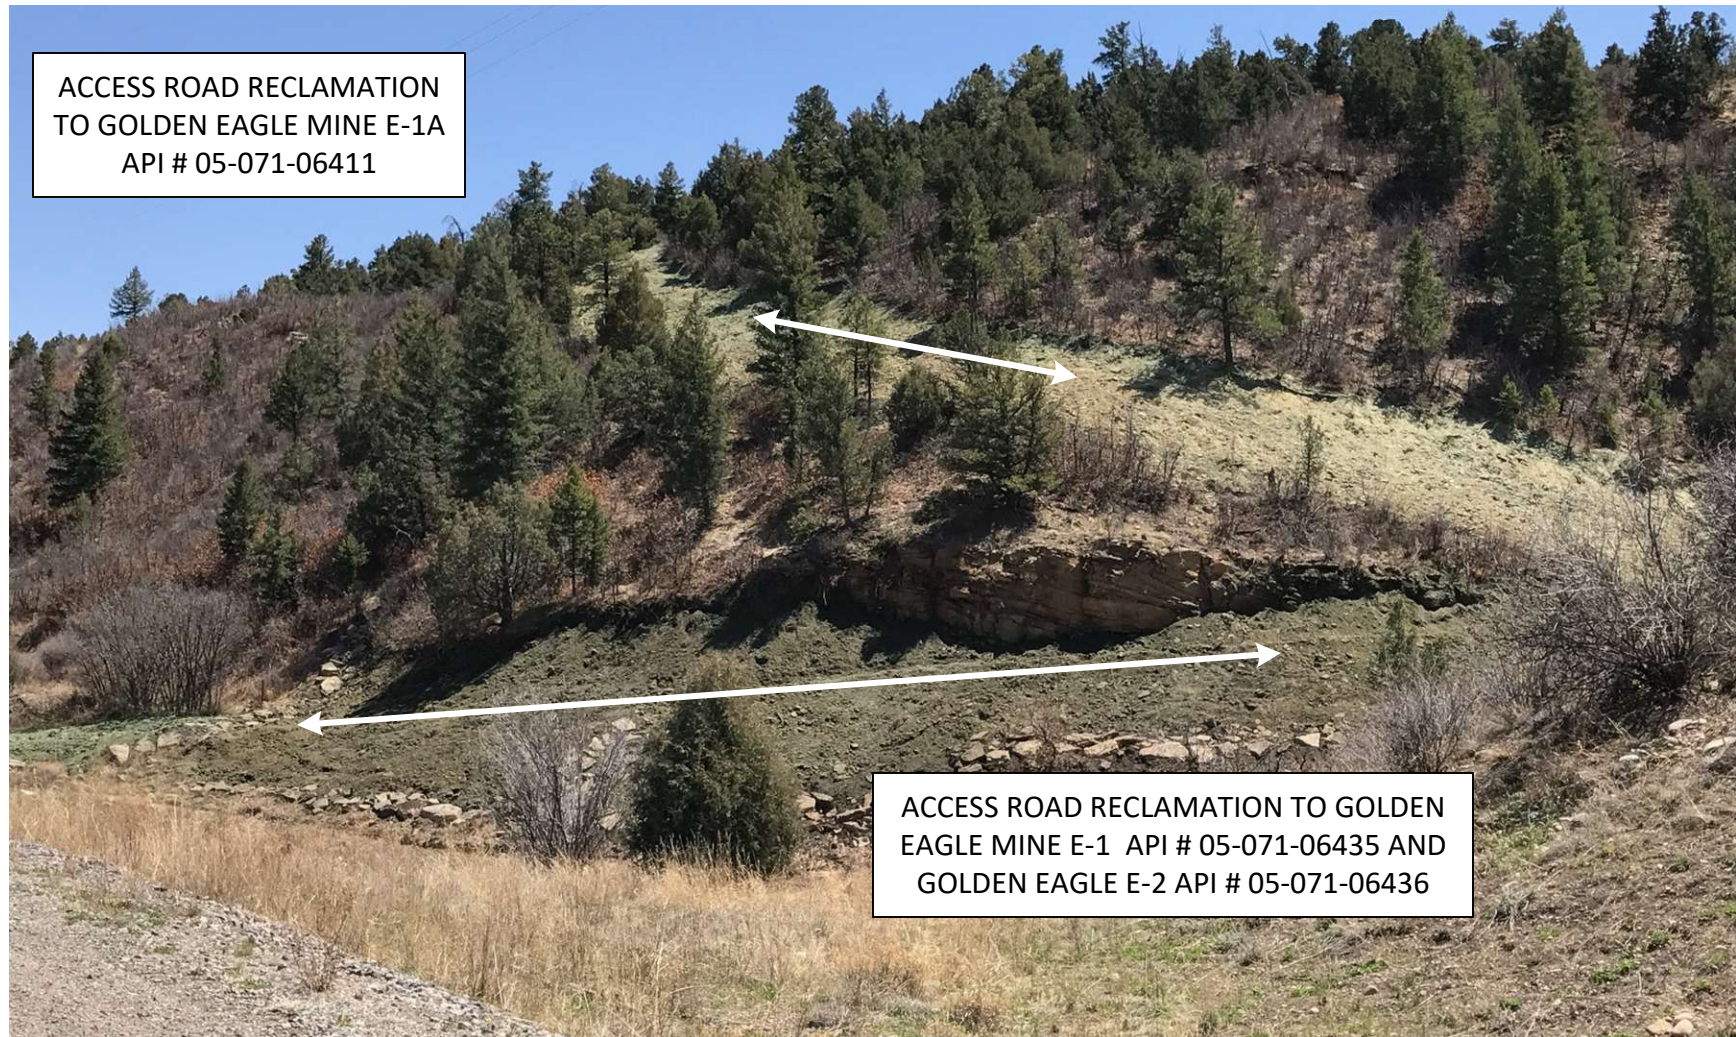
PHOTO 11: FACING SOUTHEAST AT THE GOLDEN EAGLE MINE E-1, E-2 AND E-1A ACCESS ROAD RECLAMATION FROM THE RAIL ROAD ROW. THE ACCESS ROAD WAS RECONTOURED TO MATCH THE SURROUNDING TERRAIN. GRADING TECHNIQUES WERE INSTALLED ON THE CONTOUR. ARMOR WAS INSTALLED IN AREAS OF CONCENTRATED FLOW FOR EROSION CONTROL AND PERMANENT STABILIZATION. THE EARTH DISTURBANCE WAS HYDRO-SEEDED WITH AN APPROVED COLORADO PARKS AND WILDLIFE (CPW) SEED MIX TO PROMOTE THE ESTABLISHMENT OF VEGETATION.

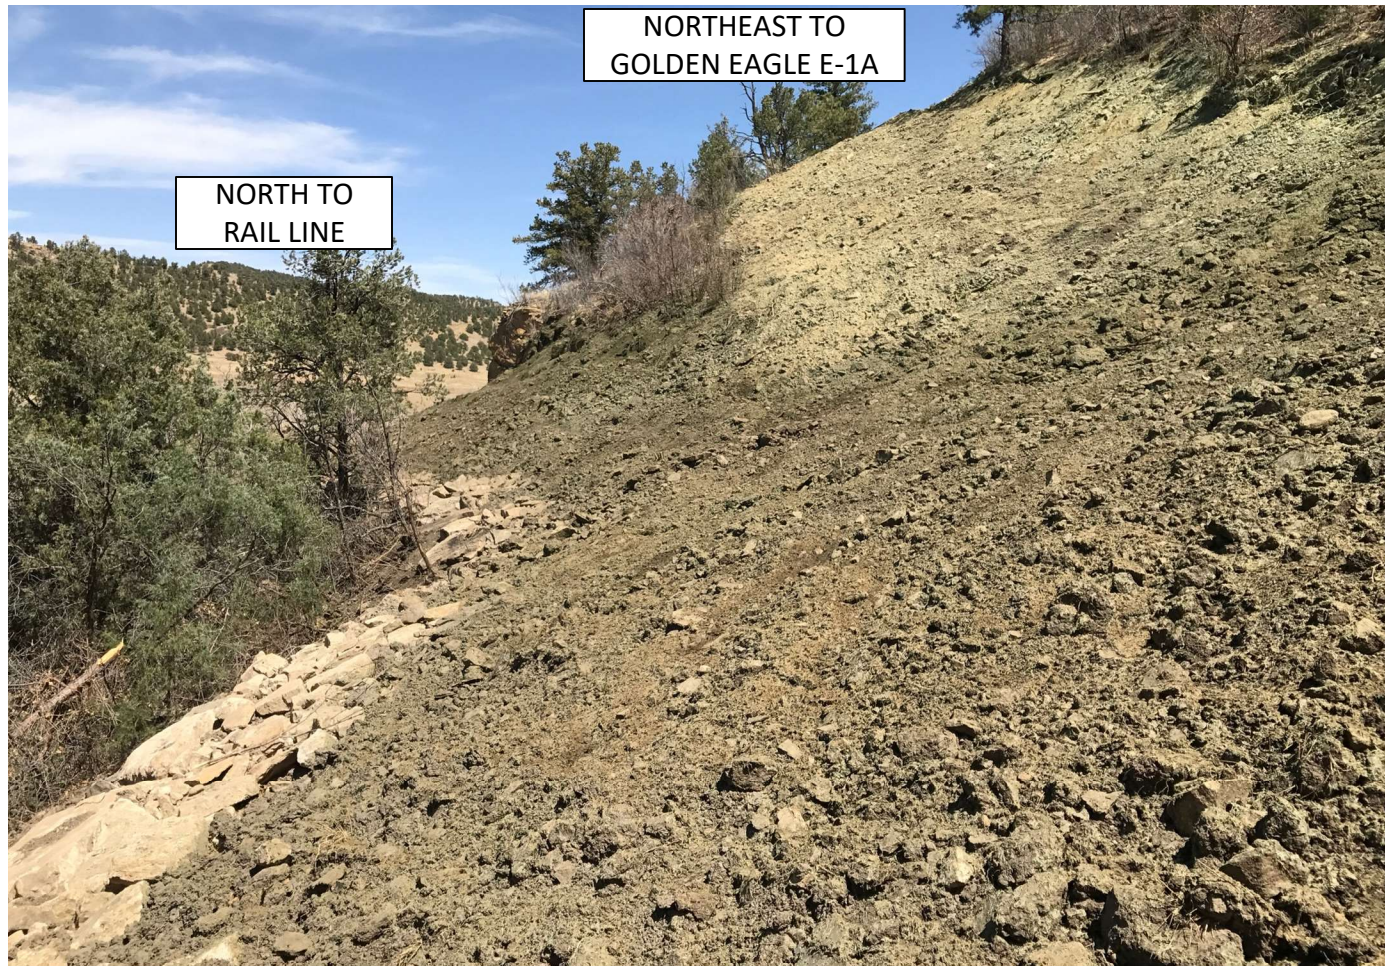
PHOTO 12: FACING NORTH TOWARD INTERSECTION OF GOLDEN EAGLE MINE E-1, E-2 AND E-1A ACCESS ROAD RECLAMATION. THE ACCESS ROAD WAS RECONTOURED TO MATCH THE SURROUNDING TERRAIN. GRADING TECHNIQUES WERE INSTALLED ON THE CONTOUR. ARMOR WAS INSTALLED AT THE TOE OF THE FILL SLOPE FOR PERMANENT STABILIZATION. THE EARTH DISTURBANCE WAS HYDRO-SEEDING WITH AN APPROVED COLORADO PARKS AND WILDLIFE (CPW) SEED MIX TO PROMOTE THE ESTABLISHMENT OF VEGETATION.
