GOLDEN EAGLE MINE 40-89 API# 05-071-06475 – TIMBER CREEK
OGCC OPERATOR NUMBER 10672 – INSPECTION DATE: APRIL 19, 2018
CORRECTIVE ACTIONS COMPLETED REGARDING COGCC FIR DOCUMENT # 680102764

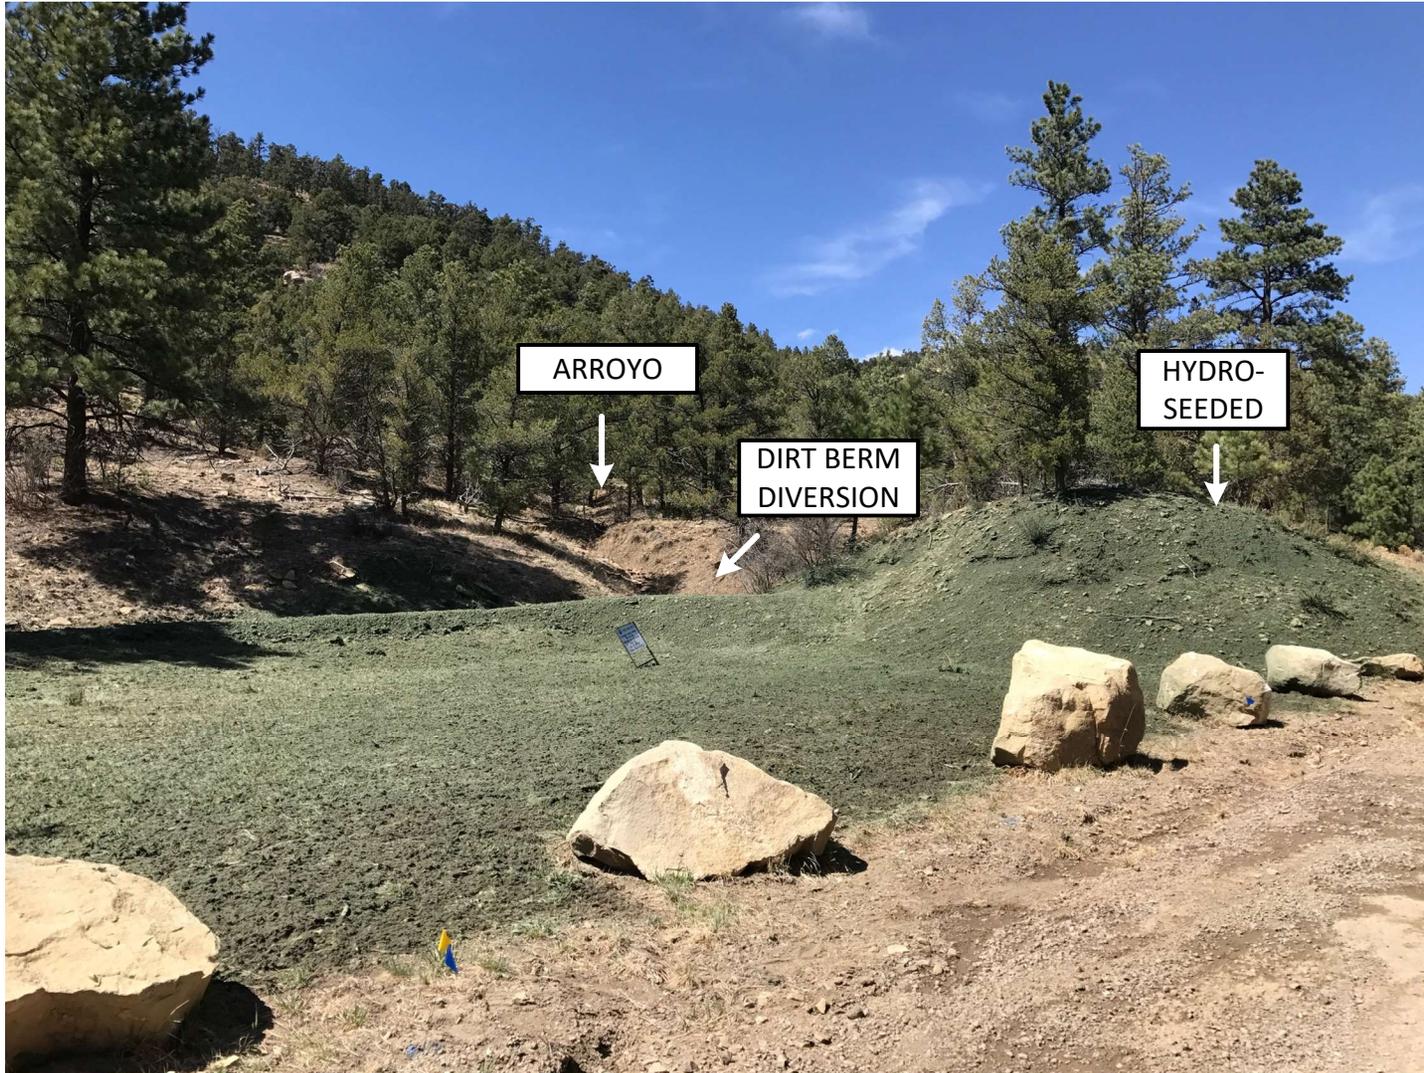
PHOTO 1: FACING NORTHWEST TOWARD THE GOLDEN EAGLE MINE 40-89 PAD RECLAMATION. THE DIRT BERM DIVERSION WAS DOMINATED TO DIRECT THE RUN ON FROM THE ARROYO AWAY FROM THE RECLAMATION AREA. THE SITE WAS HYDRO-SEEDED USING AN APPROVED HILL RANCH SEED MIX TO PROMOTE THE ESTABLISHMENT OF VEGETATION.

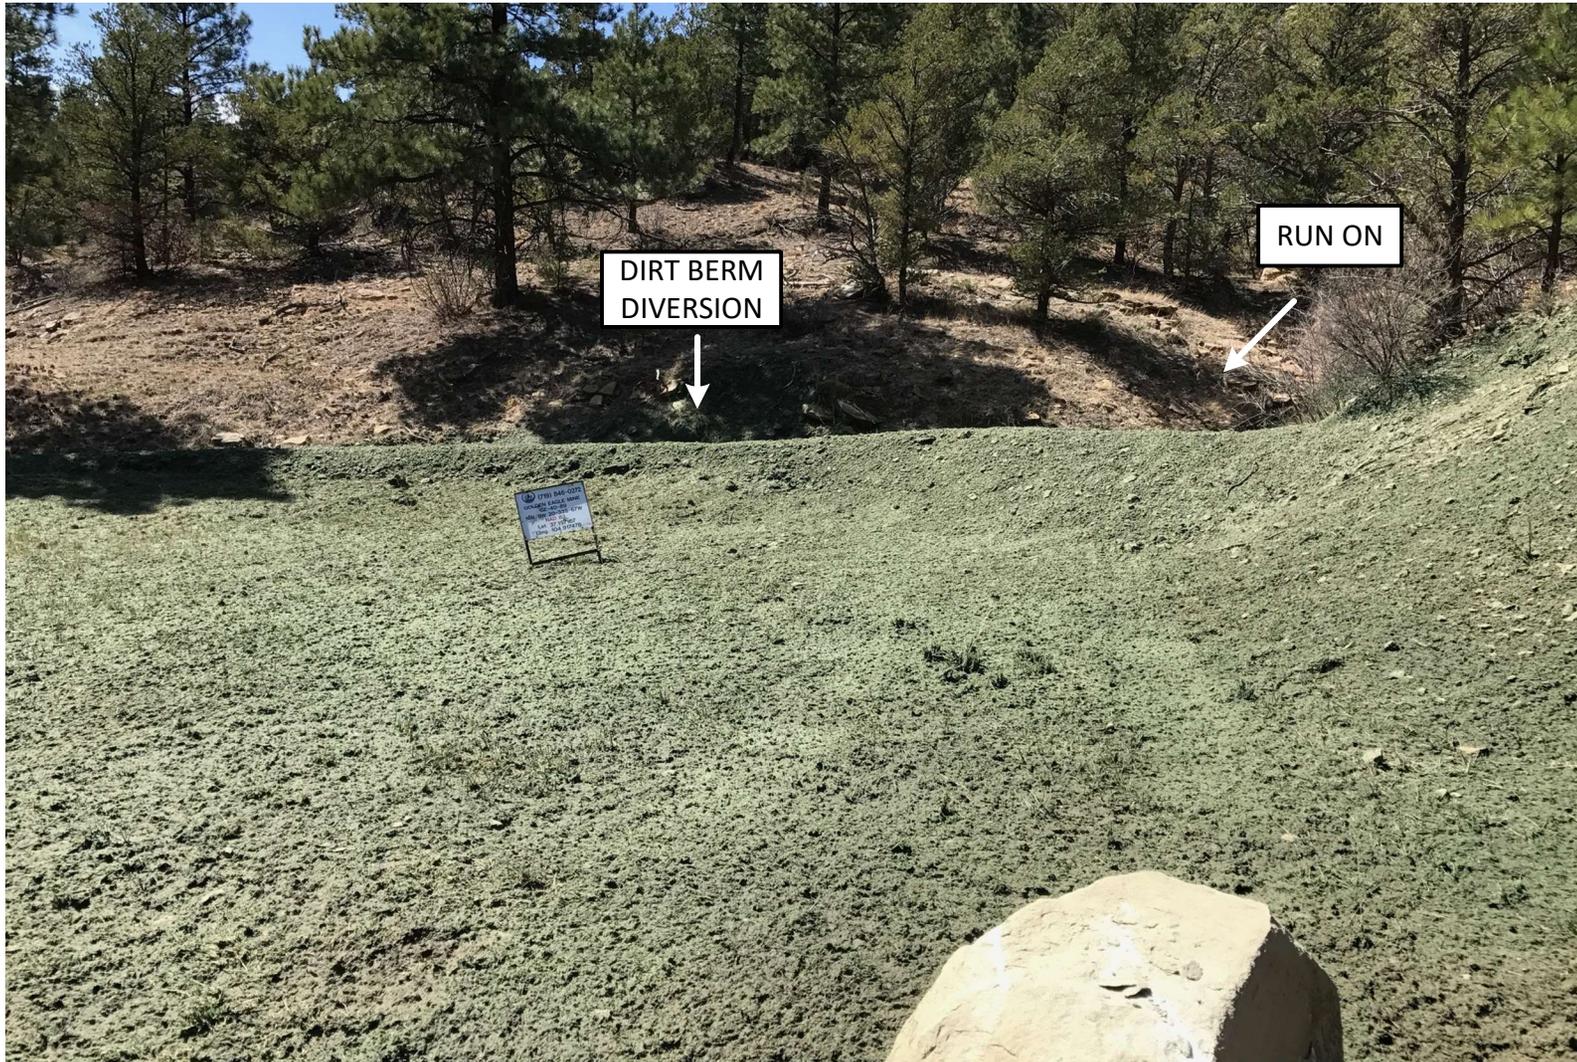
PHOTO 2: FACING WEST TOWARD THE GOLDEN EAGLE MINE 40-89 PAD RECLAMATION. RUN ON IS DIVERTED ON THE WEST SIDE OF THE RECLAMATION.

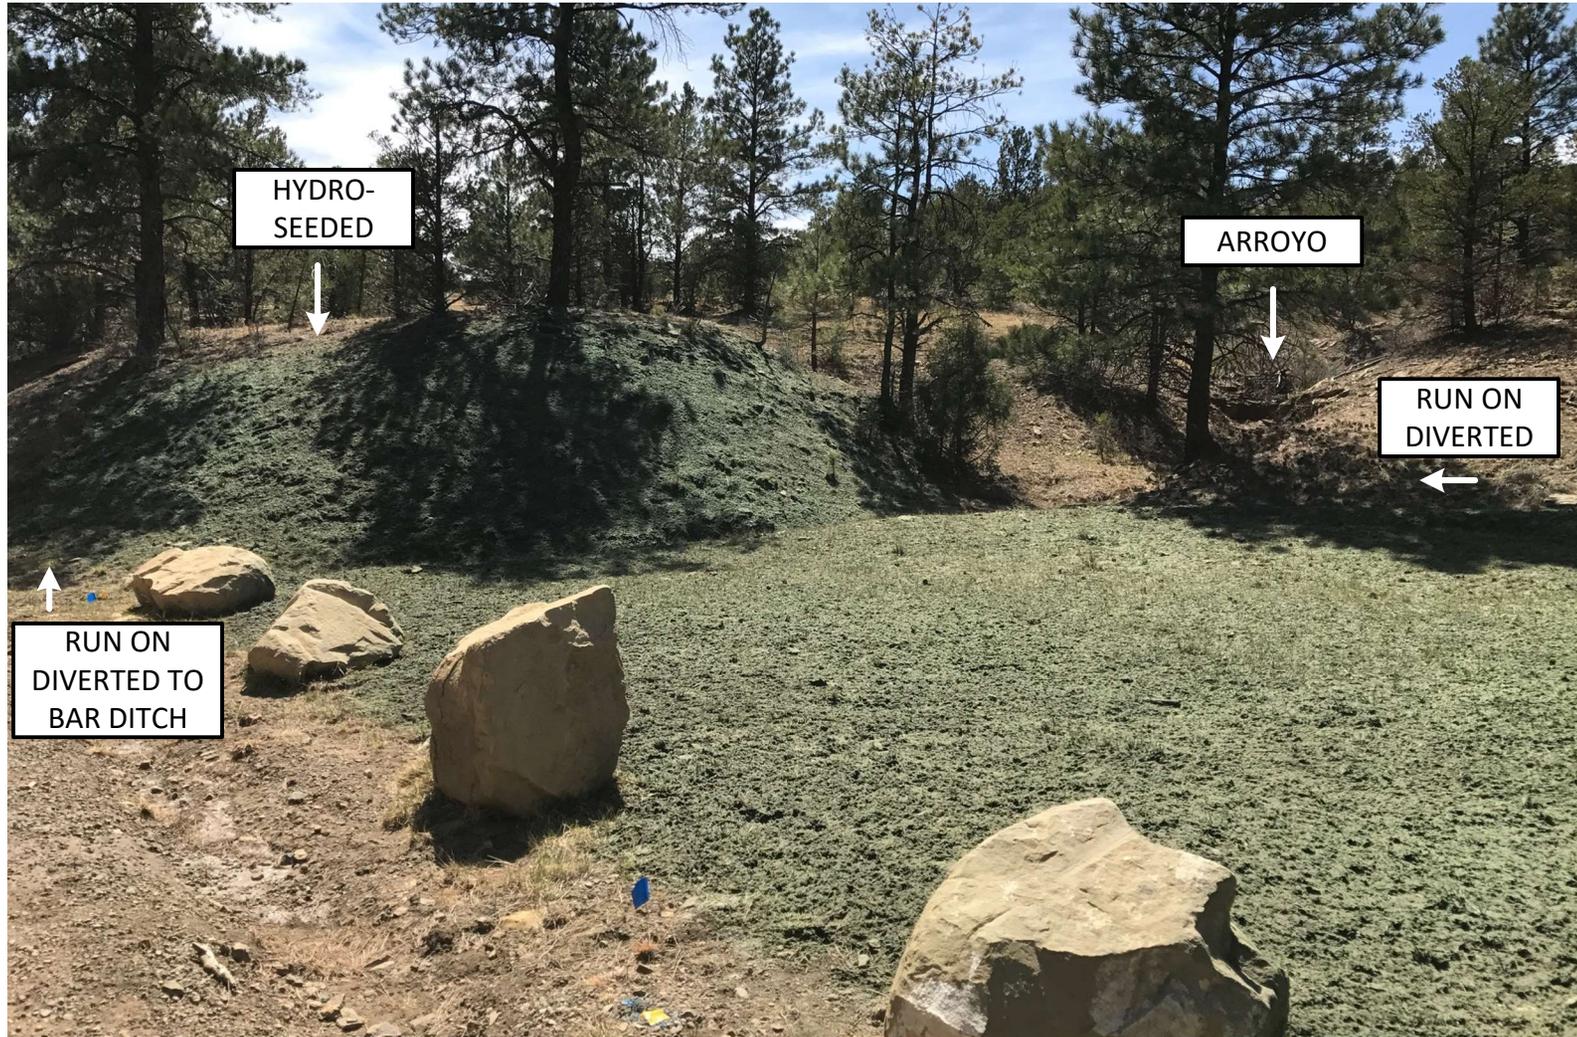
PHOTO 3: FACING SOUTHWEST TOWARD THE GOLDEN EAGLE MINE 40-89 PAD RECLAMATION. THE RUN ON FROM THE SECOND ARROYO IS DIVERTED AROUND THE PAD AND INTO THE EXISTING BAR DITCH ON THE LEASE ROAD. THE SITE WAS HYDRO-SEEDED USING AN APPROVED HILL RANCH SEED MIX TO PROMOTE THE ESTABLISHMENT OF VEGETATION.
