Inspection Photos

API: 05-067-08098

Operator: LOGOS OPERATING LLC

Inspection Date: 4/12/2018

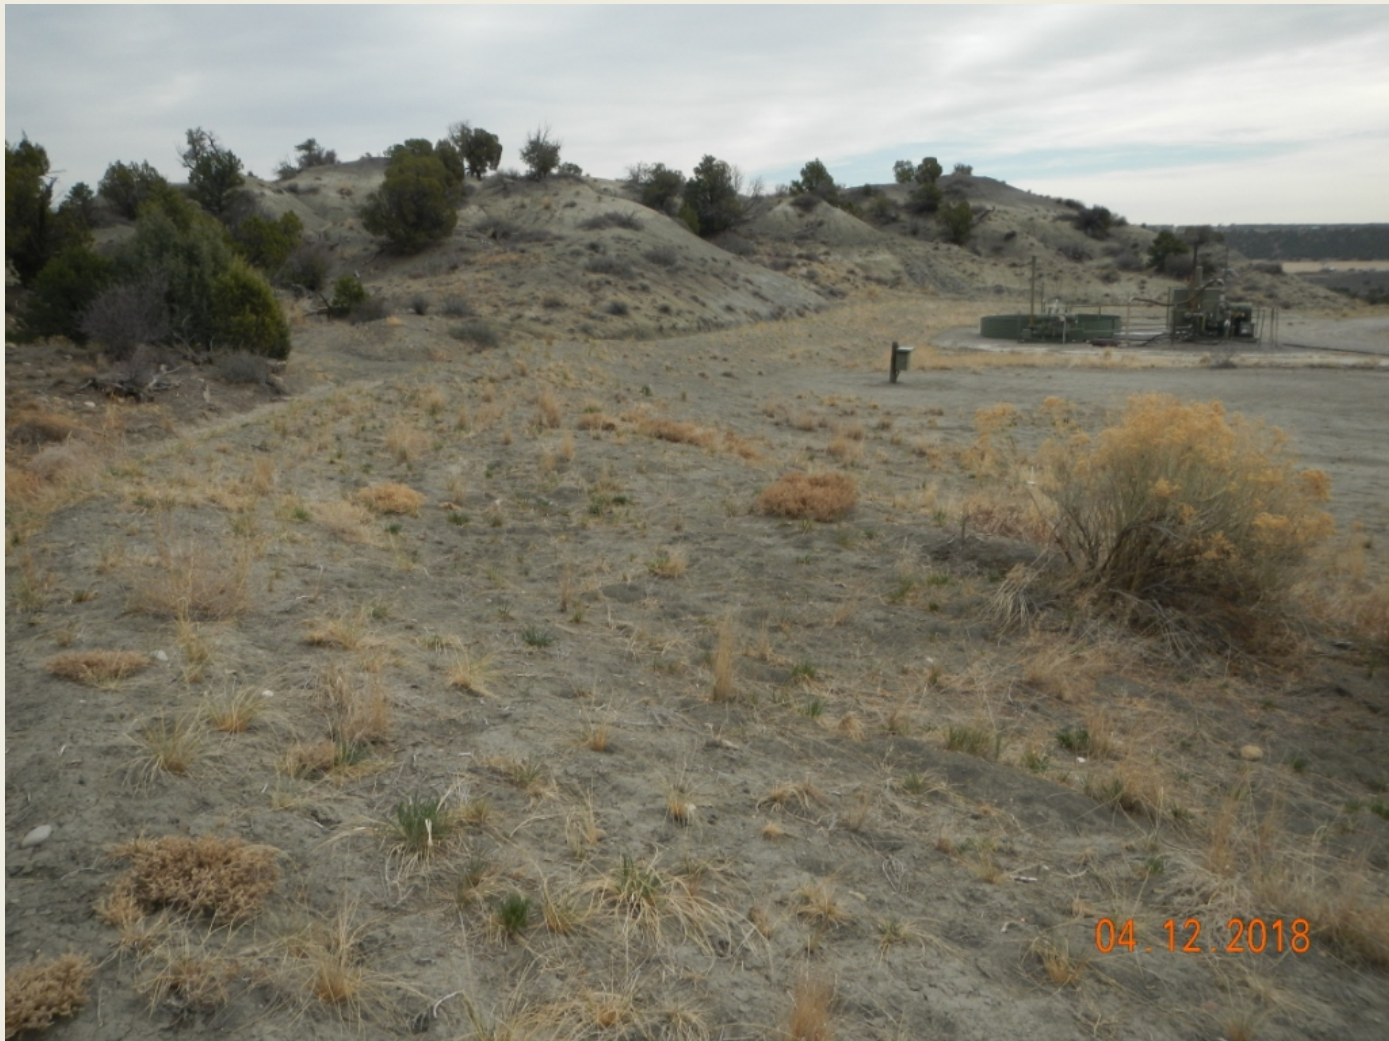
Photo 2. View of the northern portion of the project area from the northwestern corner facing eastward. Revegetation is progressing on berms and flat areas with sand dropseed (*Sporobolus cryptandrus*), western wheatgrass (*Pascopyrum smithii*), and Indian ricegrass (*Achnatherum hymenoides*), as well as rubber rabbitbrush (*Chrysothamnus nauseosus*).

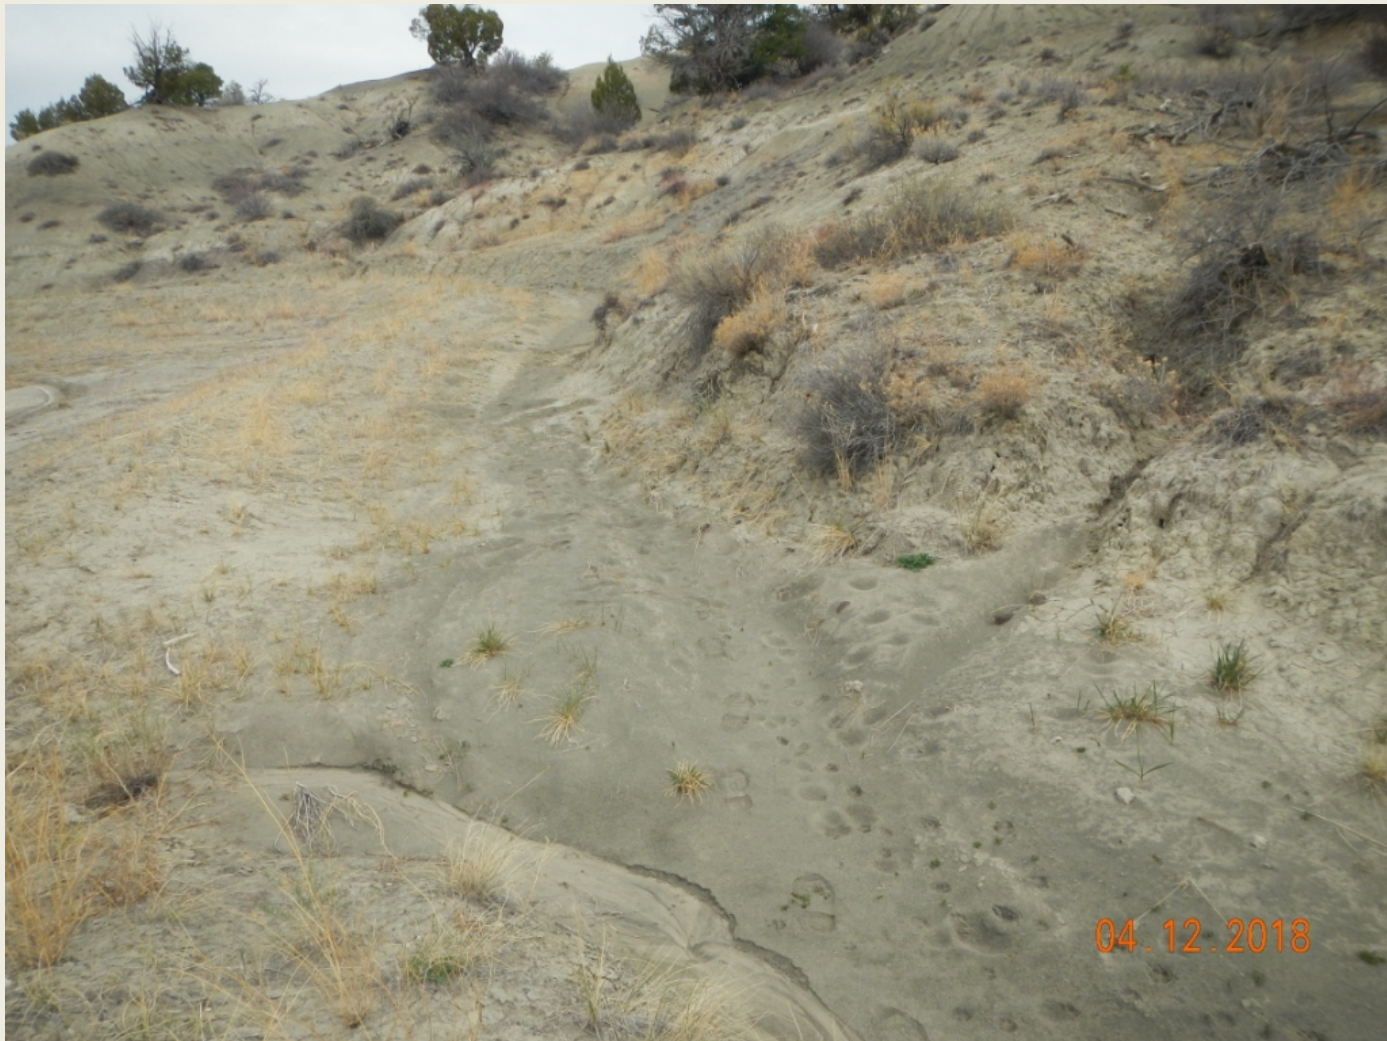
Photo 3. View of the northeastern project area from the eastern edge facing northwestward. Diversion channel is full of sediment and cut-slopes are eroding in the northern and northeastern project area. Revegetation is progressing on berms.

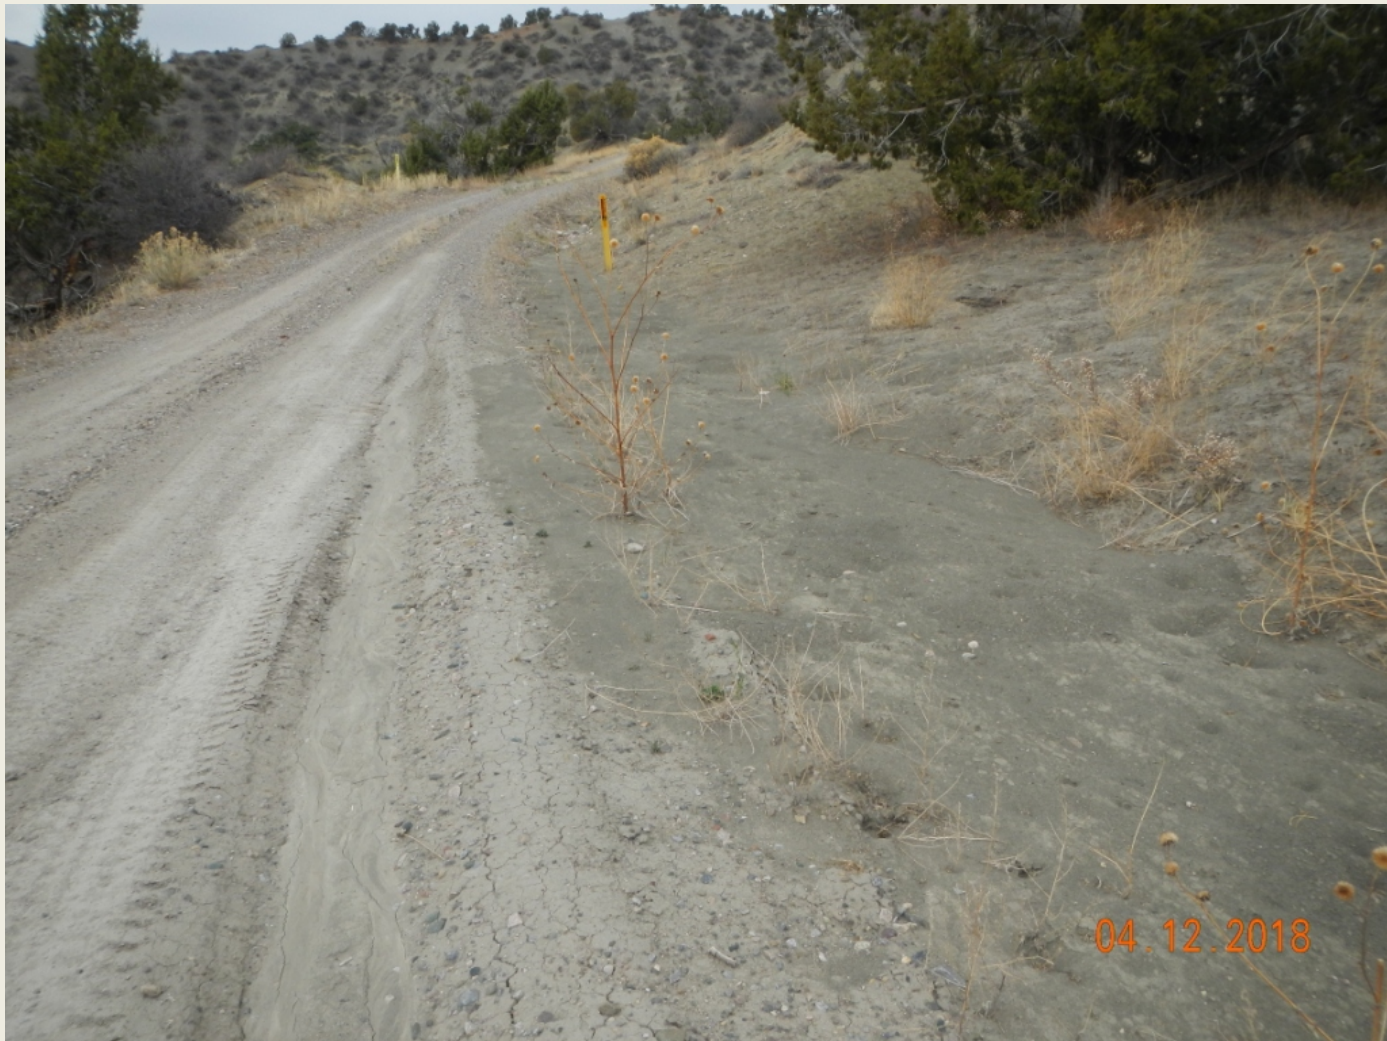
Photo 7. View of area where roadside drainage is full of sediment. Sediment controls are needed here.
