Inspection Photos 04/17/18
Location: UPRR 43 PAN AM I #23
API # 05-123-09055

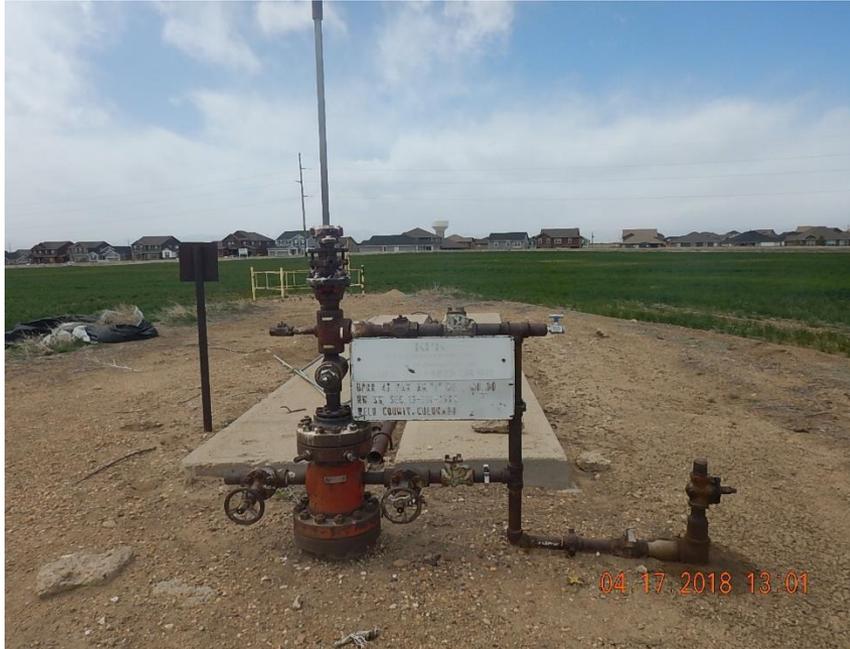
Wellhead and signage; View looking West

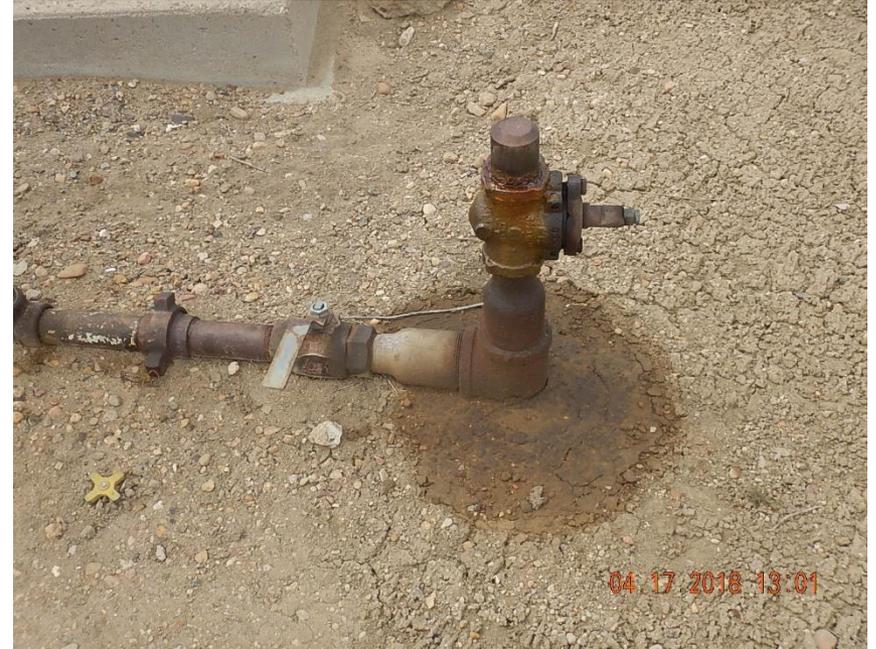
Leaking flowline valve and stained soils

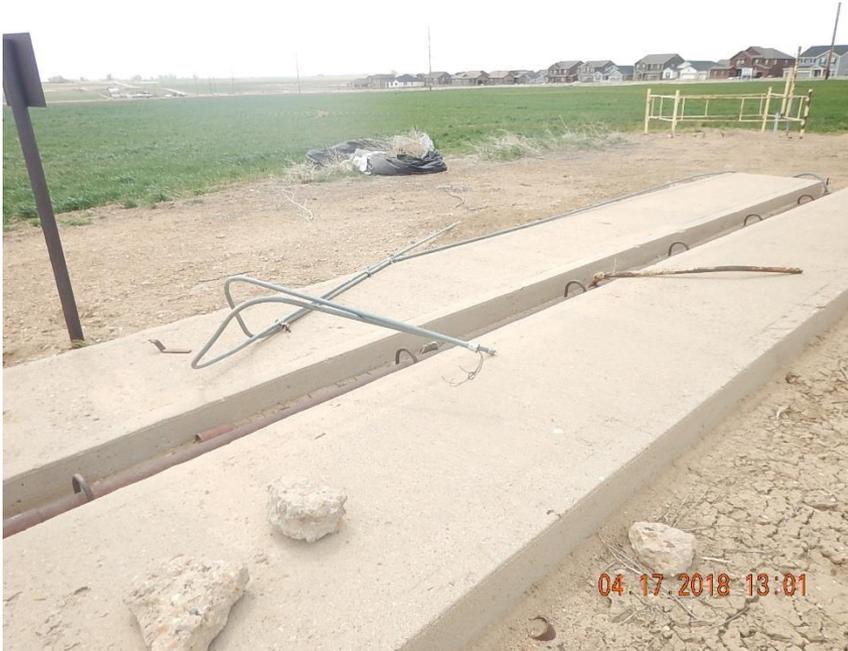
Misc trash and unused equipment on location

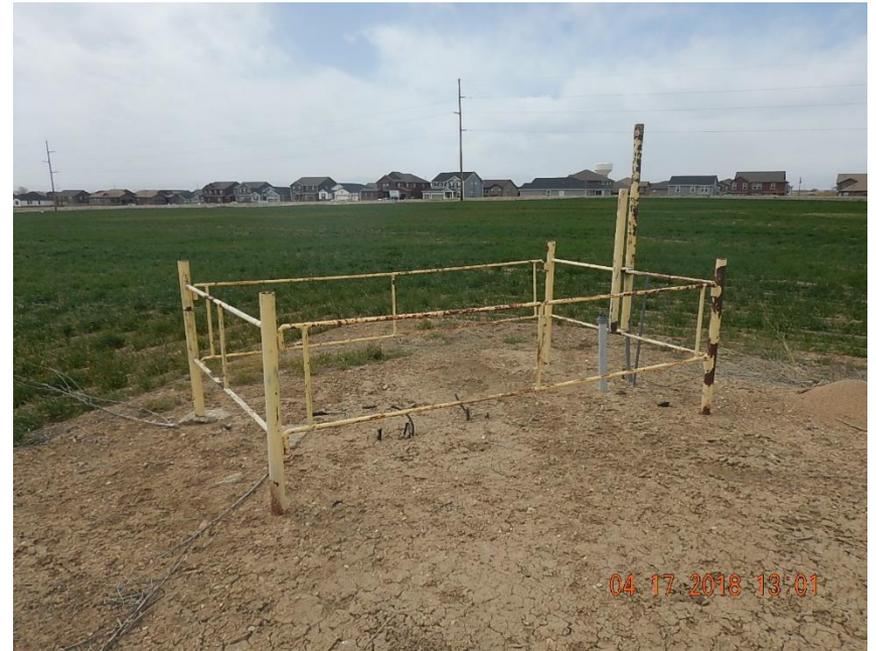
Unused pipe barrier on west side of location

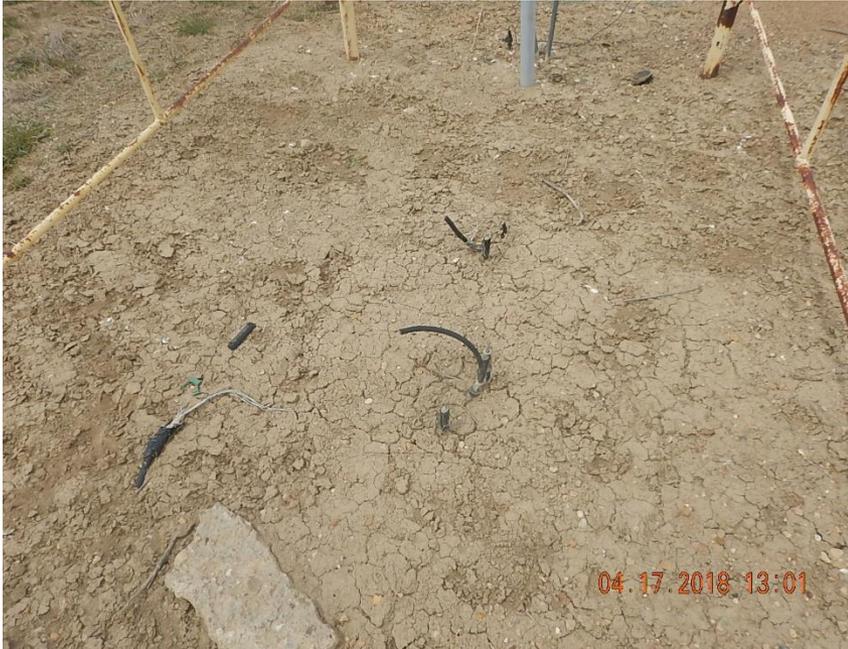
Trash/ unused electric wire and conduit requiring removal

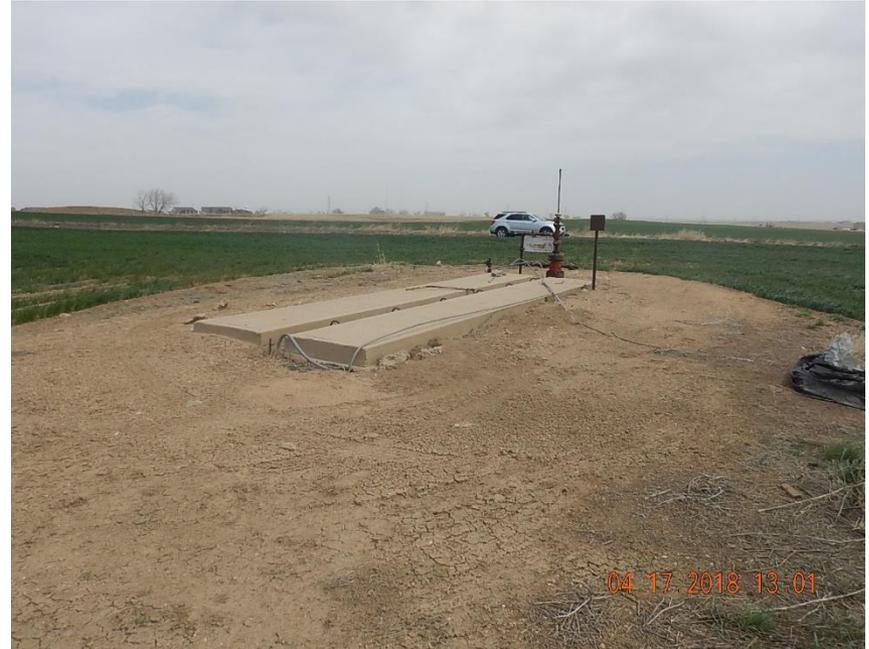
Trash and unused equipment on location (view east)
