**Inspection Photo**  
**Clough RMV 240-29**  
**API# 045-07486**  
**Inspection # 689300946**

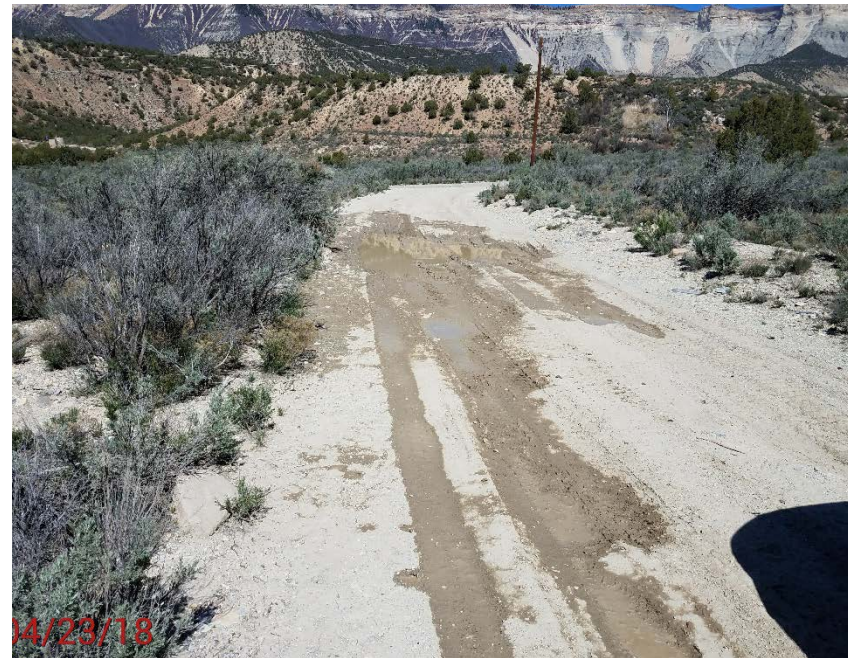
**Photo #2 Access road needs repaired**
