Caerus D09A Pad
API 045 17758
Spill/Release Point ID #454721 (Flowline Spill)

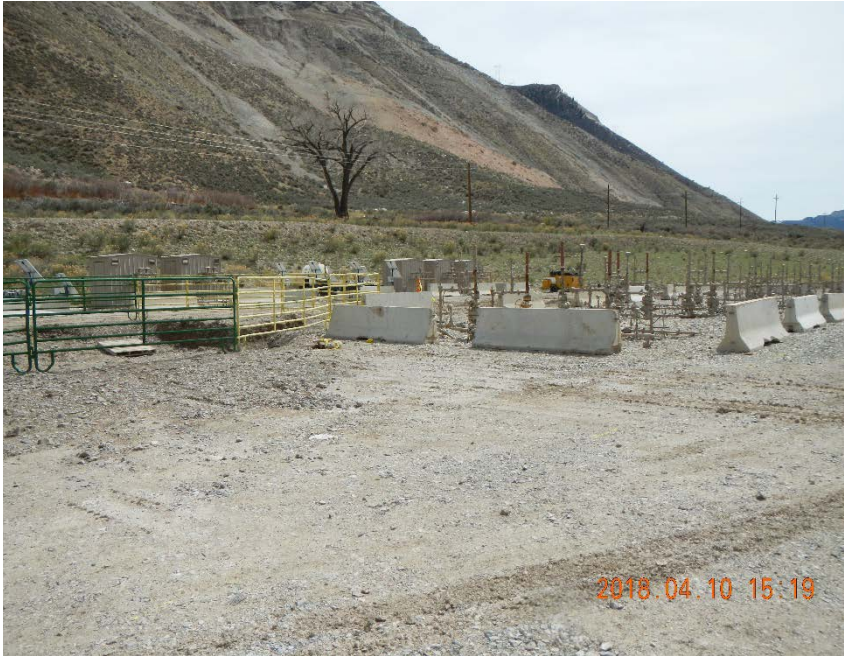
Looking south. Excavated area on the left, near wellheads

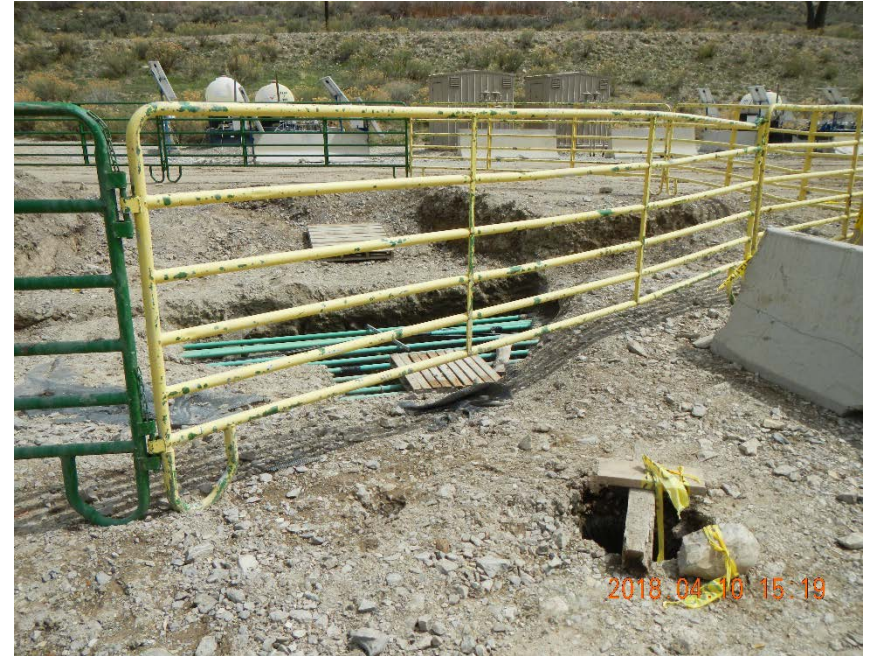
Looking east. Area excavated with hydrovac. Pipeline corridor with multiple pipelines difficult excavation.

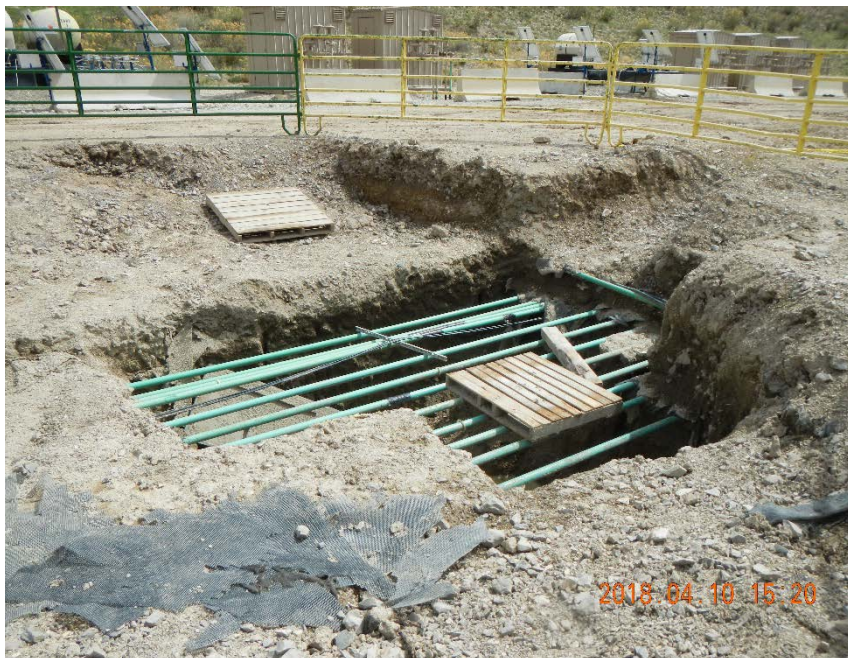
Pipeline has been repaired. Initial samples indicated some HC impact remaining. Excavation was expanded and sampling was repeated. Samples currently in the lab.

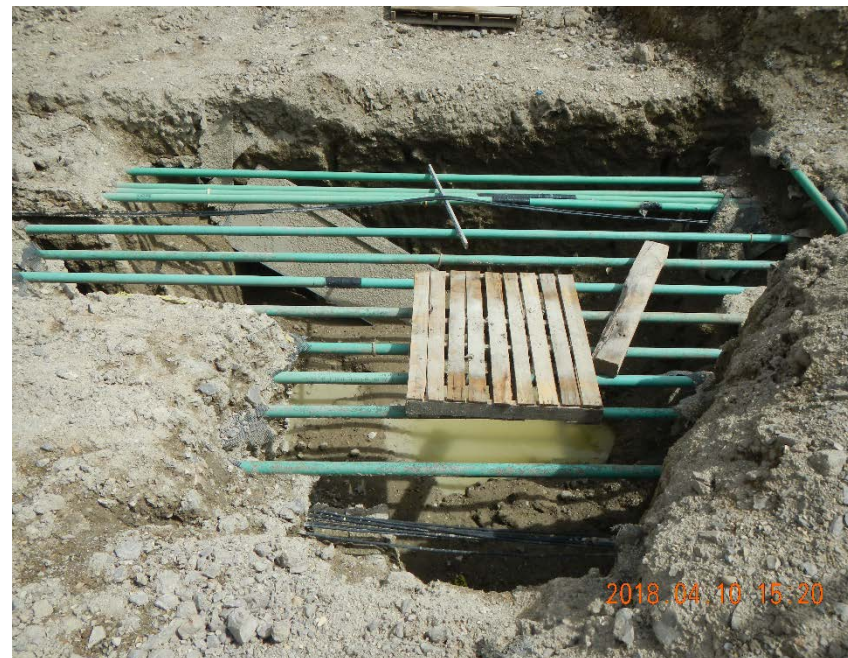
Water at the bottom is remnant of hydrovac activity.

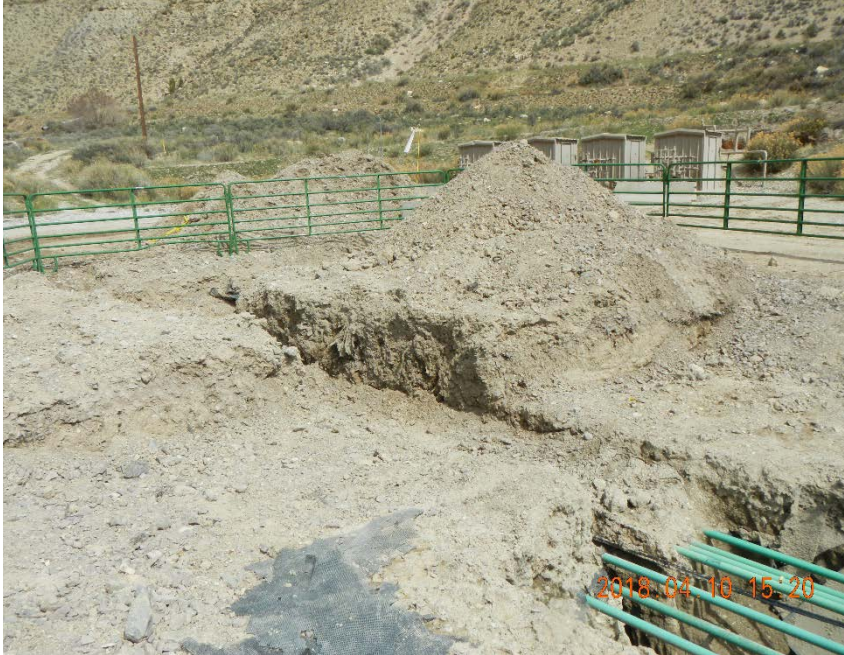
Pipeline corridor to the north

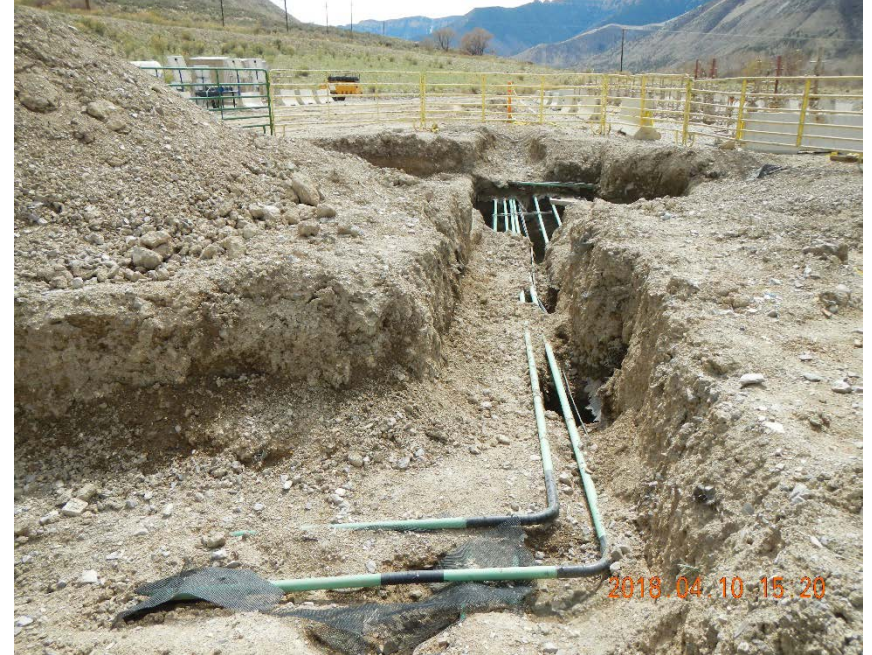
Pipeline corridor, looking south.
