Inspection Photos

API: 05-067-05624

Operator: THOMPSON ENGINEERING &
PRODUCTION

Inspection Date: 4/12/2018

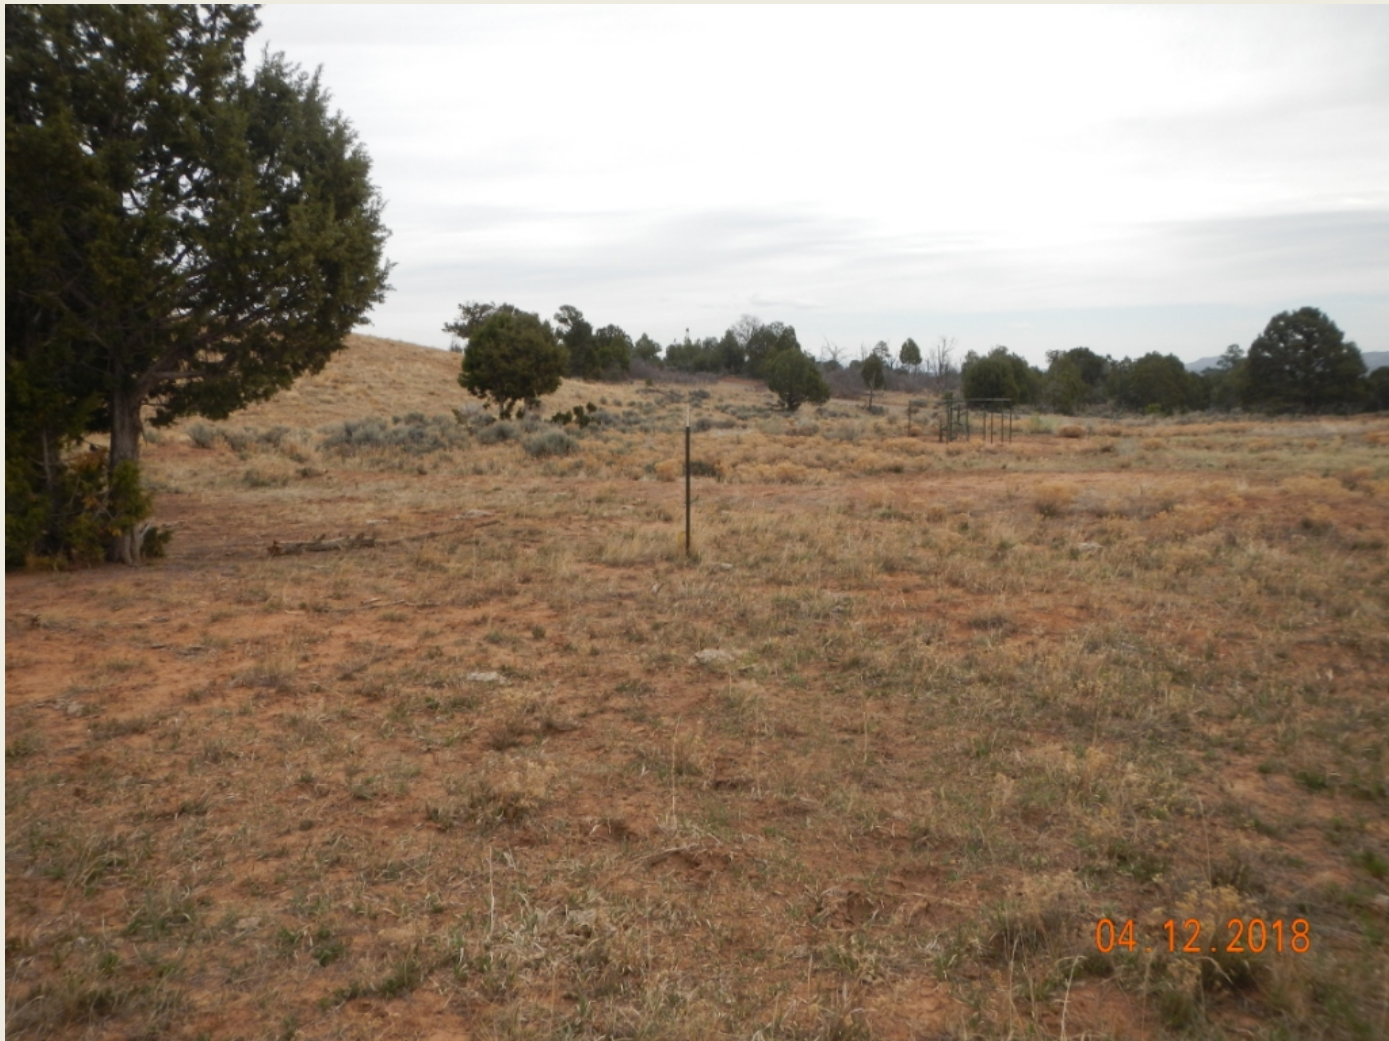
Photo 1. View of the project area from the northwestern edge facing toward the wellhead. Revegetation is progressing with grasses such as western wheatgrass (*Pascopyrum smithii*) and smooth brome (*Bromus inermis*).

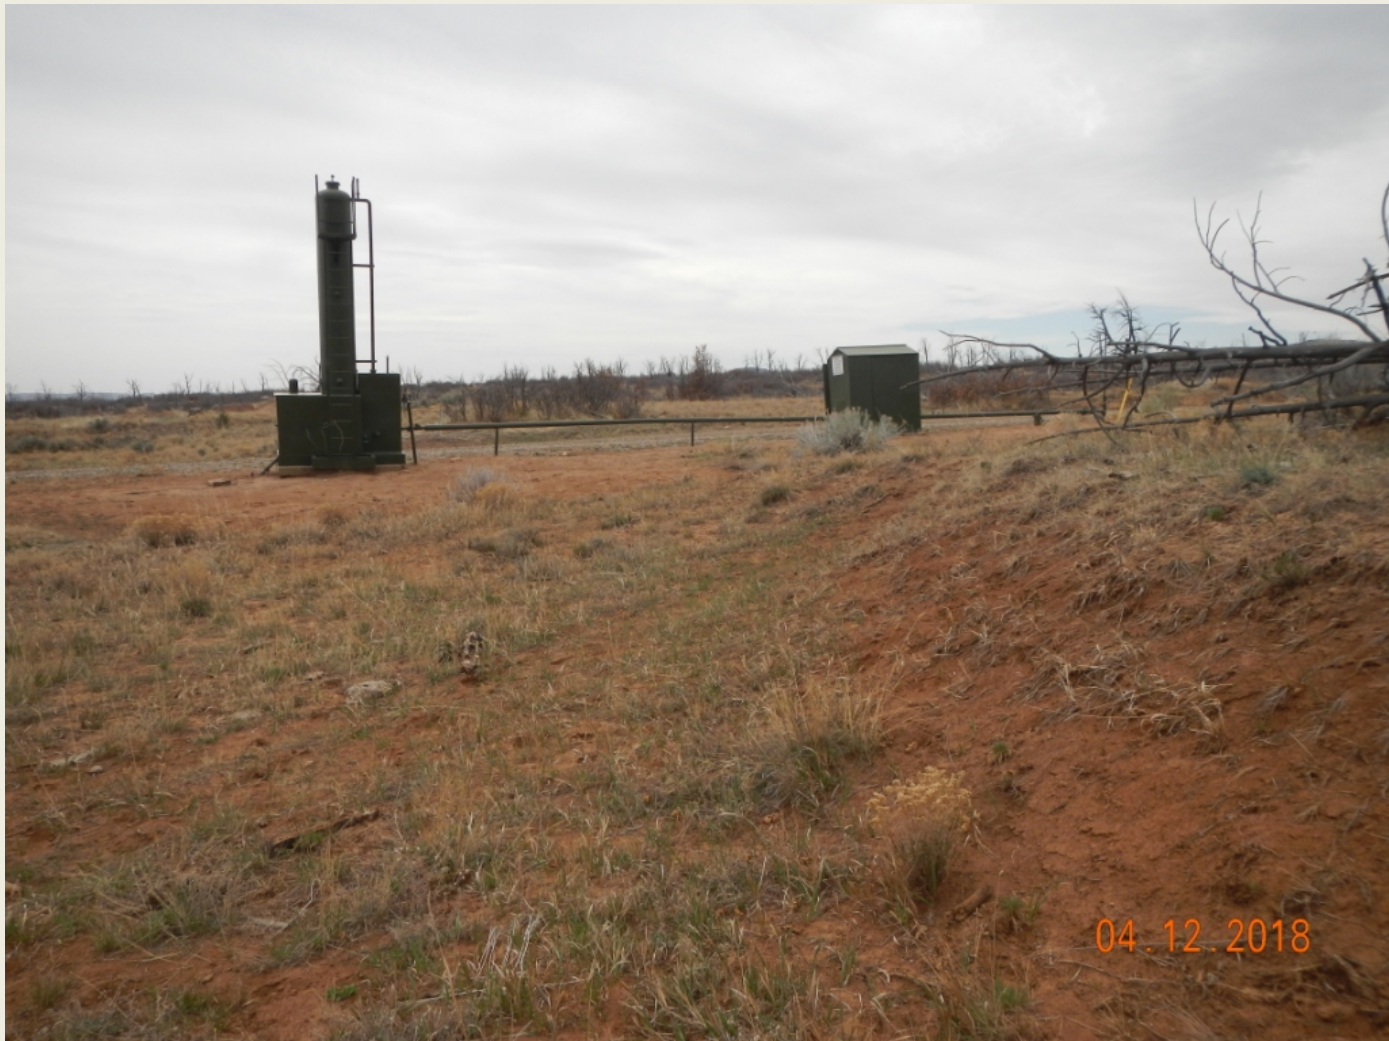
Photo 2. View of the western portion of the project area from the northwestern edge facing southward.

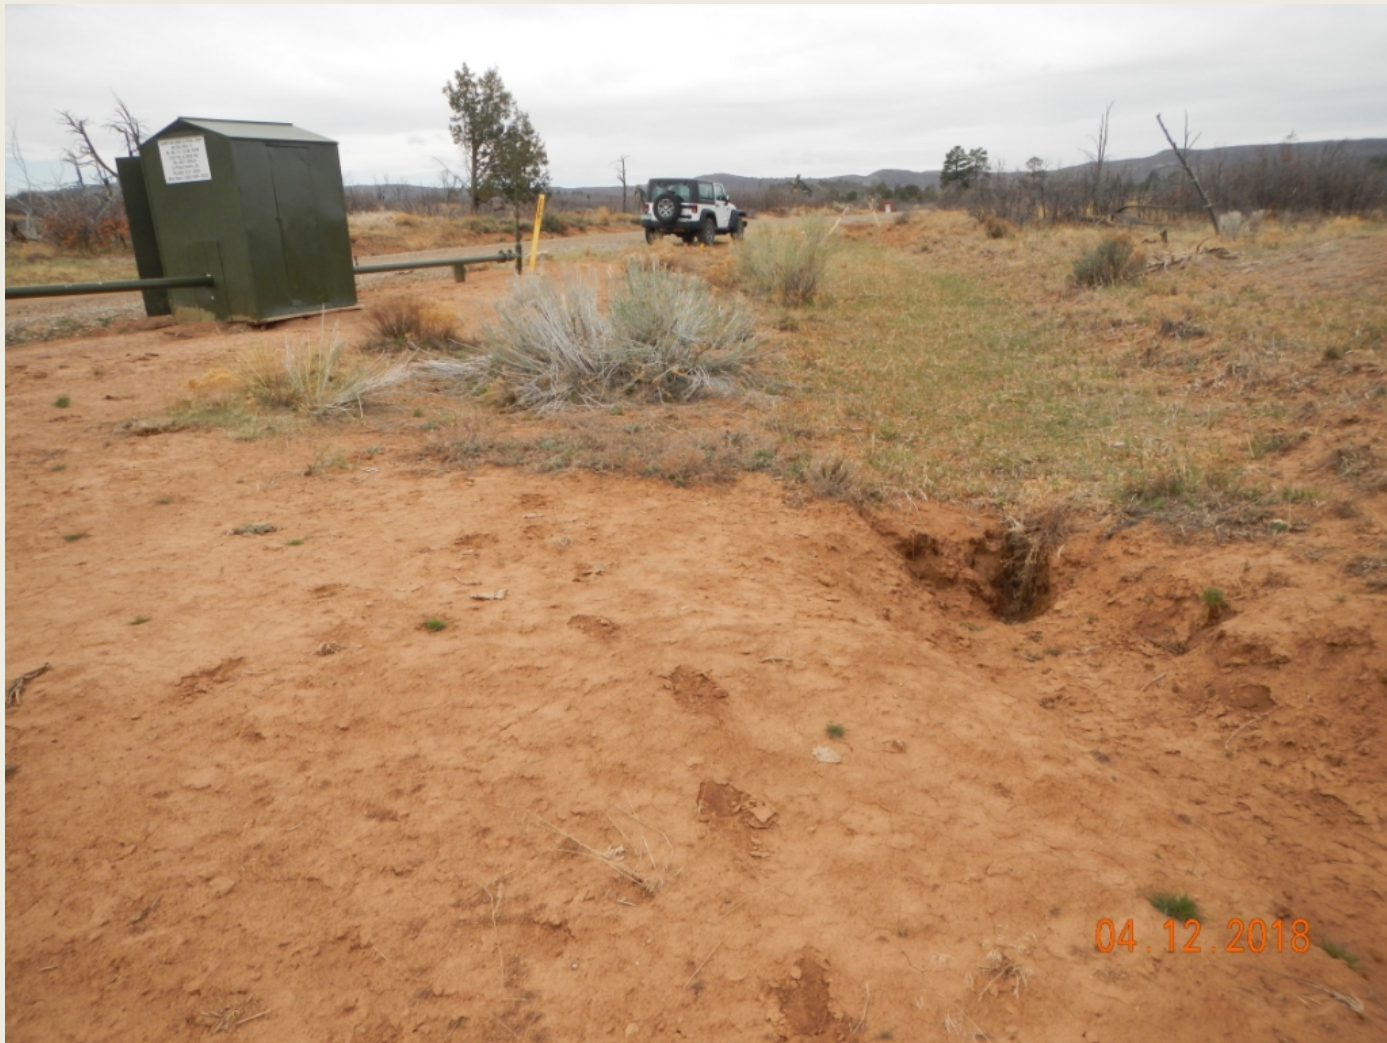
Photo 3. View of head-cut erosion occurring in the southwestern portion of the project area. Stormwater controls need to be installed to stabilize head-cut and de-energize stormwater flows here.

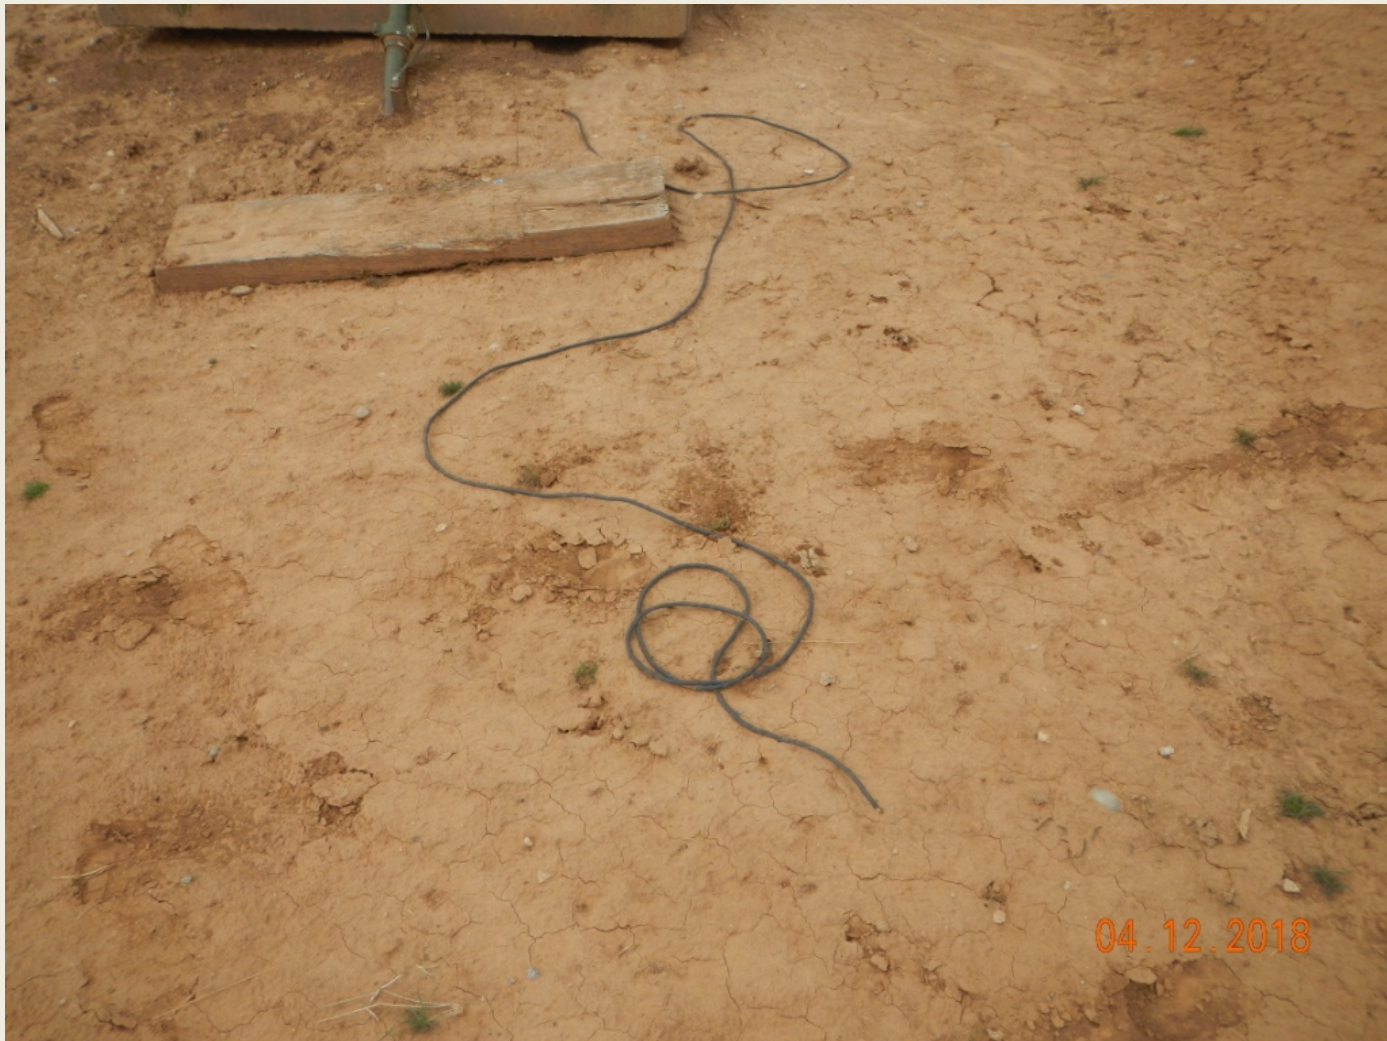
Photo 4. View of exposed wire debris near project facilities on the well pad. Several small pieces of debris observed and need to be removed.
