GOLDEN EAGLE MINE GE-71-93 API# 05-071-06455 – TIMBER CREEK
OGCC OPERATOR NUMBER 10672 – INSPECTION DATE: APRIL 23, 2018
CORRECTIVE ACTIONS COMPLETED REGARDING COGCC FIR DOCUMENT # 680102769

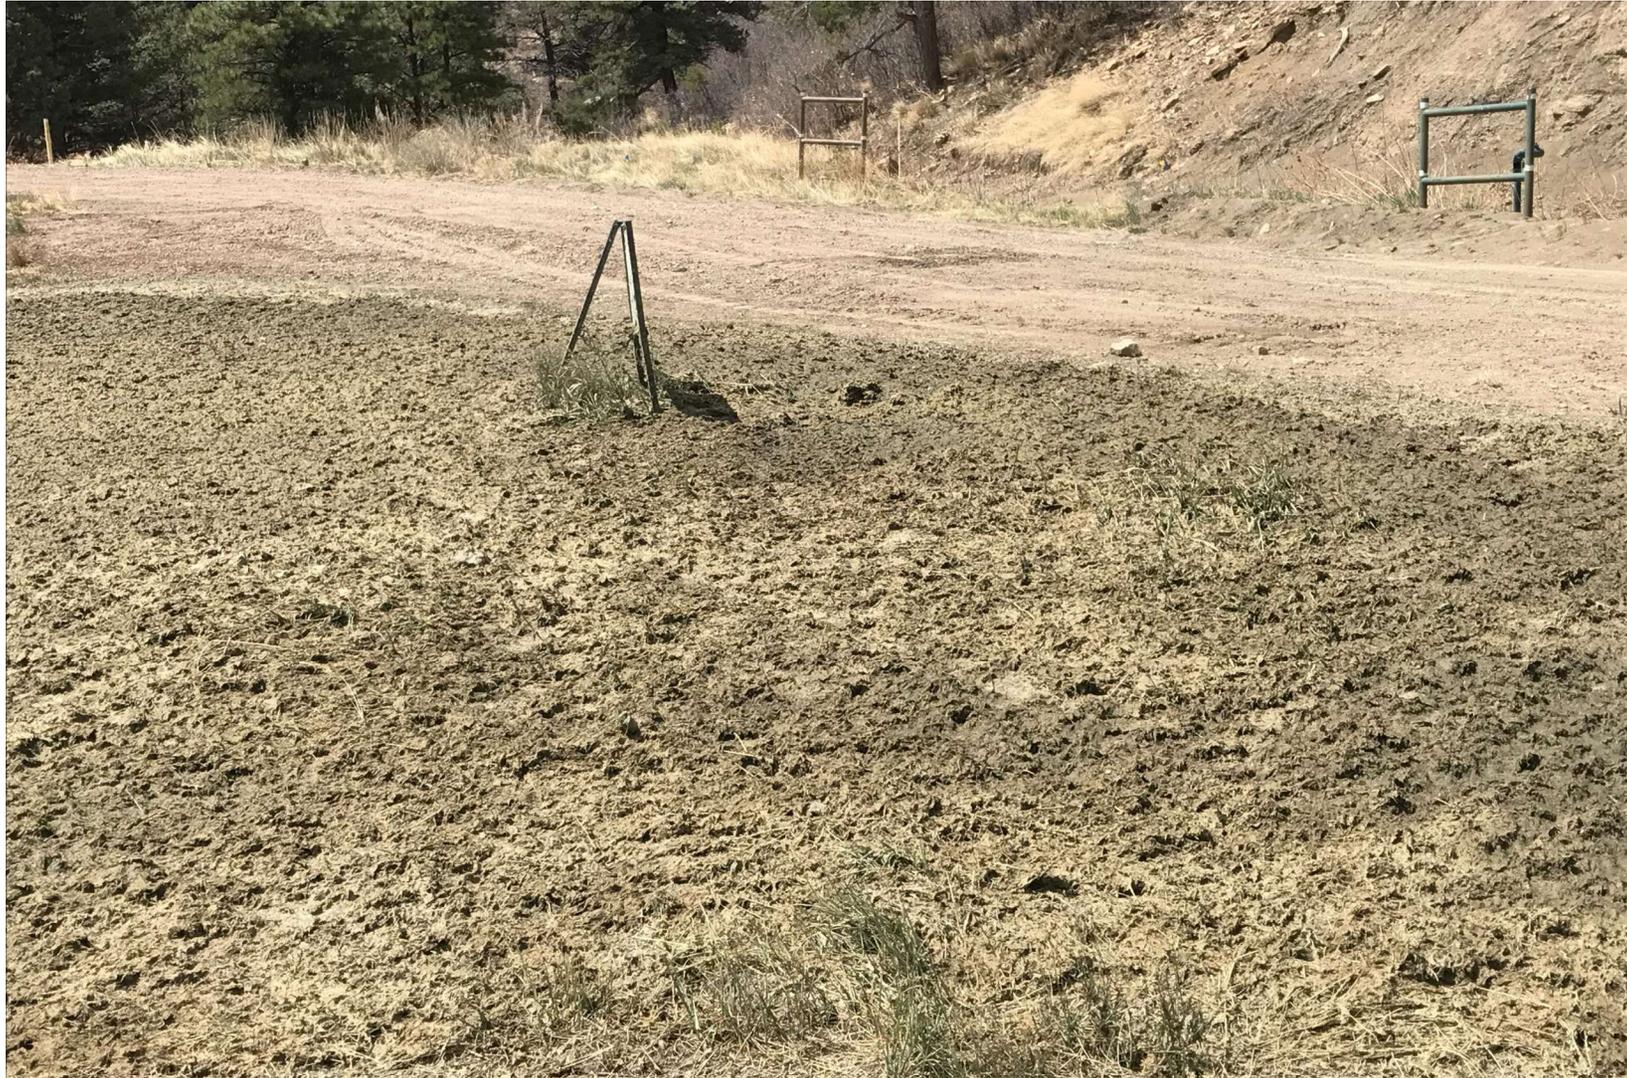
PHOTO 1: OVERVIEW OF LOCATION TO NORTHWEST

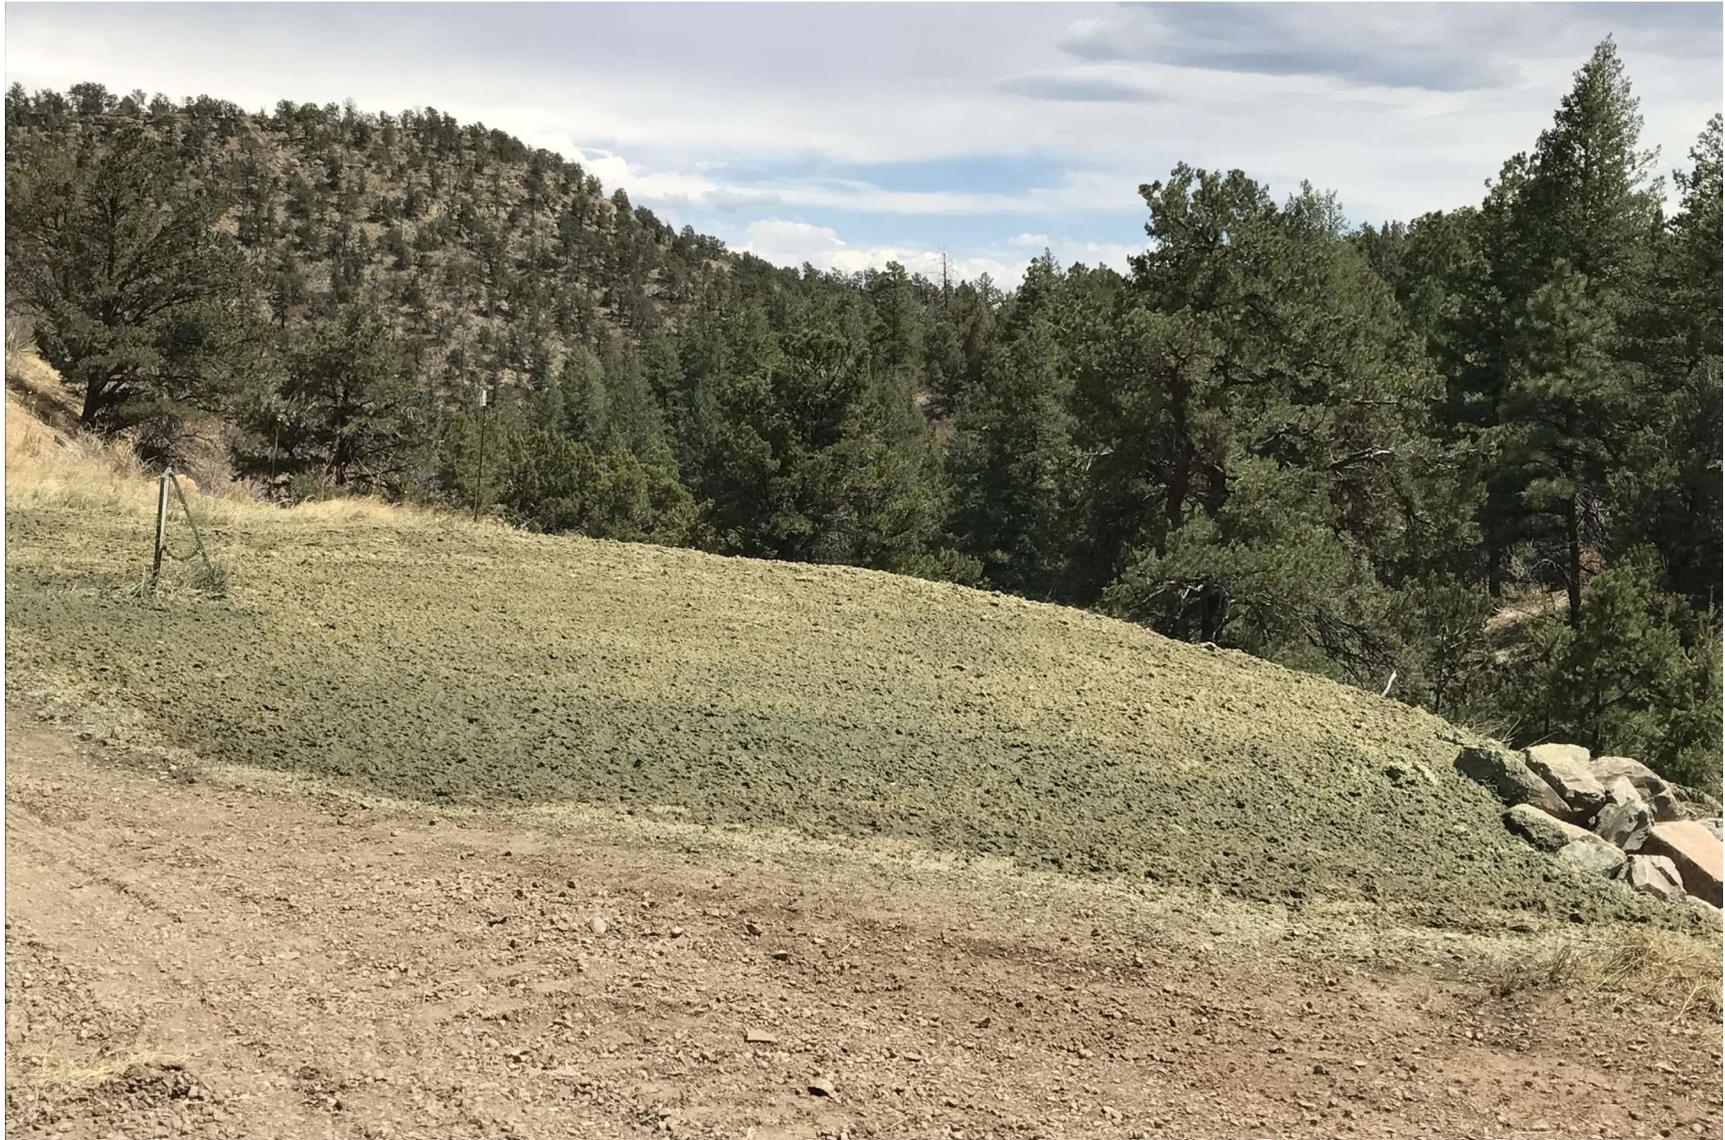
PHOTO 6: SITE FACING EAST, ADJACENT TO THE LEASE ROAD.
