Inspection Photos  
Location Name: Rouse USX A #5-17  
Location: 306455

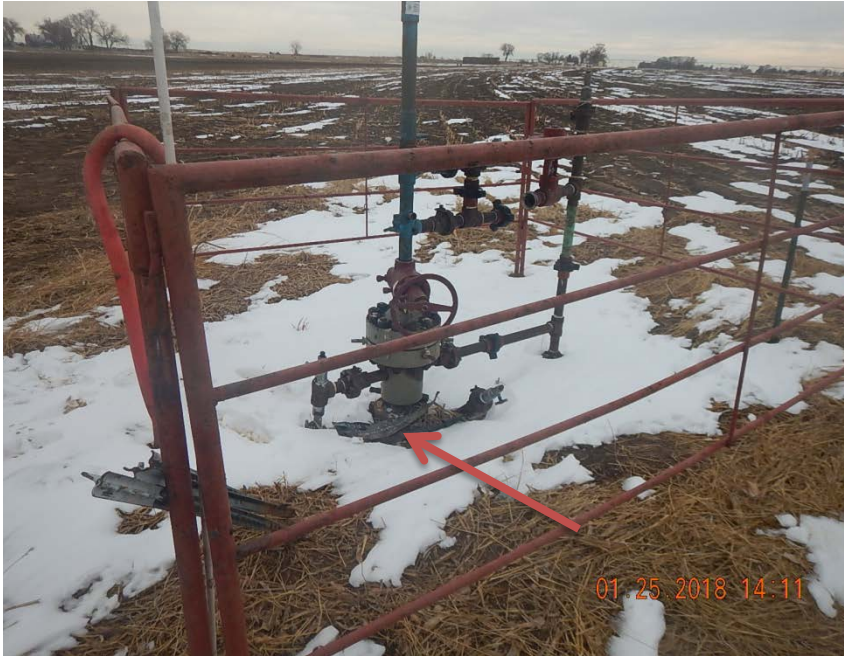
Photo from prior inspection for comparison (arrow emphasis on damaged sign)

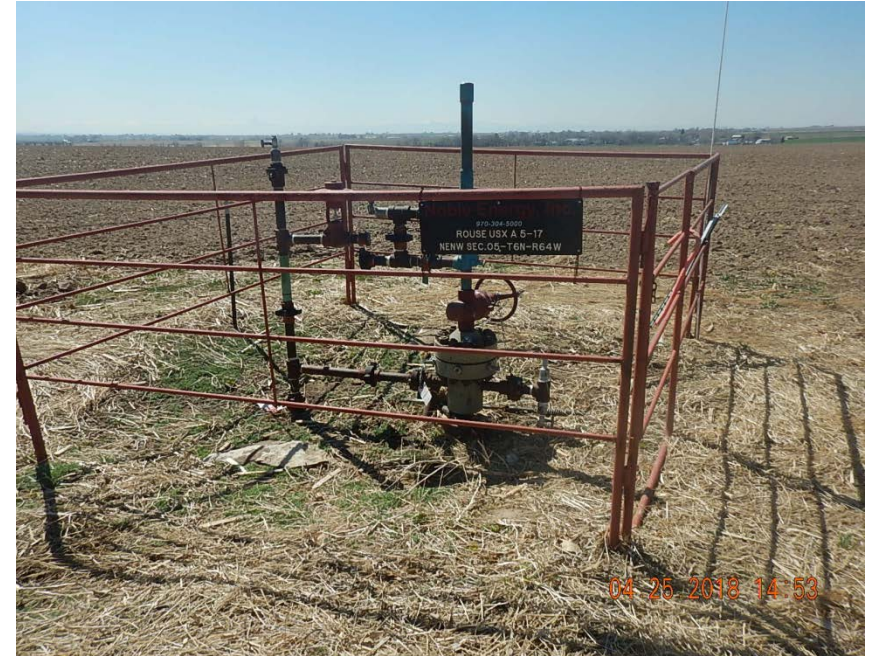
Photo 1: Wellhead, looking SW. Sign repaired.
