Inspection Photos

API: 05-067-08641

Operator: HILCORP ENERGY COMPANY

Inspection Date: 4/12/2018

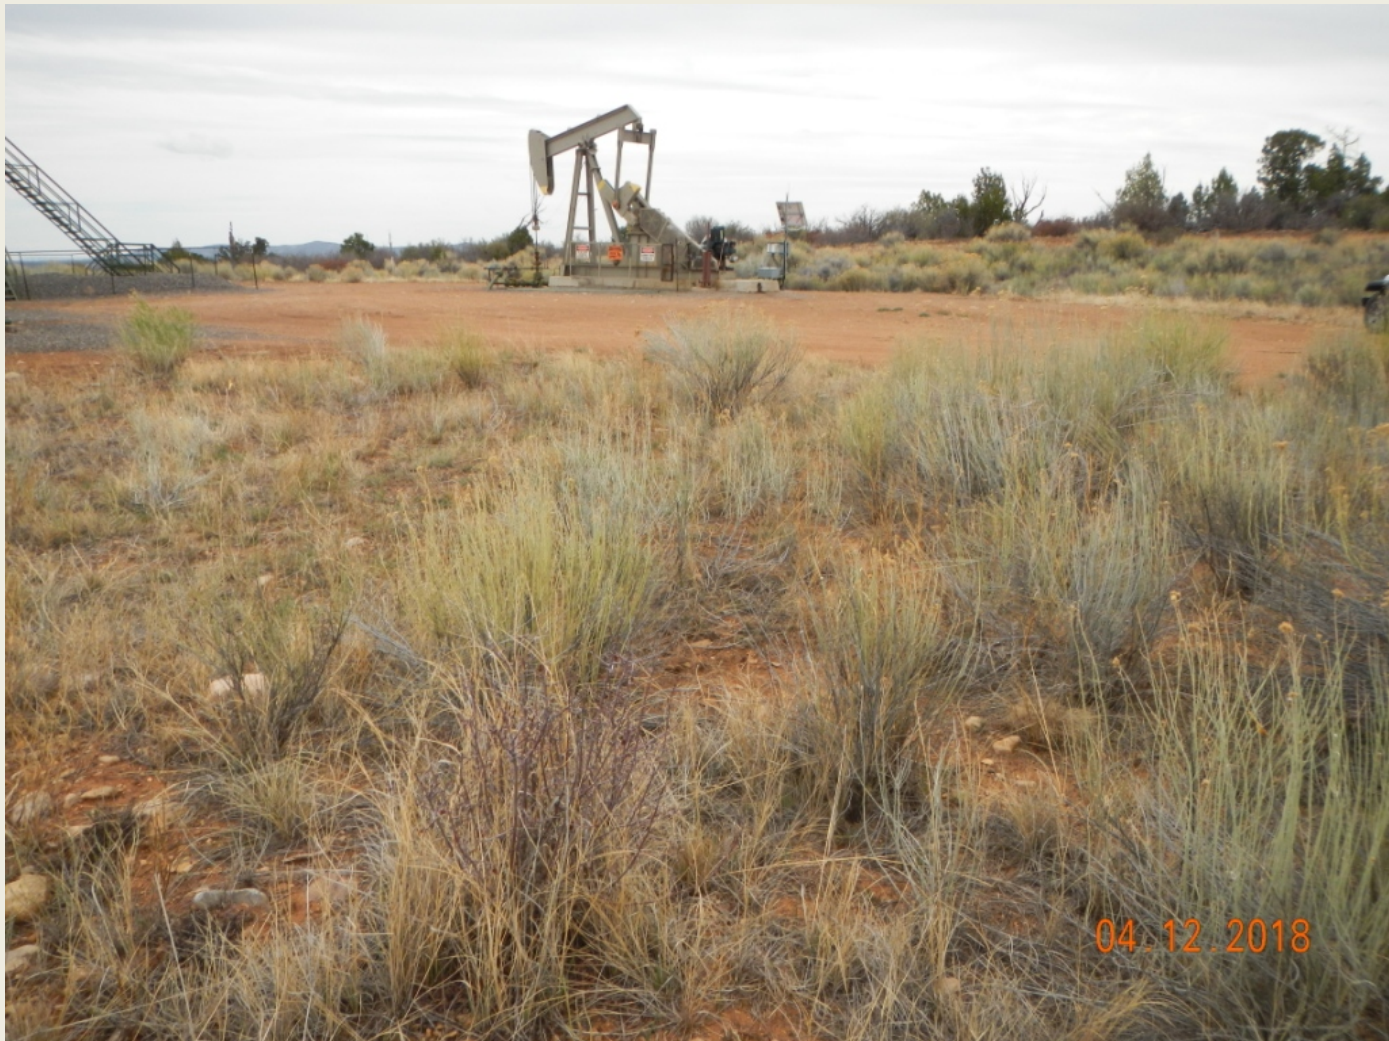
Photo 1. View of the project area from the northwestern corner facing center.

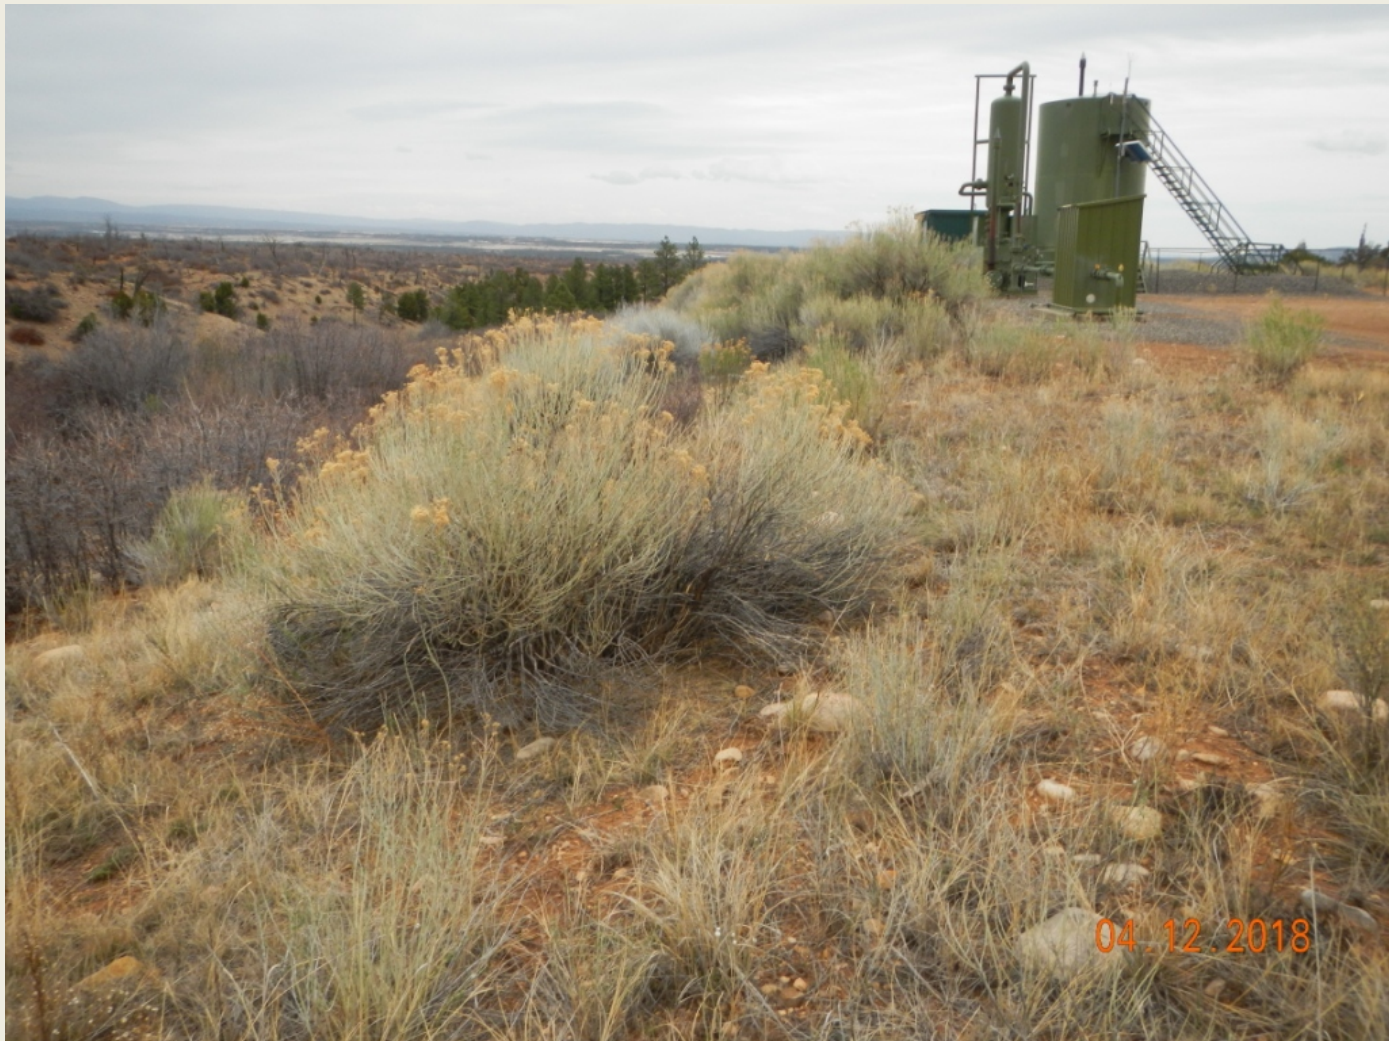
Photo 2. View of the northern portion of the project area from the northwestern corner facing eastward. Revegetation is progressing, largely with western wheatgrass (*Pascopyrum smithii*) and rubber rabbitbrush (*Chrysothamnus nauseosus*).

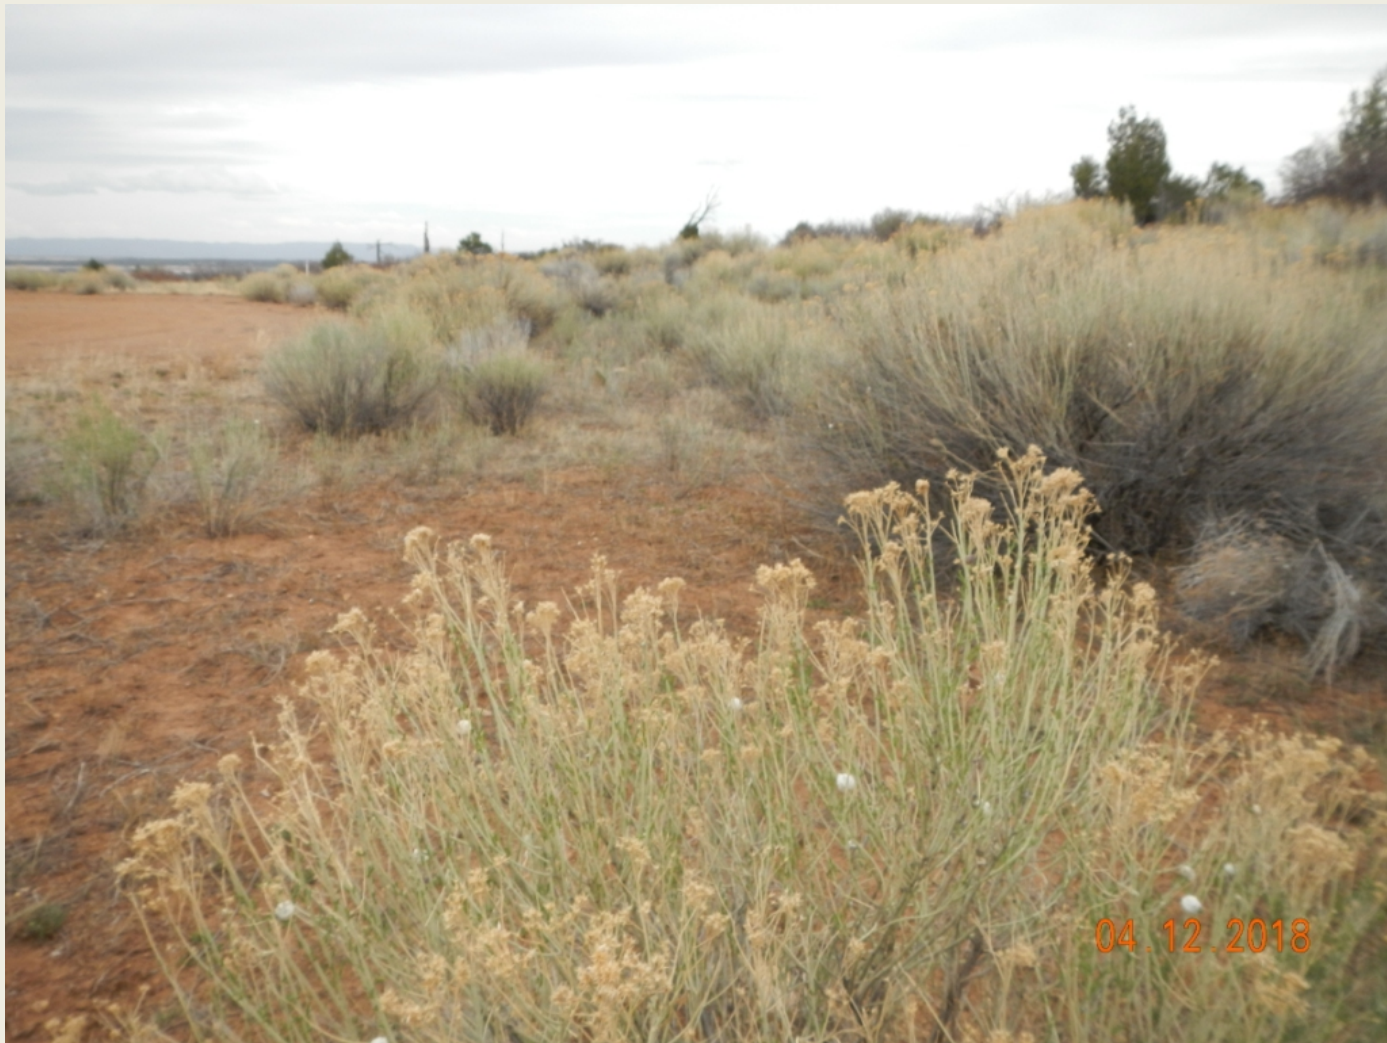
Photo 3. View of the southern portion of the project area from the southwestern portion facing eastward.

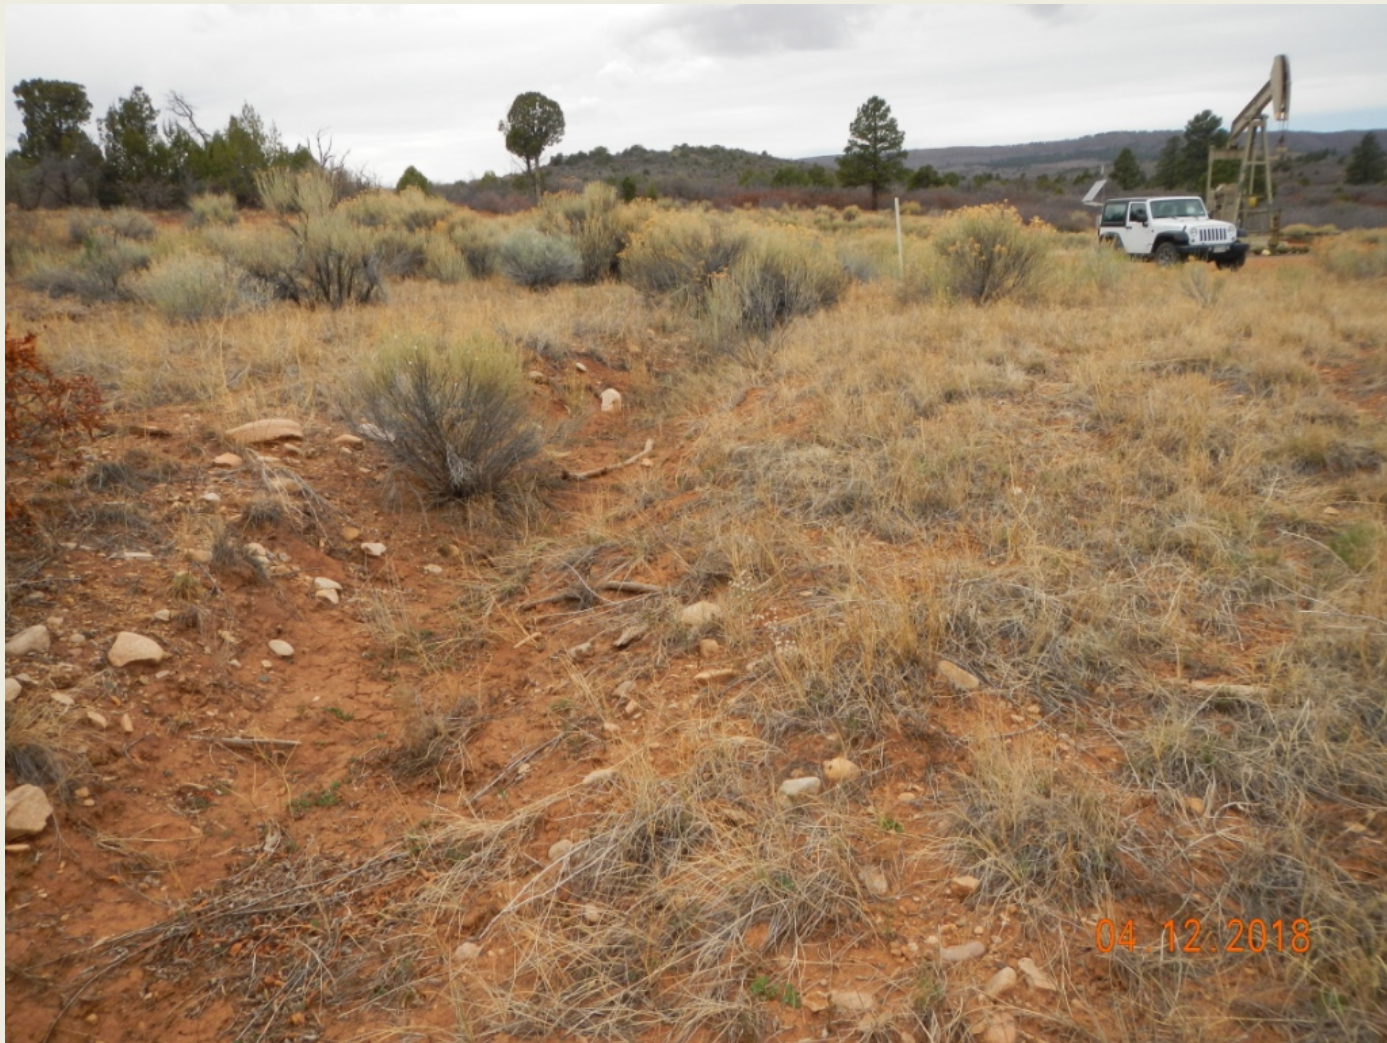
Photo 4. View of stormwater diversion in the southwestern portion of the project area.

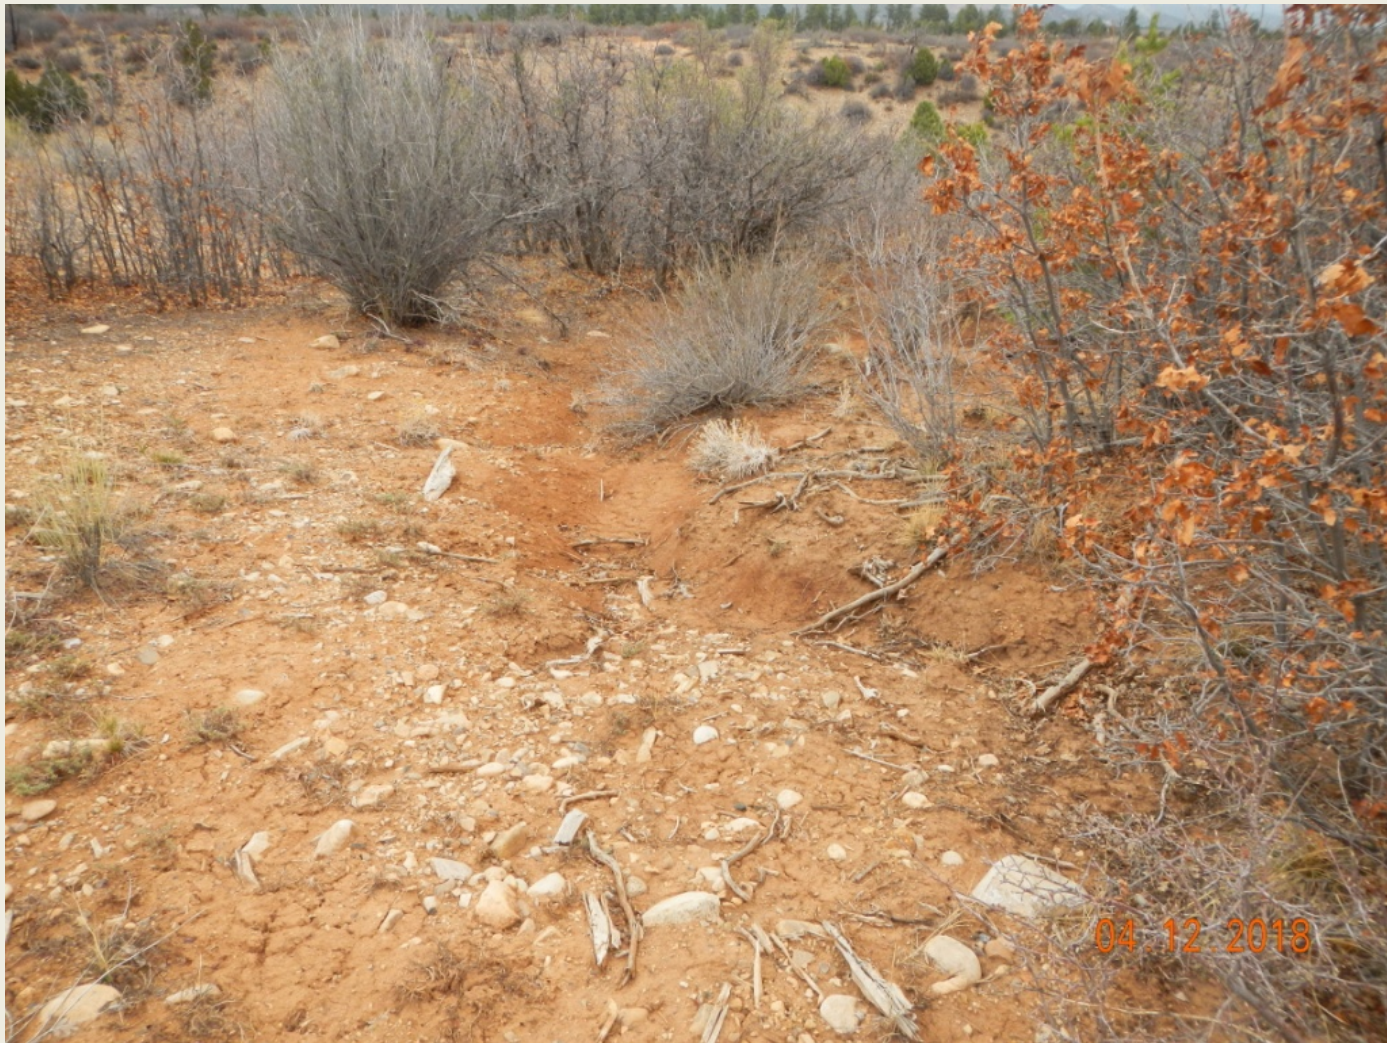
Photo 5. View of erosional channel where concentrated stormwater from well pad diversion erodes the southeastern corner of the project area. Stormwater controls are needed to de-energize flows and contain sediment.

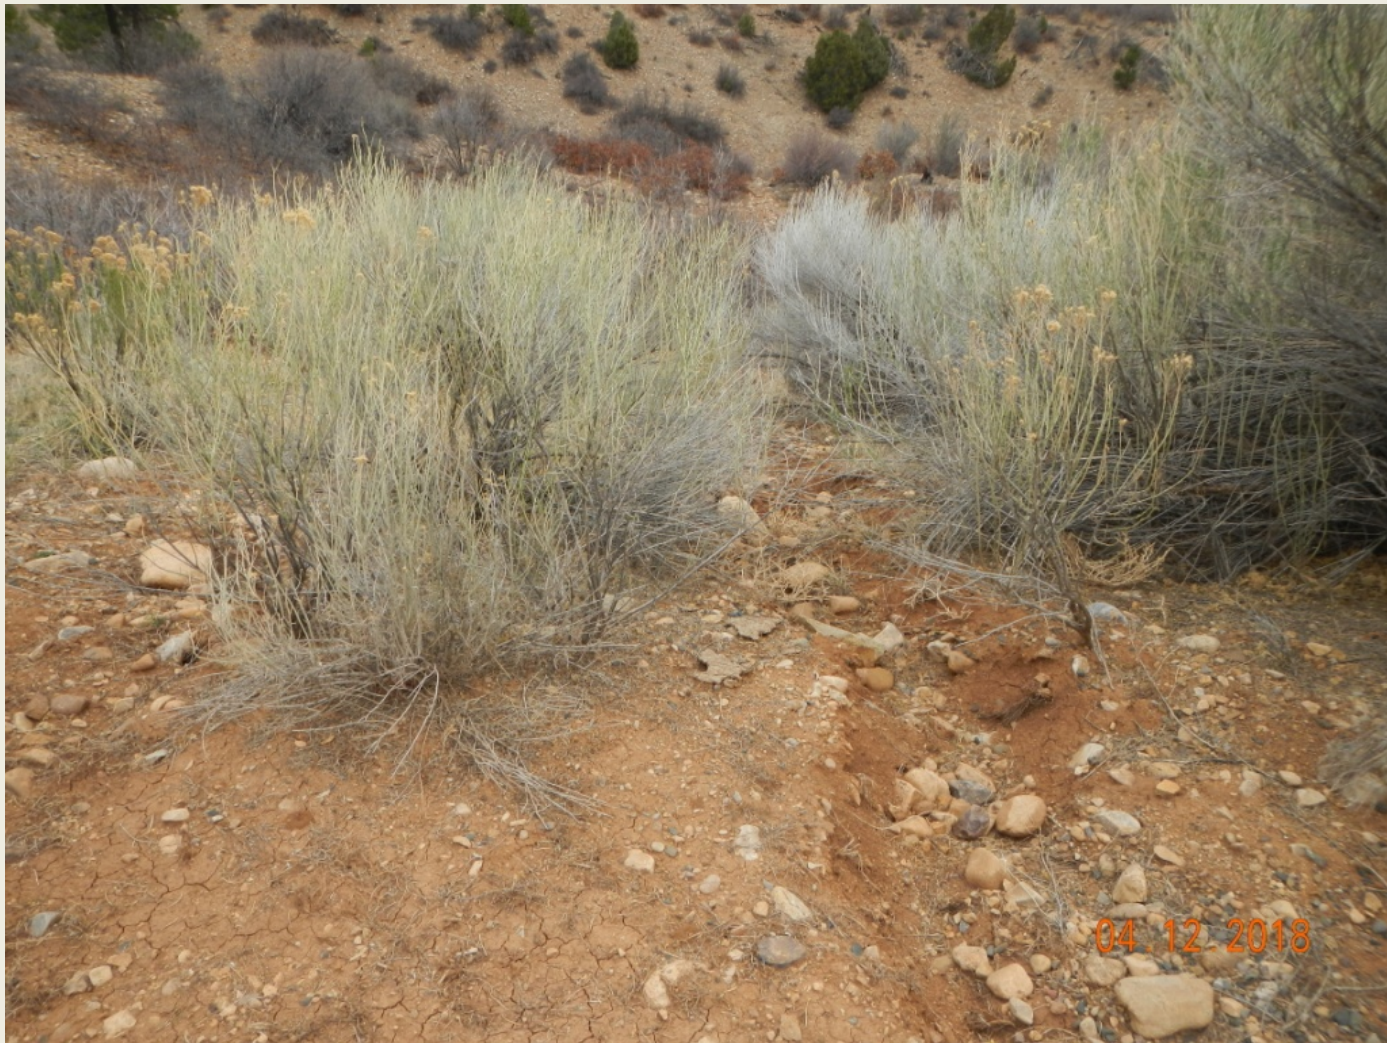
Photo 6. View of erosion where concentrated stormwater flows off of the northern project area.

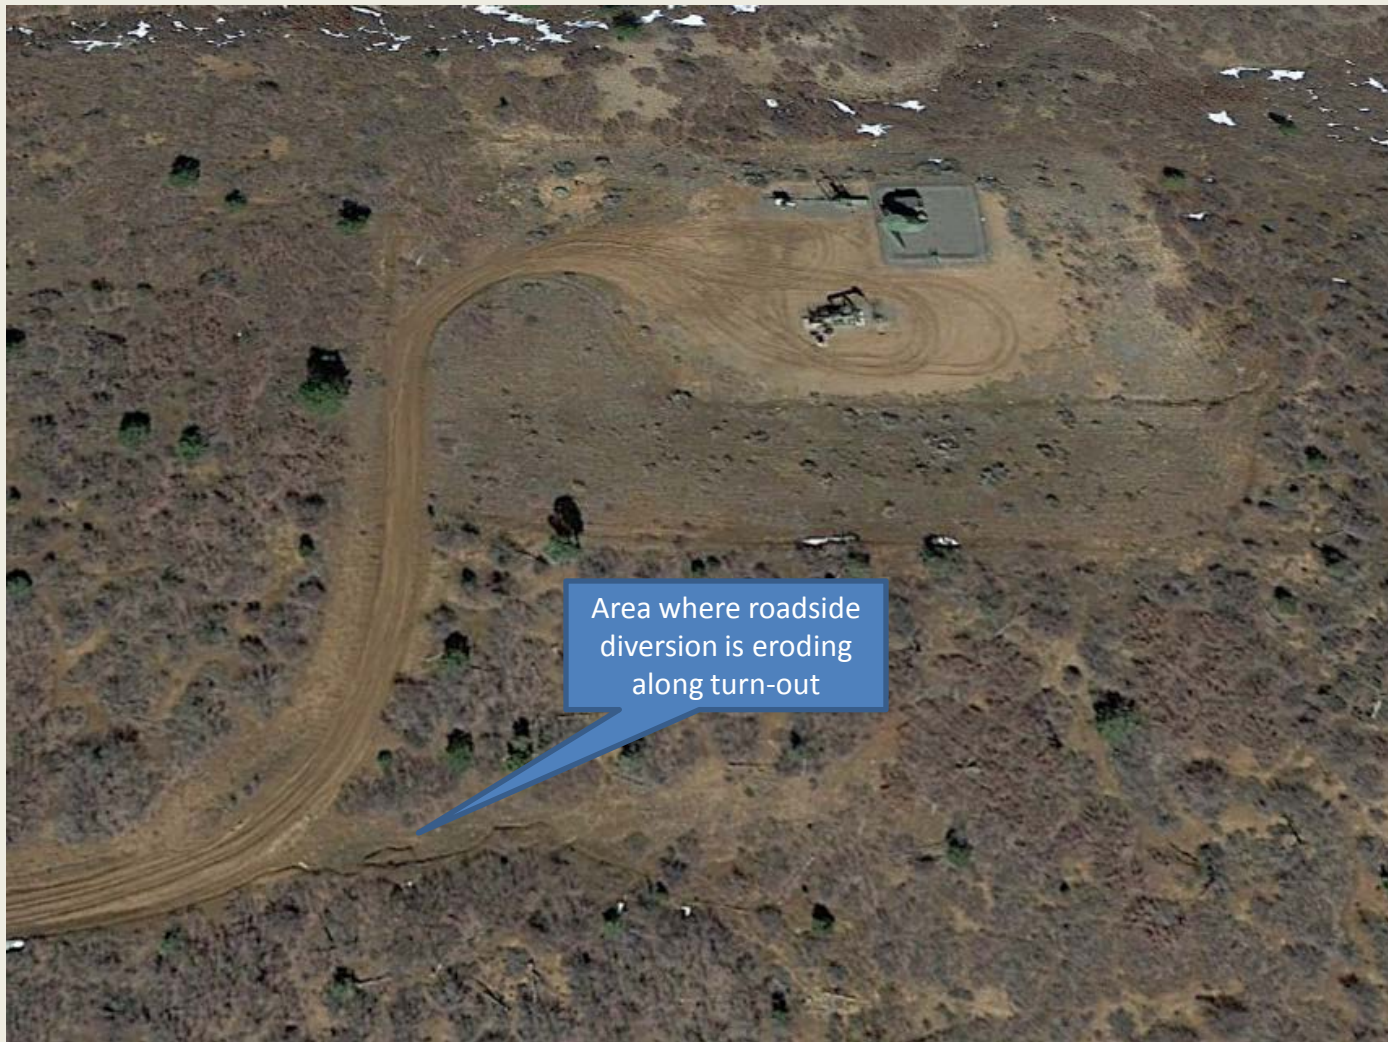
Area where roadside
diversion is eroding
along turn-out

Photo 7. Aerial view of erosion from access road.
